Project Newcomen Bank Building 16 Castle Street, Dublin 2			
Client Dublin City Council			
Drawing Cantilever Stairs			
Project Stage Planning	Date 16.02.2024	Scale Varies@A3	Project No. 0569

Drawing No. C-026	Revision -
----------------------	---------------

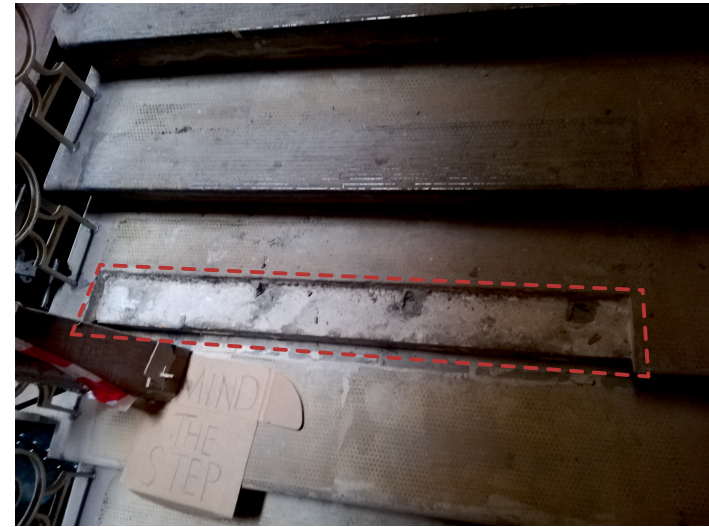
Photograph of the stairs where the metal insert has come loose

The repair approach has been outlined in the design statement. Load testing will be required to ensure that the steelwork can be removed from the underside of the stair and then determine the extent of thread replacement required.
