Project
Newcomen Bank Building
16 Castle Street, Dublin 2

Drawing
Existing North Elevation

Project Stage Planning **Date** 16.02.2024 **Scale** 1:100@A3 **Project No.** 0569 **Drawing No.** L-120 **Revision** -

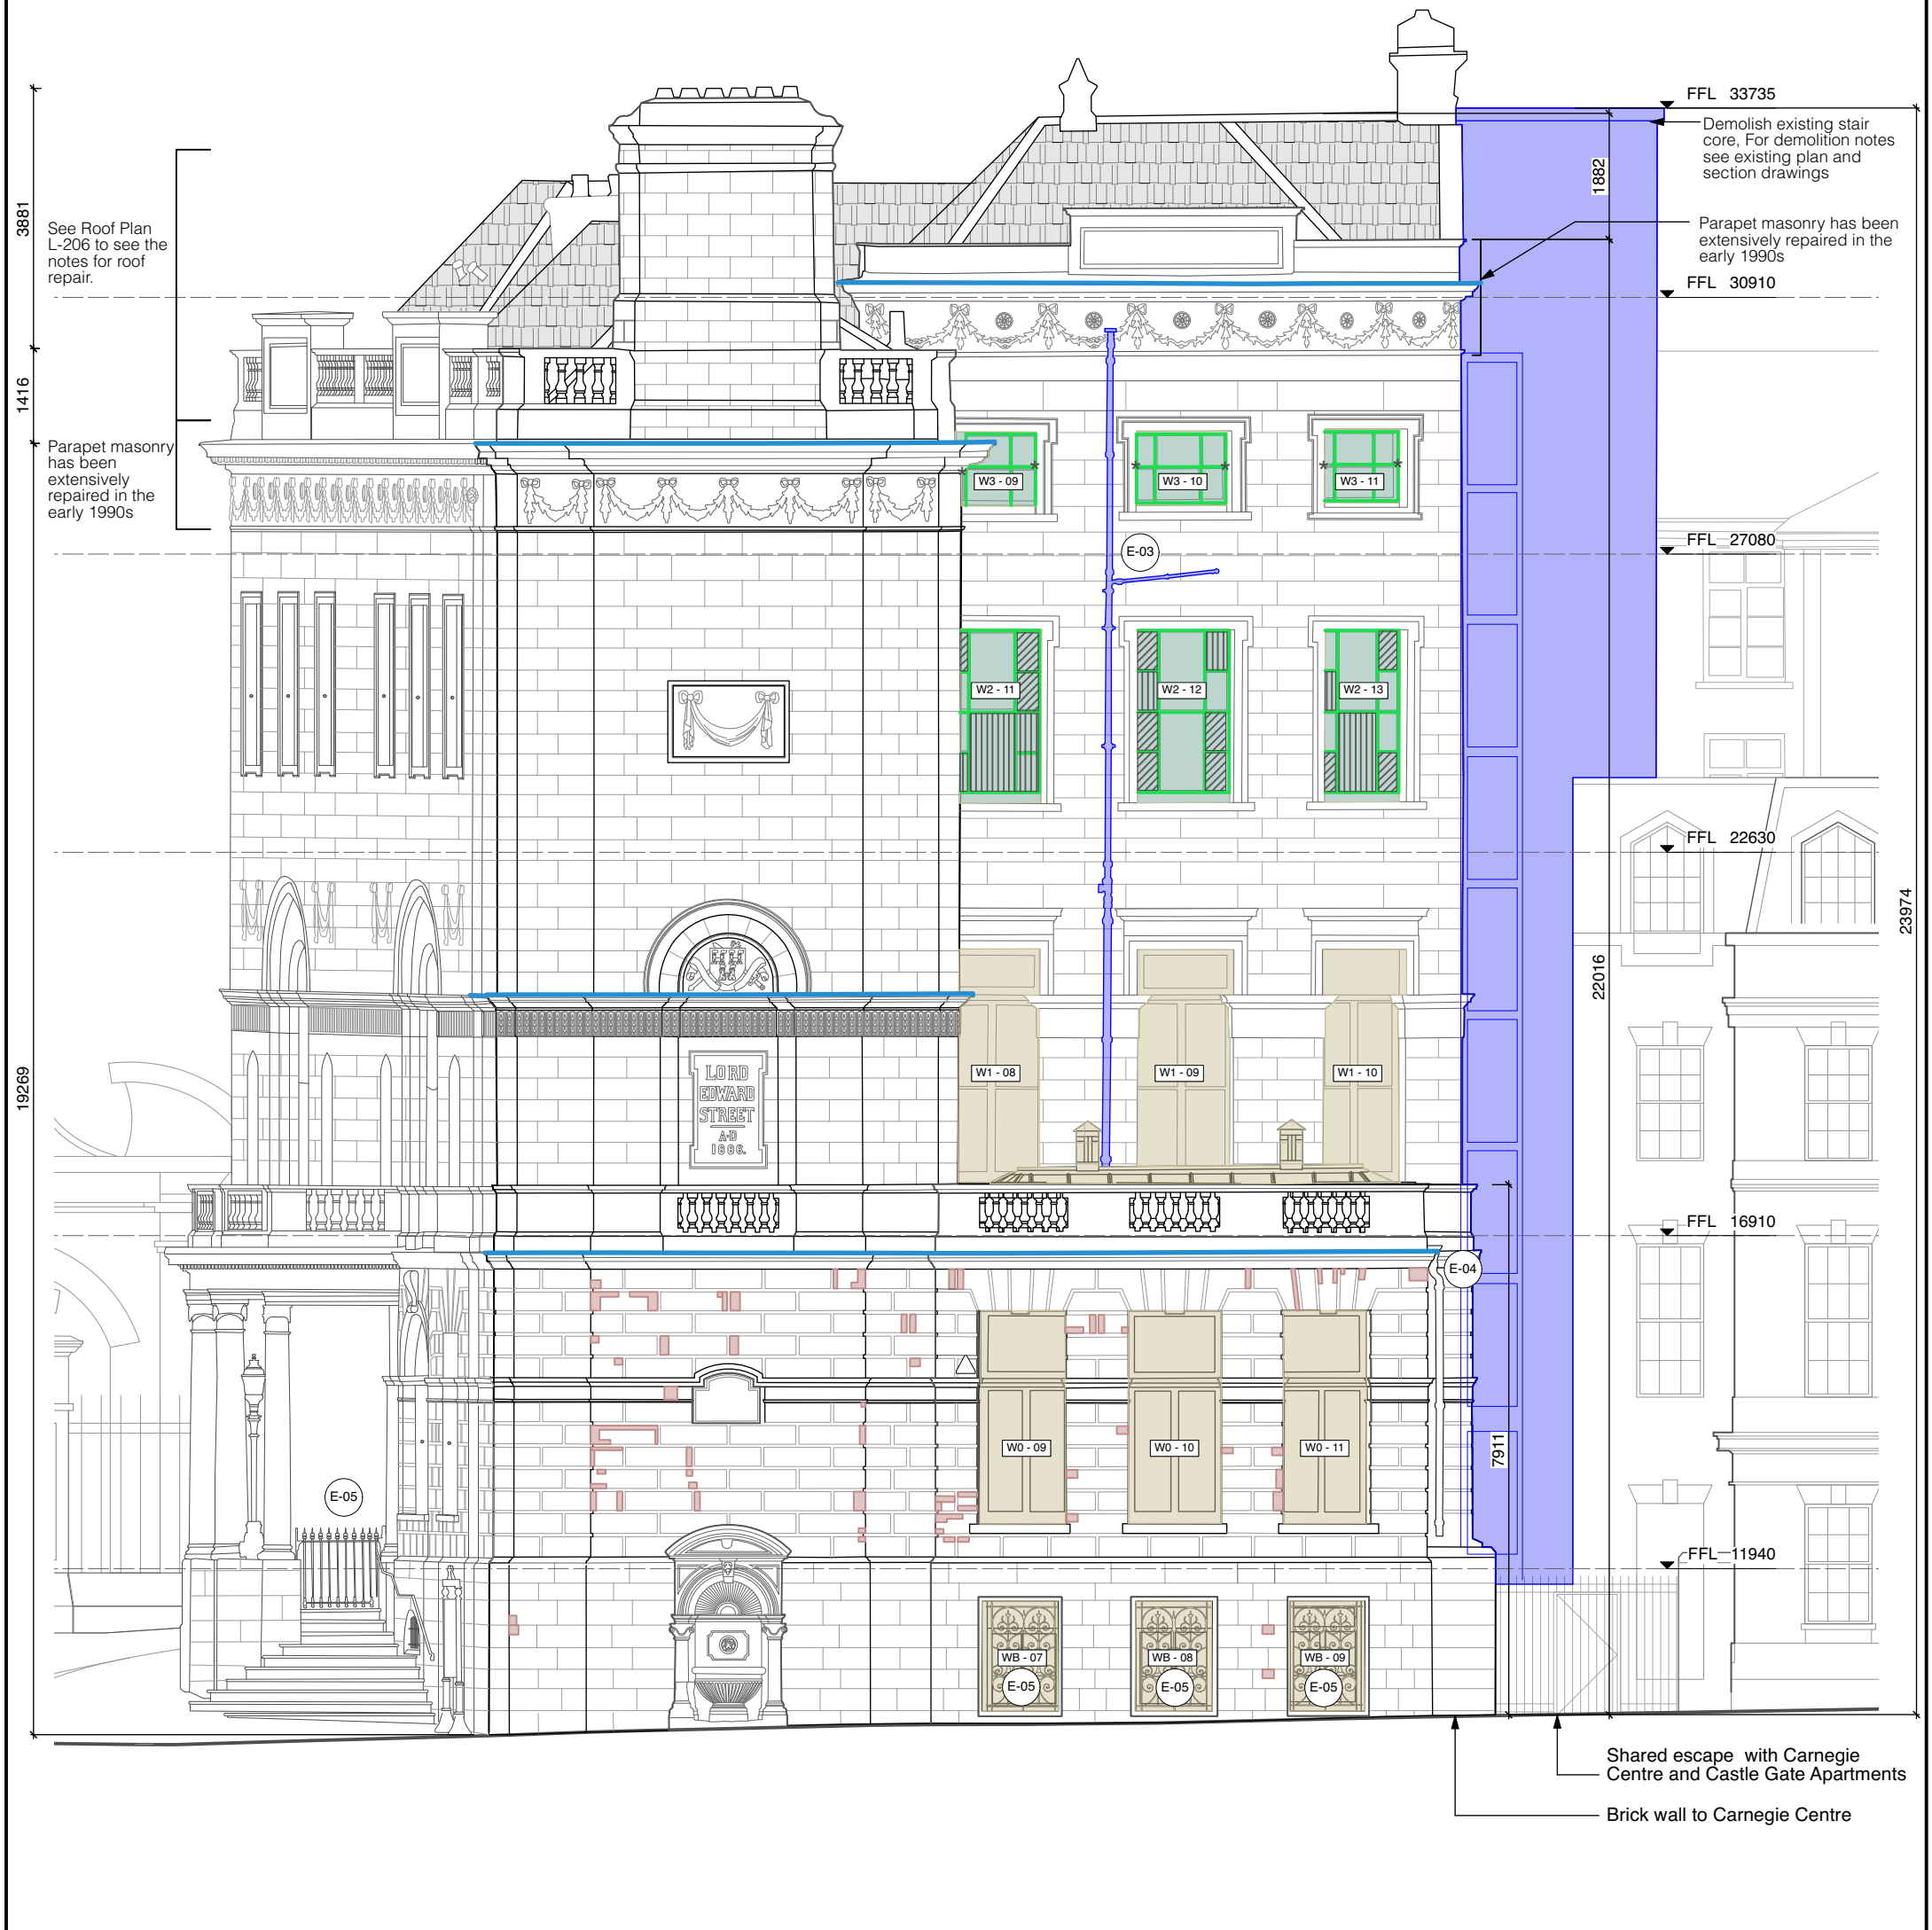
North Elevation

Windows
The windows have been repaired/ replaced on the Lord Edward Street facade. Much of the historic glass has been lost on this facade as a result of the various historic alterations to the facade.

Basement: Edwardian style windows added to the Freeman facade. Freeman extension dates to 1884. Glazing: Plate glass.

Ground floor: Edwardian style windows added to the Freeman facade. Freeman extension dates to 1884. Glazing: Plate glass.

First floor: Windows likely replaced with the current arrangement and design to match the ground floor and basement level windows. Glazing: Plate glass.

Second floor: Sash windows with a larger central pane where the central dividing glazing bars have been removed. Ovolo profile glazing bars. No horns at the sash frames. Much of the original glass has been lost or replaced.

Third floor: Sash windows with a larger central pane where the central dividing glazing bars have been removed. Ovolo profile glazing bars. Ogee horns at the sash frames. Much of the original glass has been lost or replaced.

E-01 Existing lanterns to be retained and put back into working order. Note these lanterns were repaired in 2010

E-02 Masonry repairs required to existing portland stone sill.

E-03 Existing soil vent pipe to be removed.

E-04 Repair of existing cast iron rainwater goods as required.

E-05 Retain and refurbish existing railings to Cork Hill porch and decorative guarding in front of basement windows at Lord Edward Street.
