**Project**  
Newcomen Bank Building  
16 Castle Street, Dublin 2

**Drawing**  
Existing West Elevation / Section PP

**Project Stage** Planning    **Date** 16.02.2024    **Scale** 1:100@A3    **Project No.** 0569    **Drawing No.** L-123    **Revision** -

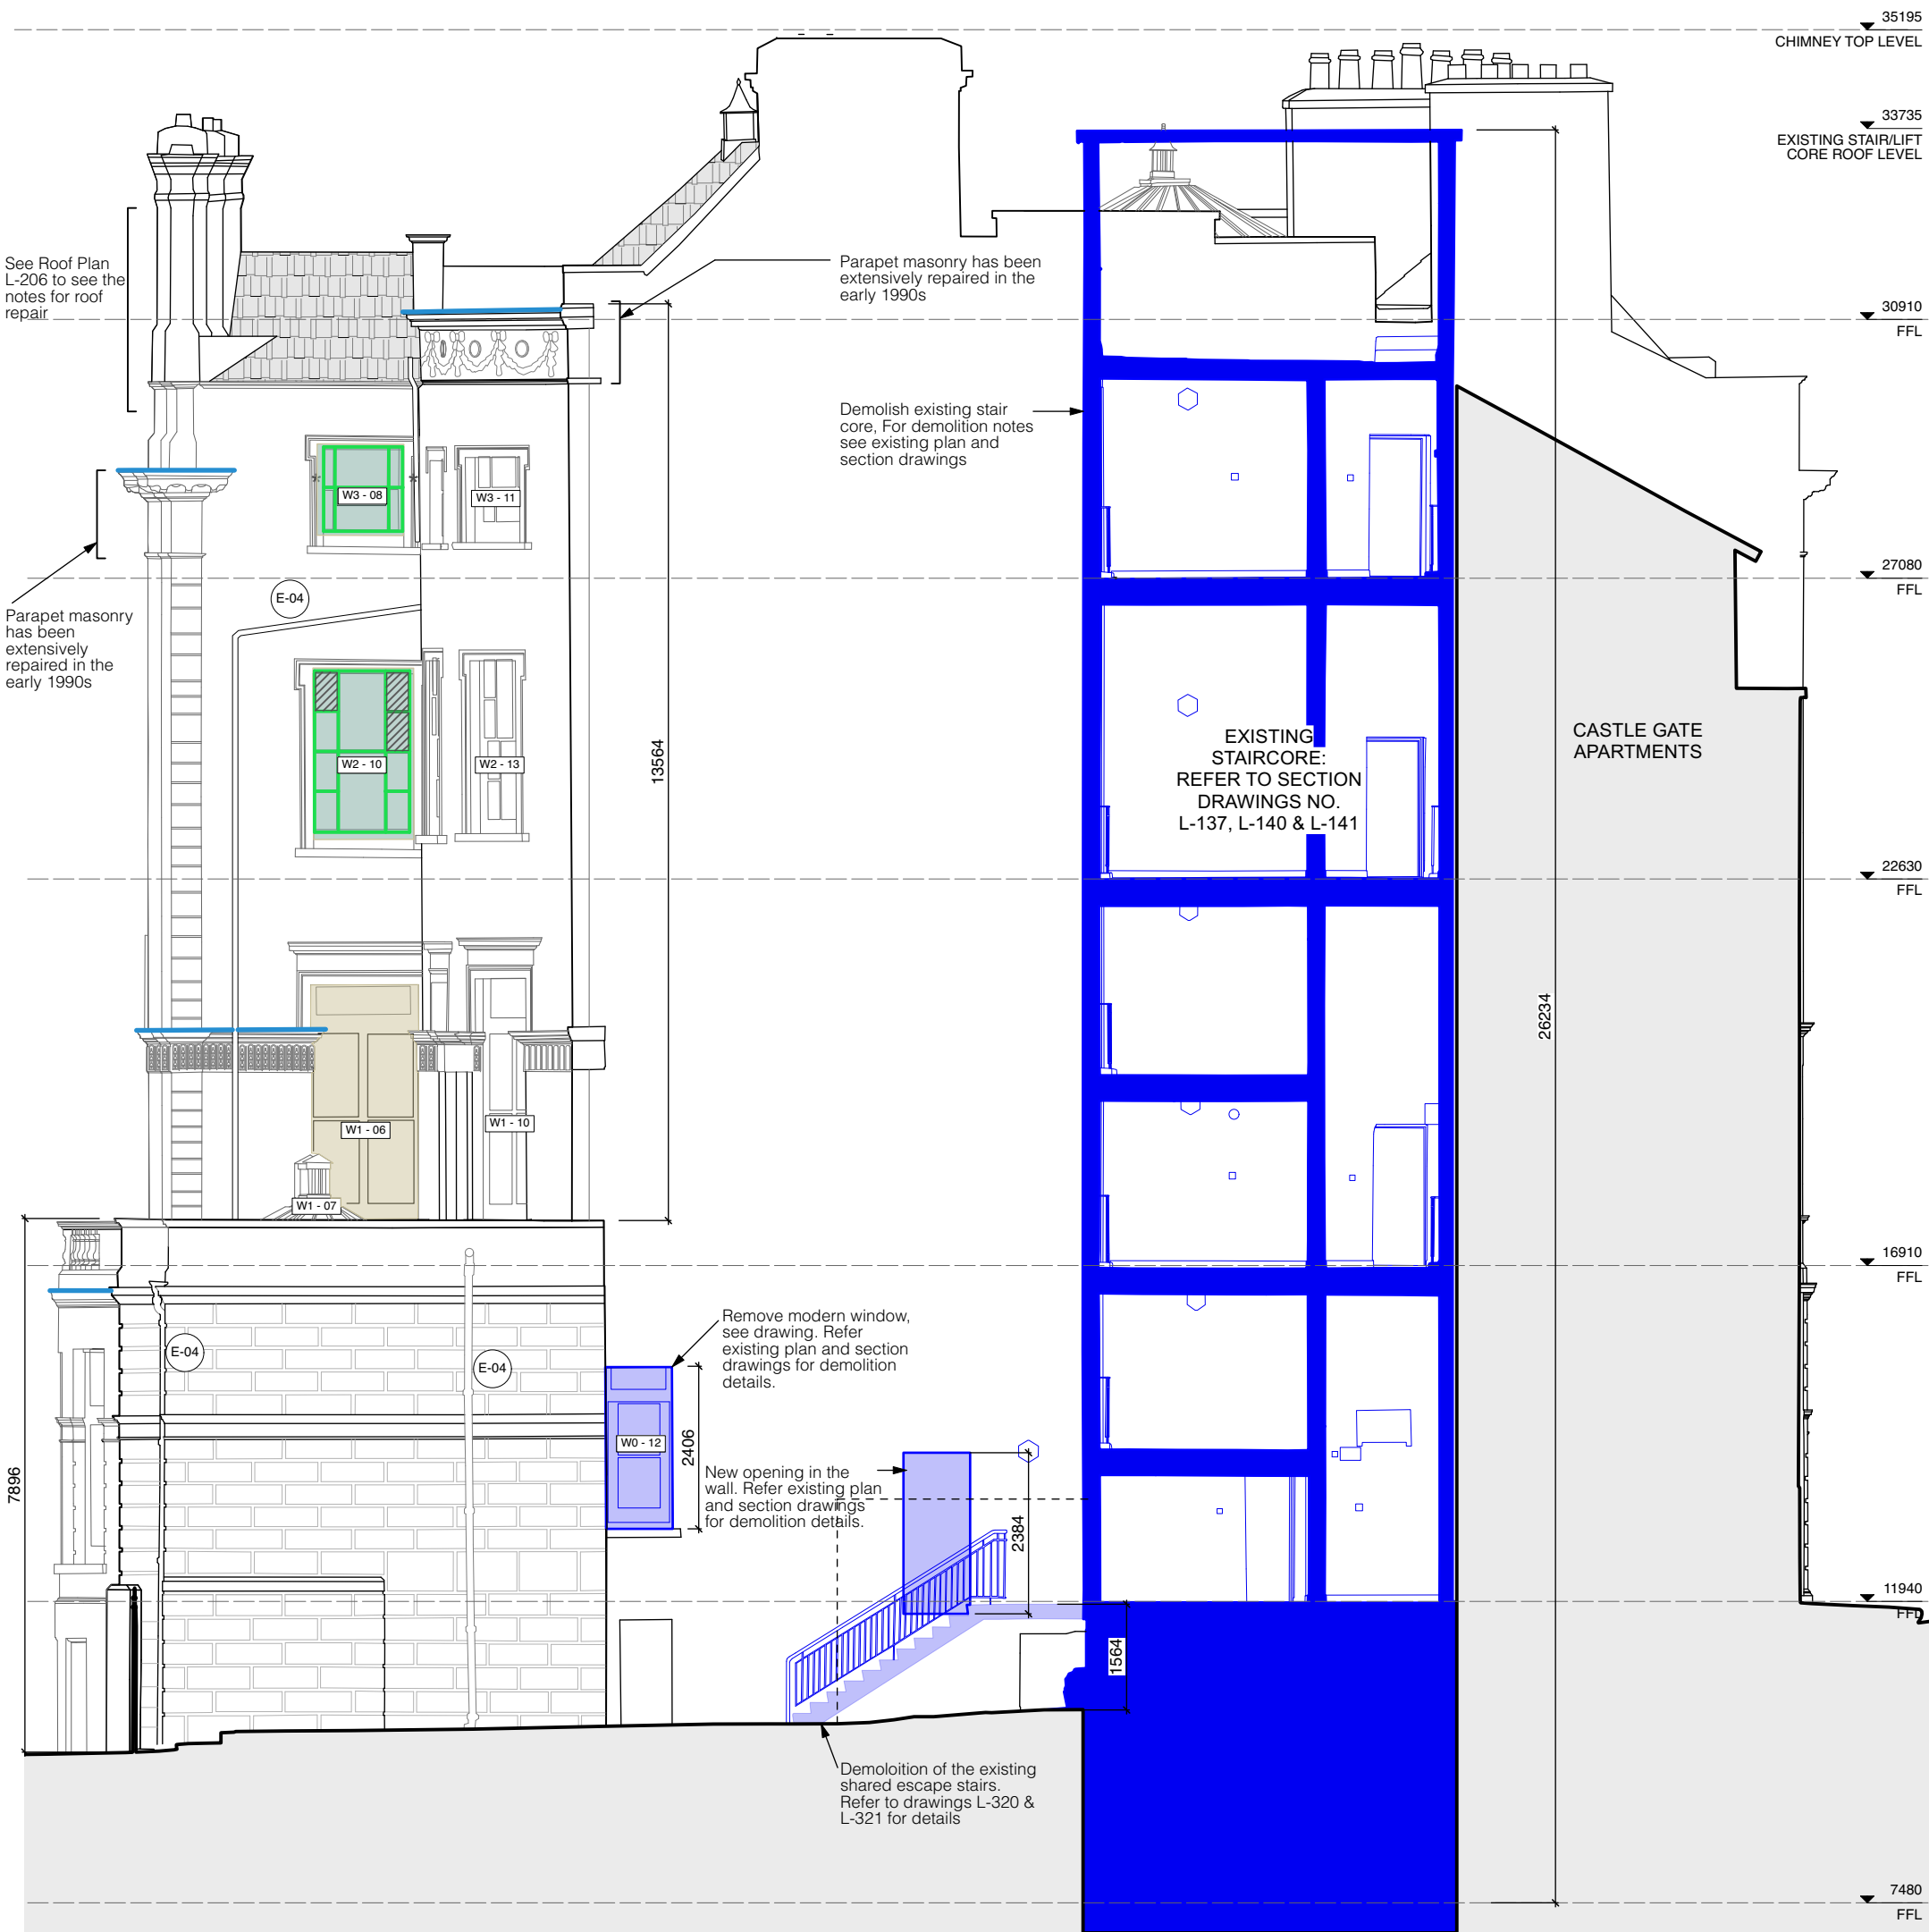
The windows have been repaired/ replaced on the west facade. Much of the historic glass has been lost on this facade as a result of the various historic alterations to the facade.

**First floor:** Window likely replaced with the current arrangement and design to match the ground floor and basement level windows on the north facade. Glazing: Plate glass.

**Second floor:** Sash window with a larger central pane where the central dividing glazing bars have been removed. Ovolo profile glazing bars. Late nineteenth century style ogee horns at the sash frames. Much of the original glass has been lost or replaced.

**Third floor:** Sash window with a larger central pane where the central dividing glazing bars have been removed. Ovolo profile glazing bars. Late nineteenth century style ogee horns at the sash frames. Much of the original glass has been lost or replaced.

**E-01** Existing lanterns to be retained and put back into working order. Note these lanterns were repaired in 2010

**E-02** Masonry repairs required to existing portland stone sill.

**E-03** Existing soil vent pipe to be removed.

**E-04** Repair of existing cast iron rainwater goods as required.

**E-05** Retain and refurbish existing railings to Cork Hill porch and decorative guarding in front of basement windows at Lord Edward Street.

- Existing leadwork to projecting cornices to be assessed and repaired/ replaced as required.
  - Edwardian style window
  - Sliding sash window
  - Replacement hinged sash window

- Cement repairs to be removed and replaced with suitable coloured mortar repair or graft repair.
  - Cleaning of masonry to remove staining from flashing or graffiti.

- Existing graft repair locations shown are based on a visual survey from ground level. This survey demonstrates the extent of the graft repairs on the building. Final survey to be completed from scaffolding. Poorly executed graft repairs which are very noticeable are to be replaced with a better graft insert.
