Parnell Square Library Project Hugh Lane Gallery

Architectural Heritage Impact Assessment
[Part 8 Application 2024]

[PSL-CRG-XX-XX-RP-X1-00011]

March 2024

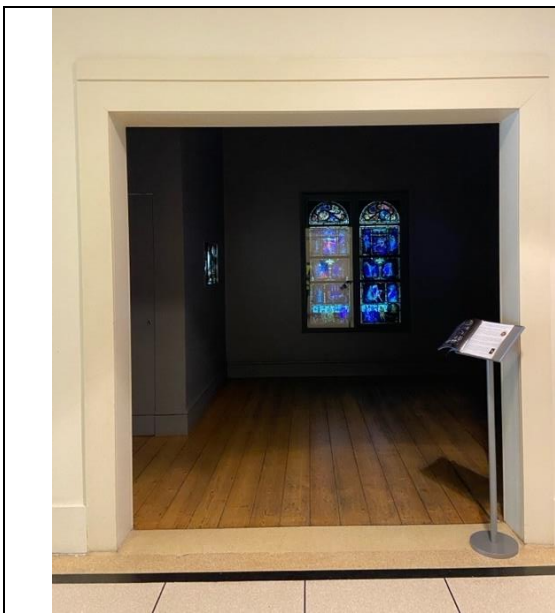
Fig 2. Entrance to Harry Clark room looking west.

Description / Inventory	<p>This room was designated for the Harry Clark permanent exhibition. It has timber floorboards and modern partition walls along the south, north and west, set back from the rooms perimeter walls and built to a lower height than the ceiling. The partition walls contain the stained-glass exhibition pieces. Historic cornices remain. Services run behind these partitions to serve the exhibition. Access to service zone is through a door located to the north-west of the room.</p> <p>To the west main wall, there is a tripartite timber sash window, with 3 over 3 side sashes, and a 9 over 9 sash to centre. All sashes with ogge horns. Modern metal bars are fixed to the reveal on the outside. Architrave remains intact.</p>
-------------------------	---

<p>Condition</p>	<p>Floor boards [modern from 12pprox.. 2006] are in good condition; except to the north area behind the partitions walls where a whole through floor is visible.</p> <p>Architrave and window board to the tripartite window are in good condition. The windows are blocked up internally and their functionality has not been tested.</p> <p>Main walls and cornice are in good condition.</p>
<p>Proposal & High Level Conservation Recommendations</p>	<p>The Harry Clarke exhibition which is located in this room is scheduled to be relocated within the Hugh Lane Gallery premises.</p> <p>A new opening is proposed to be formed to the west wall, to allow for new link between HLG and New Parnell Square Library.</p> <p>Conservation recommendations:</p> <ul style="list-style-type: none"> - Harry Clark exhibition should be re-located to a new location agreed with HLG. Extreme care must be taken while removing and transporting these art pieces. Works to be monitored by art conservation specialists of the HLG. HLG conservation staff to coordinate in advance of the refurbishment. - Partitions walls to be carefully removed to avoid damage to surrounding fabric. - Cornices should be protected at all times while remodelling works occur. - Details to be carefully designed, particularly where the new structure meets the old, and approved by conservation consultant.

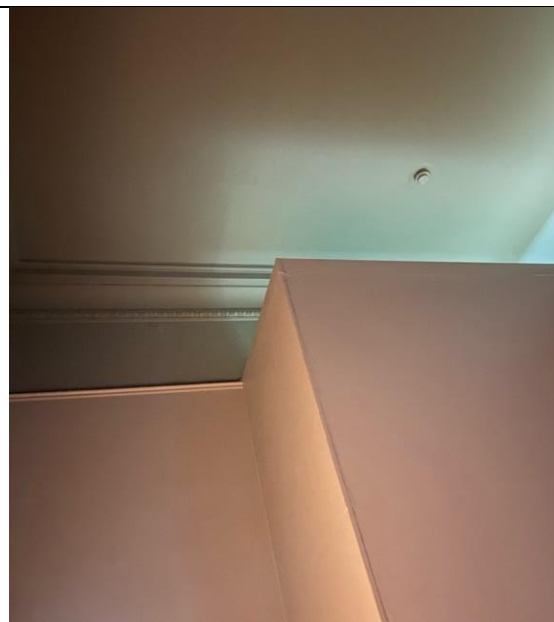
Fig 3. Detail of existing historic detailed cornice.

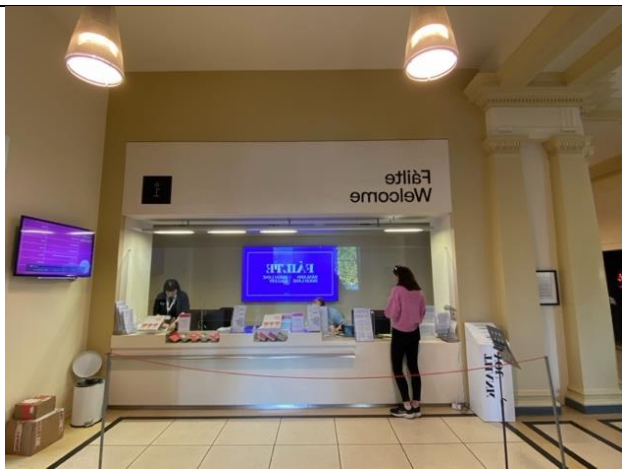
<p>Fig 4. Hugh Lane Gallery Reception desk.</p>	<p>Fig 5. Cracks to terrazzo floor to east, where entering 2006 link.</p>
<p>Description / Inventory</p>	<p>The reception room was introduced as part of the 1930s alterations. This work included the removal of a section of wall which formerly separated the entrance hall from the current front reception. A screen mimicking that of the entrance hall was built at this time¹².</p> <p>Terrazzo floor throughout, no cornice visible at present above the reception desk opening.</p> <p>Doric paired columns to the left hand side of the wall.</p>
<p>Condition</p>	<p>Cracks to terrazzo floor as per Fig.5 above.</p>
<p>Proposal & High Level Conservation Recommendations</p> <p>[NB: Works to this area refer to lobby 5 works which were previously proposed and are now omitted]</p>	<ul style="list-style-type: none"> — Partitions walls scheduled for removal to be carefully dismantled to avoid damage to terrazzo floor. — Doric columns should be protected at all times while remodelling works occur. — New proposed intervention and details to be carefully designed, particularly where the new structure meets the old, and reviewed by conservation consultant. — Any historic details discovered during the demolition works to be recorded and assessed for possible reinstatement / conservation.

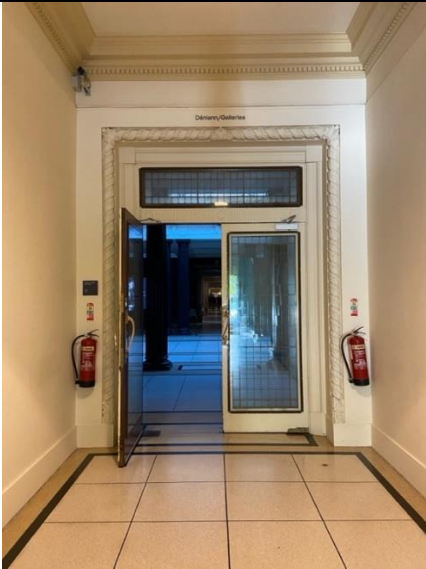
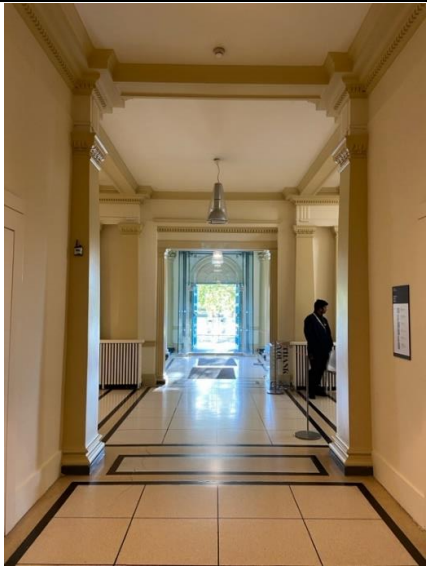
<p>Fig 6. Corridor looking north towards 1930s galleries.</p>	<p>Fig 7. View to main entrance hall (south).</p>

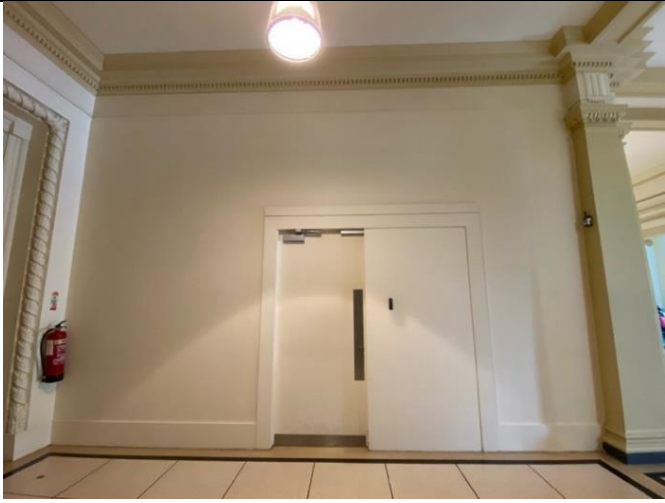
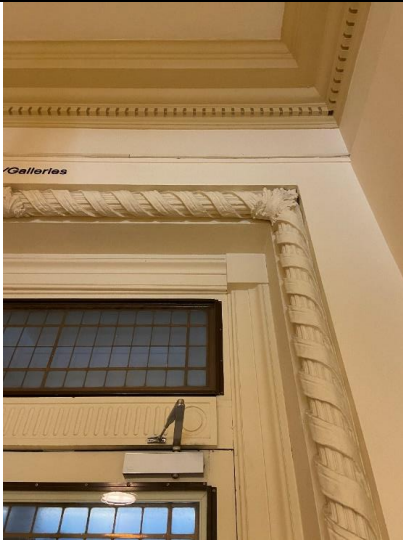
<p>Fig 8. East partition wall.</p>	<p>Fig 9. Cornice and carpentry detail.</p>
<p>Description / Inventory</p>	<p>This corridor was added in the 1930s. Prior to this intervention, there were secondary stairs in this location which can be seen on drawings predating these works¹³.</p> <p>Terrazzo floor and detailed cornice to all sides, except south. Squared based Doric columns to the south portico.</p> <p>Modern partition walls to west and east. Fire extinguishers to both sides of north portico.</p>

Detailed curved timber frame to glazed double doors and fanlight. Checked bronze canes to glazed panes. Distinctive curved brass handles and modern door closers to both door eaves.
Condition	Elements described above are in good condition overall.
Proposal & High Level Conservation Recommendations	<p>Modern partitions walls to the east are scheduled for removal.</p> <ul style="list-style-type: none"> - Retain and protect glazed double doors and fanlight during works. - Retain and protect terrazzo floor during works.. - Retain and protect cornice while partition walls are removed. - Junction details to be carefully designed and approved by a conservation consultant.

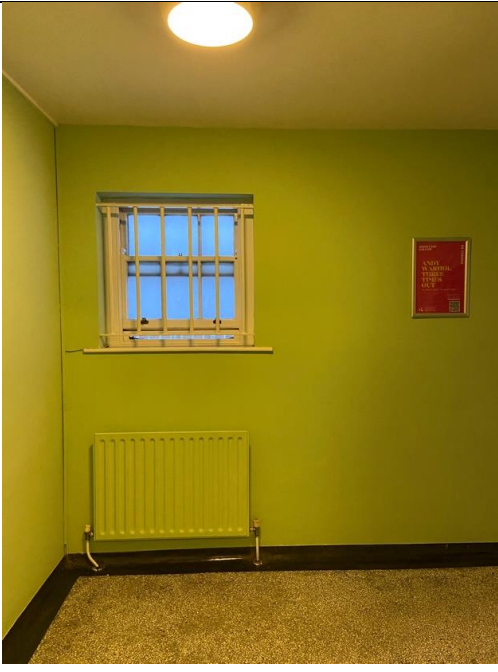
<p>Fig 14. East wall with window permanently slightly open at bottom rail.</p>	<p>Fig 15. View from hall towards its entrance, looking south.</p>

Description / Inventory	<p>Distribution hall to bathrooms and storage room. One single opening to east wall, formed by a 3 over 3 timber sash window with ironmongery remaining in place and metal bars fitted internally.</p> <p>Terrazzo floor and skirting board throughout.</p> <p>Modern radiator below window. Modern lighting, services and ceiling.</p>
Condition	<p>Terrazzo floors are in good condition, and so they are the timber doors and sash window.</p> <p>Modern services in good working order.</p>
Proposal & High Level Conservation Recommendations	<p>Room scheduled to be removed to introduce new link to New Library.</p> <ul style="list-style-type: none"> - Carefully record and remove all carpentry, label individually and store for salvage or reuse. - Where possible, remove and retain terrazzo floors. - New proposed intervention and details to be carefully designed, particularly where the new structure meets the old, and approved by conservation consultant.

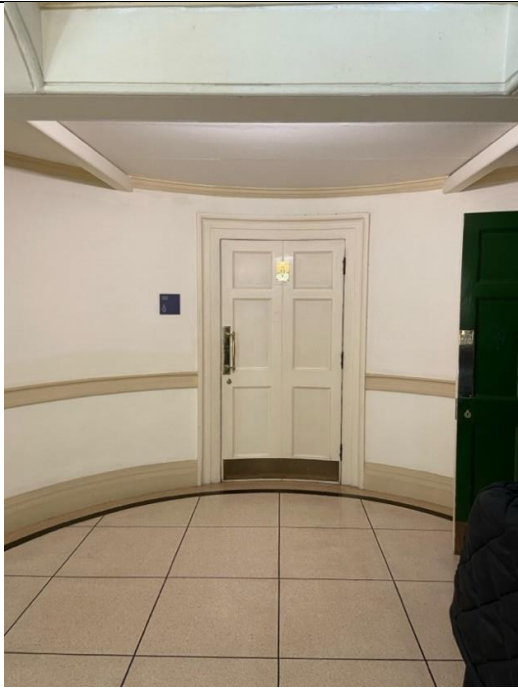
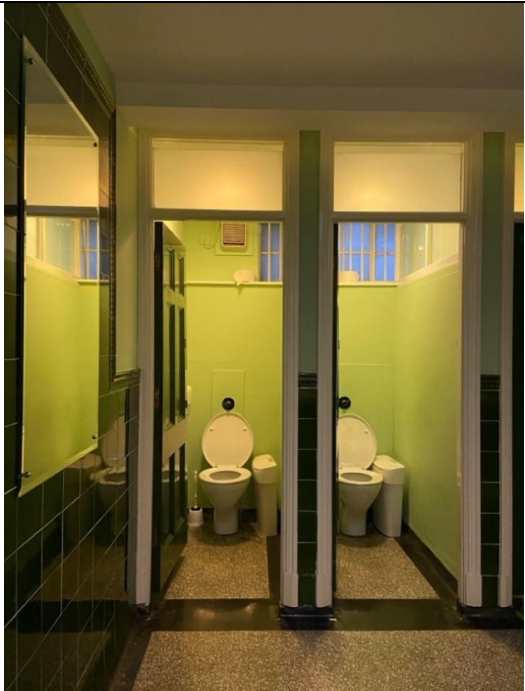
<p>Fig 18. Curved 6no. panelled entrance door to toilet.</p>	<p>Fig 19. 3no internal partitions and metal frame windows to the rear wall, looking west.</p>
<p>Description / Inventory</p>	<p>Room introduced as part of 1930s works with terrazzo floors and green coloured glazed tiles walling.</p> <p>3no partitions, each with its own door frame and 6no panelled timber doors and obscured glass fanlight.</p> <p>No.16 panes metal window to the rear wall with metal bars fixed internally. 2no. pivot casements remain opened. This is the only metal window observed in the front house.</p> <p>Modern bathroom fitting installed throughout the room. Xpeliar vent fitted to north wall next to metal window casement.</p>

Square shaped aluminium-frame rooflight with 9no panes of obscured glass.
Condition	<p>Carpentry is in very good condition, as well as the tiles and terrazzo floor.</p> <p>Metal window was not assessed due to limited access but appears to be in fair condition with lack of maintenance.</p>
Proposal & High Level Conservation Recommendations	<p>Room scheduled to be removed to introduce new link to New Library.</p> <ul style="list-style-type: none"> - Carefully record and remove all carpentry, label individually and store for salvage or reuse. - Where possible, remove and retain terrazzo floors and tiles. - New proposed intervention and details to be carefully designed, particularly where the new structure meets the old, and approved by conservation consultant.

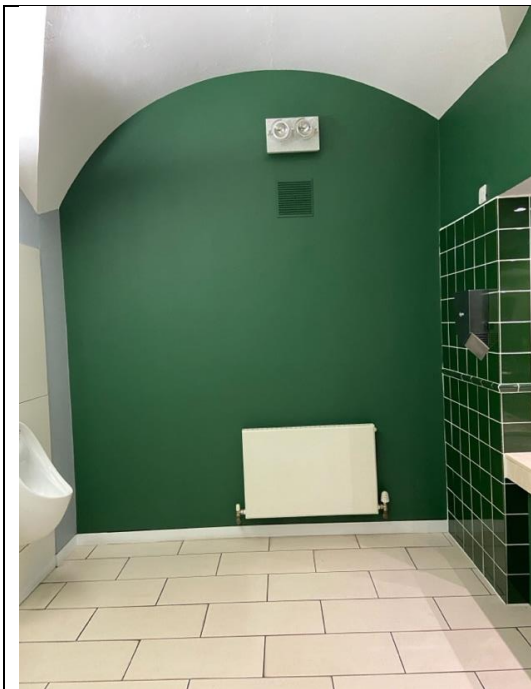
Fig 20. North wall of room no.22.B1.004.

<p>Proposal & High Level Conservation Recommendations</p>	<p>The existing window openings are proposed to be lowered to host new door openings that will connect to the extended lower ground floor bathrooms.</p>

<p>Conservation recommendations:</p> <ul style="list-style-type: none">- Remove modern linings to north walls to reveal condition of historic wall behind. Carefully remove cementitious render to the external face of the wall. Visual inspection to these by conservation consultant should be carried out. New finish to these walls to be define after inspection and to be discussed with the conservation consultants.- Make good new openings to historic wall following conservation consultant specifications.- New proposed intervention and details to be carefully designed, particularly where the new structure meets the old, and reviewed by conservation consultant.- During construction and demolition work for the bathrooms, it must be taken into consideration that the walls are located close to the Hugh Lane Gallery Archives where the entire gallery collection is stored. Vibrations, dust, should be reduced to a minimum and monitored throughout the works.

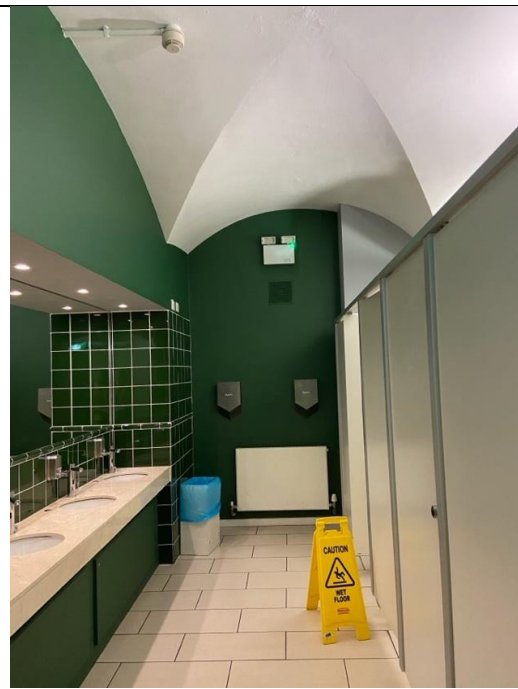
Fig 21. North wall of room no.22.B1.005.

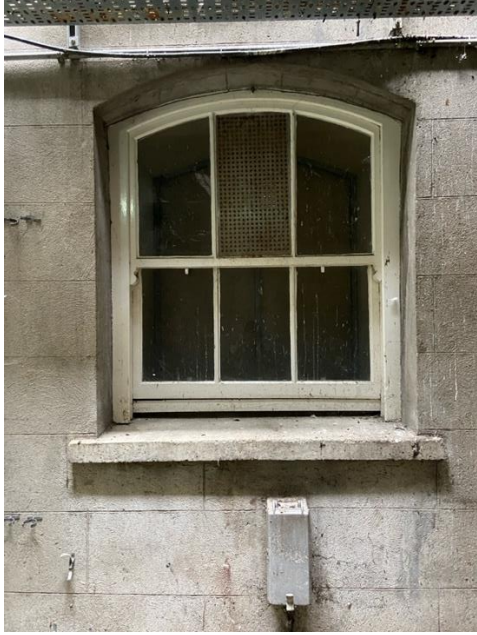
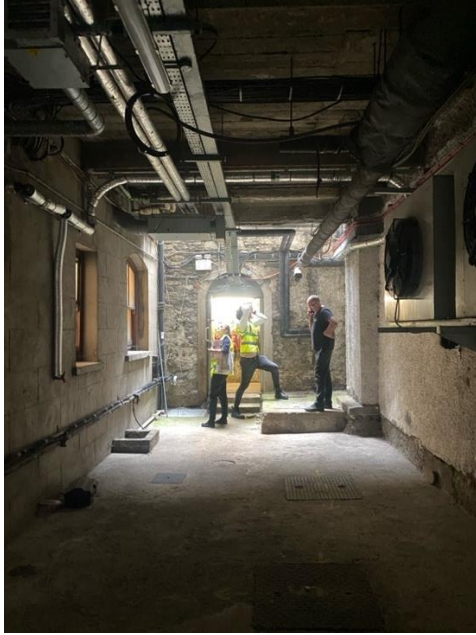
<p>Fig 22. 3 over 3 timber sash windows visible from the air alleyway to the north side of the bathrooms.</p>	<p>Fig 23. View to west end of alleyway.</p>
<p>Description / Inventory</p>	<p>Both rooms have modern partitions walls, dry lining boards, bathroom fittings, radiators and services.</p> <p>Green coloured tiles to sections of the wall to imitate the bathroom above.</p> <p>Ceramic tiles to floor are not original.</p> <p>Historic groin vaulted plastered ceiling to both rooms.</p>
<p>Condition</p>	<p>All modern interventions and services are in good condition and working order.</p> <p>Vaulted ceilings are in good condition with some modern fittings.</p> <p>The north wall, where new openings are proposed, are currently dressed with modern dry lining, a wall vent at top, radiators and other services.</p> <p>The condition of the historic wall behind it is only assessable externally. There is ruled and lined cementitious render to the outside. Windows are arched head, 3 over 3 timber sashes with ogge horns and a concrete cill. Glass is in fair condition; these are not historic panes.</p>

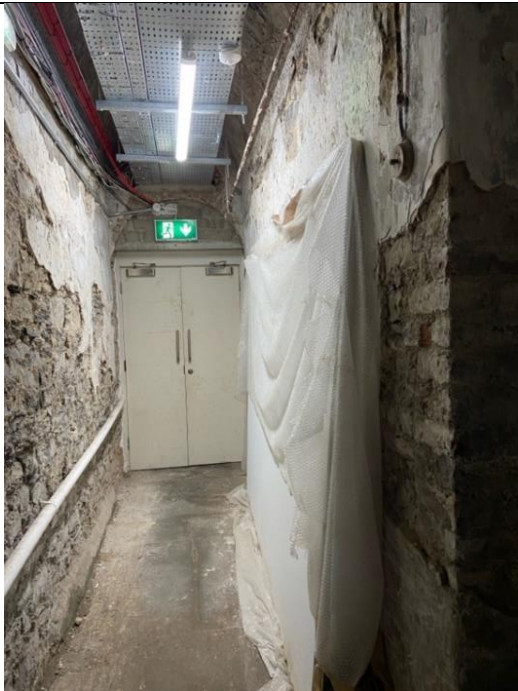
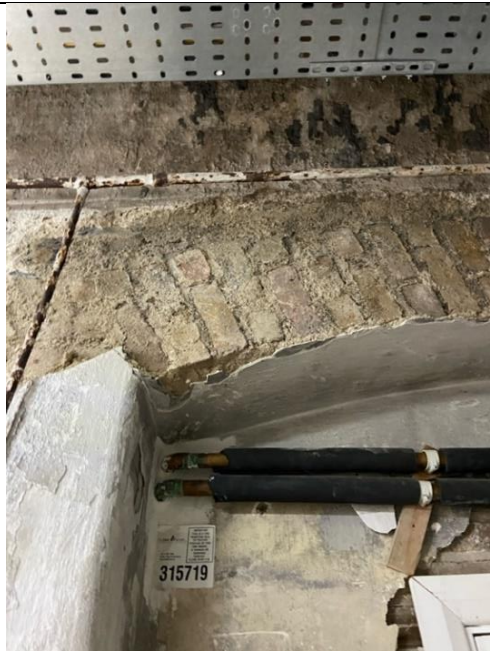
<p>Fig 24. Barrel vaulted ceiling to room no.22.B1.008.</p>	<p>Fig 25. Brick arched entrance to room no.22.B1.009.</p>

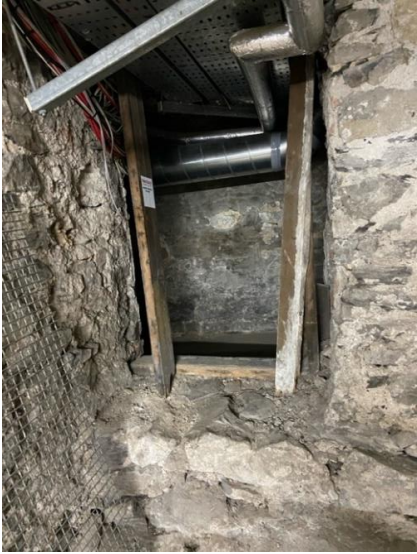
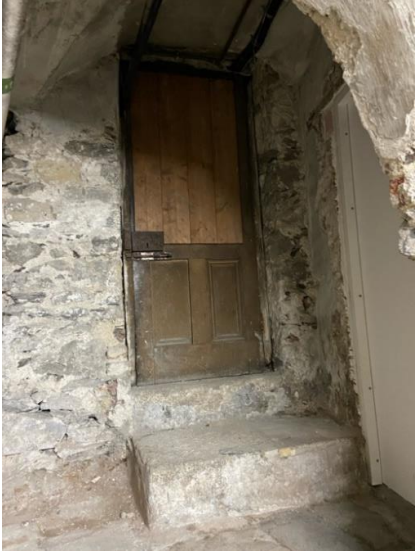
<p>Fig 26. View to service space with limited access in room no.22.B1.012.</p>	<p>Fig 27. Groin vaulted ceiling and timber door in room no.22.B1.012.</p>
<p>Description / Inventory</p>	<p>Historic brick and stone walls with lime mortar render (predominantly) and original barrel and groin vaults to all these rooms. Brick arch visible over entrance.</p> <p>Emergency Exits to room no. 22.-01-008.</p>
<p>Condition</p>	<p>Very poor condition to all rooms. Finish render is dislodging from the wall in several areas.</p> <p>Modern services have been installed, mainly at ceiling level, with trays suspended from the vaults. Services and props are poorly fitted.</p> <p>Moisture presence in walls.</p> <p>Some existing doors are blocked up and were not accessed at the time of this report.</p>
<p>Proposal & High Level Conservation Recommendations</p>	<p>Works proposed above these rooms to introduce new opening and link to New Library. The ceiling of these rooms will be altered by these works.</p> <ul style="list-style-type: none"> - Assess condition of the walls and mitigate moisture presence. - Structural engineer to inspect condition of vaulted ceilings and propose recommendation accordingly. - M&E consultants to assess existing services and design new proposal, following alteration from works above. - New design proposal to be consulted with structural engineer and conservation consultant. - Protect historic fabric during works.

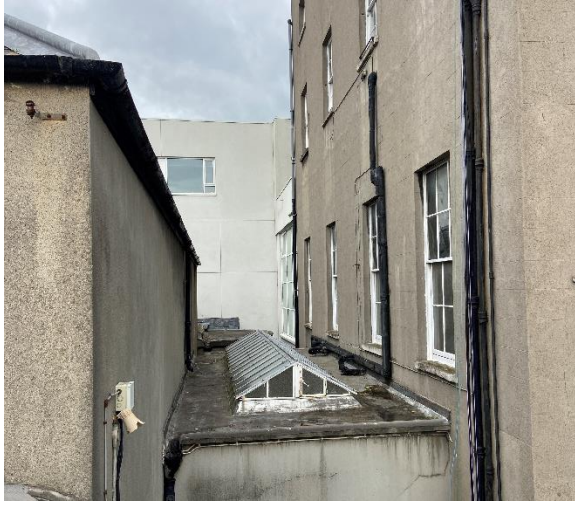
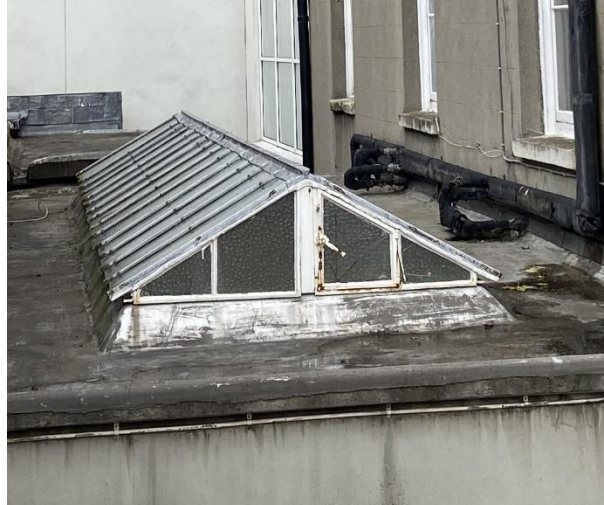
<p>Fig 28. Overall view of the lantern</p>	<p>Fig 29. Close-up of lantern gable with one side hinged casement.</p>
<p>Description / Inventory</p>	<p>Historic metal frame lantern with obscured single glaze units and 14n bays. Side-hinged casement to at least west facing gable.</p>
<p>Condition</p>	<p>Fair to poor condition overall. Access is restricted only visual assessment from neighbour roofs.</p> <p>Corroded bottom rail and handle to window casement. Corrosion signs to north corner of the gable, at bottom.</p> <p>Several capping covers over glazing bars are loose and with very poor ends.</p> <p>Glass panes seem fair overall, with the exception of the gable ends.</p> <p>Lead at ridge level appears to be in fair condition.</p>
<p>Proposal & High Level Conservation Recommendations</p>	<p>Works proposed include the removal of the existing lantern to allow for a new flat roof to be installed. This is to allow for MEP ducts that form part of the MEP strategy upgrades for the Hugh Lane Gallery.</p> <p>Lantern to be carefully removed and made available for salvage and storage.</p>

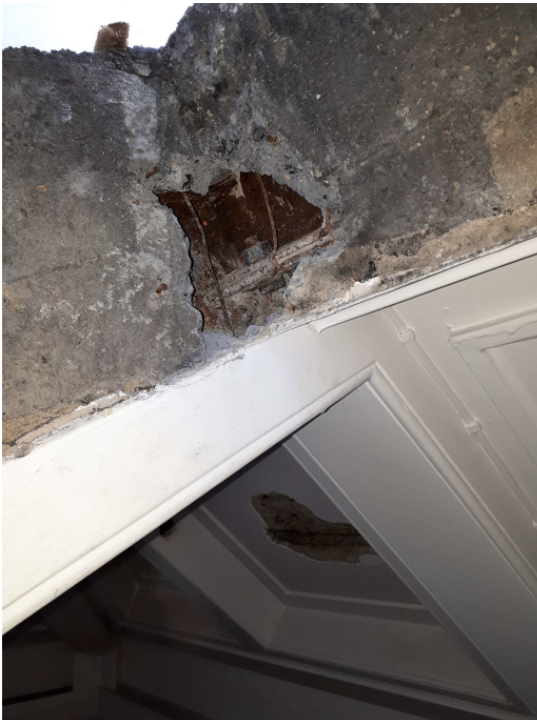
Existing concrete encased beams to be exposed

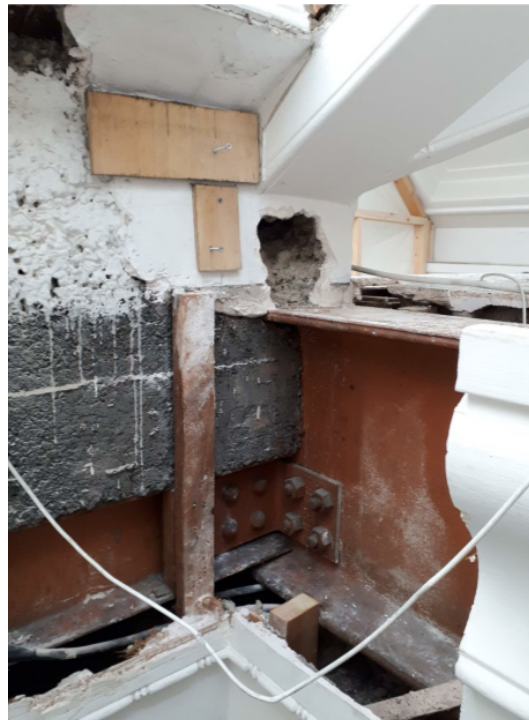
Existing exposed steel to be measured

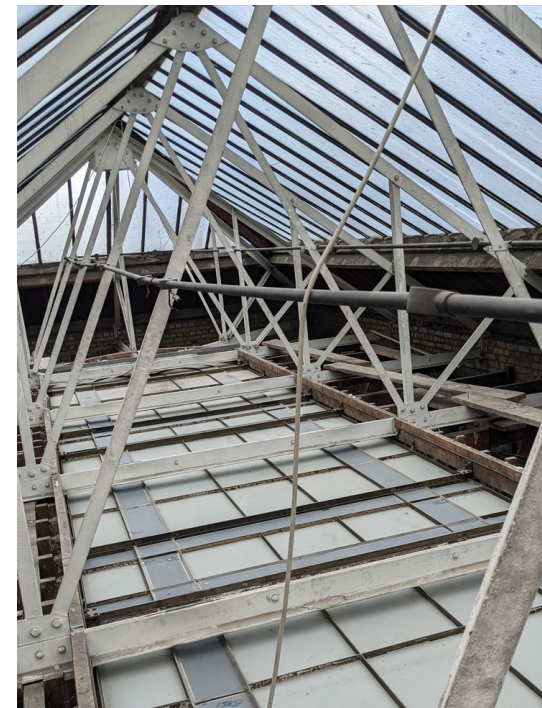
Sculpture Gallery steel to be measured
