Architectural Heritage Impact Assessment

ARCHITECTURAL HERITAGE IMPACT ASSESSMENT

FLOOD RELIEF WORKS
PROPOSED TO A SECTION OF THE
DODDER RIVER WALL ADJACENT
TO ANGLESEA ROAD

July 2018

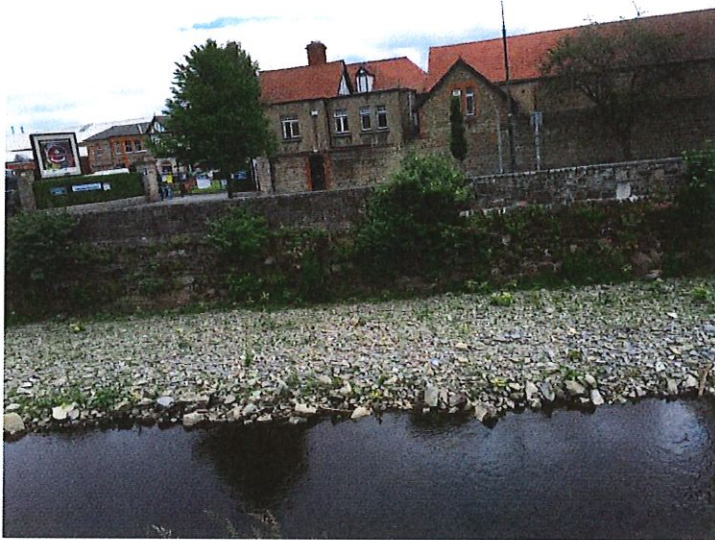
Current view of river wall. Extensive vegetation visible along length of wall.

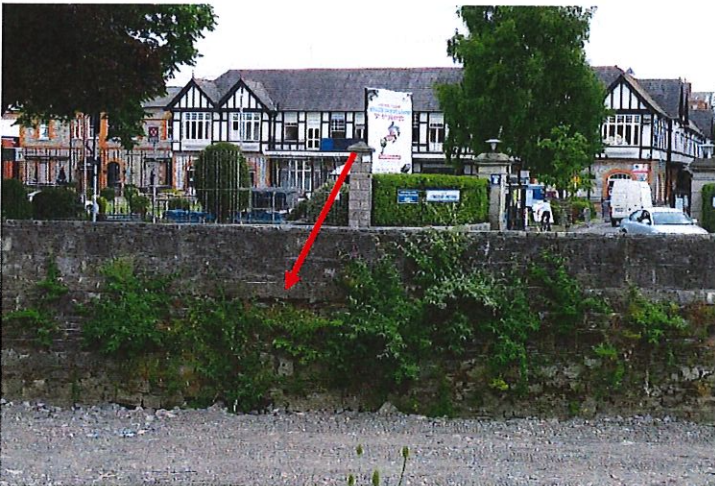
Concrete beam indicated at footpath level.

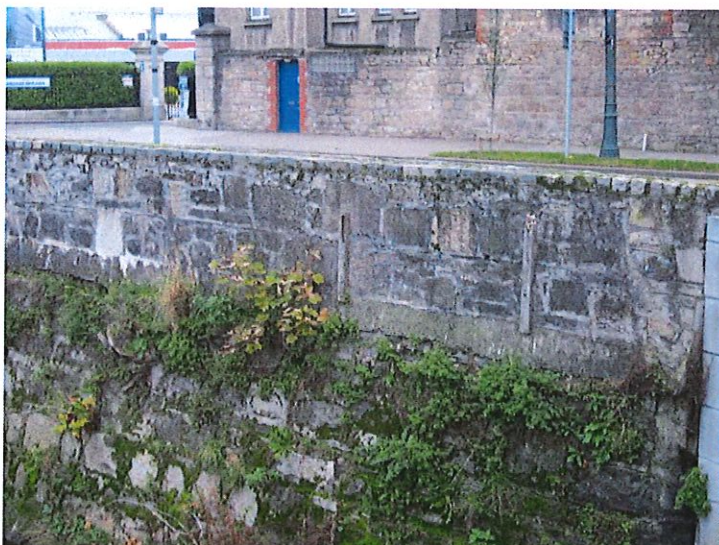
Concrete beam with more recent parapet wall above. Wall capped with sets. Original river wall visible below beam.

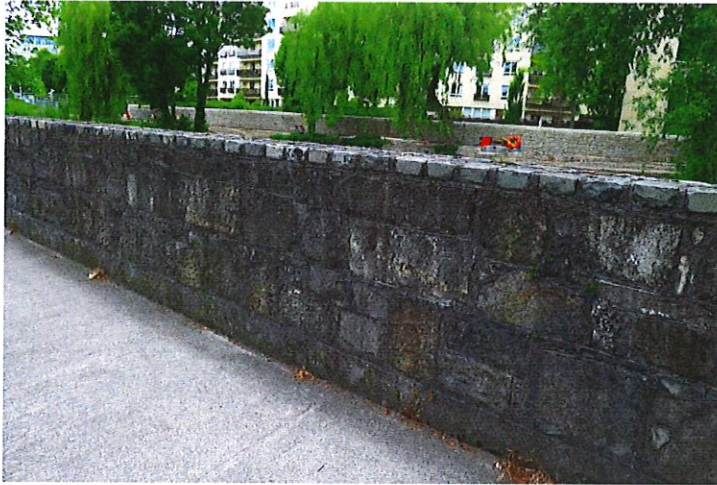
Face of parapet wall from Anglesea Road. Limestone and granite stonework visible with a setts capping.

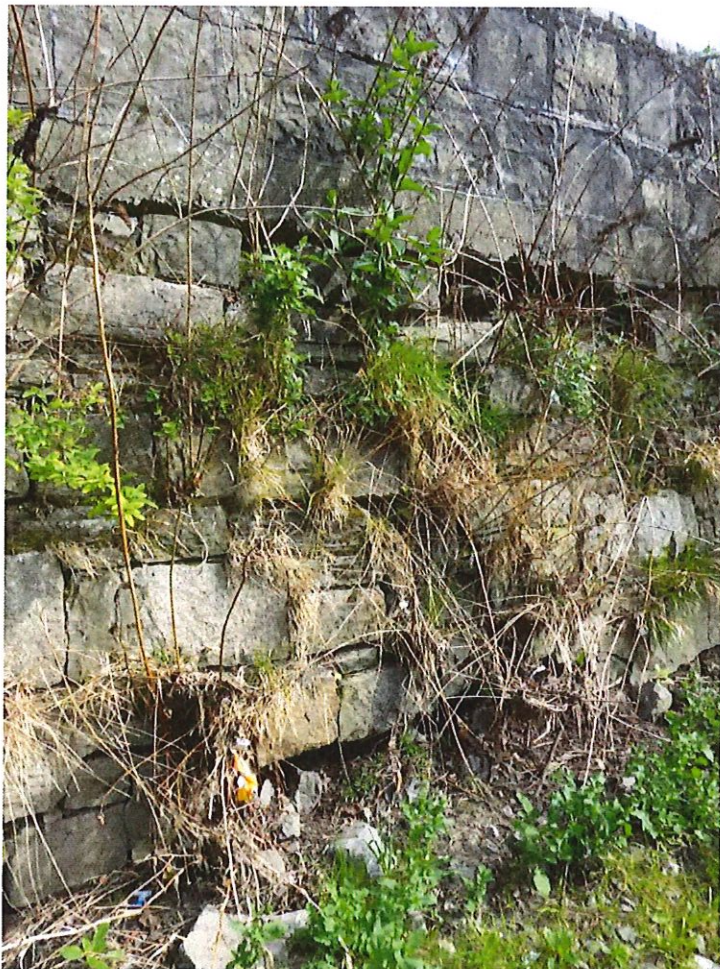
Condition of original stonework visible below concrete beam. Pockets of original stone lost throughout.

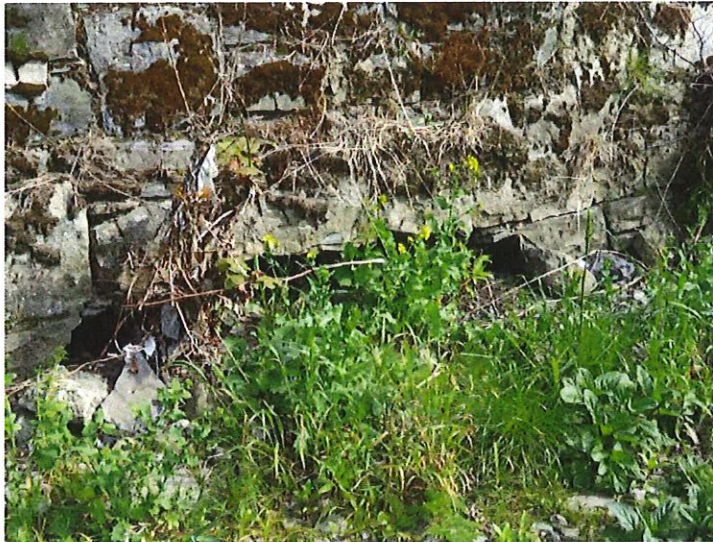
Facing stone lost at low level

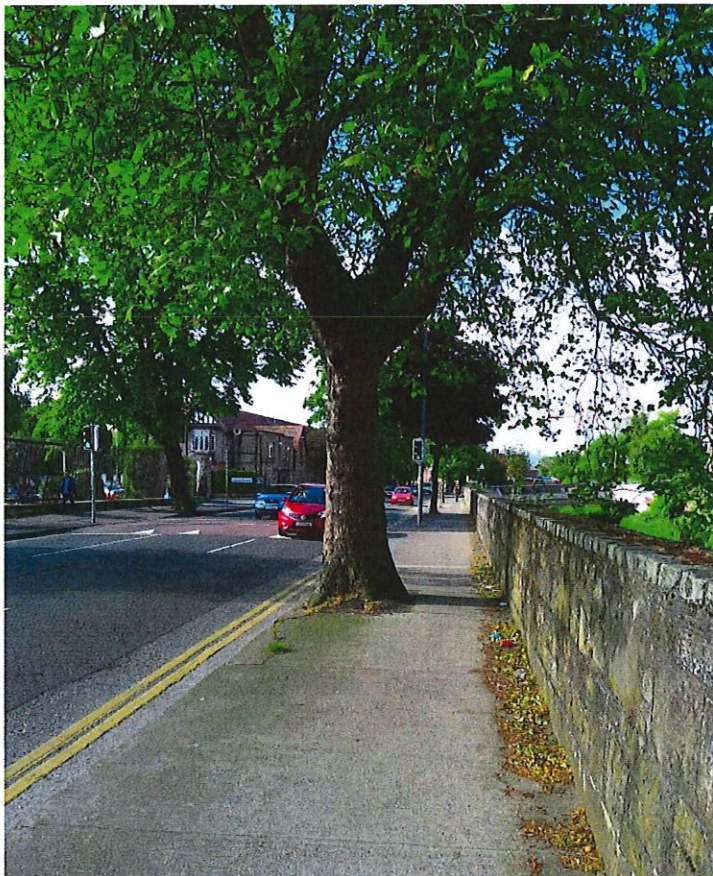
Mature trees on Anglesea Road that will be retained with chosen approach.
