Residential Development at
Shangan Road, Co. Dublin

Combined Stage 1 & 2
Road Safety Audit

Document Ref: P21-090-PSW1-RP-001

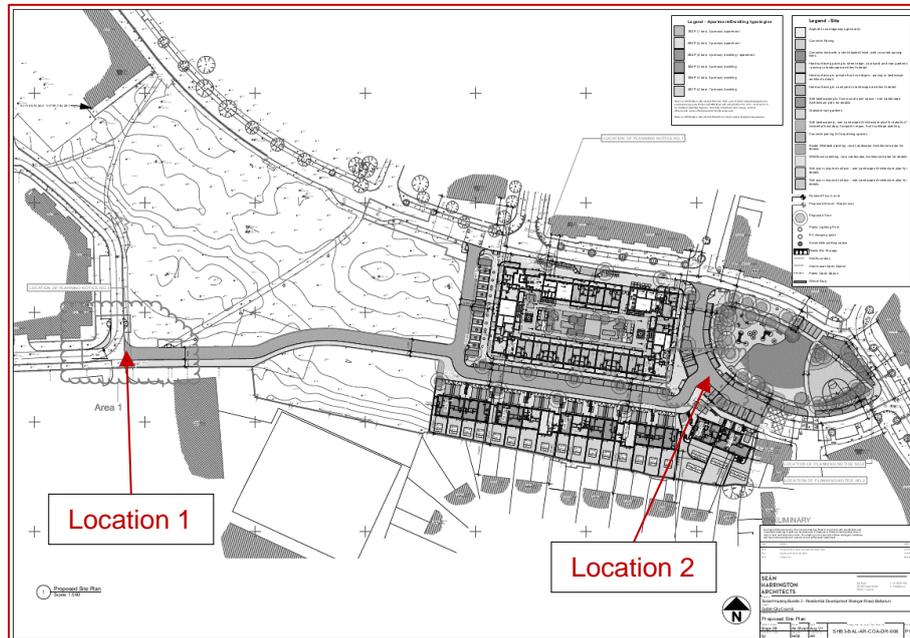
FIGURE 2-2 LOCATION OF DESIGN CHANGES RECEIVED 25TH FEBRUARY 2022

- Location 1:** A new access road will tie into Shangan Road near the rear access to Trinity Comprehensive School. The new access road will extend in an east-west direction, and require a revision to the priority of the existing road at this location. A raised table will be provided with an uncontrolled pedestrian crossing on the minor arm of the new T-Junction. The junction shall include a Stop sign and associated road markings.
- Location 2:** A new uncontrolled pedestrian crossing will be provided at the Public Open Space in the north-eastern corner of the development. The uncontrolled pedestrian crossing will provide access for pedestrians, including visually and mobility impaired pedestrians, wishing to access the amenities within the Public Open Space.

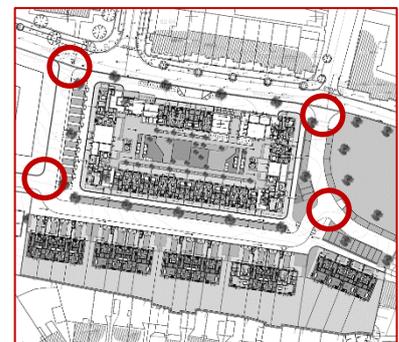
Summary: No junction control or priority type has been indicated at the development's accesses onto Shangan Road.

The junction control (stop, yield etc.), and subsequently priority, at the proposed development accesses onto Shangan Road have not been indicated. This could increase the risk of overshoot collisions where drivers fail to slow and stop when exiting the development.

Ensure the junction control at the development's accesses onto Shangan Road is clear (via signage/road markings) to drivers exiting the development.

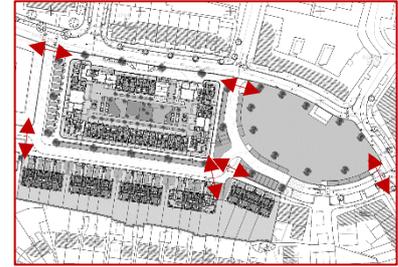
Summary: No tactile paving provision within the development, or on either side of pedestrian crossings across side road accesses.

Formal pedestrian crossing points, including dropped kerbs and tactile paving, have not been indicated within the development or across the accesses on Shangan Road. A failure to provide dropped kerbs at crossing points and along pedestrian desire lines could result in mobility impaired pedestrians being unable to safely and independently enter the carriageway to cross to the opposite footpath. This could result in slips, trips or falls as these pedestrians attempt to descend the kerb. Similarly, a failure to provide tactile paving at dropped kerb locations could lead to an increased risk of visually impaired pedestrians unintentionally entering the carriageway where they could be struck by vehicles.

Formal uncontrolled pedestrian crossings, including dropped kerbs and tactile paving, should be provided at pedestrian crossing points/desire lines.

Additionally, tactile paving should be provided at each Mobility Parking space (in combination with the dropped kerbs indicated on the plan) located at the development's western boundary.

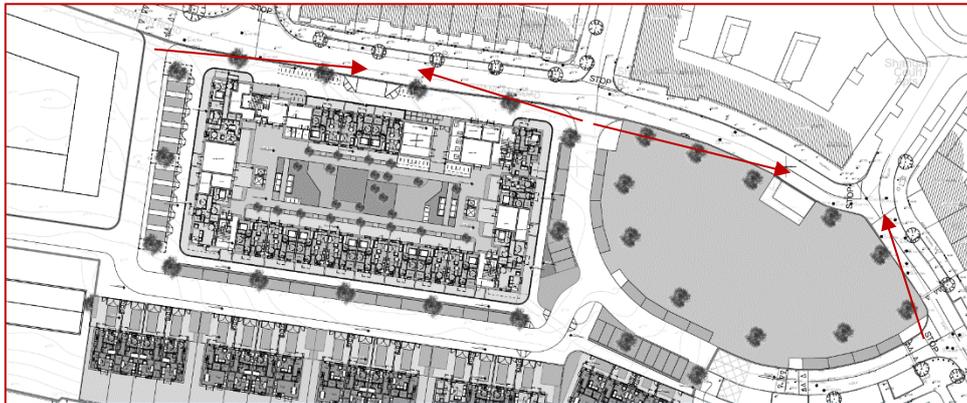
Summary: Unclear if proposed trees shall reduce visibility for drivers exiting side road junctions.

It is unclear if the proposed location of trees within the verge shall obstruct visibility for drivers exiting junctions and parking spaces within the proposed development. This could result in drivers exiting side roads and parking spaces when it is unsafe to do so ahead of oncoming vehicles leading to side-on collisions.

Ensure sufficient visibility is available at all junctions and parking spaces within the proposed development. It may be necessary to relocate trees to achieve the required visibility.

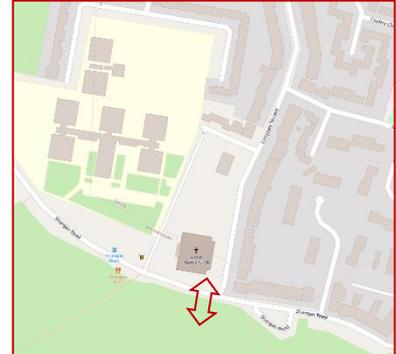
Summary: Likely pedestrian desire line not accommodated, which could lead to slips, trips and falls as pedestrians, particularly mobility impaired pedestrians, attempt to cross Shangan Road.

Existing amenities to the north of Shangan Road are likely to be an attractive destination for residents of the new development. Residents wishing to access, for example, the Catholic Church of the Virgin Mary, the Ballymun East Community Centre, and the Ballymun Child and Family Resource Centre will need to cross Shangan Road.

The absence of existing uncontrolled pedestrian crossing facilities may increase the risk of slips, trips and falls as pedestrians, particularly mobility impaired pedestrians, attempt to cross the road.

A new pedestrian crossing of Shangan Road should be provided to support safe movement of pedestrians across Shangan Road.

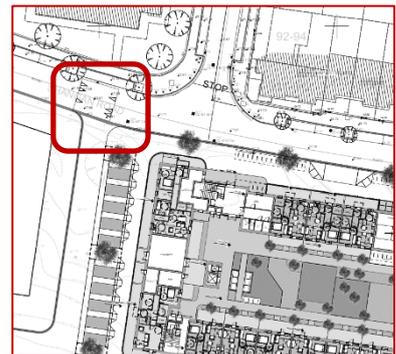
Summary: Existing speed table on Shangan Road may interfere with the safe movement of vehicles entering/exiting the development.

The location of a raised speed table directly adjacent one of the development accesses may complicate the safe movement of vehicles entering or exiting the development, leading to driver hesitation. This may increase the risk of rear-end-shunt collisions.

The speed table should be relocated so as not to interfere with entry/exit manoeuvres, or a raised table should be provided at the junction.

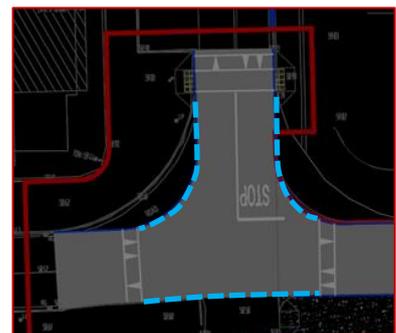
Summary: Visually impaired pedestrians may inadvertently enter the carriageway, where there is an increased risk of being struck by a vehicle.

It is unclear if the raised table will be set flush with the surrounding footway. Should the raised table be level with the surrounding footway, there is a risk that visually impaired pedestrians may be unable to identify the footway edge, and inadvertently continue into the carriageway where there is a risk of vehicle/pedestrian collisions.

The plateau of the raised table should be set lower than the surrounding footway, allowing visually impaired pedestrians to identify the kerb edge.

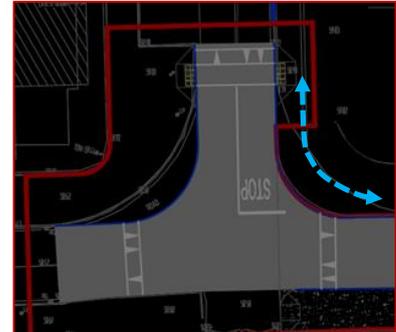
Summary: Absence of footway connection may increase the risk of slips, trips, and falls.

It is not clear from the sketch provided if a new footway connection will be provided between the existing Shangan Road footway in the north, and the new access road in the east. Failure to provide a pedestrian footway linking the two footways may lead to informal pedestrian routes through grassed areas, which may become worn and rutted over time, leading to ponding, slips, trips, and falls.

Ensure a pedestrian footway connection is provided between Shangan Road and the new development access road.

Additionally, the uncontrolled pedestrian crossing on the minor arm should be relocated to the south along the east-to-west desire line.

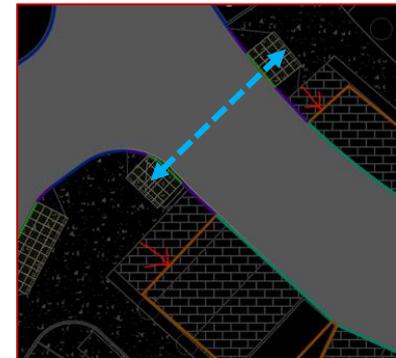
Summary: Vehicle speeds near uncontrolled pedestrian crossing may increase the risk of vehicle/pedestrian collisions.

The new pedestrian link between the development and the Public Open Space, which will include a playground, basketball court and grassed areas, is likely to be a popular route for residents. The pedestrian route is likely to attract small children and scooter users, who may be less attentive when crossing the road. The RSA Team supports the measures taken to increase inter-visibility between pedestrians and drivers, but are concerned that vehicle speeds in this area may be high. This could lead to vehicle/pedestrian collisions at the crossing.

Parking should be relocated further east to maximise inter-visibility between pedestrians and drivers, and a raised junction table should be provided in this location to passively control vehicle speeds.
