**KAVANAGH
MANSFIELD
& PARTNERS
CONSULTING
STRUCTURAL
AND CIVIL
ENGINEERS**

CL 2357

**NDFA SOCIAL HOUSING
BUNDLES 04 AND 05
STRUCTURAL SURVEY REPORT ON
BUILDINGS TO BE DEMOLISHED**

**Marrowbone Lane –
Forbes Lane Depot site**

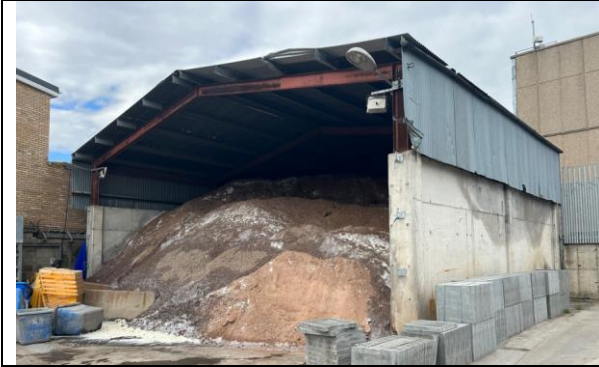
ELEMENT	DESCRIPTION	COMMENT
Ground Floor	The floor is a concrete insitu slab in all of the rooms. (photos 01 and 02)	No Opening Up was carried out to expose the foundation, the type of the foundation and depth aren't possible to identify.
Roof	The Roof is a duo pitch made of metal sheet roofing, supported by purlins, which are supported by steel UB rafter. (Photos 02,03 and 04)	
External Wall	The side and rear enclosure comprise a 3.0-meter-high concrete wall with approximately 200mm-250mm thickness, which is surmounted by a 1.5-meter trapezoidal metal sheet covering. (photos 01 and 04)..	
Portal Frame	The portal frame is made of a steel Column and a Steel rafter UB Steel, steel roof bracing is also installed at the rear of the building. (photos 02, and 04).

Front view - Photo 1

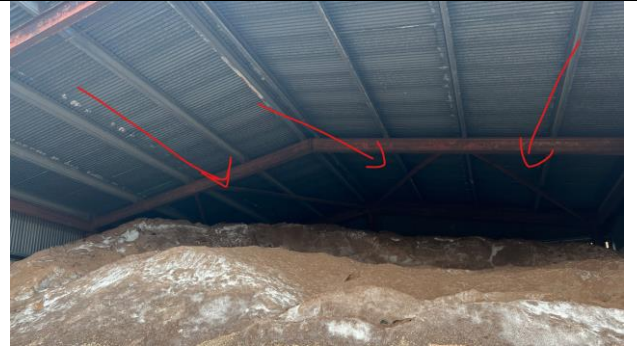
Top view- rear bracing - Photo 2

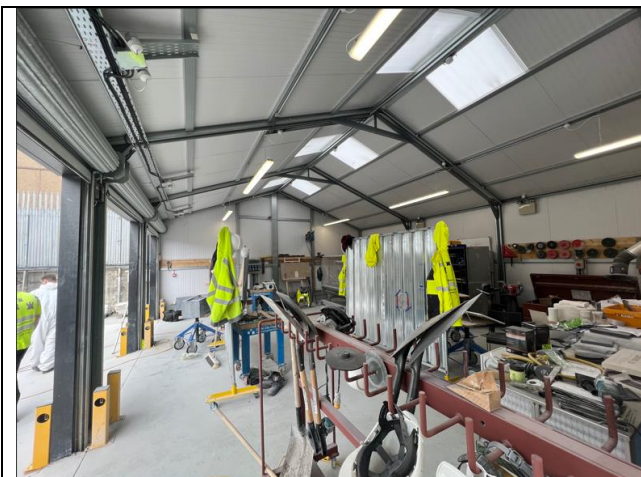
ELEMENT	DESCRIPTION	COMMENT
Ground Floor	The ground floor slab is made of in-situ concrete (photos 5 and 6).	No Opening Up was carried out to expose the foundation, the type of the foundation and depth aren't possible to identify
Roof	The roof is made of Metal Cladding Roof Sheets. (photos 5,6,7 and 8).	
External Wall	The external wall is a cladding made of

internal view - Photo 5

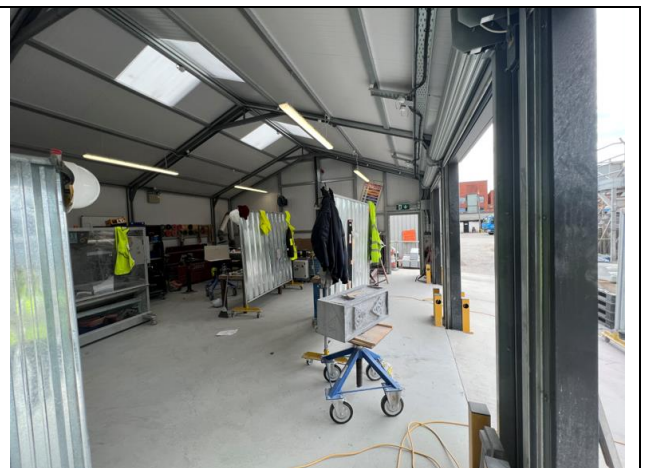
Top view- Photo 6

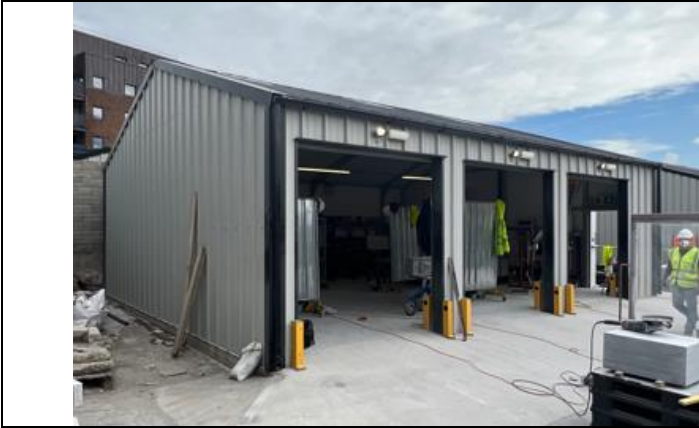
metal a trapezoidal sheet wall; (Photos 7 and 8)	
Portal Frame	The portal frame is made of a steel Column UC and a Steel rafter UC, (photos 5 and 6)

External side view- Photo 7

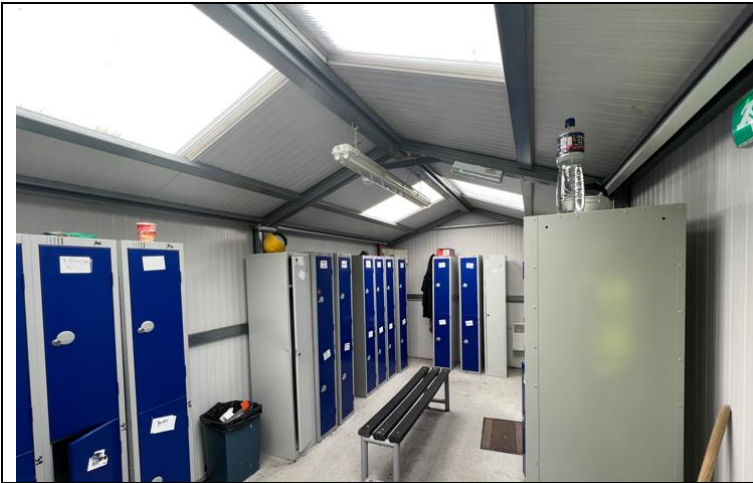
ELEMENT	DESCRIPTION	COMMENT
Ground Floor	The ground floor slab is made of in-situ concrete (photos 9 and 10)	No Opening Up was carried out to expose the foundation, the type of the foundation and depth aren't

internal view - Photo 9

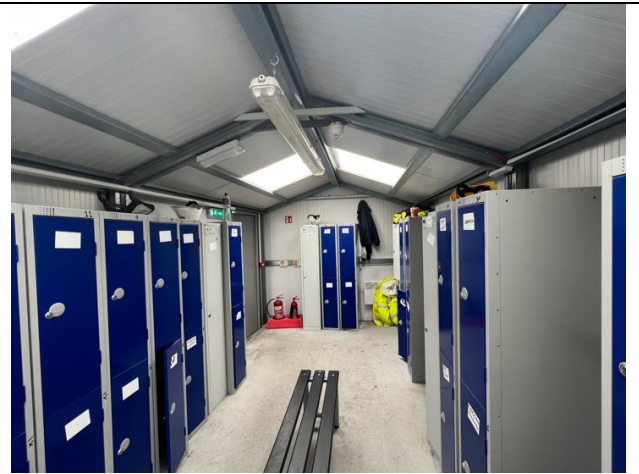
Top view- Photo 10

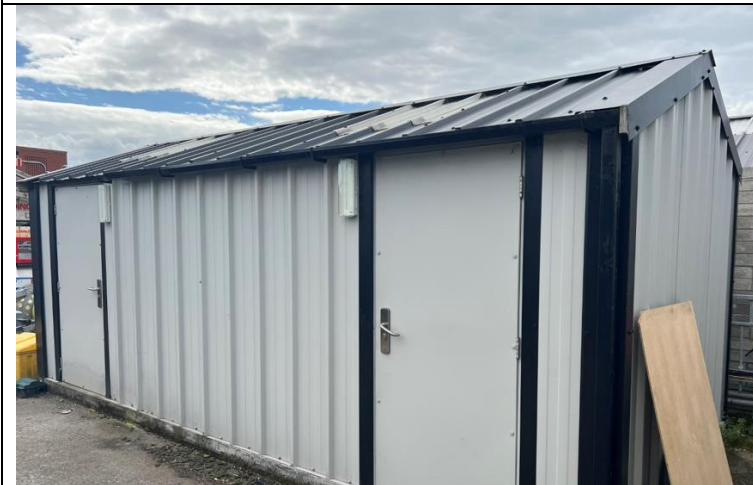
possible to identify
Roof	The roof is made of Metal Cladding Roof Sheets. (photo 9,10,11 and 12)	
External Wall	The wall is made of Metal Cladding sheets (photos 11 and 12)	
Portal Frame	The portal frame is made of a steel Column UC and a Steel rafter UC, (photo 9 and 10)

External side view- Photo 11

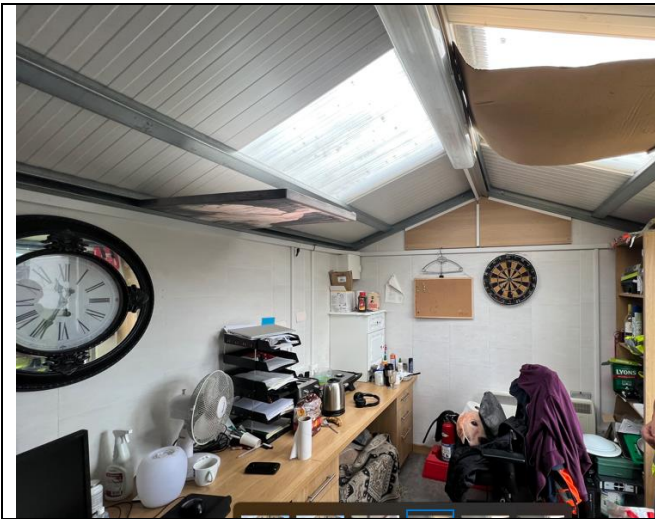
ELEMENT	DESCRIPTION	COMMENT
Ground Floor	The ground floor slab is made of in-situ concrete (photos 13 and 14).	No Opening Up was carried out to expose the foundation, the type of the foundation and depth aren't possible to identify.
Roof	The roof is made of Metal Cladding Roof Sheets. (photo 13,14 and 15)	
External Wall	The wall is made of Metal Cladding sheets (photo 13)	
Portal Frame	The portal frame is made of a steel Column UC and a Steel rafter UC, (photos 13 and 14)

internal view - Photo 13

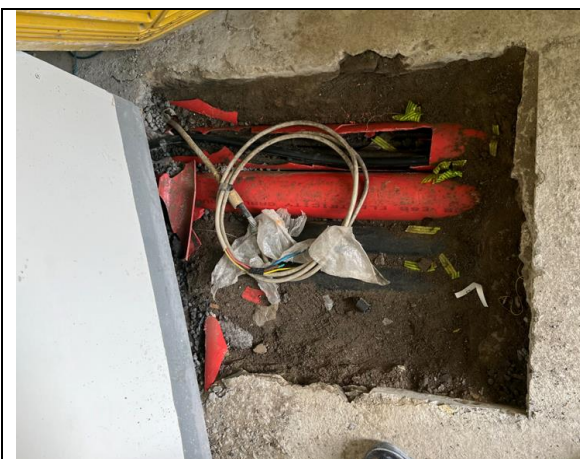
ELEMENT	DESCRIPTION	COMMENT
Ground Floor	The floor slab is a insitu concrete in all of the rooms (photos 16 and 17)	
Roof	The roof is a mono-pitch asbestos roof which is supported by Purlins, with timber ceiling beneath (Photo 17,18, 19, and 20).	It is necessary to confirm on-site before the demolition,
External Wall	The external and internal walls are made of concrete blocks with approximately 215mm. (Photos 17,19, and 20).

Concrete floor - Photo 16

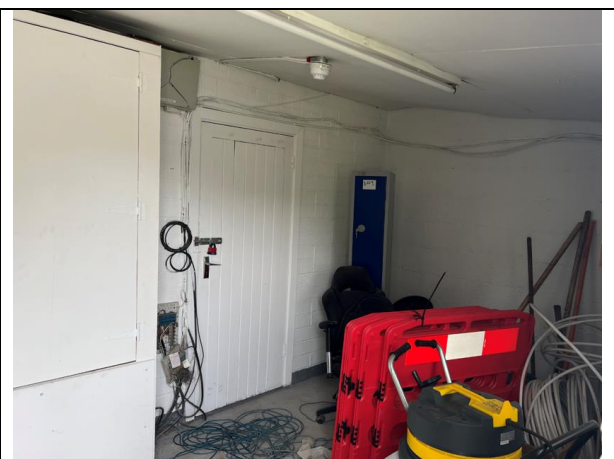
Top view- Photo 17

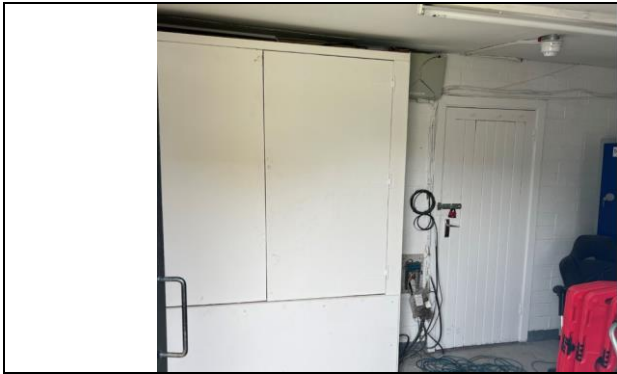
internal room view - Photo 18

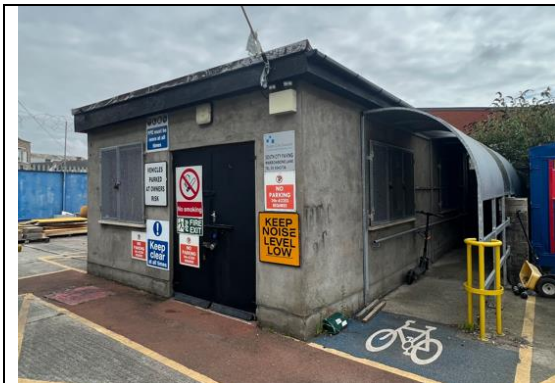
ELEMENT	DESCRIPTION	COMMENT
Ground Floor	The ground floor slab is made of in-situ concrete (Photo 21)	No Opening Up was carried out to expose the foundation, the type of the foundation and depth aren't possible to identify
Roof		The roof was covered and the building was locked during the visit because of that it was not possible to identify the type of roof structure
External Wall	The external and internal walls appear to be made of 215mm concrete blocks. (Photos 21,22, and 23).	During the visit, we didn't have access to the building. Need to be confirmed

Concrete floor - Photo 21

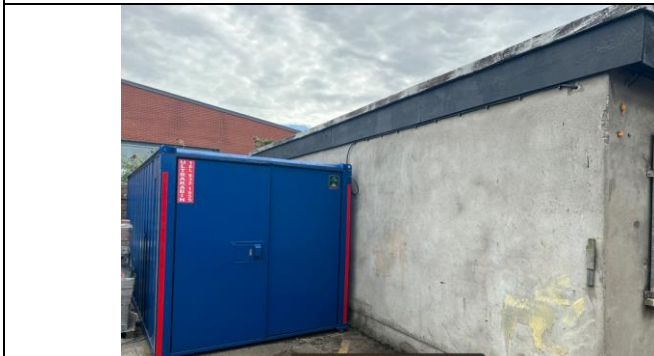
external view - Photo 23

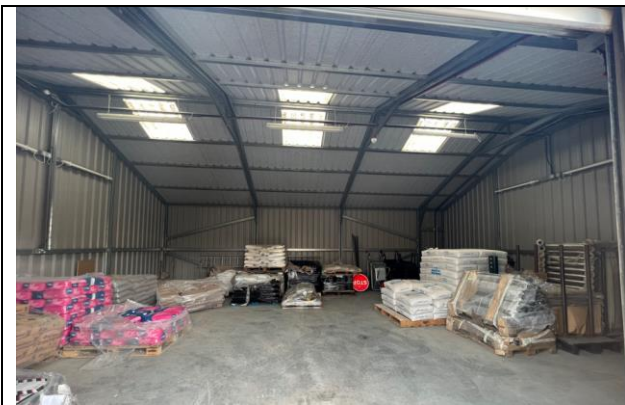
ELEMENT	DESCRIPTION	COMMENT
Ground Floor	The ground floor slab is made of in-situ concrete (photos 24 and 25).	No Opening Up was carried out to expose the foundation, the type of the foundation and depth aren't possible to identify
Roof	The roof is made of Metal Cladding Roof Sheets. (photos 25, 26, 27).	
External Wall	The wall is made of Metal Cladding sheets (photos 25, 26, 28).	
Portal Frame	The portal frame is made of a steel Column UC and a Steel rafter UC, (photos 25 and 26).

Concrete floor - Photo 24

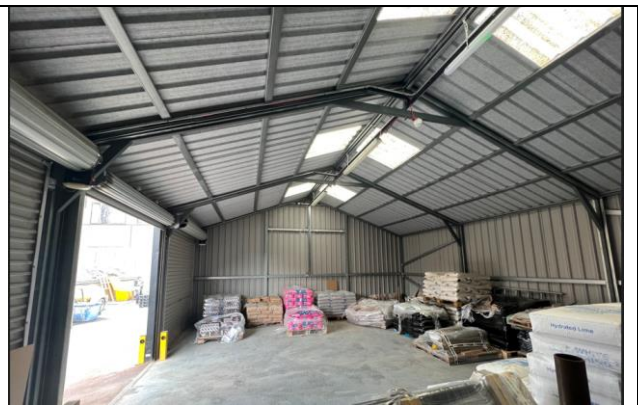
Top view - Photo 25
