24050-02-001

PROPOSED HOUSING DEVELOPMENT AT CROKE VILLAS, DUBLIN

Stage 1 Quality Audit

(Incorporating a DMURS Street Design Audit, and Audits of Accessibility, Cycling, Walking and Road Safety)

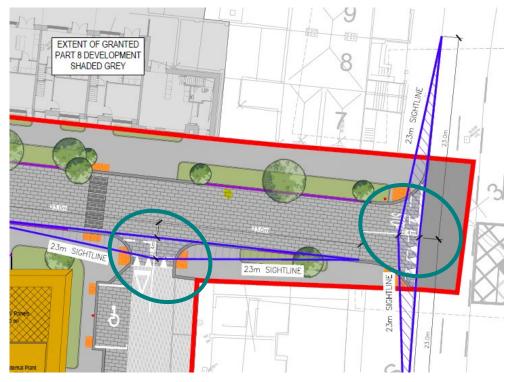
Figure 5.1 – Raised Crossings without drainage detail

It is noted that the proposed raised tables and grade changes throughout the development (Figure 5.1 and Figure 5.2), do not feature drainage measures on either side of continuous ramps. This lack of drainage may result in ponding water, and/or associated silt forming, which may result in cyclists slipping and falling onto the road with associated injuries.

Ensure that adequate drainage measures are included for all such grade changes.

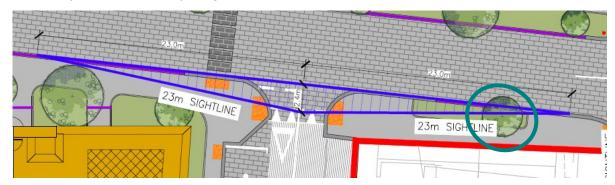
Sightlines at the priority junction in Figure 5.5 appears to be interrupted by a tree. This may increase the likelihood of vehicle collisions due to the reduced sightlines created by this tree, especially so close to Ballybough Road.

Figure 5.5 – Visibility Splay interrupted by tree

Ensure adequate visibility splays at all junctions from edge of carriageway. Remove trees or any other obstructions from visibility splays.

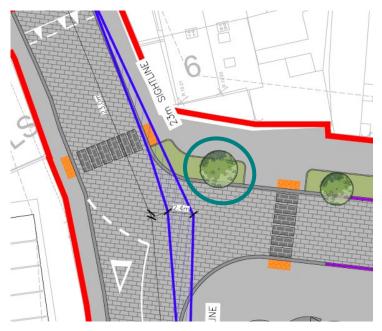
The stopping sight distance (for vehicles approaching from the northwest) appears to be obstructed by a proposed tree (Figure 5.6), which may compromise visibility. This may increase the likelihood of vehicle collisions due to the reduced sightlines created by trees. Visibility of pedestrians approaching the priority crossing may also be obscured, potentially causing injuries for users.

Figure 5.6 – Stopping Sight Distance compromised by tree

The sightlines at the junction in Figure 5.6 have been assessed for a 'major' arm of the junction. As the Yield line is curved on the minor arm, it is not clear where the visibility splay should be or if it is adequate. Incomplete visibility splays can give rise to sudden braking or vehicle collisions.

Ensure adequate stopping sight distance along all roadways, particularly at bends.

Visibility splays should be assessed for the minor arm at this junction, 2.4 metres back from the corresponding edge of carriageway.

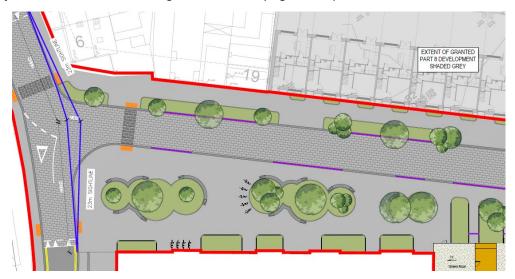
The development features a social housing development, and redevelopment of Sackville Ave, and surrounding streets with an adjacent development already approved. There does not appear to be an increase in parking provision in this area which may result in informal parking on the plaza area, which is at the same level/grade as the roadway. In addition to challenges for pedestrians (including those with vision or mobility impairments) this may compromise sightlines especially in the areas close to the junction in Figure 5.7 causing an increased likelihood of collisions or pedestrian injury. Precedent of illegal/informal parking on footways was observed on Google Streetview (Figure 5.8).

Figure 5.7 – Plaza area with at-grade footways which may cause informal parking

Ensure appropriate parking provision. Ensure vehicles can't be parked on footways through provision of bollards or similar.

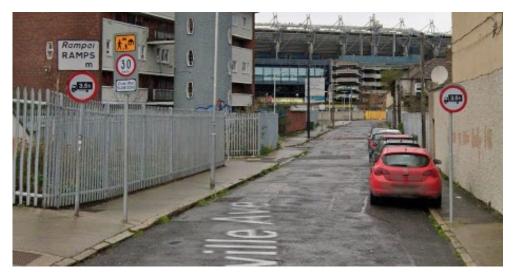
Figure 5.8 – Precedent of informal / illegal parking (from Google Streetview)

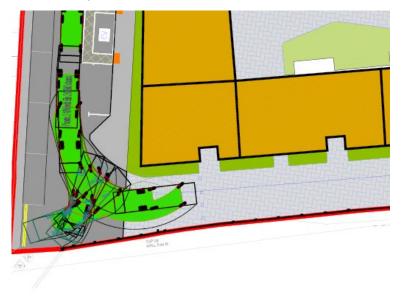
Swept Path Analyses for various vehicle types have been supplied but they are not exhaustive and do not show vehicles making all likely manoeuvres at all junctions. Some swept path analyses show vehicles doing a turnabout (Figure 5.9) while others show vehicles following onto the alignment of Sackville Ave (Figure 5.10). It is not clear if the proposed street network is adequate for all anticipated vehicle manoeuvres, and this may increase the likelihood of vehicle collisions or larger vehicles overrunning footways with associated pedestrian injuries, especially in the context of parked vehicles.

Figure 5.9 – Large vehicle making a turnabout manoeuvre

Ensure all required/intended vehicular movements can be supported by the road network without having to mount kerblines, boundaries or parking bays.

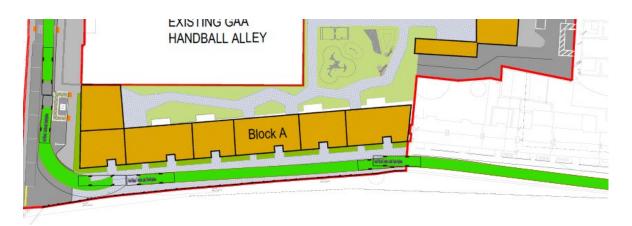
Figure 5.10 – Large vehicle following new route to Sackville Ave

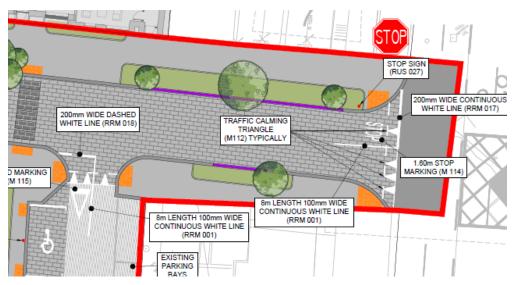
The stop sign warning in Figure 5.13 may not be visible to approaching motorists, due to the proposed trees. The may also may not see the Stopline which is at the bottom of the ramp on the raised carriageway and may be obscured from vision. This may cause vehicles to overshoot resulting in collisions.

Figure 5.13 – Proposed Trees hiding Stop sign and Stopline at the bottom of ramp

Ensure full visibility of Stop sign and Stopline for all users an approach. Remove/relocate trees as required.

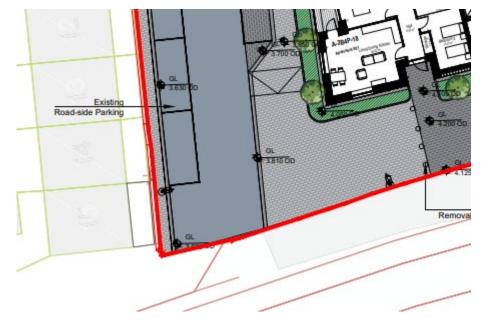
It is intended that the area on the east side of the cul-de-sac in the southwest corner of the development act as a shared space between vehicles turning and pedestrians travelling to and from the residential units. The use of this area as a shared space may increase collision risk particularly as it involves vehicles turning and reversing.

Figure 5.14 – Proposed shared space at turning area

Provide a segregated footpath and vehicular turning area at this location.

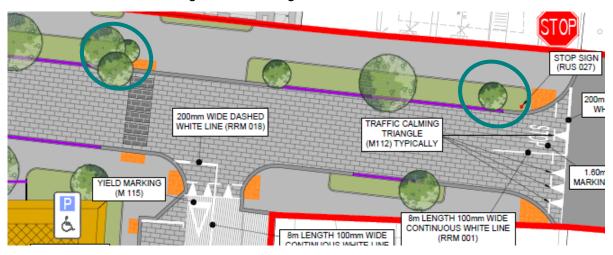
Inter-visibility between pedestrians and drivers at crossings in the proposed development may be significantly compromised by the proposed tree locations. This may increase the risk of collisions and pedestrian injuries at these locations because of trees including, but not limited to, those circled in Figure 6.1 and Figure 6.2.

Figure 6.1 – Proposed Trees compromising intervisibility of pedestrians and motorist at crossings

Ensure adequate inter-visibility between pedestrians and drivers at priority crossings. Relocate trees as appropriate.

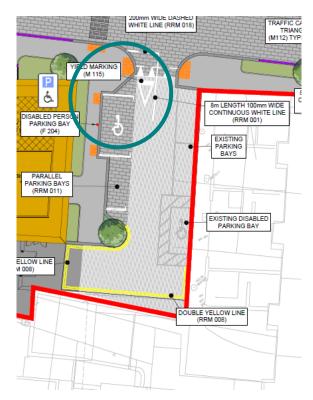
Inter-visibility between pedestrians and drivers at crossings in the proposed development may be significantly compromised by parked vehicles in the disabled bay (Figure 6.4). This may increase the risk of collisions and pedestrian injuries at this location.

Figure 6.3 – Proposed Disabled Bay compromising intervisibility when occupied

Ensure adequate inter-visibility between pedestrians and drivers at priority crossings.

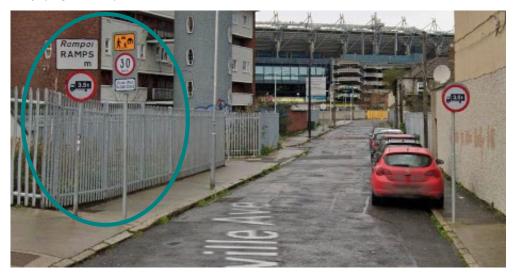
At the Sackville Ave / Ballybough Road Junction there are multiple warning sign poles in close proximity. This will reduce the effective width of the footway and the level of service of this footway (Figure 6.4).

Figure 6.4 – Warning Sign Poles reducing effective width of footway

Rationalise the amount of street clutter and street poles.

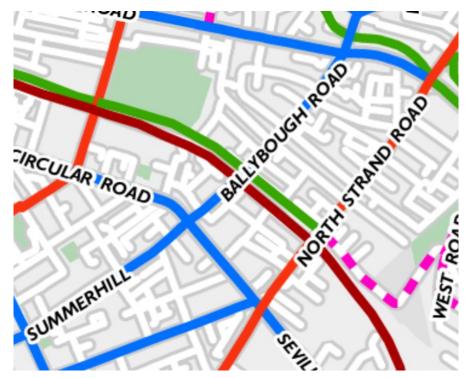
While there is no proposed cycle infrastructure in the development, the local DMURS type street adopted is intended to be a low-speed environment. It is not clear however how the development will tie into the proposed 'Secondary' Cycle Route (blue in Figure 7.1) along Ballybough Road, the 'Utility Greenway' Route (green in Figure 7.1) along the canal / railway alignment or the 'Primary Orbital' Route (dark red in Figure 7.1) along the canal / railway alignment. A lack of coordination may reduce the effectiveness of these schemes, proposed by Dublin City Council and National Transport Authority, and undermine potential to achieve cyclist desire lines.

Consider wider network impacts of future schemes to support a network of segregated cycleways through the development. Consult with Dublin City Council Active Travel to ensure the development is futureproofed.

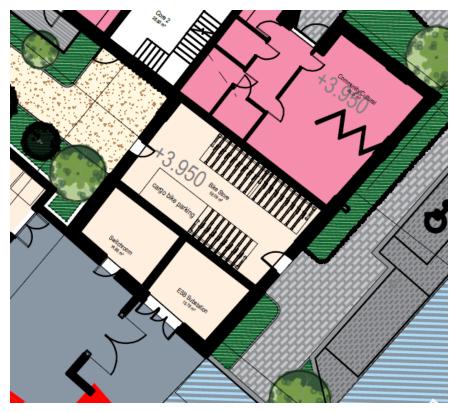
It is unclear if the proposed secure cycle storage in the development (e.g. Figure 7.2) will be adequate for the envisaged densities, especially in the absence of vehicular parking. While some space for cargo cycles has been provided, it is not clear how many or if the space for manoeuvrability required has been included. This may cause cyclists to lock cycles to other street furniture, creating a navigation risk and reducing the effective widths of footways, especially for cargo cycle users.

Figure 7.2 – Secure cycle storage

Provide adequate volumes of secure storage for cycles and cargo cycles.

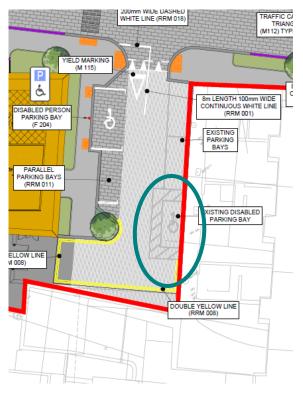
An existing disabled bay (Figure 8.3 and Figure 8.4) was observed to have tactile paving ramps down to access the disabled bay. This may result in confusion for pedestrians with a vision impairment who may assume this is a pedestrian crossing. These pedestrians may then cross the street, meet a kerb with no tactile paving, and become disoriented.

Figure 8.3 – Existing disabled bay

Remove tactile paving from access ramps.

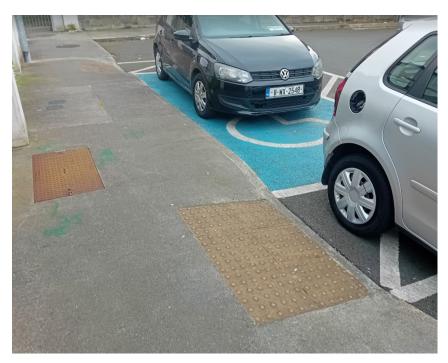
Figure 8.4 – Existing disabled bay

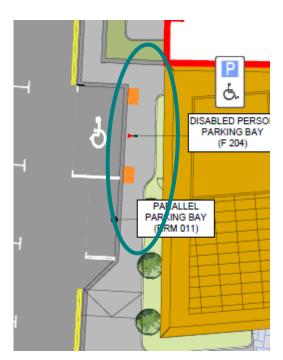
A proposed disabled bay (Figure 8.4 and Figure 8.5) shows conflicting information between drawings regarding how much footway space is between the edge and the building and how much will be grassed area. Inclusion of ramps recessed into the footway at this location may significantly reduce the effective width of the footway and post challenges for pedestrians with mobility impairments. The provision of tactile paving to access the disabled bay may also result in confusion for pedestrians with a vision impairment who may assume this is a pedestrian crossing. These pedestrians may then cross the street, meet a kerb with no tactile paving, and become disoriented.

Figure 8.5 – Proposed disabled bay

Ensure adequate access routes around and adjacent to the disabled bays. Remove tactile paving from access ramps.

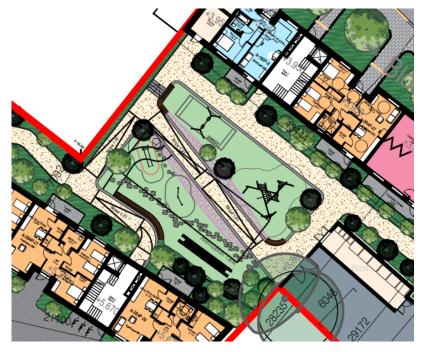
Proposed ramps and steps within the development courtyard area including, but not limited to, those in Figure 8.6, do not appear to feature railings or tactile paving. This means that users with mobility or vision impairments may struggle to navigate this area.

Figure 8.6 – Ramps and steps with no tactile paving

Ensure provision of tactile paving and railings at all locations as required.

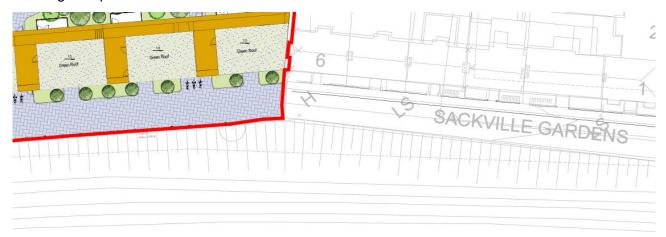
Figure 8.8 – Sackville Gardens Access

The proposed infrastructure appears to provide for a tie-in to Sackville Gardens (Figure 8.8 and Figure 8.9). It is not clear how the existing segregated roadway and footway on Sackville (Figure 8.10) will tie into the proposed shared space local street proposed. They may cause confusion for a pedestrian with a vision impairment and an increased likelihood of vehicles colliding with pedestrians.

This tie in should be redesigned to ensure continuity and clarity for pedestrians with vision and mobility impairments.
