Residential Development at
Collins Avenue, Co. Dublin

Combined Stage 1 & 2
Road Safety Audit

Document Ref: P21-090-PSW3-RP-001

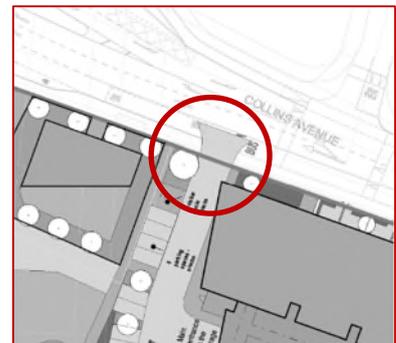
3.3 Problem

Summary: No junction control or priority type has been indicated at the development access.

The junction control (stop, yield etc.), and subsequently priority, at the proposed development access has not been indicated. This could increase the risk of overshoot collisions where drivers fail to slow and stop when exiting the development's access.

Ensure the junction control at the development access is clear (via signage/road markings) to drivers exiting the development.

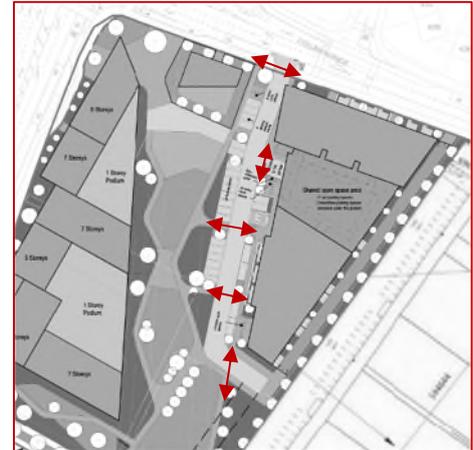
3.4 General Problem

Summary: No tactile paving provision within the development.

Formal pedestrian crossing points, including dropped kerbs and tactile paving, have not been indicated within the development. A failure to provide dropped kerbs at crossing points and along pedestrian desire lines could result in mobility impaired pedestrians being unable to safely and independently enter the carriageway to cross to the opposite footpath. This could result in slips, trips or falls as these pedestrians attempt to descend the kerb. Similarly, a failure to provide tactile paving at dropped kerb locations could lead to an increased risk of visually impaired pedestrians unintentionally entering the carriageway where they could be struck by vehicles.

Formal uncontrolled pedestrian crossings, including dropped kerbs and tactile paving, should be provided at pedestrian crossing points/desire lines.

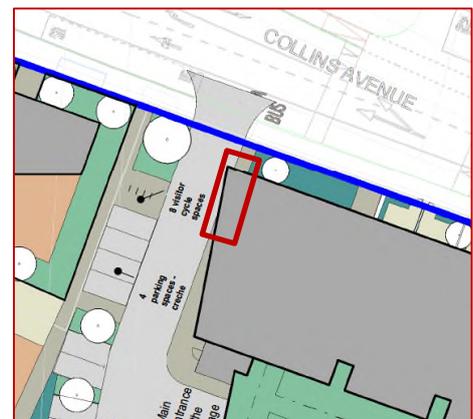
3.5 Problem

Summary: Unclear if Building Overhang will have sufficient clearance to high sided vehicles entering the development.

The apartment block in the northeast corner of the development appears to overhang the access road. The plan does not indicate what the vertical clearance between the carriageway level and the structure is, so it has not been possible to determine if there is sufficient clearance between the structure and a high sided vehicle. Insufficient clearance may lead to material damage collisions, and critical structural damage to the structure.

Ensure sufficient clearance between the carriageway and the structure is provided for all vehicle types.

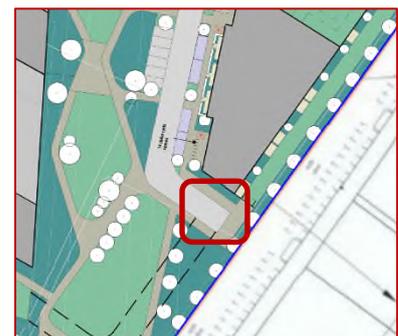
3.6 Problem

Summary: Large vehicles may be forced to reverse long distances within the development, increasing the risk of rear-end-shunt and VRU/vehicle collisions.

A turning head is not indicated at the end of the access road. Large vehicles may therefore be unable to safely turn their vehicle before exiting, increasing the risk of HGV drivers needing to reverse along the development access road to exit the development. This may lead to rear-end-shunt and vehicle/VRU collisions.

Provide a turning head at the end of the access road.

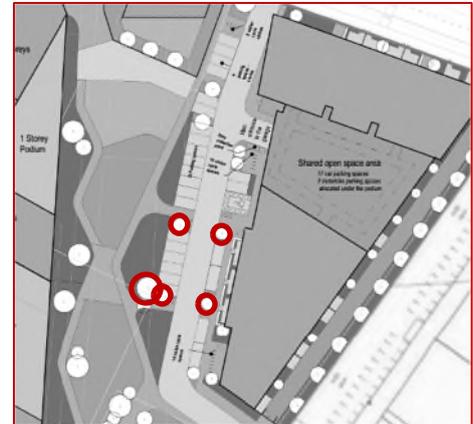
3.7 Problem

Summary: The location of trees at pedestrian crossing points may block or reduce pedestrian/driver inter-visibility, increasing the risk of a vehicle/pedestrian collisions.

Trees are indicated near pedestrian crossings within the development. The location of the trees may block inter-visibility between drivers and pedestrians. This could lead to pedestrians stepping out onto the crossing being insufficiently aware of approaching vehicles and in turn drivers being insufficiently aware of the pedestrians commencing a crossing. This may result in pedestrian/vehicle collisions and serious injury.

Ensure trees do not block driver/pedestrian inter-visibility on the approach to pedestrian crossings.
