**KAVANAGH
MANSFIELD
& PARTNERS
CONSULTING
STRUCTURAL
AND CIVIL
ENGINEERS**

**NDFA SOCIAL HOUSING
BUNDLES 04 AND 05
STRUCTURAL SURVEY REPORT ON
BUILDINGS TO BE DEMOLISHED**

STANLEY STREET

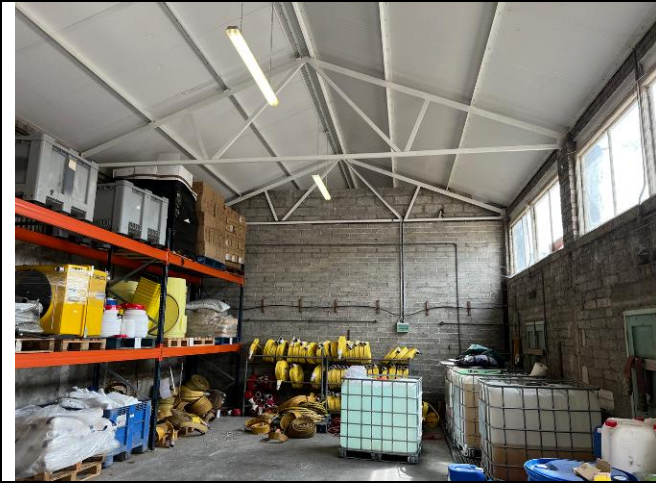
ELEMENT	DESCRIPTION	COMMENT
Ground Floor	The Floor slab is in-situ concrete in all of the rooms(photo 7)	No Opening Up was carried out to expose the foundation, type of the foundation and depth isn't possible to identify.
Roof	The roof is made of metal deck roofing with two slopes and is supported by purlins, which are supported by fink trusses. The exception is the last room on the right side of the building which has a concrete slab which is supported by concrete beams which are supported by the load bearing wall (photo 8 & 9)	
External Wall	The external walls are made of a 215 concrete blocks on flat. (Photo 10).	No opening up was made to determine if it was a cavity wall or a single/double solid block, it is necessary to carry out an investigation during the demolition plan.
Internal Wall – GFL	Internal partitions are made of 215 concrete blocks on flat. (photos 7, 8 & 9)	No opening up was carrying out during our visit.

Standard Internal side (photo 7)

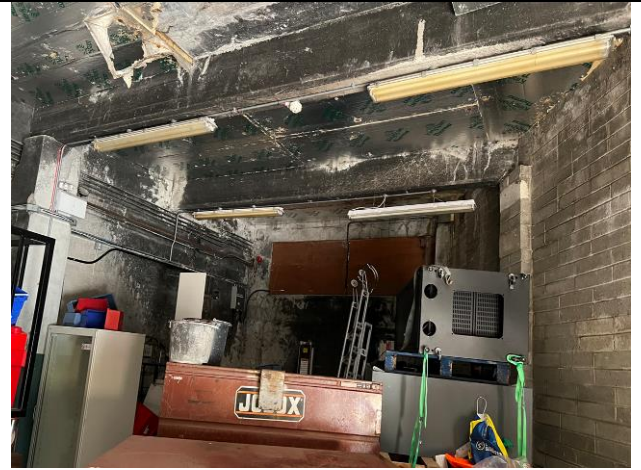
Internal view - standard room (photo 8)

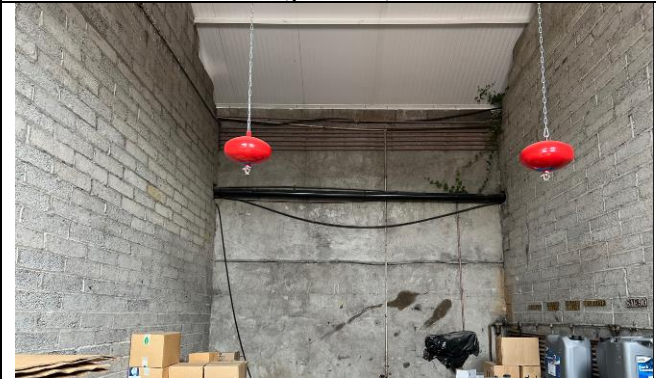
Standard Internal side (photo 9)

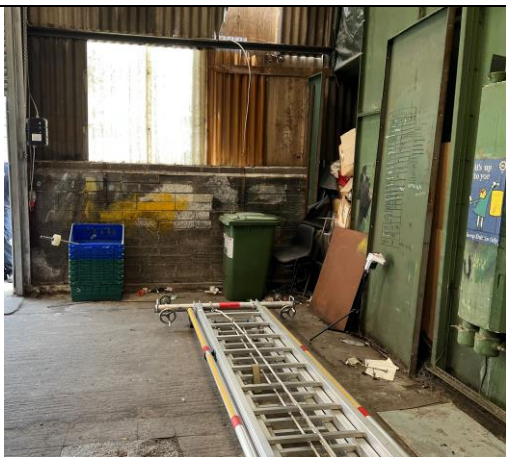
ELEMENT	DESCRIPTION	COMMENT
Ground Floor	The Floor slab is an in-situ concrete in all of the rooms (photo 11)	No Opening Up was carried out to expose the foundation, type of the foundation and depth isn't possible to identify.
Roof	The duo pitch roof is made of metal trapezoidal sheet roofing supported by purlins, which are supported by steel fink trusses (photo 12).	
External Wall/Cladding	The side and rear walls are constructed using an average of 215mm masonry walls laid flat. The front elevation of the building is clad with metal trapezoidal sheets. There are 2 large roller shutter doors at the front elevation of the building. (photo 13 &14)	No opening up was carrying out during our visit. Thickness need to be confirmed.
Portal Frame	The portal frame is made of a steel columns and a Steel trusses (photos 13,14 and photo 15)

Internal view (photo 11)

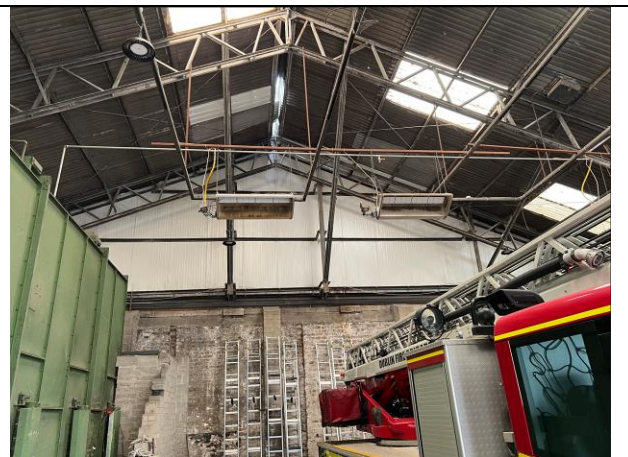
Internal view - roof structure (photo 12)

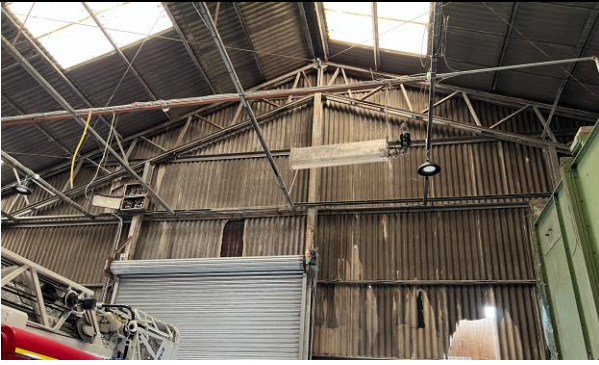
Internal view – front elevation of the building (photo 13)

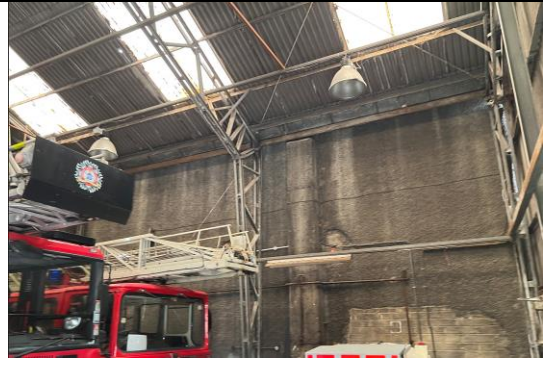
Internal view – external wall, Right side (photo 14)

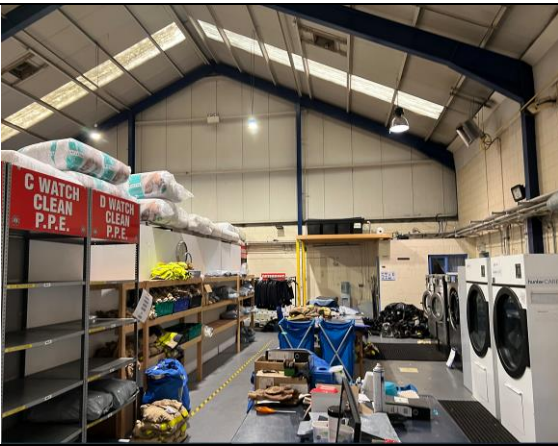
ELEMENT	DESCRIPTION	COMMENT
Ground Floor	The ground Floor is a insitu concrete in all of the rooms (photo 15) ;	No Opening Up was carried out to expose the foundation, type of the foundation and depth isn't possible to identify.
Roof	The roof is made of metal decking with two slopes and is supported by Purlins, which are supported by steel pitched rafter roof metal/Steel portal frame (photo 16).	
External Cladding/wall	The masonry walls appears to be constructed using an average of 400mm concrete block. The front elevation of the building is clad with metal trapezoidal sheets. There are 3 large roller shutter doors at the front elevation of the building. (Photo 17 & 18).	There is a small room made of flat blocks, with just one level in the rear of the building

Internal view – photo 15

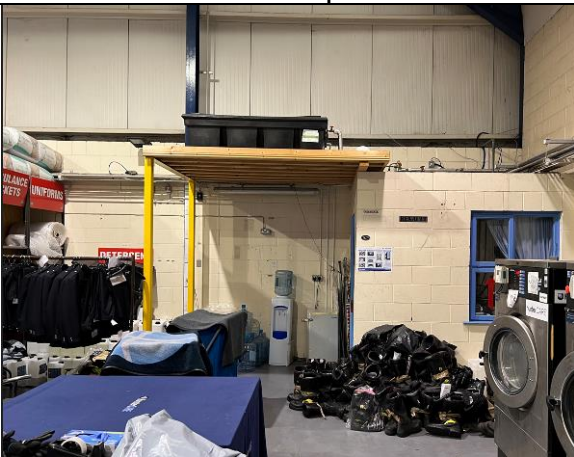
External/Internal wall – photo 17

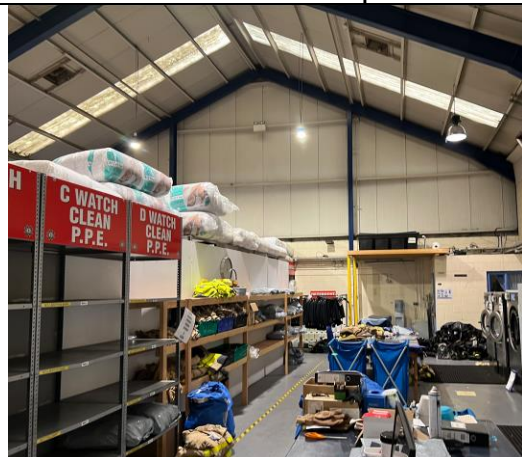
External/Internal wall – photo 18

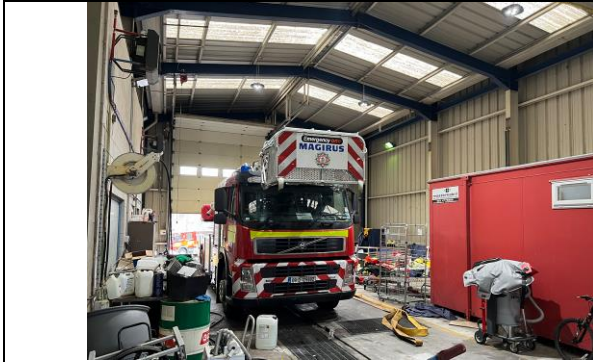
ELEMENT	DESCRIPTION	COMMENT
Ground Floor	The Floor slab is insitu concrete in all of the room (photo 19);	No Opening Up was carried out to expose the foundation, the type of the foundation and depth aren't possible to identify.
Roof	The roof is made of metal trapezoidal sheet roofing tile with two slopes and is supported by Purlins, which are supported by steel pitched rafters (photo 20);	
External Wall/cladding	The external cladding is made of metal trapezoidal sheets ; the walls are supported by sheeting rails (photo 20);

Internal View - Back to front (photo 19)

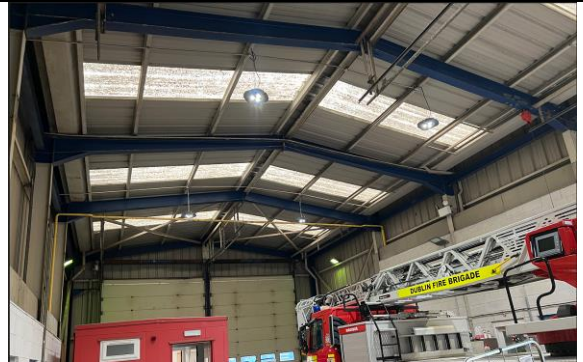
Internal view - Front to back (photo 20)

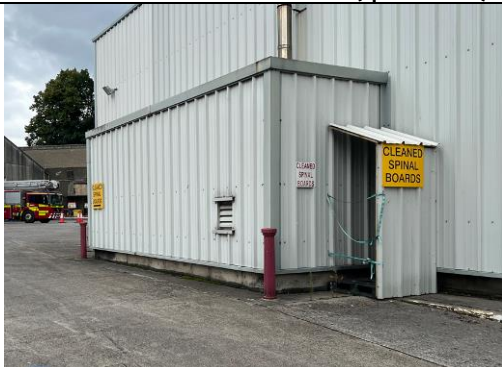
Annex building – Ground Floor	The ground Floor is a concrete raft slab (photo 22);	
Annex building – Roof	The roof is made of metal trapezoidal sheet roofing tile with two slopes and is supported by purlins which is supported by steel beams UB (photo 21 & 22);	
External Wall/cladding	The external walls is made of a Metal cladding .There are also two larges roller shutters door to the front elevation of the building (photo 21 & 22);

Internal View - standard room (photo 21)

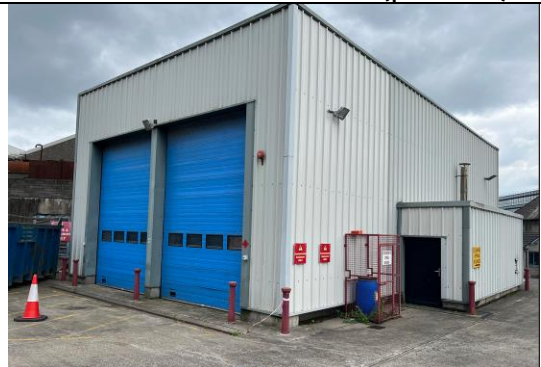
External View - rear side (photo 22)

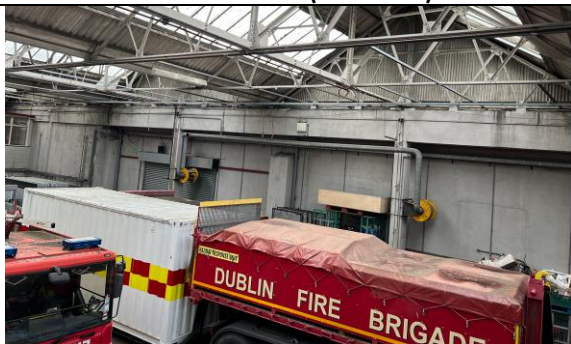
Concrete Frame	The roof are supported by a concrete frame , which comprises concrete beams and concrete columns (photos 25, 26 & 27)

Internal Side view (photo 25)

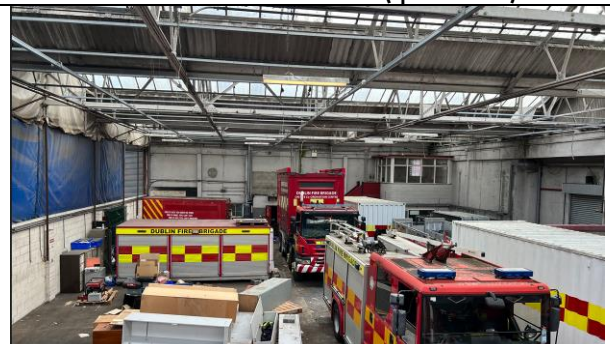
ELEMENT	DESCRIPTION	COMMENT
Ground Floor	The floor slab is insitu concrete in all of the rooms (photo 23);	No Opening Up was carried out to expose the foundation, type of the foundation and depth isn't possible to identify.
Roof	The roof is constructed with asbestos material, featuring two slopes. It is further enhanced with a few lines of translucent sheets. The roof is supported by purlins, which are in turn supported by primary and secondary steel beams. (Photos 23, 24, 25 & 26).	The mono-pitch asbestos must be removed prior to demolition by a licensed waste disposal company
External Wall	The masonry walls appear to be constructed using an average of 215mm concrete block. (photos 26)	No opening up was made, because of the mortar on the wall is not possible to identify whether it was made from a hollow block or a flat solid block, need to be confirmed during demolition plan.
Internal wall	The internal walls are made of an average of 215 mm concrete blocks (photos 26, 27 & 28)

Internal Side view (photo 26)

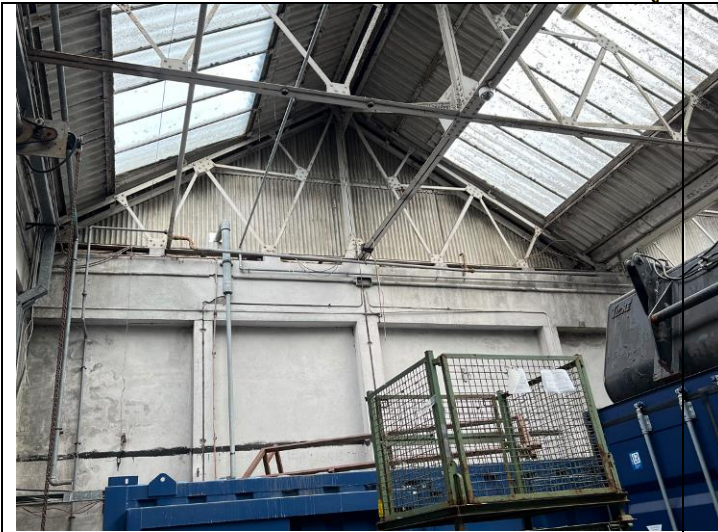
Roof view (photo 27)

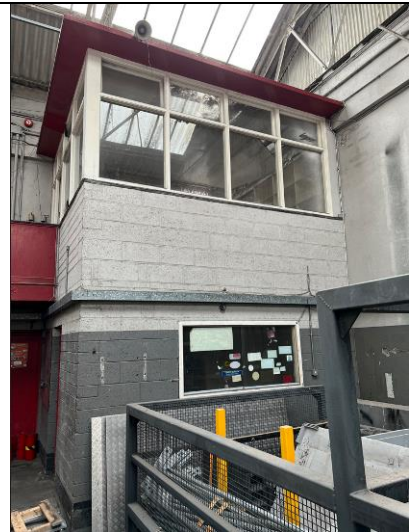
internal View - internal room (photo 28)

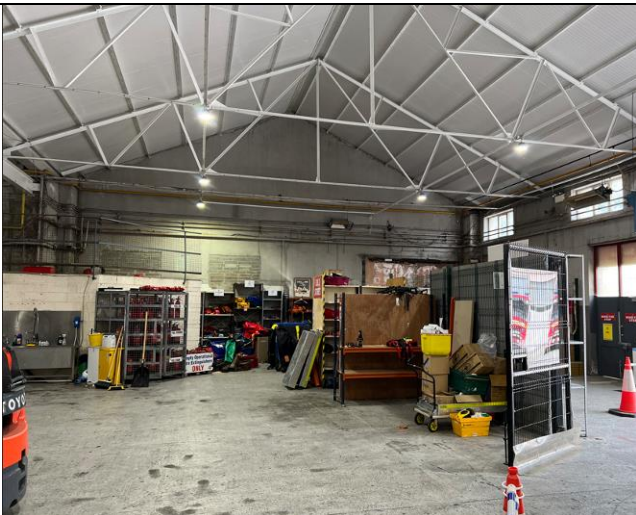
ELEMENT	DESCRIPTION	COMMENT
Ground Floor	The Floor slab is in-situ concrete in all of the rooms (photo 29);	No Opening Up was carried out to expose the foundation, type of the foundation and depth aren't possible to identify.
Roof	There are two roof structures connected to each other. The roofs are made of metal trapezoidal sheet roofing tile with two slopes each and is supported by Purlins, which are supported by fink truss roof metal (photo 29 & 30)	
Mezzanine floor	Mezzanine floor is made of timber	No Opening Up was carried out to expose the slab, it seems to be a timber floor slab, although needs to be check on site. (photo 32 & 33)
1 st floor– internal mezzanine	Mezzanine floor is made of timber . The internal wall is made of 215mm masonry wall (photo 32 & 33)	No Opening Up was carried out to expose the slab, it seems to be a timber floor slab, although needs to be checked on site. (photo 32 & 33)

Internal View (Photo 29)

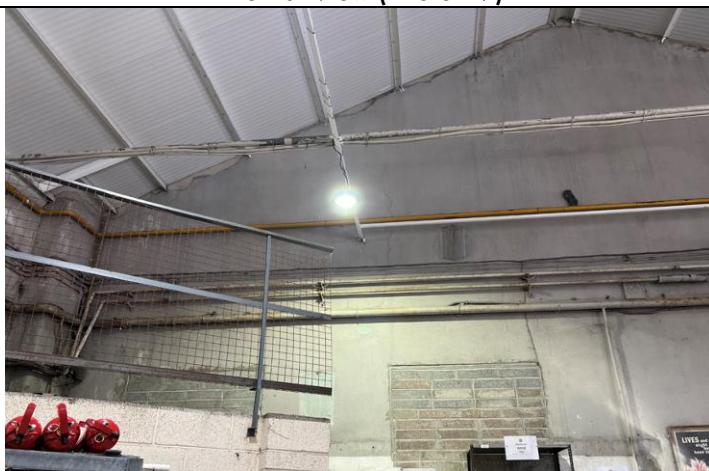
External Wall	The external walls are made of 400mm masonry wall (photo 31).	No opening up was made to confirm if it is a concrete wall or a masonry wall, it is necessary to carry out an investigation during the demolition plan.
Internal wall	The internal walls are made of 215mm masonry wall. (Photo 32).

Internal Side view (photo 31)

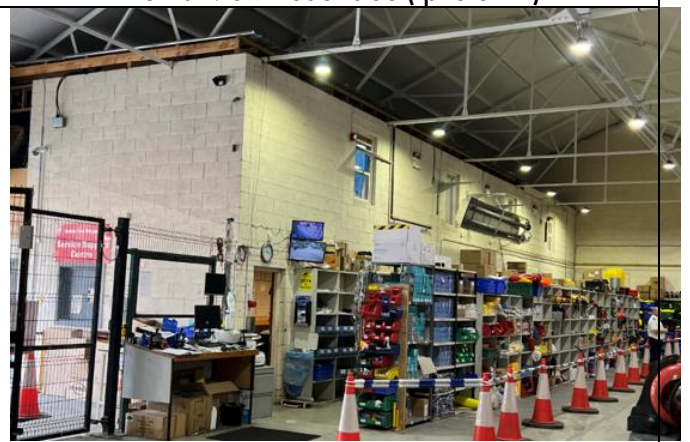
Internal Side view (photo 32)

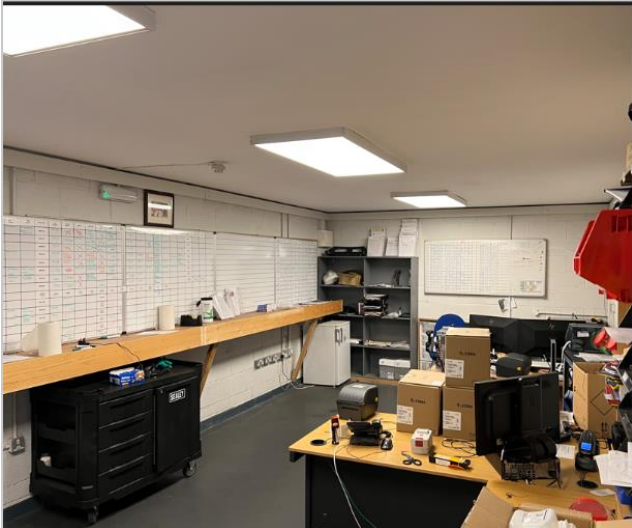
Standard Internal side of the annex building (photo 33)

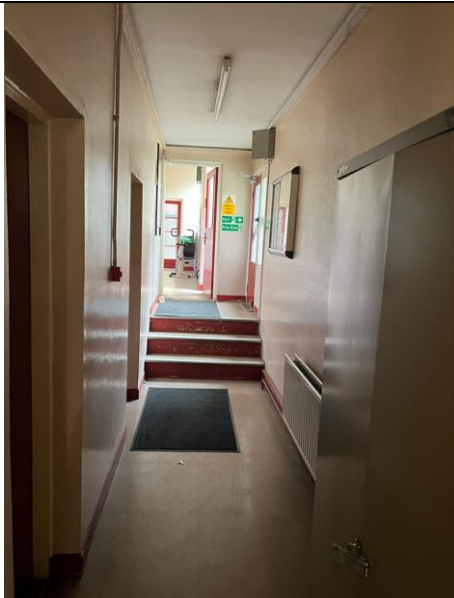
ELEMENT	DESCRIPTION	COMMENT
Ground Floor	The Floor slab is in-situ concrete in all of the rooms (photo 35)	No Opening Up was carried out to expose the foundation, the type of the foundation and depth isn't possible to identify.
1 st Floor	The 1 st floor seems to be a timber floor supported by loadbearing masonry walls (photo 36)	No Opening Up was carried out to expose the slab, it seems to be a timber floor slab, although need to be check on site. (photo 36)
Roof	the roof seems to be made of corrugated asbestos sheet metal with one slope and is supported by Purlins.(Photo 37)	No Opening Up was carried out to expose the slab, it seems to be a timber floor slab, although need to be check on site. (photo 37)
External Wall (GF & 1 st floor)	The external wall seems to be made of a 400mm cavity wall (photo 37 & 38)	No opening up was carried out during our visit.

Internal View (Photo 35)

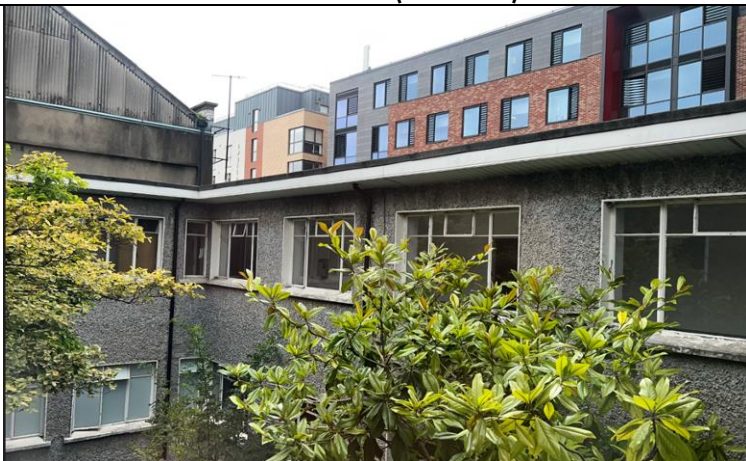
external Side view (photo 37)

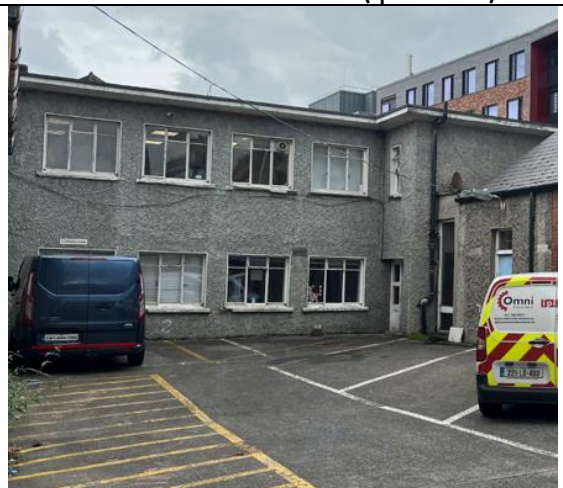
External Side view (photo 38)

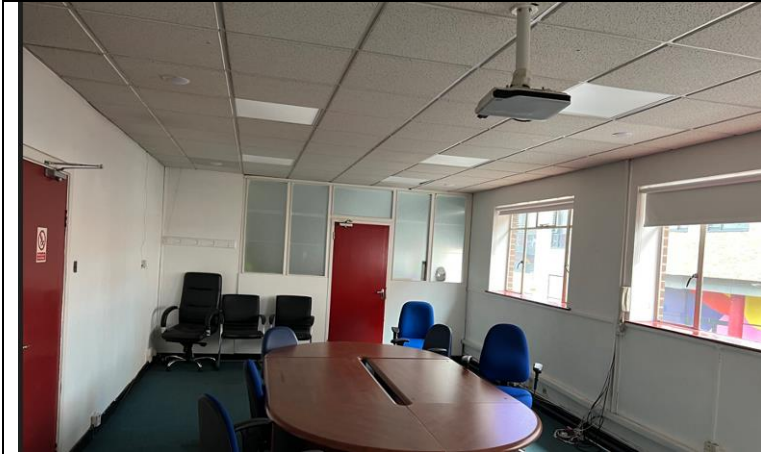
Internal Wall (GF & 1 st floor)	The internal wall seems to be made of a 215mm masonry wall and some partition walls (photo 39 & 40)	No opening up was carried out during our visit.
---------------------------------------------	-----------------------------------------------------------------------------------------------------	-------------------------------------------------

Standard rooms (photo 39)

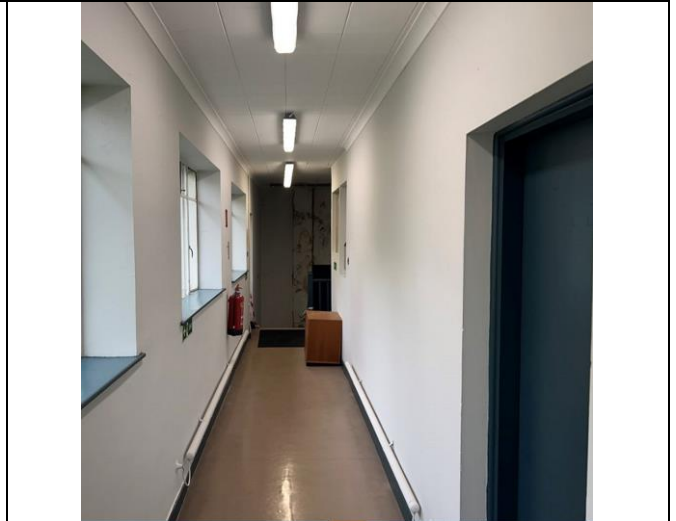
Standard Internal side of the building (photo 40)

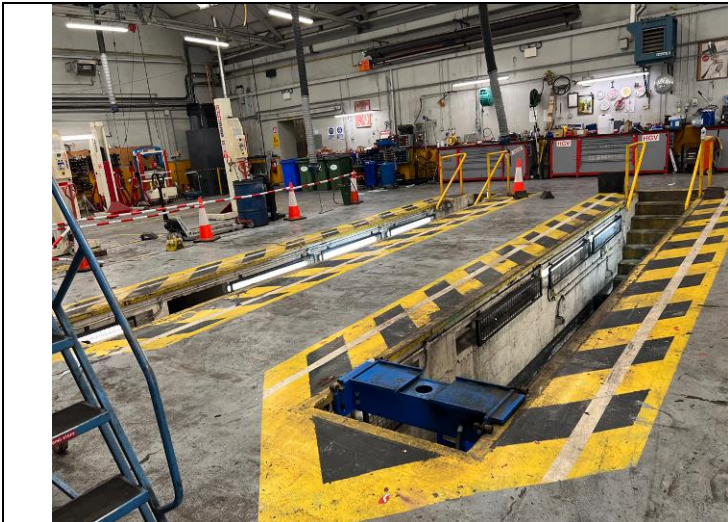
ELEMENT	DESCRIPTION	COMMENT
Ground Floor	The ground floor is made of concrete slab; there are some openings in the floor for vehicle maintenance (photo 41, 42)	No Opening Up was carried out to expose the foundation, type of the foundation and depth isn't possible to identify.
Roof	The roof is made of metal trapezoidal sheet roofing tile with two slopes and is supported by Purlins, which are supported by fink truss roof metal.(43 ,44 and 45)	
External Wall	The external wall seems to be made of a 400mm-500 mm concrete wall – (photo 45 & 46).	No opening up was carried out during our visit. Thickness need to be confirmed.

Internal view ground floor slab (Photo 41)

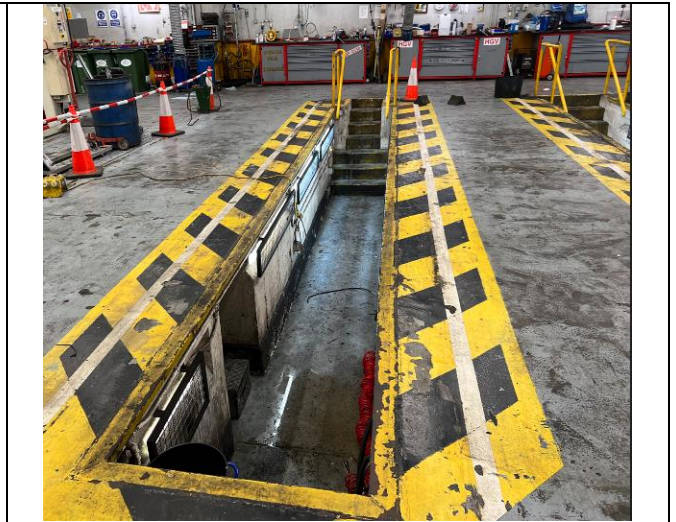
Internal view ground floor slab (Photo 42)

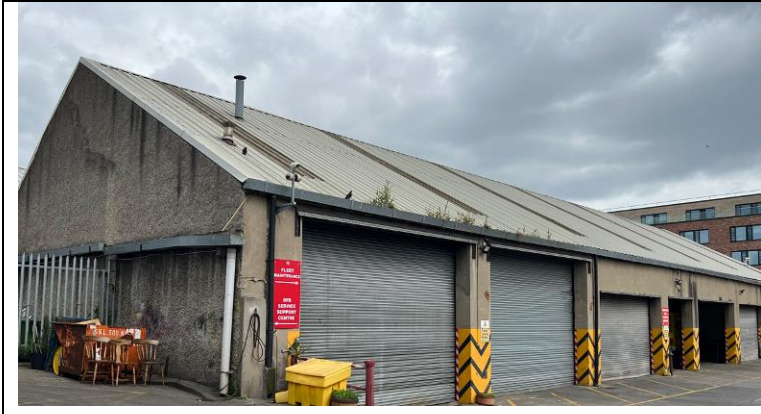
Roof view external side (photo 45)

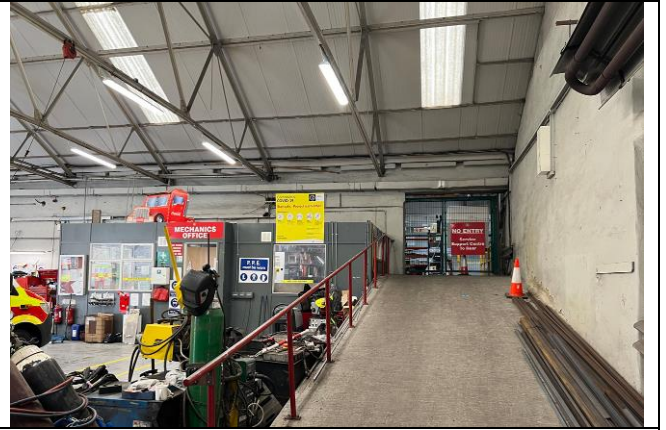
Standard Internal side of the building (photo 46)

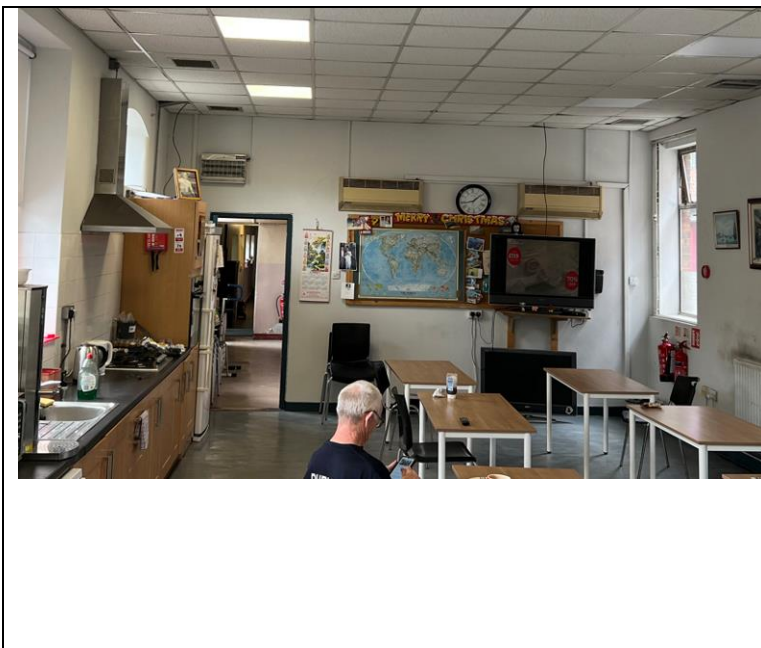
ELEMENT	DESCRIPTION	COMMENT
Ground Floor	The floor slab is made of insitu concrete in all of the rooms; (photo 47, 48)	No Opening Up was carried out to expose the foundation, the type of the foundation and depth aren't possible to identify.
Roof	The roof is made of slate roofing, which are supported by trusses.(49,50)	No Opening Up was carried out to expose the roof structure, type of the roof structure isn't possible to identify
External Wall	The external wall appears to be made of a 350mm masonry wall - concrete block (photo 51 & 52)	No opening up was carried out during the visit
Internal Wall	The internal wall are also 215 masonry wall with some lightweight partition walls (photos 53 & 54)	No opening up was carrying out during our visit.

Internal view ground floor slab (Photo 47)

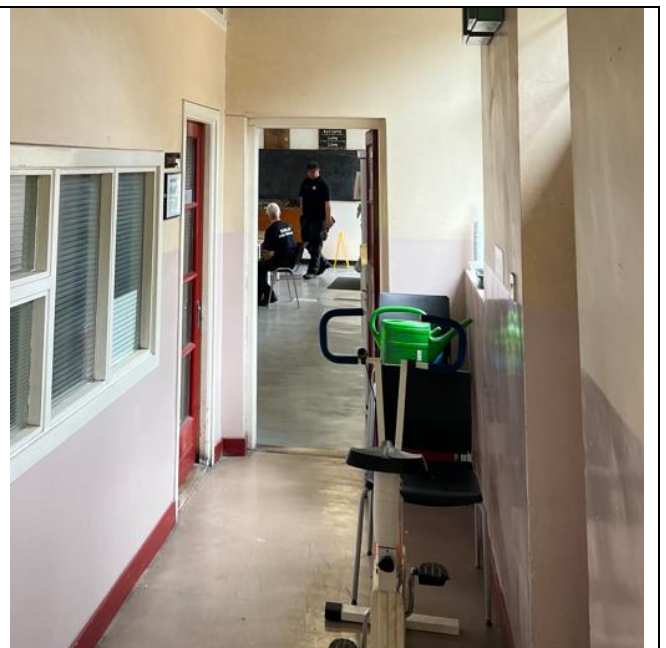
Internal view ground floor slab (Photo 48)

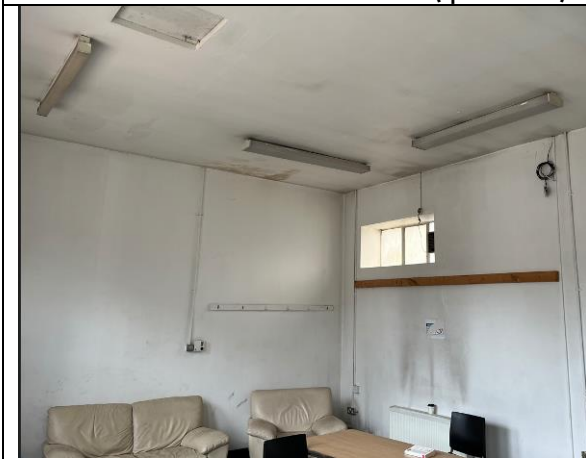
view from the inside (photo 53)

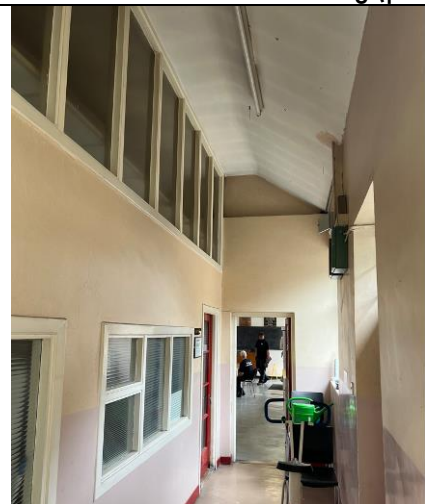
view from the inside (photo 54)

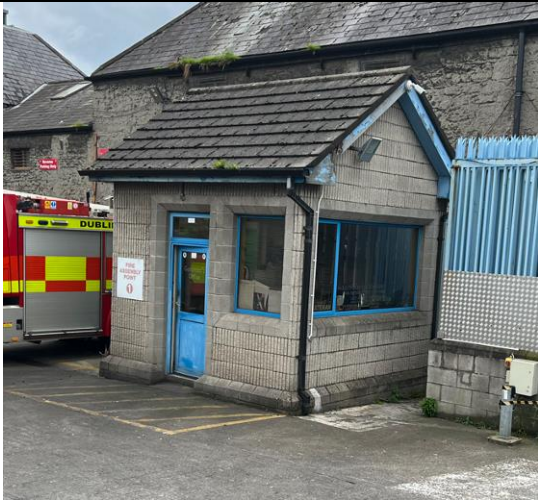
ELEMENT	DESCRIPTION	COMMENT
Ground Floor	The floor slab is made of insitu concrete; (photos 56 and 57)	No Opening Up was carried out to expose the foundation, the type of the foundation and depth aren't possible to identify.
Roof	The roof is made of slate roofing with concrete tile , which are supported by trusses.(49,50)	No Opening Up was carried out to expose the roof structure, type of the roof structure isn't possible to identify
External Wall	The external wall is made of 315 mm masonry wall (photo 51 & 52)

External view (Photo 56)

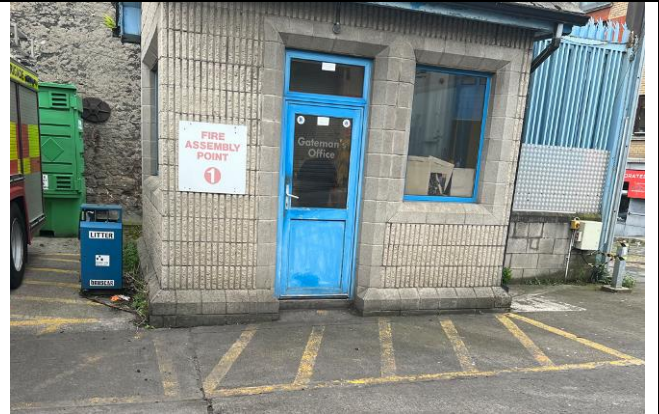
External view (Photo 57)
