SOCIAL HOUSING BUNDLE 4 DEVELOPMENT AT THE STANLEY STREET DEPOT, DUBLIN 7

Boundary Wall Survey SHB4-SSD-RP-MOR-CS-P3-004

DUBLIN CITY COUNCIL
September 2024

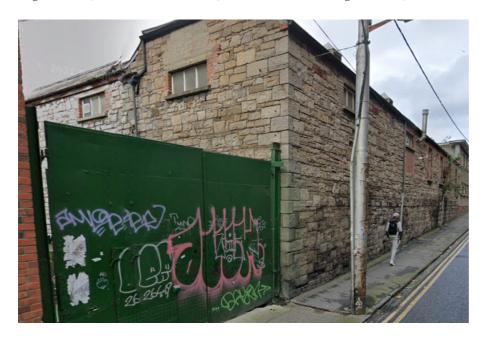
Figure 4.3 (500mm stone walls)

Southeast section of boundary walls consists of approximately 500mm thick stone walls. The first 27m forms part of the old Maltings building as shown in fig 4.1, the middle 19m (Fig 4.2) forms part of a free standing 3.7m high boundary between Stanley Street Depot and a neighbouring property. The final 47m as shown in fig 4.3 forms part of an existing Stanley depot building and ESB substation. The wall forms part of a retaining wall due to difference in ground floor level of 2.5m.

The wall is out of plum due to the horizontal forces from retaining 2.5m of soil. For the redevelopment of Stanley Street large openings will be provided in the stone wall and the soil will be removed for 23m section of the 30m long wall to allow the wall to act as a free-standing wall. The structural integrity of the wall seems sound in its current state and there is no concern with horizontally stability of the wall up to 6.1m, assuming the wall will be horizontally propped at Level +0.00 (13m AOD). The retaining section of the 7m long section of the stone wall will need to be investigated further to ensure it can continue to act as a retaining wall for the new development.

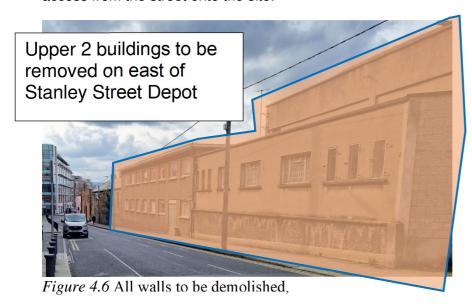
The buildings along Grange Gorman street lower are to be demolished down to ground level to allow full access from the street onto the site.

No further action, as all walls to be demolished.

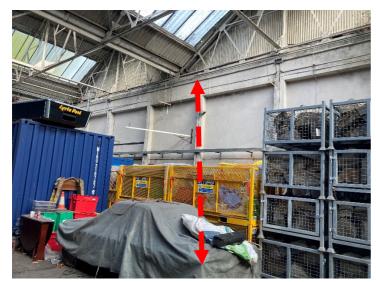
Figure 4.7 North Boundary wall of Building 05

This wall consists of 300mm x 300mm concrete columns at 3m centres with 5.5m high 200mm wide solid blockwork infill and a 900mm deep concrete beam on top, making the overall height of the wall internally 6.4m. Photos below show the external wall elevation on the north and internal wall elevation on the southside. The difference in level on both sides of the wall is 700mm with Grange court having a FFL of 13.45m and Stanley street building 05 having a FFL 12.85m.

6.4m high wall Reduced to 3m

No evidence of structural stability issues. Preliminary guidance is that wall heights are going to be reduced to 2.4m. The wall seems sound in its current state. However, the building it part will be demolished, and the wall will be reduced in height. We are not concerned with stability once reduced to a height of 3.5m.

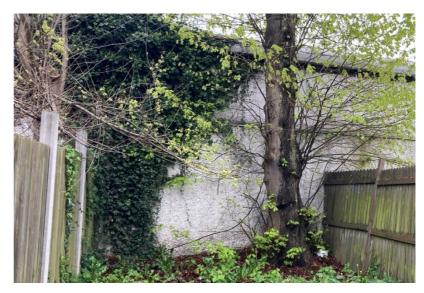
Figure 4.11 Garden of Stanhope Green Terrace Houses

5m high internal concrete wall of assumed 200mm thickness with external stone wall of varying thickness as shown in photos below.

No evidence of structural stability issues. The wall seems sound in its current state, and we are not concerned with stability once the height is reduced to 3.5m.

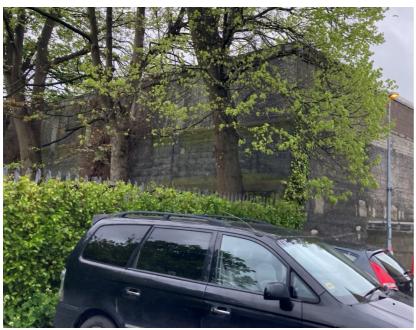
Figure 4.12

10.5m high boundary wall with varying thickness forms part of a two-storey building on Stanley depot. There is a stonewall up to 3m high on the external north elevation with concrete wall behind up to 5.8m height of unknown thickness. Concrete wall is capped with 2.2m high blockwork 200mm wide (as photos below).

No evidence of structural stability issues. The wall seems sound in its current state. However, the building it part will be demolished, and the wall will be reduced in height. We are not concerned with stability once reduced to a height of 3.5m.

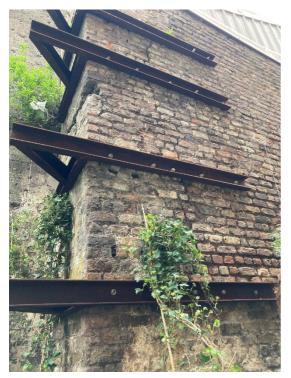
Figure 4.13

Defects were noted on the old brickwork wall. Vertical cracking was visible running the full height of the wall. Remedial works were undertaken in the past in the form of stitching across the cracked brick sections of wall with steel channels and bolting into secure brickwork either side of the cracks.

The historic brickwork wall will be maintained to its fully height. Wall is of unknown thickness. Steel sections have been used to tie the wall together to stitch across the vertical cracks visible in the external brickwork. Cracking and the remedial works are to be investigated further, along with the wall existing foundation and foundation retaining structure. The wall is retaining 1.5m of soil due, to a difference between FFL on the Student Accommodation side and the Stanley Street Depot side.

The wall has had repairs and stiffening works in the past. We are of the opinion that sections of the wall will become unstable if the surrounding walls are interfered with or removed. Permanent support will be required.

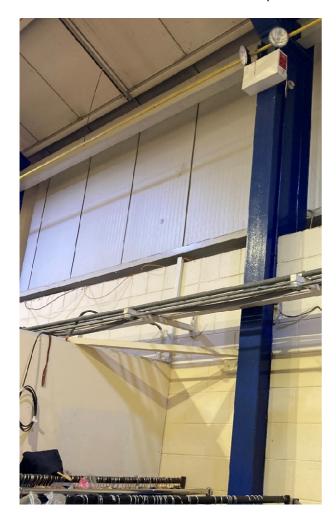
This wall section currently acts as a perimeter wall to the vehicle wash building. Wall design to be checked to ensure the wall can function as a free-standing 5m high wall once the building has been removed.

The wall forms part of the of the vehicle wash building. The wall is 225mm thick hollow block with outer 100mm solid block outer leaf. The boundary wall is 3m high of the Stanley street depot side and 5m high on the Manor Street side and the wall forms part of a 2 metre high retaining wall.

(Figure 4.16 & 4.17) Vehicle wash building external photo on the Manor Street and Internal photo.

No Evidence of structural defects. Wall stability is required to be checked as a free-standing wall.

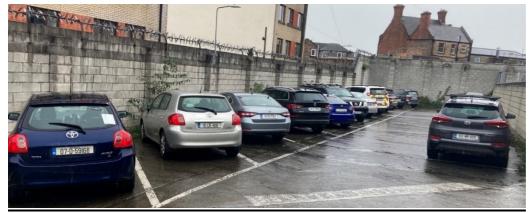
Figure 4.18

The existing boundary wall consists of 225mm wide hollow block with piers at 3.4m centres and movement joints at 6.8 metre centres. Wall height is 2.9m on the southern boundary and increases to 4.3m on the western boundary. The wall will be reduced on the height on the southern boundary.

No evidence of structural stability issues. Wall can continue to function as a boundary wall for the new development.
