ASBESTOS DEMOLITION SURVEY REPORT

DCC Stanley Street Depot

Grangegorman

Project Number
39237

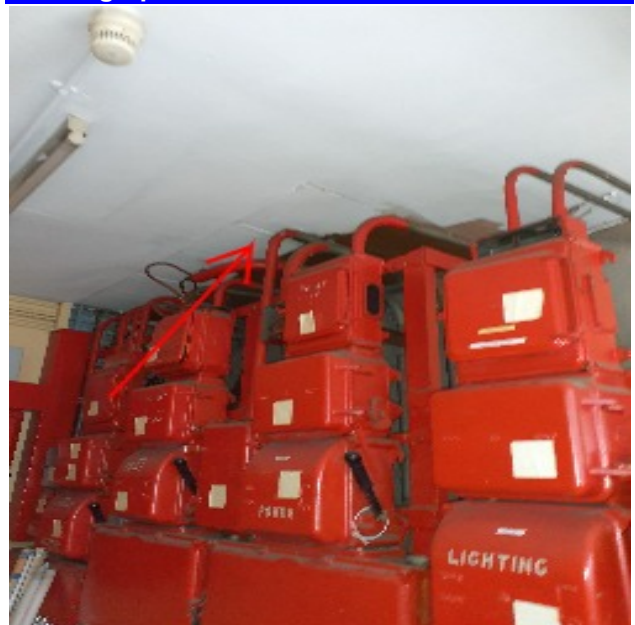
Panels are live

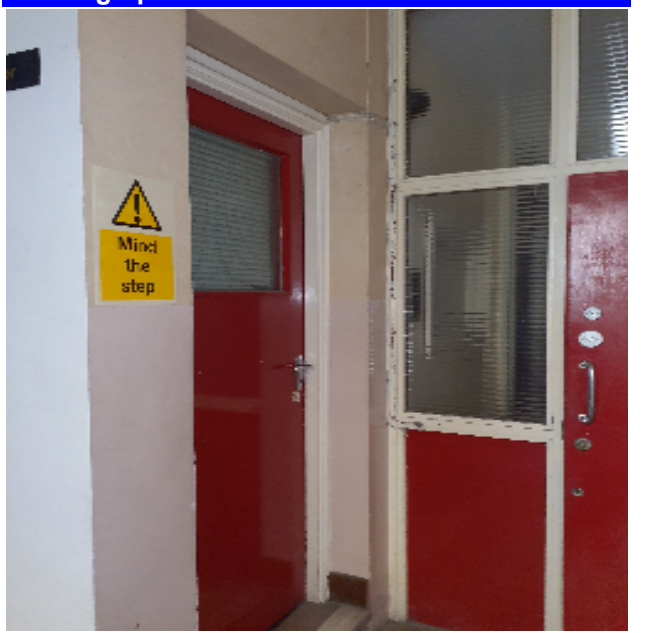
Normal Occupant Activity :	0
Likelihood of Disturbance	
Location :	0
Accessibility :	0
Extent/Amount : > 10m(m2) to <=50m(m2)	2
Human Exposure Potential	
Number of Occupants : None	0
Frequency of Use :	0
Average Time of Use :	0
Maintenance Activity	
Type of Maintenance :	0
Frequency of Maintenance :	0
Material and Priority Assessment Score :	11

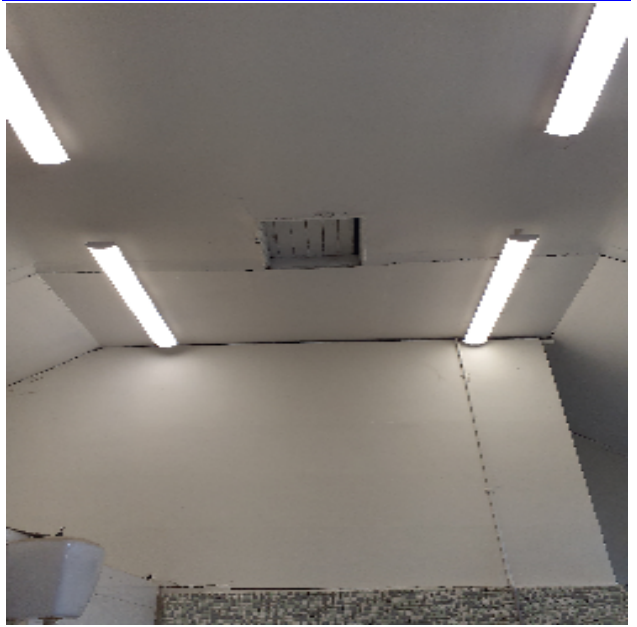
Normal Occupant Activity :	0
Likelihood of Disturbance	
Location :	0
Accessibility :	0
Extent/Amount : >50m2 or >50m pipe run	3
Human Exposure Potential	
Number of Occupants : None	0
Frequency of Use :	0
Average Time of Use :	0
Maintenance Activity	
Type of Maintenance :	0
Frequency of Maintenance :	0
Material and Priority Assessment Score :	10

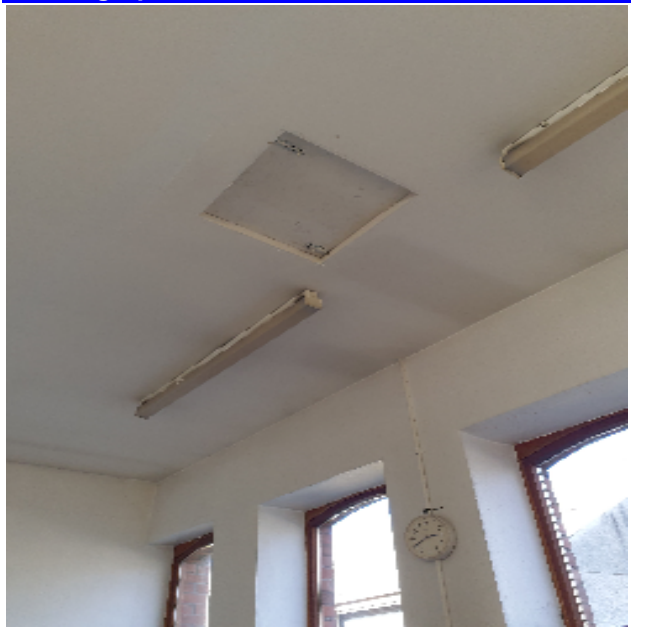
Normal Occupant Activity :	0
Likelihood of Disturbance	
Location :	0
Accessibility :	0
Extent/Amount : >50m2 or >50m pipe run	3
Human Exposure Potential	
Number of Occupants : None	0
Frequency of Use :	0
Average Time of Use :	0
Maintenance Activity	
Type of Maintenance :	0
Frequency of Maintenance :	0
Material and Priority Assessment Score :	10

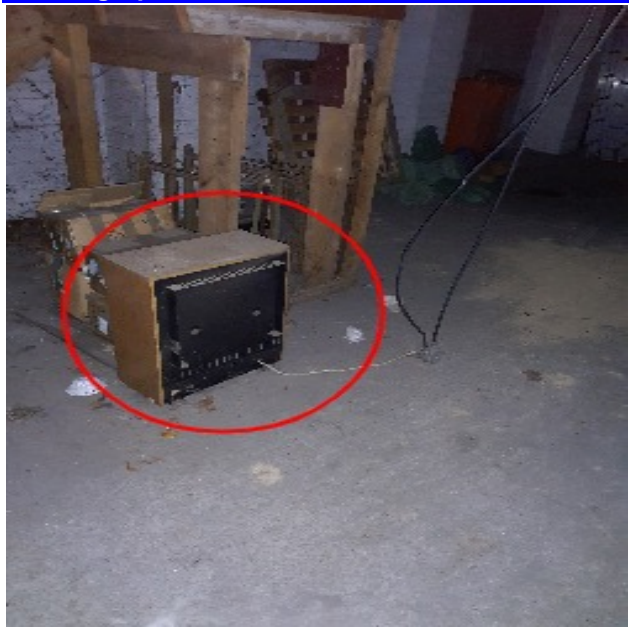
Normal Occupant Activity :	0
Likelihood of Disturbance	
Location :	0
Accessibility :	0
Extent/Amount :	0
Human Exposure Potential	
Number of Occupants : None	0
Frequency of Use :	0
Average Time of Use :	0
Maintenance Activity	
Type of Maintenance :	0
Frequency of Maintenance :	0
Material and Priority Assessment Score :	6
