CL 2357

NDFA SOCIAL HOUSING
BUNDLES 04 AND 05
STRUCTURAL SURVEY REPORT ON
BUILDINGS TO BE DEMOLISHED AND RETAINED.

BASIN VIEW FLATS

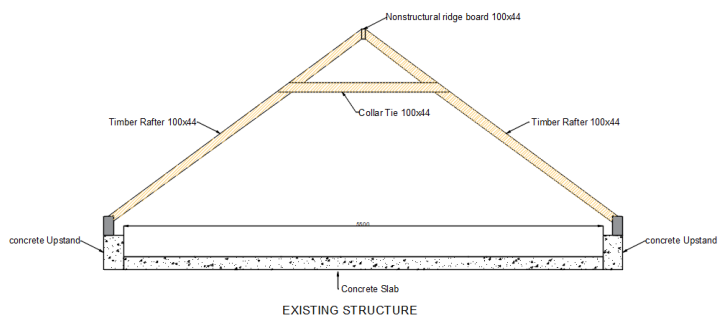
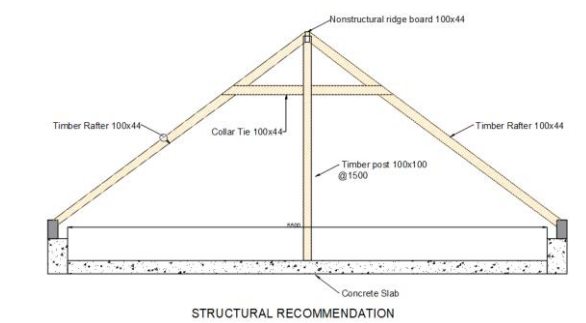
Roof Verification – Recommendation

A structural survey was conducted in the attic space to assess the integrity of the roof and the feasibility of maintaining the existing structure or making structural adjustments to ensure the roof's integrity for the next 50/100 years. After the survey and some structural checks on the existing structure, it was determined that the structure has been well-maintained internally without any apparent moisture marks in the wood or internal environment, despite being built over 50 years ago. However, a structural verification of the existing structure according to current Eurocode standards revealed that the current structure does not meet all the requirements recommended by Eurocode. Therefore, we recommend installing Timber props 100x100 fixed on the concrete slab every 1500mm to ensure the durability of the structure for the next 50 years. See below image with the existing situation and our recommendation.

We also recommend creating a Roof Maintenance Plan that prioritizes planned preventative maintenance, including inspections, general roof repairs, debris removal, gutter cleaning, and mould removal, to ensure the durability of the structure.

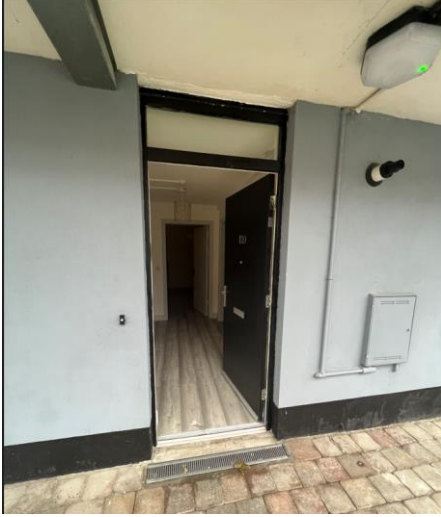
Ground Floor apartment - Photo 1

ELEMENT	DESCRIPTION	COMMENT
Ground Floor	The floor slab is in-situ concrete in all of the rooms. (photos 01 and 02).	No Opening Up was carried out to expose the foundation, the type of the foundation and depth aren't possible to identify
Ground, 1 st and 2 nd Floor (Levels 1 and 2)	The floor slabs are reinforced concrete slabs that are approximately 200mm thick with a concrete beam on the edges with 235mm thick approximately (Photos 03,04,05, and 06)	No Opening Up was carried out to expose the slabs.
Roof	The roof is a type of butterfly roof consisting of a central duo pitch roof supporting concrete tiles, flanked by roof surfaces sloping from the outer walls to form a valley at the base of the duopitched roof approximately 1200mm wide. The parapet wall is capped with concrete coping stones which are

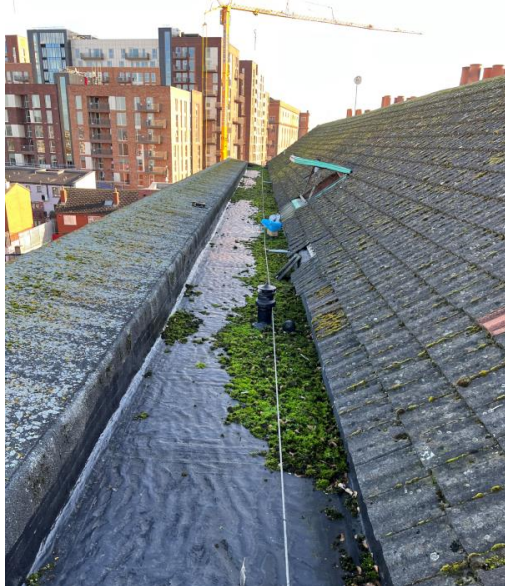
Roof - external view- Photo 7

made of concrete and are weathered with a waterproof membrane. The duo-pitch roof is made of 100X44 timber rafters spanning from eaves to ridge without intermediate purlin supports. (photos 07,08,09,10, 11 and 12)	
External Wall	The external walls are made of two blocks leaves and a cavity between them, the thickness of the wall is approximately 300mm. (Photos 13, 14, 15 and 16).	No Opening Up was carried out to expose the wall.
Internal Wall –	The Internal party walls are approximately 200 mm concrete walls between the apartments, and 100mm masonry wall inside of the apartments (Photos 17).	No Opening Up was carried out to expose the wall.
Corridor/stairs	The corridor and stairs slab is made of concrete in situ slab.
