ASBESTOS DEMOLITION SURVEY REPORT

Block 20-43 Basin Street Flats

Project Number
39150

Client	National Development Finance Agency	
Project Title	39150 NDFA Project Basin Street Flats RDAS	
Document Title	Asbestos Demolition Report	
Report No.	39150-A

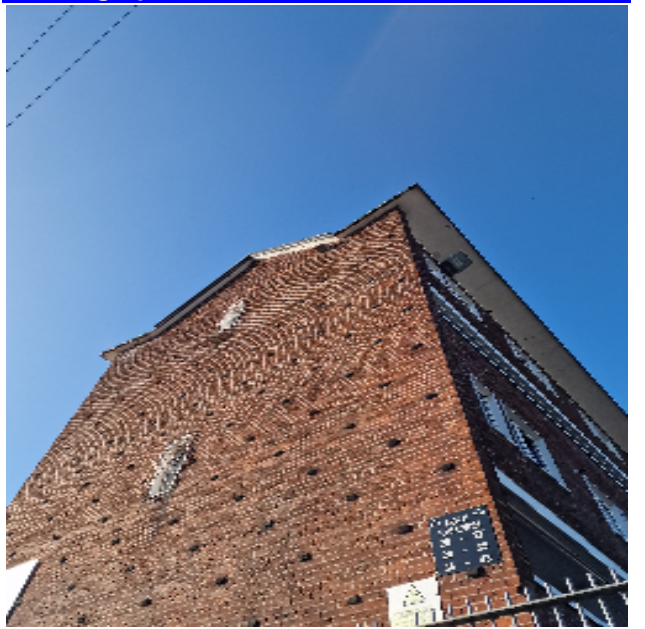
Photograph

Asbestos Type : Chrysotile	Score 1
Type Of Product : Asbestos Cement	1
Condition : Low Damage	1
Surface Treatment : Asbestos Cement	1
Quantity :	
Material Assessment Score :	4

Normal Occupant Activity :	0
Likelihood of Disturbance	
Location :	0
Accessibility :	0
Extent/Amount :	0
Human Exposure Potential	
Number of Occupants : None	0
Frequency of Use :	0
Average Time of Use :	0
Maintenance Activity	
Type of Maintenance :	0
Frequency of Maintenance :	0
Material and Priority Assessment Score :	4

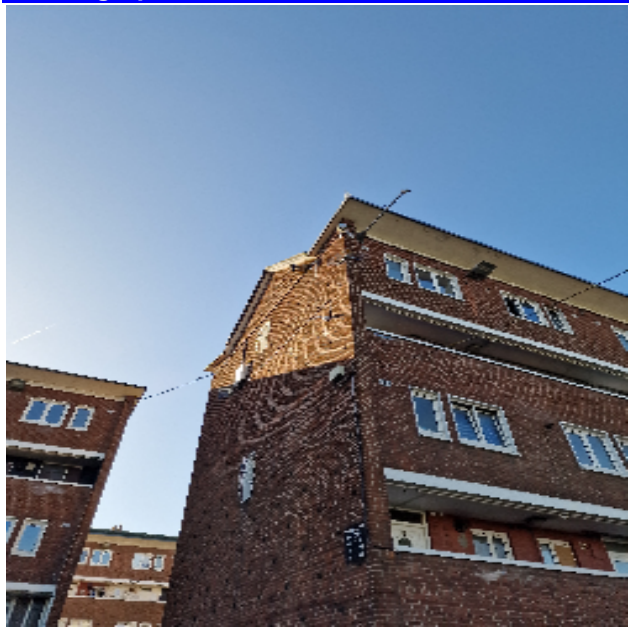
Photograph

Normal Occupant Activity :	0
Likelihood of Disturbance	
Location :	0
Accessibility :	0
Extent/Amount :	0
Human Exposure Potential	
Number of Occupants : None	0
Frequency of Use :	0
Average Time of Use :	0
Maintenance Activity	
Type of Maintenance :	0
Frequency of Maintenance :	0
Material and Priority Assessment Score :	4

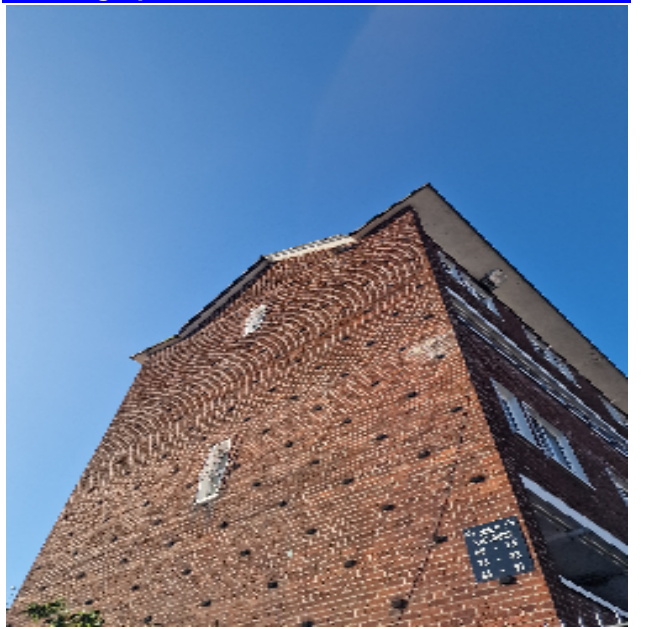
Photograph

Normal Occupant Activity : Likelihood of Disturbance	0
Location :	0
Accessibility :	0
Extent/Amount :	0
Human Exposure Potential	
Number of Occupants : None	0
Frequency of Use :	0
Average Time of Use :	0
Maintenance Activity	
Type of Maintenance :	0
Frequency of Maintenance :	0
Material and Priority Assessment Score :	4

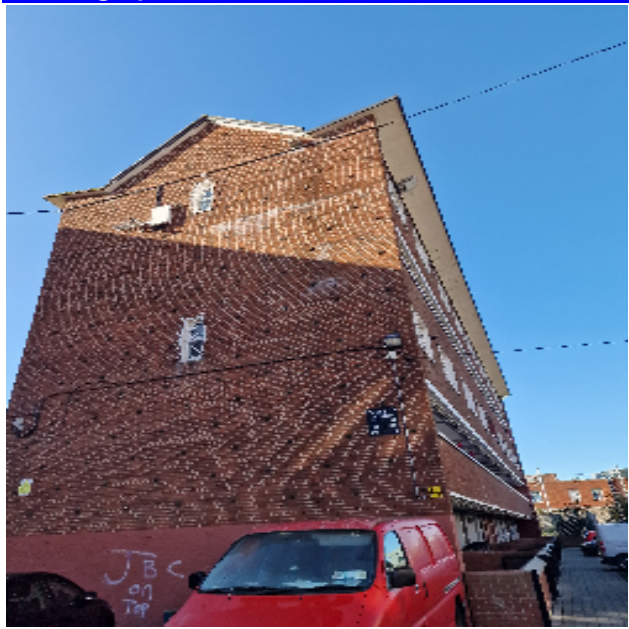
Photograph

Normal Occupant Activity :	0
Likelihood of Disturbance	
Location :	0
Accessibility :	0
Extent/Amount :	0
Human Exposure Potential	
Number of Occupants : None	0
Frequency of Use :	0
Average Time of Use :	0
Maintenance Activity	
Type of Maintenance :	0
Frequency of Maintenance :	0
Material and Priority Assessment Score :	4

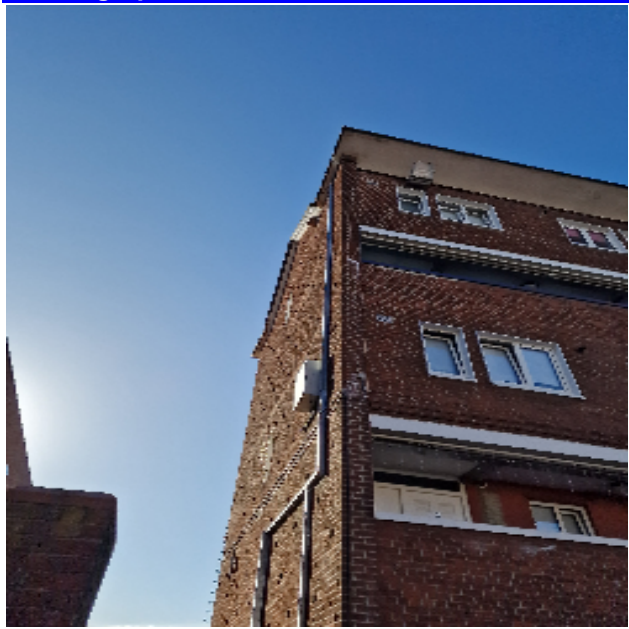
Photograph

Normal Occupant Activity : Likelihood of Disturbance	0
Location :	0
Accessibility :	0
Extent/Amount : Human Exposure Potential	0
Number of Occupants : None	0
Frequency of Use :	0
Average Time of Use : Maintenance Activity	0
Type of Maintenance :	0
Frequency of Maintenance :	0
Material and Priority Assessment Score :	4
