ASBESTOS DEMOLITION SURVEY REPORT

Collins Avenue Depot

Project Number
39361

Client	Malone O Regan Consulting Engineers	
Project Title	39361 NDFA Project Collins Avenue Depot	
Document Title	Asbestos Demolition Report	
Report No.	39361

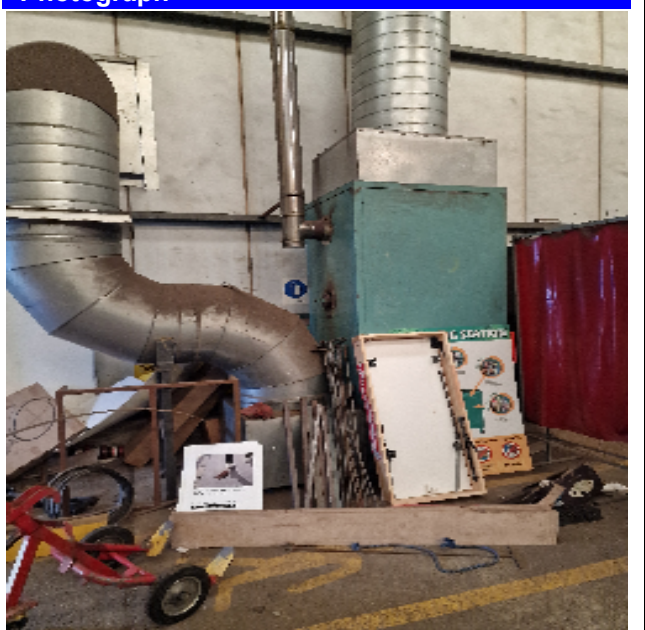
Asbestos Type : Presumed ACM Present	Score	
Type Of Product :	6	High Risk
Condition :	0	Midium Risk
Surface Treatment :	0	Low Risk
Quantity :	0	Very Low Risk
Material Assessment Score :	6	Low Risk

Priority 1 : Investigate prior to disturbing

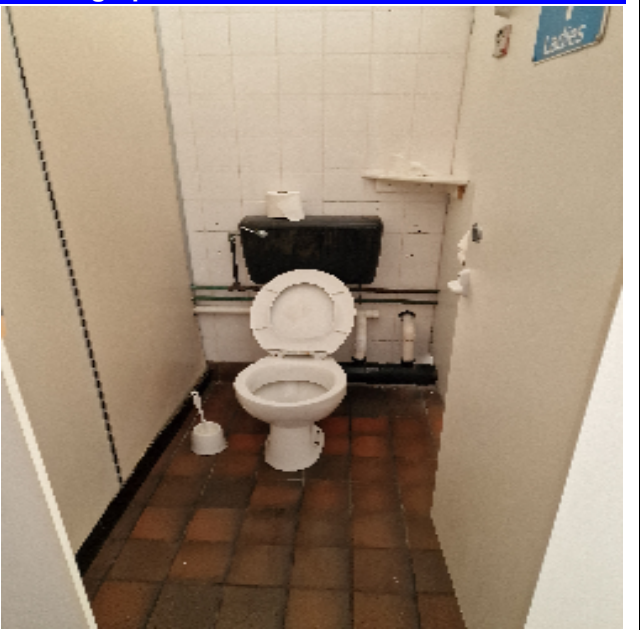
Asbestos Type : Amosite	Score	Risk Rating
Type Of Product : Toilet Cisterns	2	High Risk
Condition : Good Condition	1	Midium Risk
Surface Treatment : Composite Materials Containing Asbestos	0	Low Risk
Quantity :	0	Very Low Risk
Material Assessment Score :	3	Very Low Risk

Priority 1 : Remove ACM's Prior to Refurbishment or Demolition.

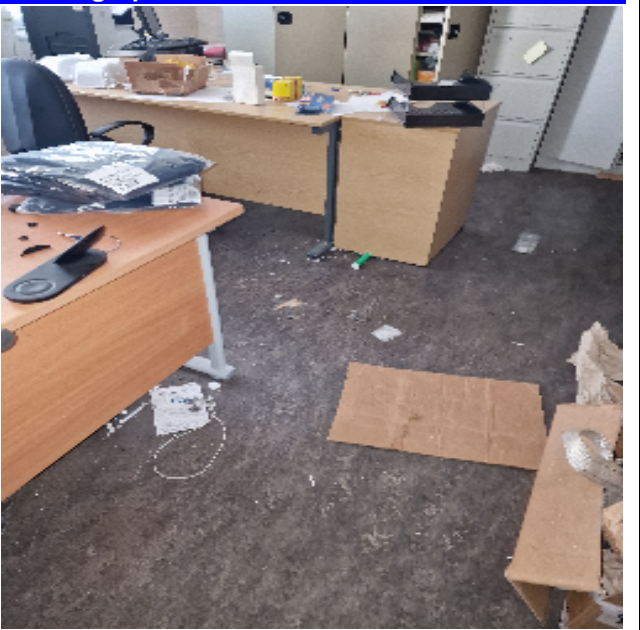
Asbestos Type : Chrysotile	Score	Risk Rating
Type Of Product : Vinyl Floor Tiles & Bitumen	1	High Risk
Condition : Good Condition	1	Midium Risk
Surface Treatment : Composite Materials Containing Asbestos	0	Low Risk
Quantity :	0	Very Low Risk
Material Assessment Score :	2	Very Low Risk

Priority 1 : Remove ACM's Prior to Refurbishment or Demolition.

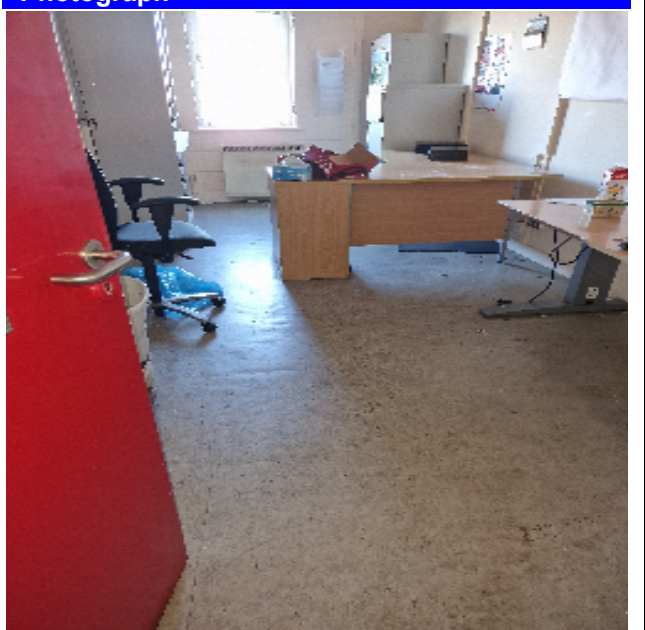
Score	Risk Rating
Asbestos Type : Chrysotile	1	High Risk
Type Of Product : Vinyl Floor Tiles & Bitumen	1	Midium Risk
Condition : Good Condition	0	Low Risk
Surface Treatment : Composite Materials Containing Asbestos	0	Very Low Risk
Quantity :		Very Low Risk
Material Assessment Score :	2	Very Low Risk

Priority 1 : Remove ACM's Prior to Refurbishment or Demolition.

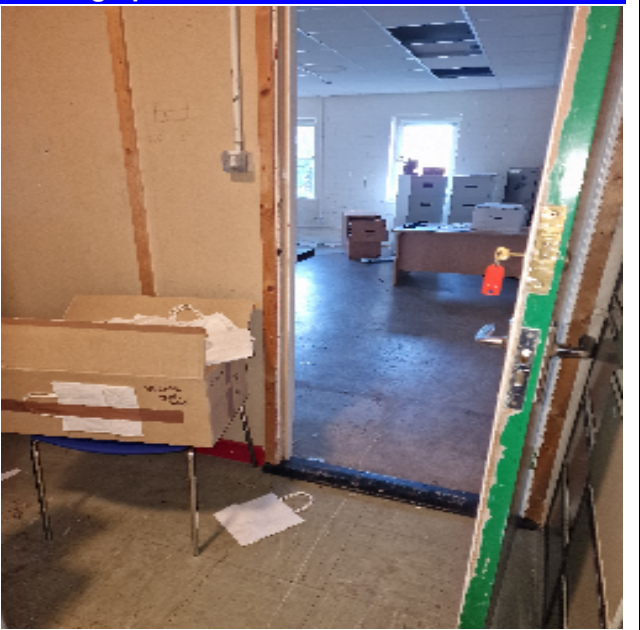
Score	
Asbestos Type : Chrysotile	1	High Risk
Type Of Product : Vinyl Floor Tiles & Bitumen	1	Midium Risk
Condition : Good Condition	0	Low Risk
Surface Treatment : Composite Materials Containing Asbestos	0	Very Low Risk
Quantity :		Very Low Risk
Material Assessment Score :	2	Very Low Risk

Priority 1 : Remove ACM's Prior to Refurbishment or Demolition.

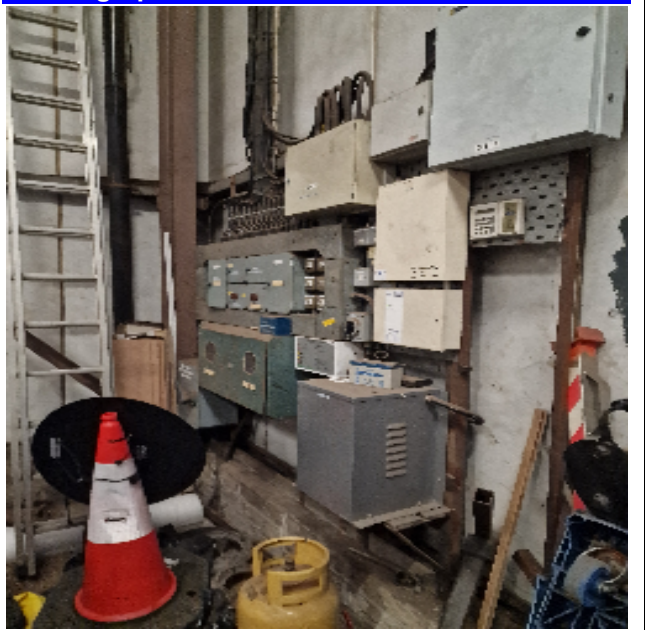
Asbestos Type : Chrysotile	Score	Risk Rating
Type Of Product :	1	High Risk
Condition :	0	Midium Risk
Surface Treatment :	0	Low Risk
Quantity :	0	Very Low Risk
Material Assessment Score :	1	Very Low Risk

Priority 1 : Investigate prior to disturbing

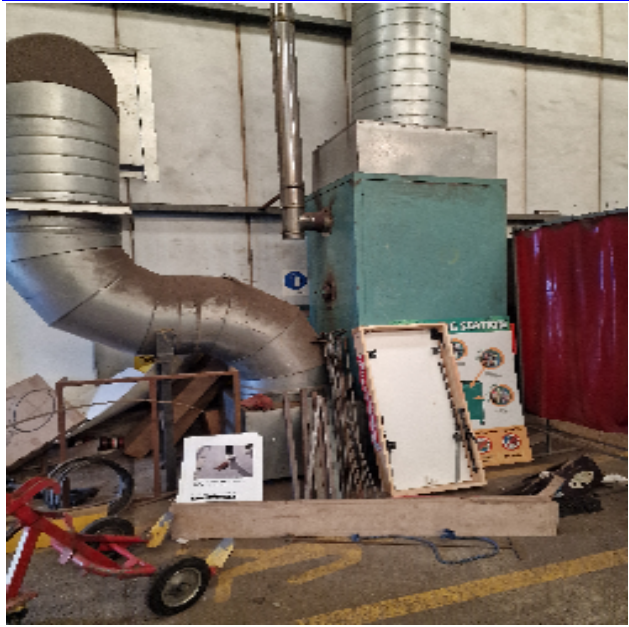
Asbestos Type : Presumed ACM Present	Score
Type Of Product :	6
Condition :	0
Surface Treatment :	0
Quantity :	0
Material Assessment Score :	6

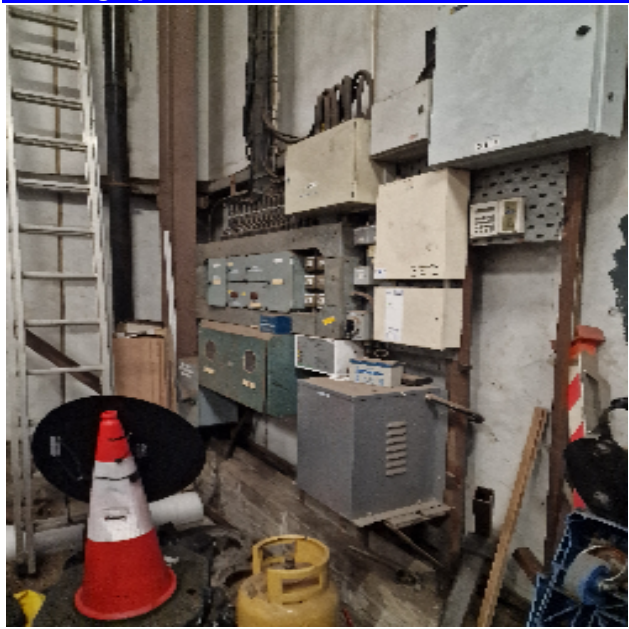
Asbestos Type : Chrysotile	Score 1
Type Of Product :	0
Condition :	0
Surface Treatment :	0
Quantity :	0
Material Assessment Score :	1

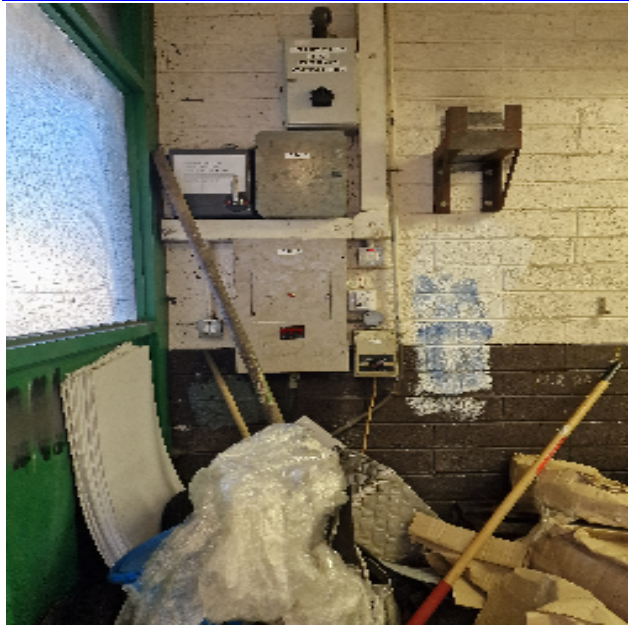
Asbestos Type : Chrysotile	Score 1
Type Of Product :	0
Condition :	0
Surface Treatment :	0
Quantity :	0
Material Assessment Score :	1

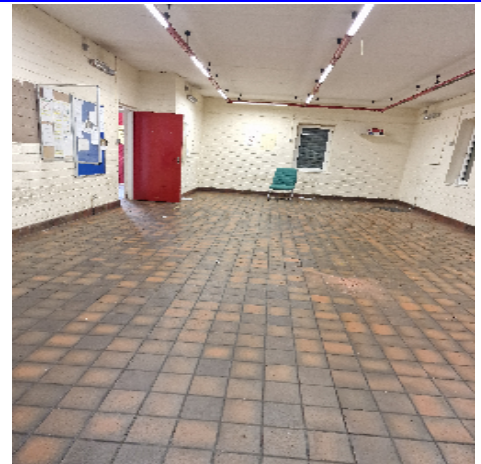
Location Details : 81112 No Asbestos Found

Building/Area :
 Room/Section : Kitchen/diningroom
 Location : Walls floor and ceiling
 Description : ceramics and concrete
 Sample No. :
 Confirmation : No Asbestos Detected
 Access : Full Access
 Normal Use :
 Recommendations :
 Notes :

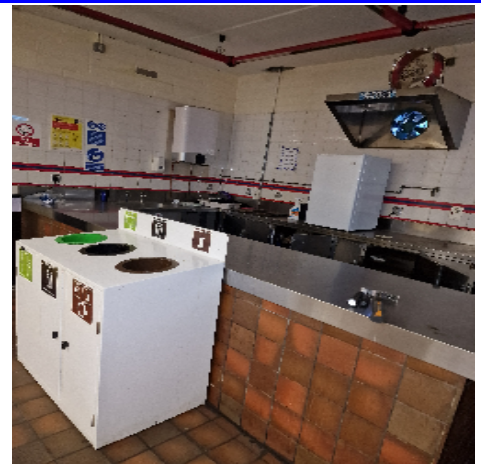
Location Details : 81113 No Asbestos Found

Building/Area :
 Room/Section : Kitchen
 Location : Kitchen area
 Description : stainless steel
 Sample No. :
 Confirmation : No Asbestos Detected
 Access : Full Access
 Normal Use :
 Recommendations :
 Notes :

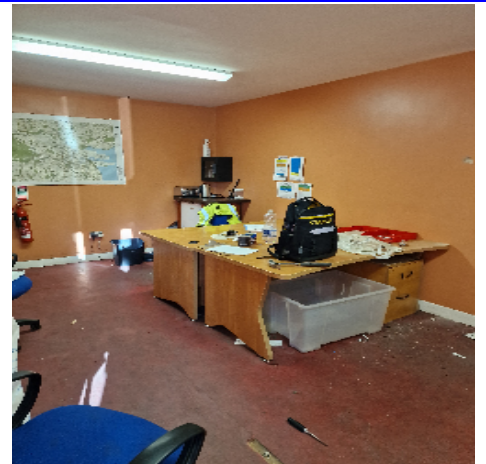
Location Details : 81121 No Asbestos Found

Building/Area :
 Room/Section : Store office
 Location : walls and ceiling
 Description : plasterboard
 Sample No. :
 Confirmation : No Asbestos Detected
 Access : Full Access
 Normal Use :
 Recommendations :
 Notes :

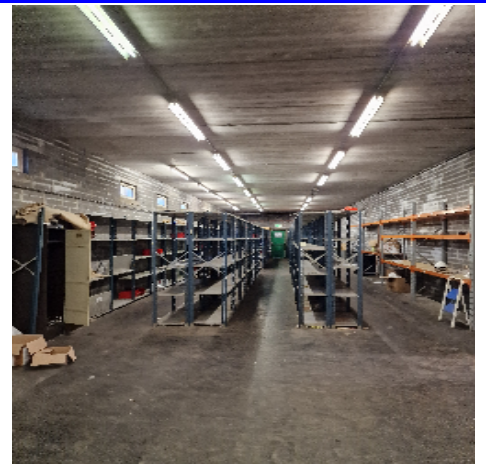
Location Details : 81122 No Asbestos Found

Building/Area :
 Room/Section : Store
 Location : Walls floor and ceiling
 Description : ceramics and concrete
 Sample No. :
 Confirmation : No Asbestos Detected
 Access : Full Access
 Normal Use :
 Recommendations :
 Notes :

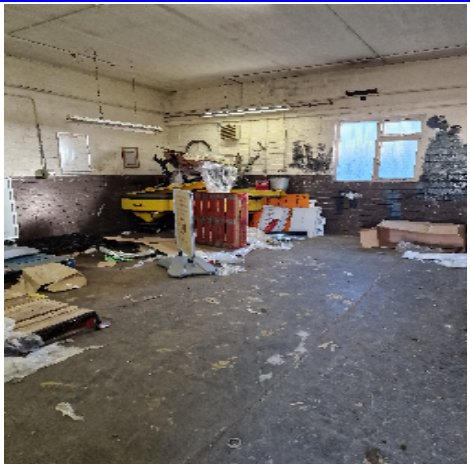
Location Details : 81124 No Asbestos Found

Building/Area :
 Room/Section : Store
 Location : Walls floor and ceiling
 Description : concrete
 Sample No. :
 Confirmation : No Asbestos Detected
 Access : Full Access
 Normal Use :
 Recommendations :
 Notes :

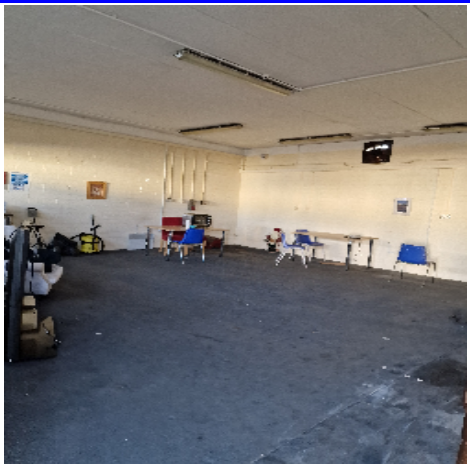
Location Details : 81126 No Asbestos Found

Building/Area :
 Room/Section : Store/canteen
 Location : Walls floor and ceiling
 Description : concrete
 Sample No. :
 Confirmation : No Asbestos Detected
 Access : Full Access
 Normal Use :
 Recommendations :
 Notes :

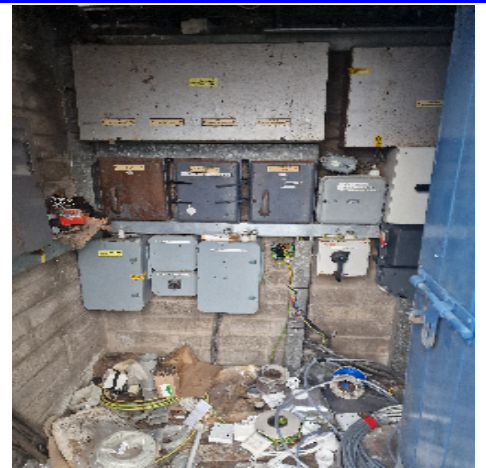
Location Details : 81132 No Asbestos Found

Building/Area : ESB room
 Room/Section : Esb room
 Location : Switchgear
 Description : modern switchgear
 Sample No. :
 Confirmation : No Asbestos Detected
 Access : Full Access
 Normal Use :
 Recommendations :
 Notes :
