Reference Plan: George's Dock

Georges Dock Survey Drawings Prepared by Murphys Surveyors (2019)

HOWLEY HAYES ARCHITECTS							
19 Rock Hill, Blackrock, Co. Dublin info@howleyhayes.ie T:01 278 4644 F:01 278 4464							
PROJECT: White Water Rafting Course							
CLIENT: Dublin City Council							
DRAWING TITLE: Plan						DRAWING NO.: P-000	
PROJECT STAGE: Planning	JOB NO.: 0519	SCALE: 1:500@A3	DATE: 05.02.19	DRAWN: EMK	CHECKED BY: LOC	REVISION: B

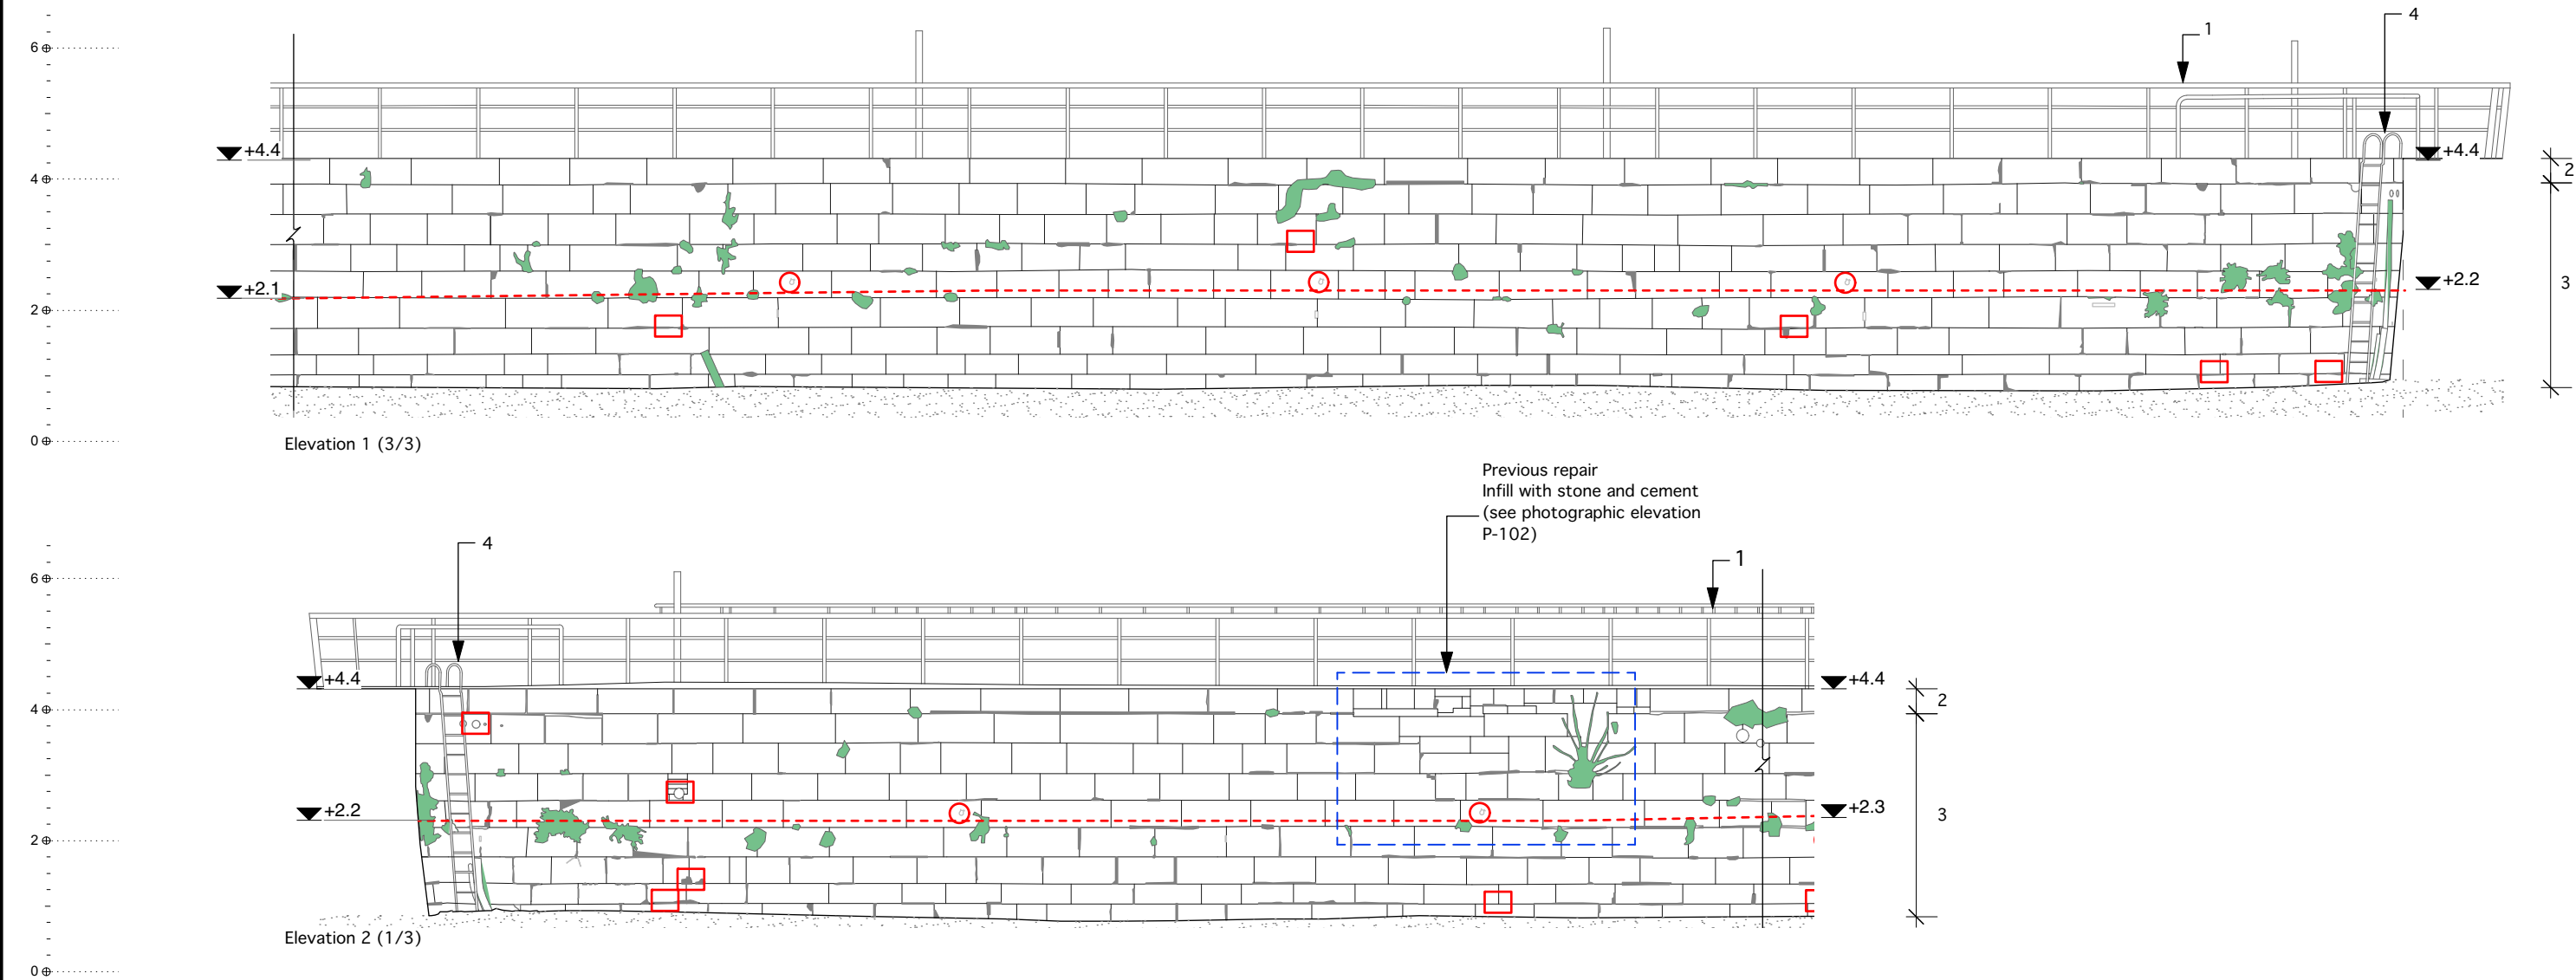
Elevation 2: Visible: 108.87sqm
Hidden: 125.36sqm

3. Assess all cracks and openings with structural engineer.
4. Repointing of joints where required, with suitable mortar mix. Note large open joints may require significant repointing to considerable depth, with stone inserts where required. Open joints will be closed. Existing mortar to be analysed to determine mix.

5. Investigate source of all ground water ingress. It is likely ground water seeping through the open joints.
Note: repointing of the walls will ensure that this does not continue to the same extent. Adequate drainage channel to be provided to the base of the new wall.

6. Treat rusted elements in situ where possible - remove rust and apply rust resistant coating. Remove rusted elements beyond repair.
7. Remove all friable/ loose cement repairs.

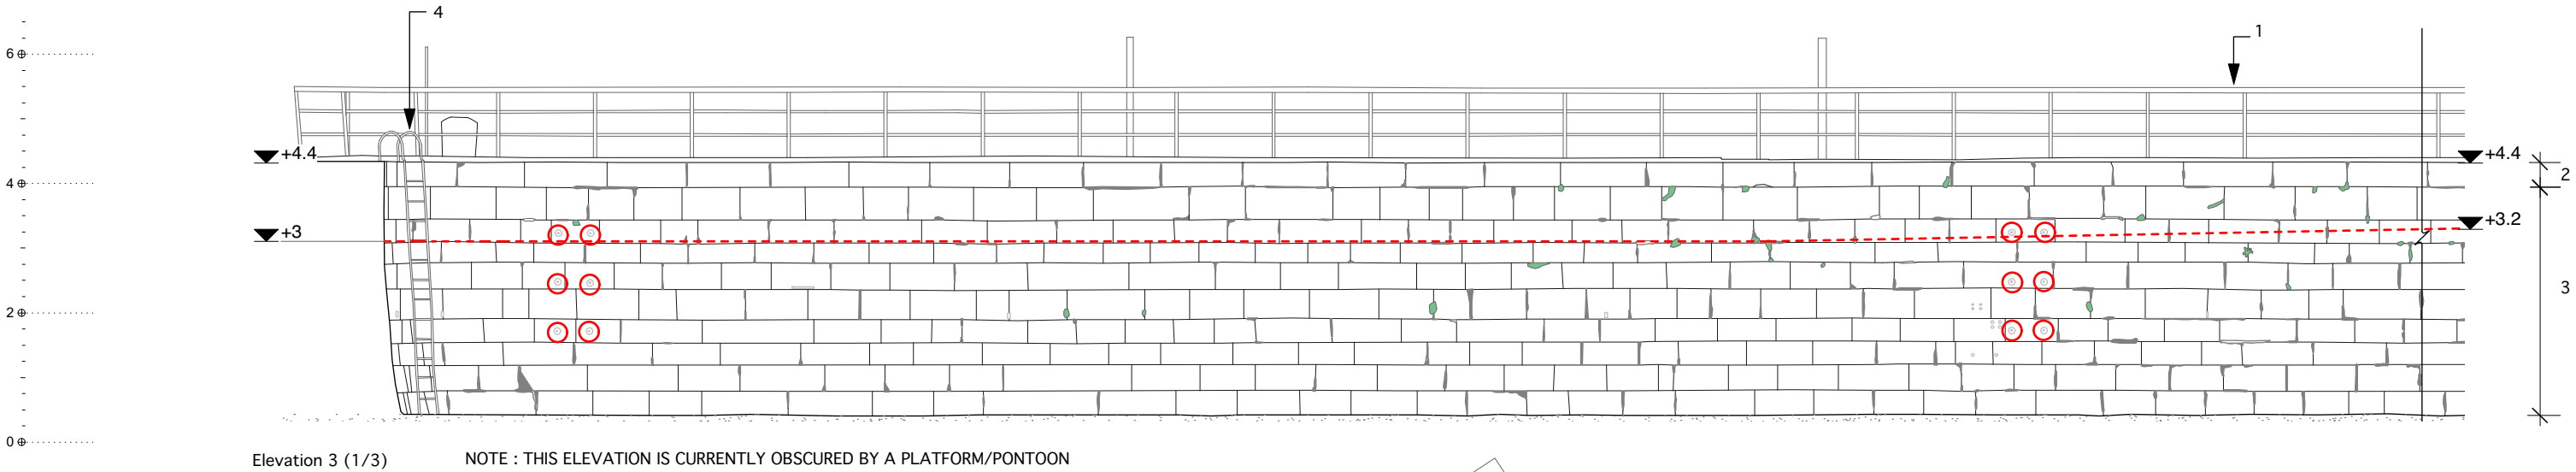
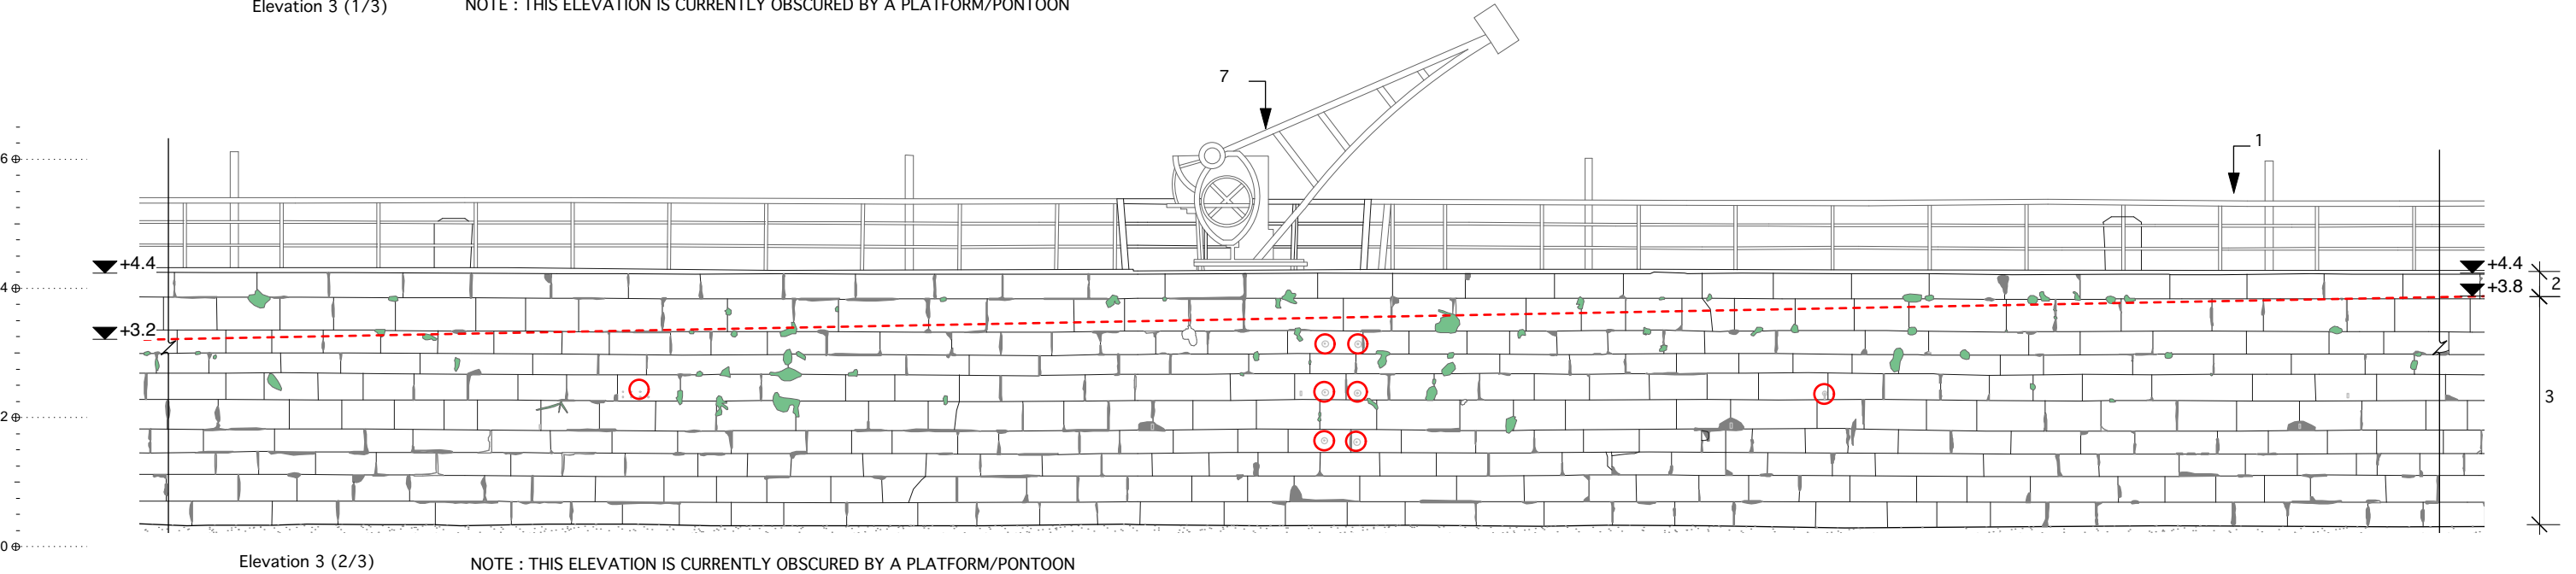
Elevation 3: Visible: 66.27 sqm
Hidden: 315.132 sqm

3. Assess all cracks and openings with structural engineer.
4. Repointing of joints where required, with suitable mortar mix. Note large open joints may require significant repointing to considerable depth, with stone inserts where required. Open joints will be closed. Existing mortar to be analysed to determine mix.

6. Treat rusted elements in situ where possible - remove rust and apply rust resistant coating. Remove rusted elements beyond repair.
7. Remove all friable/ loose cement repairs.

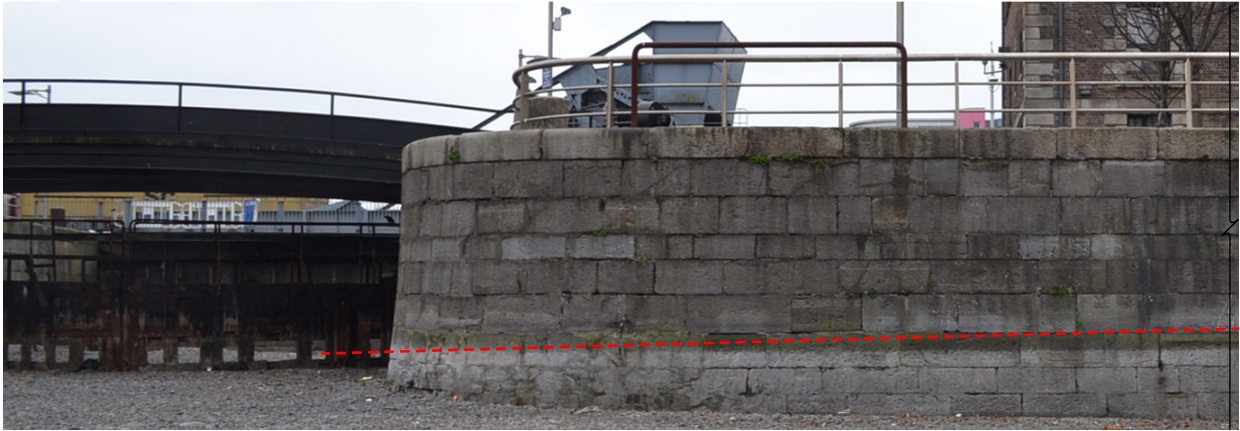
Elevation 4 (2/3)

Elevation 3 and 4 are currently obscured by
a platform/ pontoon thereore access has
been limited for photographic survey.
