LIBRARY SQUARE RINGSEND – PUBLIC REALM IMPROVEMENT AND LIBRARY
REFURBISHMENT AND EXTENSION

BUILDING SURVEY CONDITION & CONSERVATION REPORT

RINGSEND LIBRARY, BRIDGE STREET, RINGSEND, DUBLIN 4

Date of report: 5 April 2023 Rev A

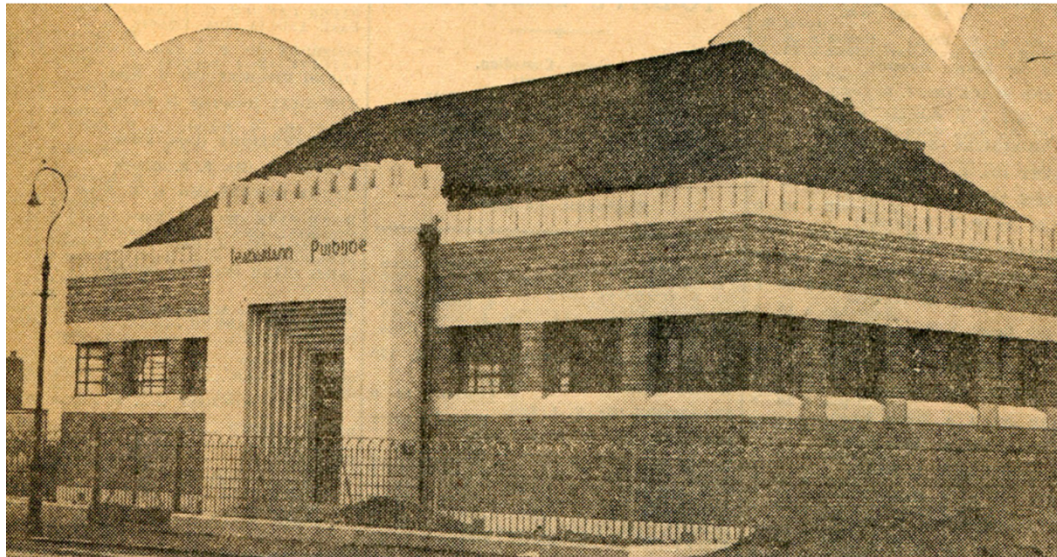
- 3.8 It is unknown, but suspected that a damp proof course is incorporated into the top of the parapet wall beneath the modern precast concrete coping. It is noted from earlier photographs (Fig. 4 below) that

the coping may not have existed originally suggesting that it may have been installed to rectify a defect/damp ingress issue. This coping detail exists at the two other similar library buildings (Fig. 2 above). Nonetheless, we suggest it would be prudent to investigate the presence of a DPC in this location as part of the planned refurbishment. Although, we see no current evidence to suggest the existence of any issues with water penetration (which can occur through the joints in the concrete coping) into the top of the parapet and external wall fabric, we do however highlight the net effect of the planned wrap around extension, which abuts three sides of the existing building. From this perspective, it is noted that these three external walls will transition to an internal wall at lower level within the new extension below. As such, their weather tightness will take on a greater significance and importance in the extended property.

*Fig. 5: Photo taken at the opening of the library in 1937.
Note the absence of the in-situ coping to the roof parapet*

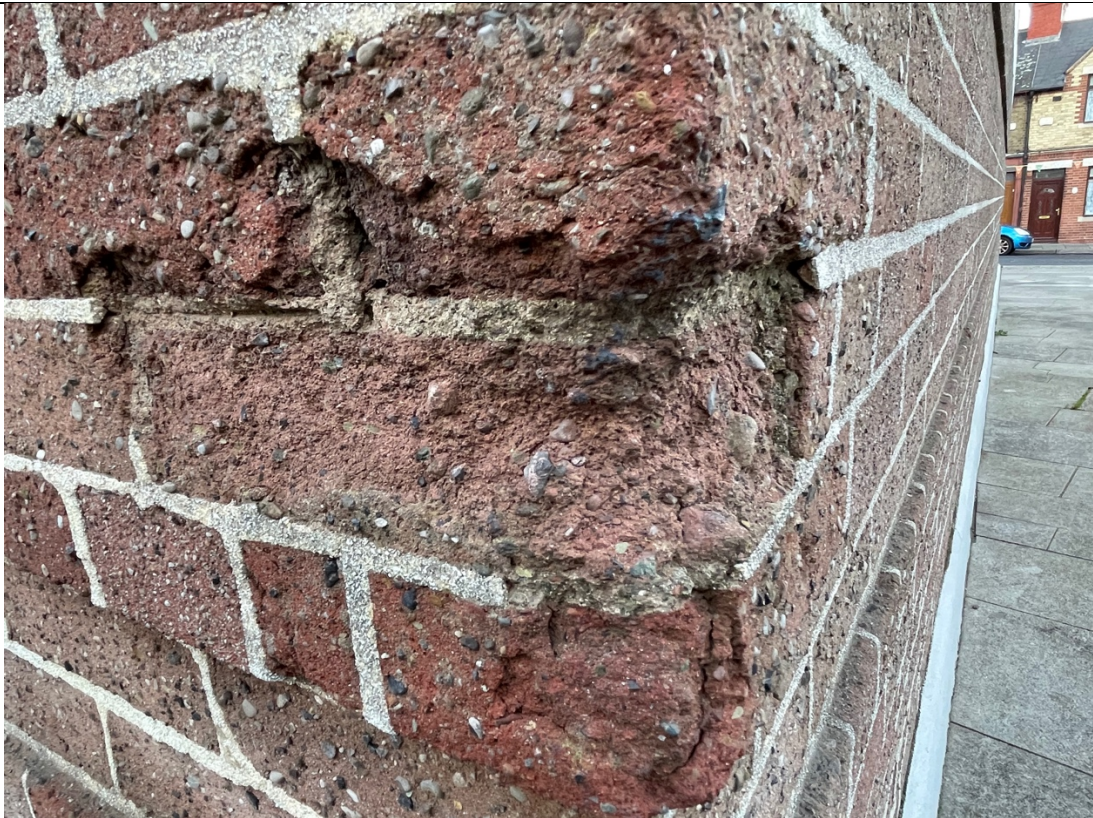
- 5.3 The external brick are a pink/red coloured concrete brick with a c. 5mm down exposed aggregate. Some of the brickwork displays evidence of weathering and deterioration in localised areas (Appendix A, photos 10-11). This is more prevalent on the more exposed corners and upper ledges of the brick string-courses and on the southern façades. This damage is most likely due to the repetitive and cumulative freeze-thaw action of moisture naturally absorbed by the brick and corresponds with the areas of brickwork prone to retaining moisture for more prolonged periods due to either to the detailing of the projecting stringcourse ledges or the increased exposure of the southern façade, which faces the prevailing wind and rain. In these locations, the brickwork is exposed to increased moisture levels for longer periods, thereby elevating the risk of freeze-thaw damage. Rainwater naturally absorbed by the brick may not have sufficient time to evaporate prior to a cold snap when the entrapped moisture then freezes and expands, thus exerting pressure within the saturated face of the brick and causing it to spall. It is however noted that the majority of the worst affected areas are to be enveloped by the proposed wrap around extension and as such, exposure to excessive and consequent freeze thaw risk would no longer apply.

10. - Detail to corner of above location, evidencing deteriorated brick condition

- 5.4 Nevertheless, the aesthetic appearance of the existing weathered bricks may prompt a discussion on the merits of potential repair or replacement. Options for repair include 'plastic' repairs using a coloured repair mortar blended to replicate the existing brick matrix (aggregate and binder content) and appearance in terms of colour, texture, shape, removing and reversing bricks or sourcing new replacement bricks. The wrap-around extension will internalise a number of walls but it is understood that the brick facing may be retained exposed within the building. The break-outs for new openings into the main library space will provide an opportunity for salvage of bricks for external façade repairs which may be the preferred option. The bricks are pointed with a white mortar with a fine quartz-type aggregate to a depth of 8-10mm over an apparently softer & darker bedding mortar. This is an unusual & interesting use of a traditional pointing technique used on a 20th century concrete-brick finished building. Efforts should be made to replicate the pointing mortar insofar as possible based on a number of trials as part of any brick repair proposals.

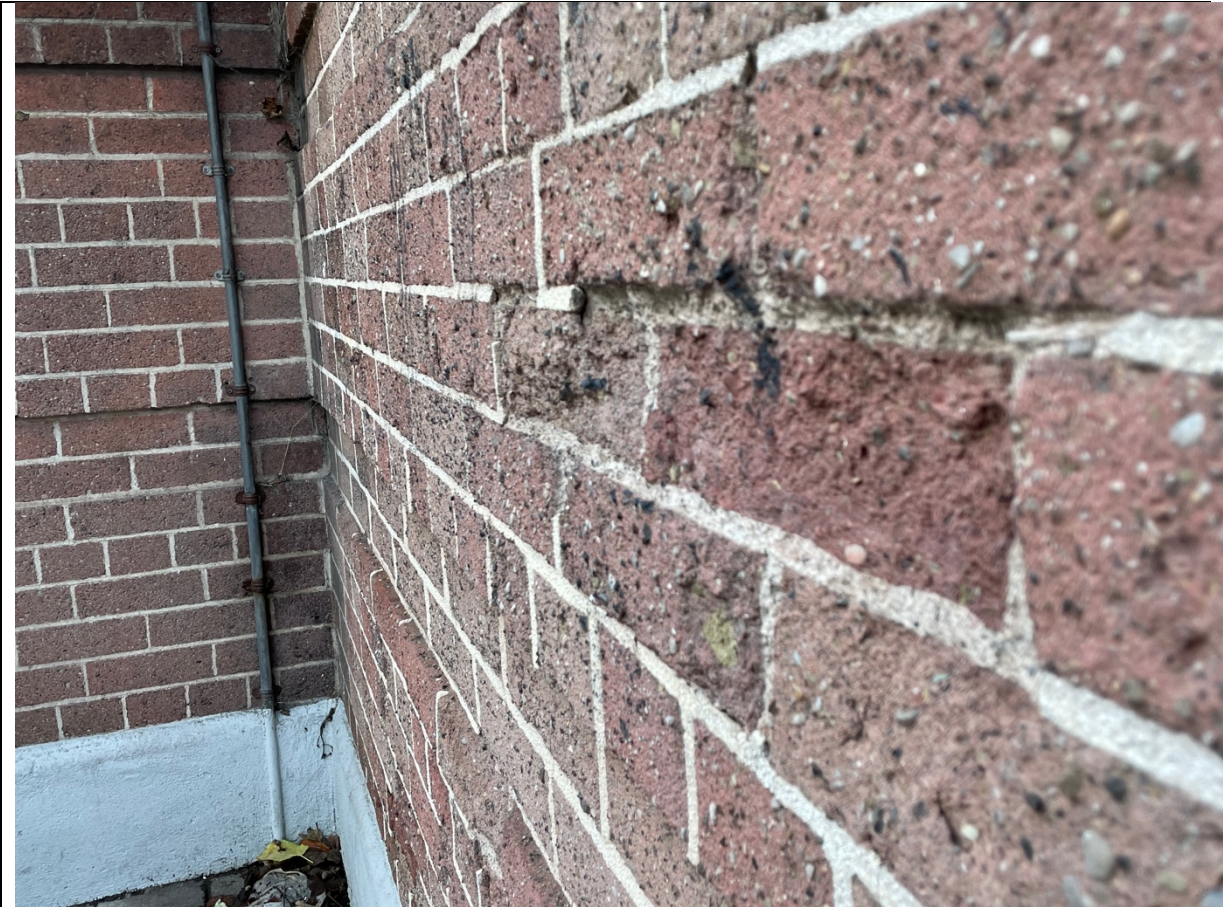
11. – Detail to above location, evidencing deteriorated brick condition

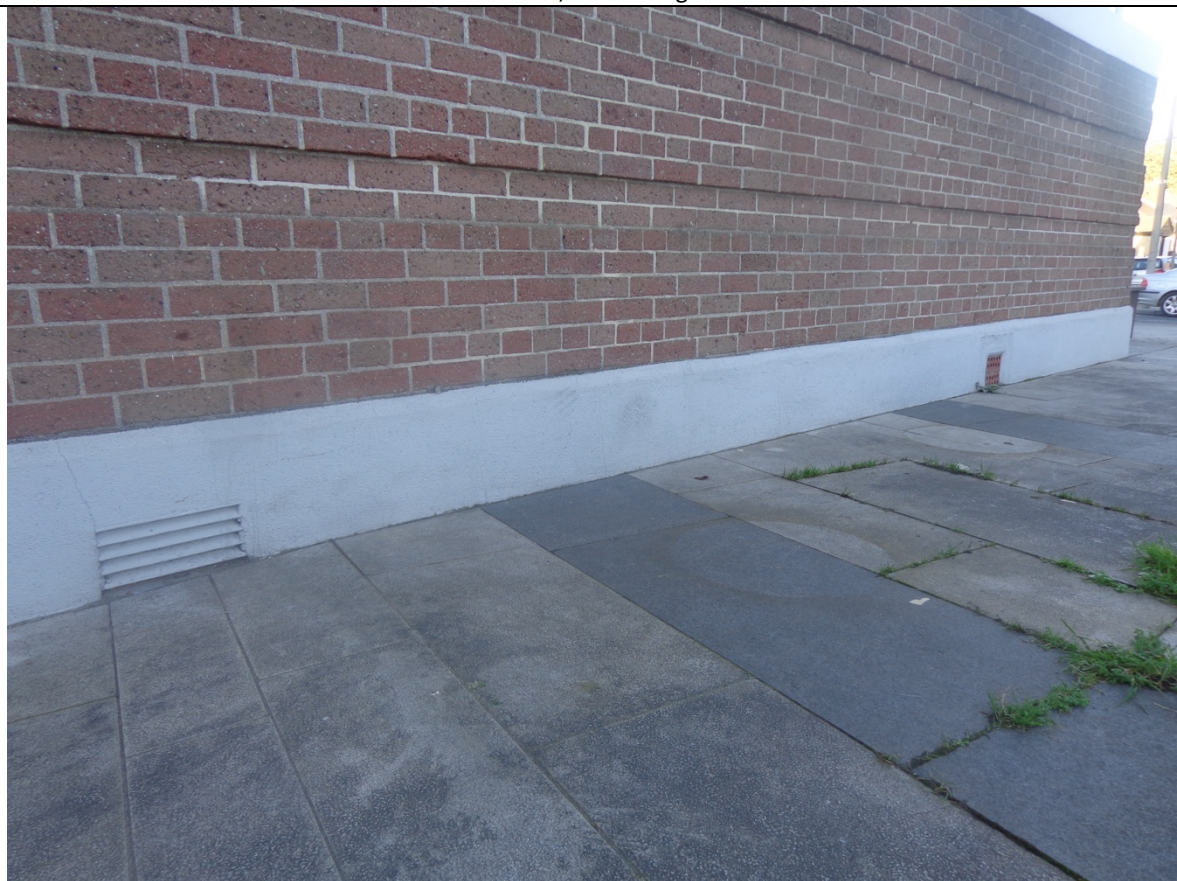
- 2.22 A series of through wall vents are provided around the perimeter of the subfloor. These appear to coincide with the grilles in the paving around the perimeter of the building (as noted previously).

12. View of subfloor wall vents (South wall).

Note: Estimated DPC level is flush with external ground level

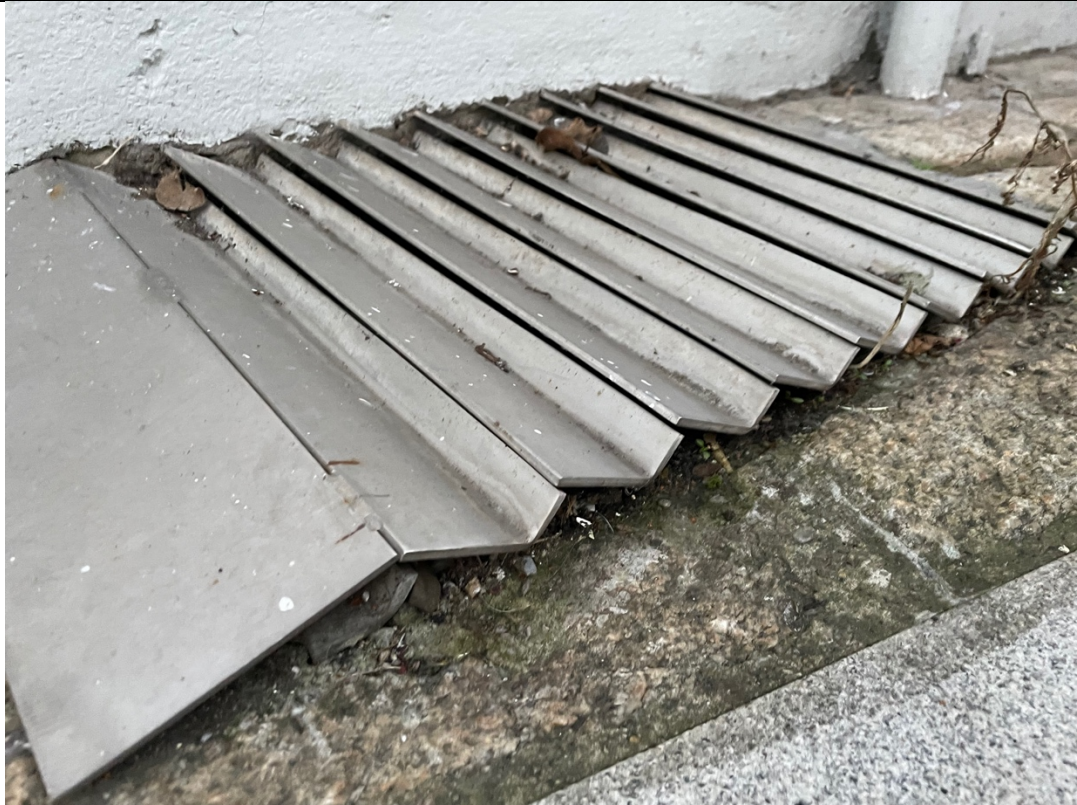
- 2.16 Nine stainless steel grilles (Appendix A, photo 13) are located in the paving against the base of the external walls on three sides of the building (North, East and West). These seem to coincide with the location of the original underfloor vents on these elevations, which were encroached upon and therefore required alteration when raising the external ground levels. It appears these grilles were purposely designed to try to limit the unrestricted entry of surface water from the adjacent paved surfaces whilst still providing some degree of ventilation to the subfloor, albeit at a much reduced surface area.

13. - View of bespoke surface vent to altered original subfloor vent locations

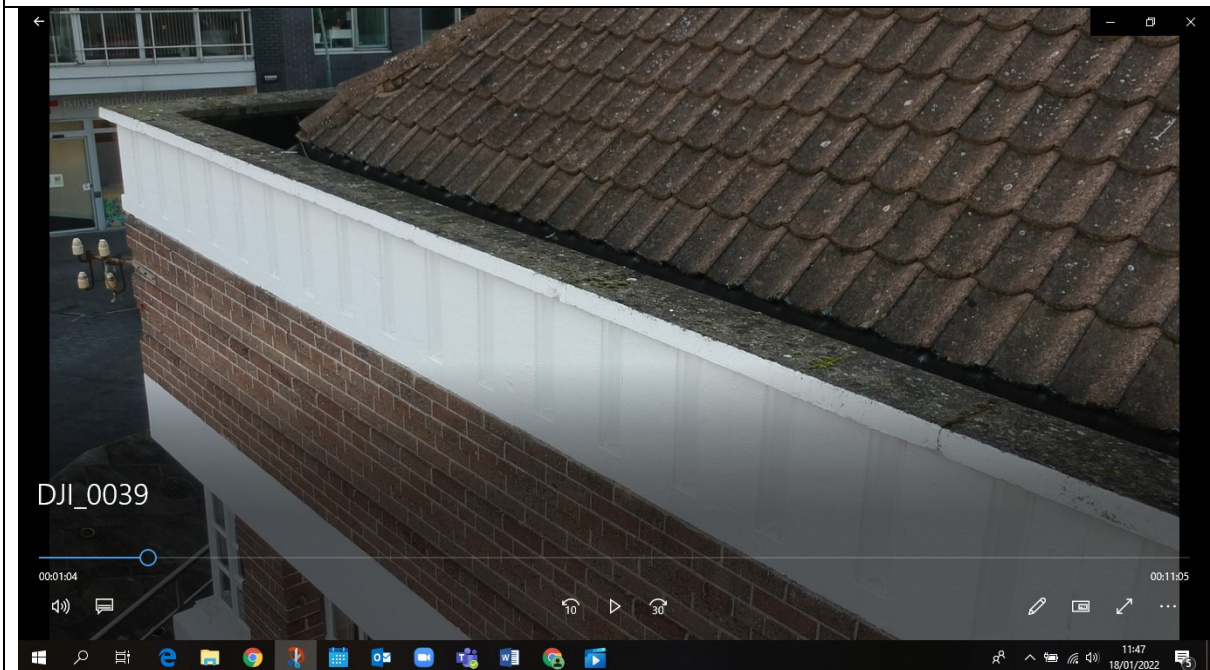
16. – Drone view of feather edged modern precast concrete coping to South parapet

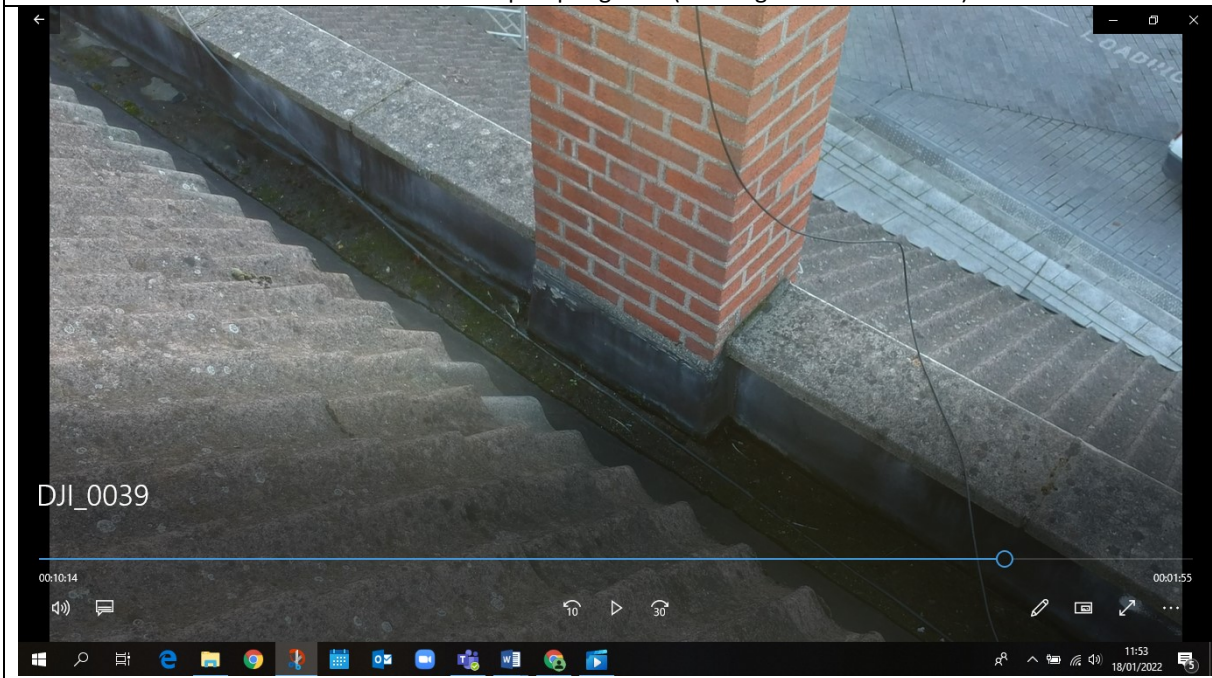
22. - View of abutment detailing at chimneystack penetration

- 3.12 The arrangement of the chimneystack flashings is not ideal. Despite the absence of any existing internal damp staining in this area, we recommend the proactive improvement of the flashing to include adequately detailed abutment cover flashings.

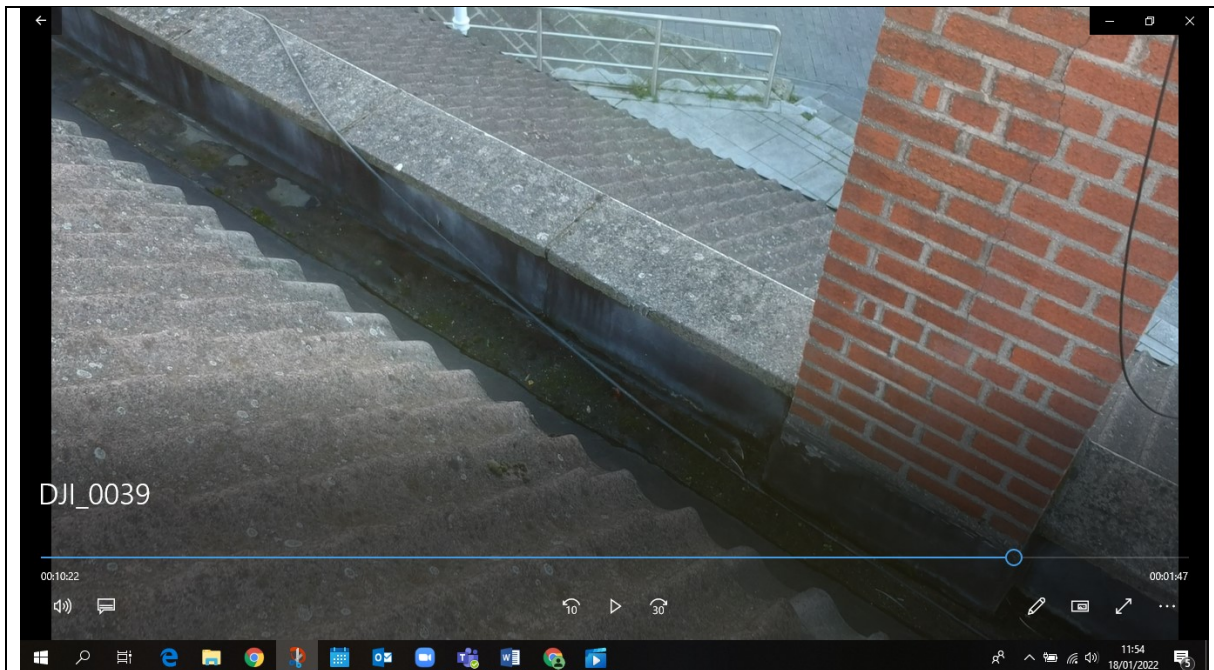
- 3.9 The chimneystack appears in generally good condition with no evidence of significant cracking, deflection or instability. However, a vertical hairline crack (Appendix A, photo 43) is evident on the centre of the front face (facing the main roof slope). The exact cause of cracking could not be determined on the day of inspection. However, we are of the opinion that the likely cause is due to inadequate allowance for expansion of the assumed flue liner during initial construction of the stack. Flue liners tend to expand and contract very slightly during periods of use and intervening non-use. These movements exert forces on the surrounding masonry resulting in vertical cracking in order to release the pressure. We recommend that this cracking be fully raked out, repaired with stainless-steel tie-bars and filled to prevent ingress.

23. - View of vertical hairline cracking to front side of chimneystack

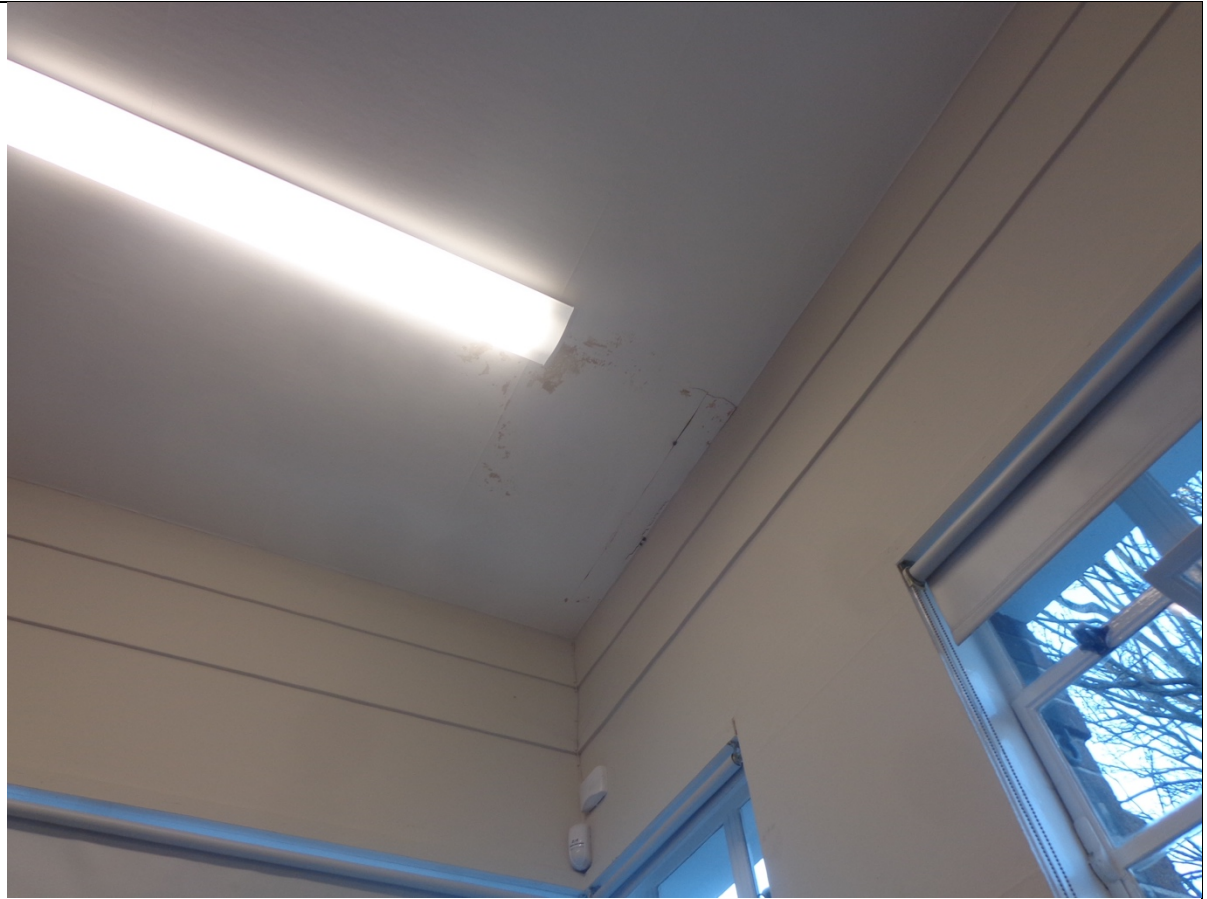
- 3.10 There are approximately three cases of localised damp staining on the library ceiling, the most noticeable of these being in the extreme rear right corner and the immediate right of the front entrance where the damp staining continues down the inside face of the front external wall. Localised repairs and renewal are required to internal finishes whilst further investigations should be conducted at ceiling and roof level to determine the condition of the timber joists and rafters in these areas. Until this can be confirmed, a budget should be retained for the localised careful spliced repair and replacement of the bearing ends of these structural timber components and the associated wall plate (say maybe 8 - 10 rafter and joist ends). Such an allowance should also cover the parapet decking board and bearing timbers, which support the underside of the parapet deck.

33 - View of water ingress in extreme rear right corner

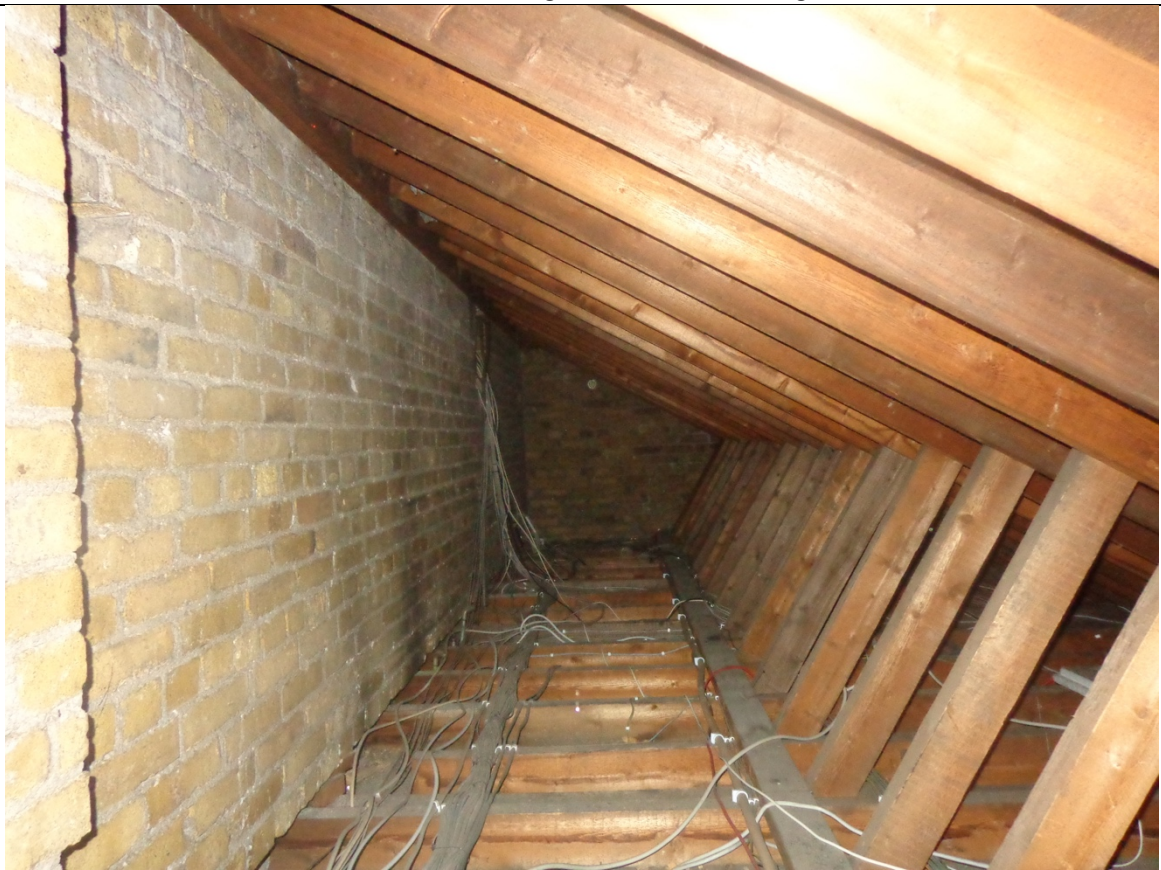
- 4.5 The lean-to roof timber structure appears in generally good condition with no evidence of significant distortion, movement or water ingress into the roof void. No further comment is warranted on the understanding the rear lean-to is to be demolished.

34- View of roof void over rear lean-to

- 4.6 The roof void of the lean-to is uninsulated. Should the lean-to be retained in any revised proposals, we recommend it be provided with 300 mm of quilt insulation or equivalent to bring the property up to modern standards. This upgrade will result in a colder internal environment within the roof void above the insulation layer and an increased risk of condensation on the underside of the impervious roofing felt. It is very important that adequate cross ventilation be incorporated to counteract this probability (as already recommended).

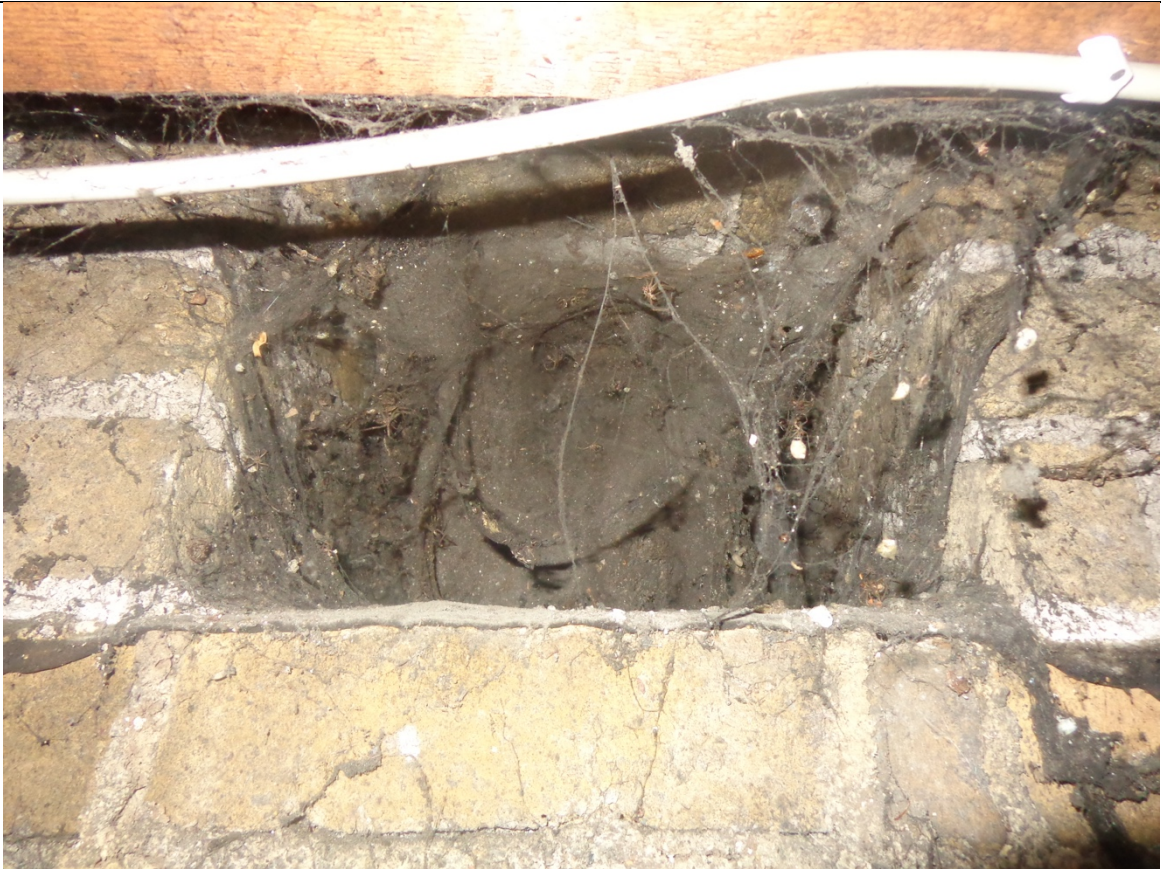
- 7.1.2 As noted above, the c2003 external landscaping works appear to have reduced subfloor ventilation when the ventilation grilles were re-set horizontally at ground level. There is evidence of cobwebs around ventilation openings in the subfloor indicated that there is inadequate airflow through the subfloor area (Appendix A, photo 40).

41 - Ditto. Note proliferation of cobwebs evidencing the absence of sufficient ventilation

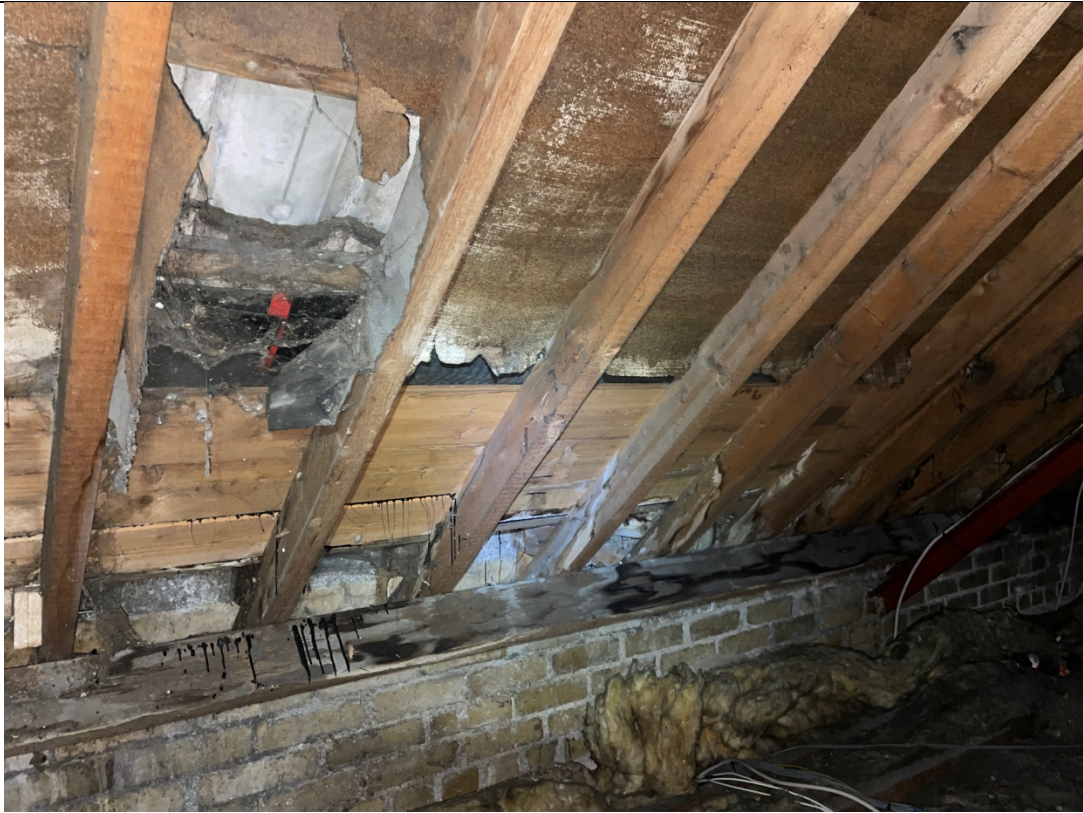
- 4.2 The roof structure of the main roof appears in generally good condition. The main steel trusses appear in good order and condition with no sign of visible corrosion. Areas of previous water ingress staining around the lower purlin and rafter-ends at parapet levels is evident (Appendix A, photo 53-54).

- 4.3 The original bitumen type underlay is present below the concrete roof tiles in the main roof. The underlay is largely intact but friable damaged in a number of areas. Patch repairs to the underlay should ideally be undertaken from the exterior with localised removal of tiles (which may only be nailed every 2nd/3rd course) and battens. New sections of roofing membrane can be then inserted where required. The delicate nature of the concrete roof tiles is noted as above and will require protection measures during this work.

53 – Typical damage to roof underlay above parapet level &

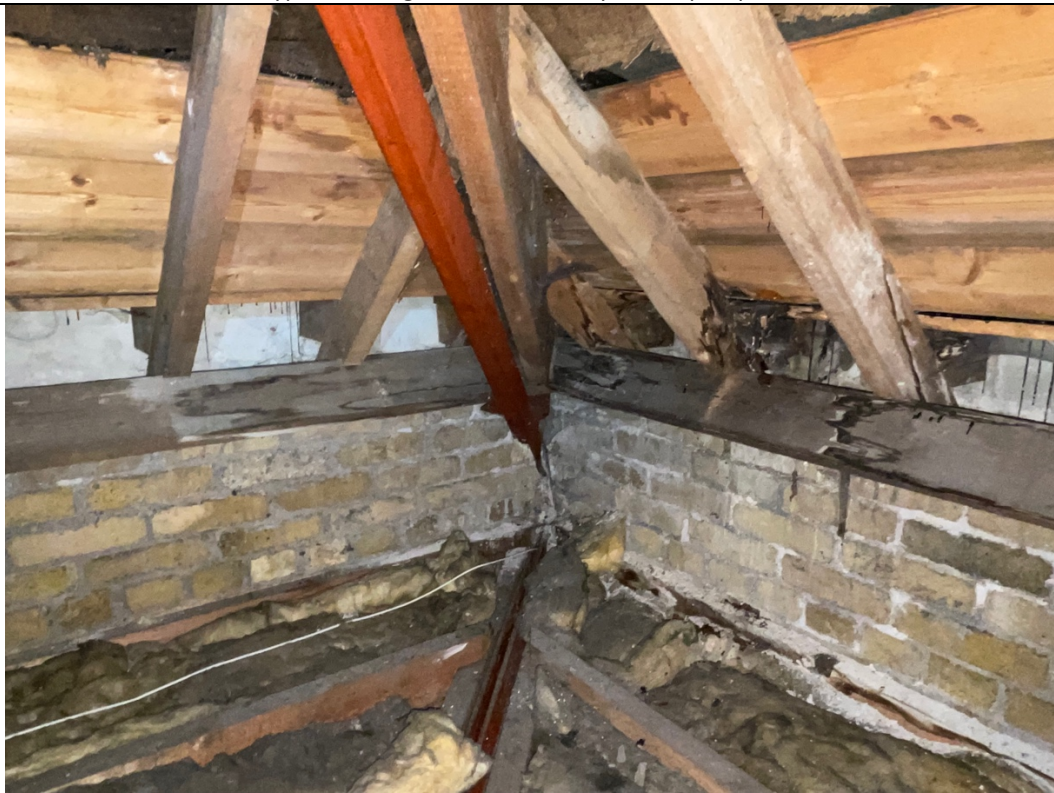
54 – Detail at corner & water ingress staining to lower purlin
