# ARBORICULTURAL ASSESSMENT & IMPACT REPORT

## Library Square Ringsend - Public Realm Improvement & Library Refurbishment & Extension

<b>Project No.</b>	<b>Date</b>	<b>Revision</b>
TIRI001	22/04/22	-

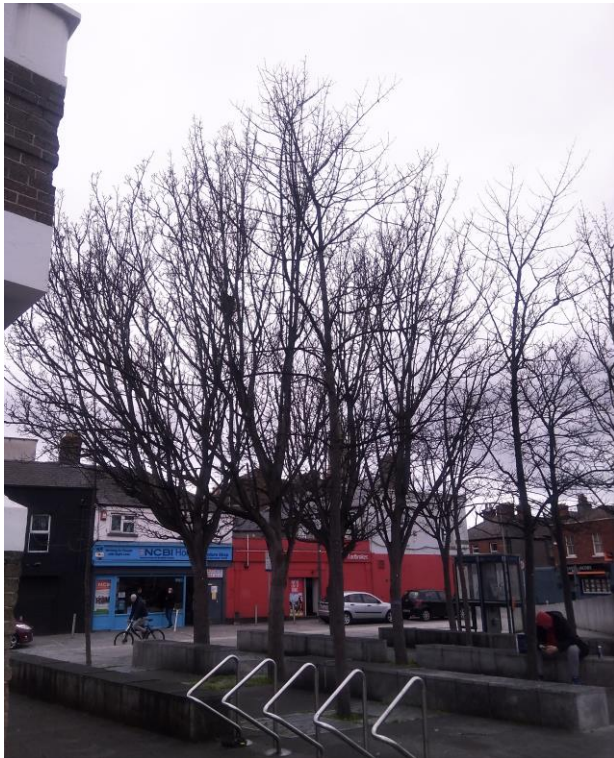
All of the trees recorded are Norway maple (*Acer platanoides*). The trees beside the library and are an even-aged group of variable size and quality (image 2). The condition of the trees suggests that they were planted with insufficient distance between trees within sub-standard planting pits with the result that intense competition and poor root conditions has led to a number of trees performing very poorly. In addition, all the trees' crowns are affected in some way by completion from neighbouring trees. Tree grills are an issue particularly where trees have developed larger trunks and are becoming enmeshed in the grills.

**Image 2.** Trees adjacent to the library. Note variable quality of trees.

It is the opinion of the author of this report that with the possible exception of tree #593 that all the trees should be removed and replaced with more appropriate species / cultivars with the potential to become trees of appropriate stature for this location. This will require long-term management with trees planted within suitable planting pits where root systems can develop in support of the trees.

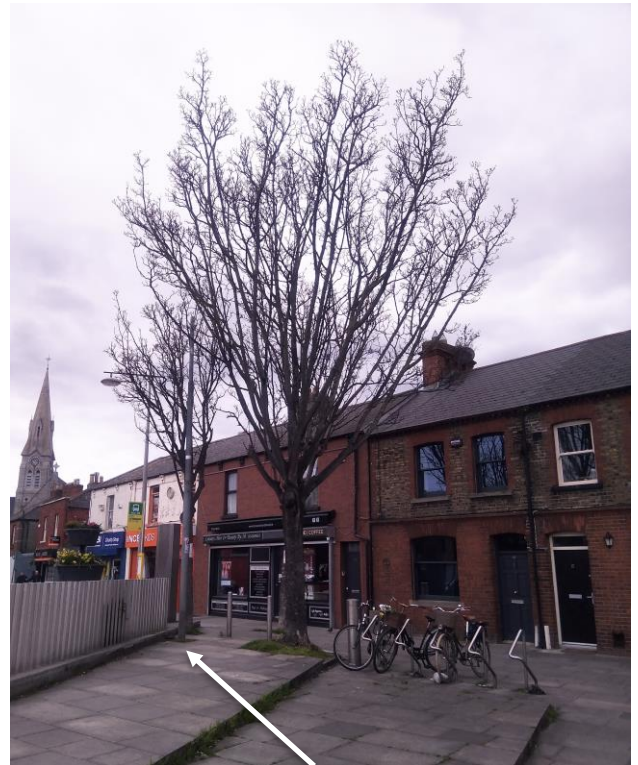
The three trees on the northern side of the R802 are also Norway maple of variable quality. All have had extensive crown raising leading to large pruning cuts. There is no evidence of associated decay at present however decay is likely to become an issue in time. One tree (#592) is in contact with raised paving and will cause damage in time (image 3).

**Image 3.** Trees on the northern side of the R802. Note proximity of tree trunk to raised paving (arrowed).
