**Phase 1 Environmental Due
Diligence Assessment
Dalymount Park**

**On behalf of
IDOM**

Title: Phase 1 Environmental Due Diligence Assessment, Dalymount Park, IDOM, Avda. Zarandoa, 23. Bilbao

Job Number: E1891

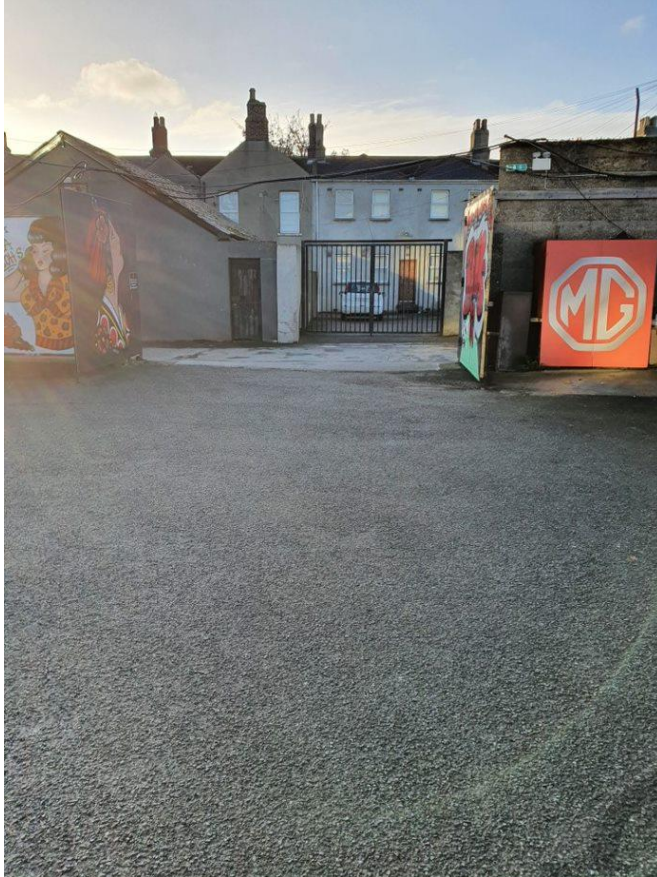
Photo 1: Staff Car Park

- There is a small staff car park area, which is located to the south-east of the Site. In this carpark area the following was observed:
 - The car park comprised of tarmac and appeared to be in good condition. See Photo 1.

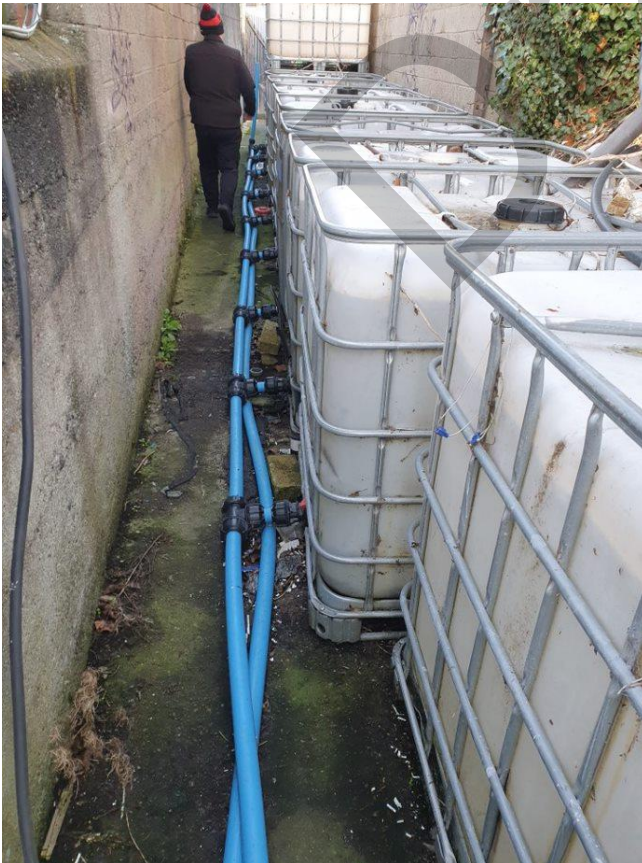
Photo 6: IBCs beside East Stands

- Eighteen (18 No) IBCs containing groundwater pumped from the onsite groundwater well were observed east of the car park and along the southern boundary of the east stands (currently not in use). These IBC's are connected through blue pipes and this water is only used to water the pitch. The pump house where the well is located was just beyond these IBCs. MOR did not have access to the pump house during the site visit. A photographic record of the pump house and the groundwater well was requested by MOR, however, they were not made available to MOR at the time of this report. There was a lot of debris in this area including wood and plastics. According to site personnel, the area of the pump house is not within the boundary of the Site. See Photo 6 and 7.

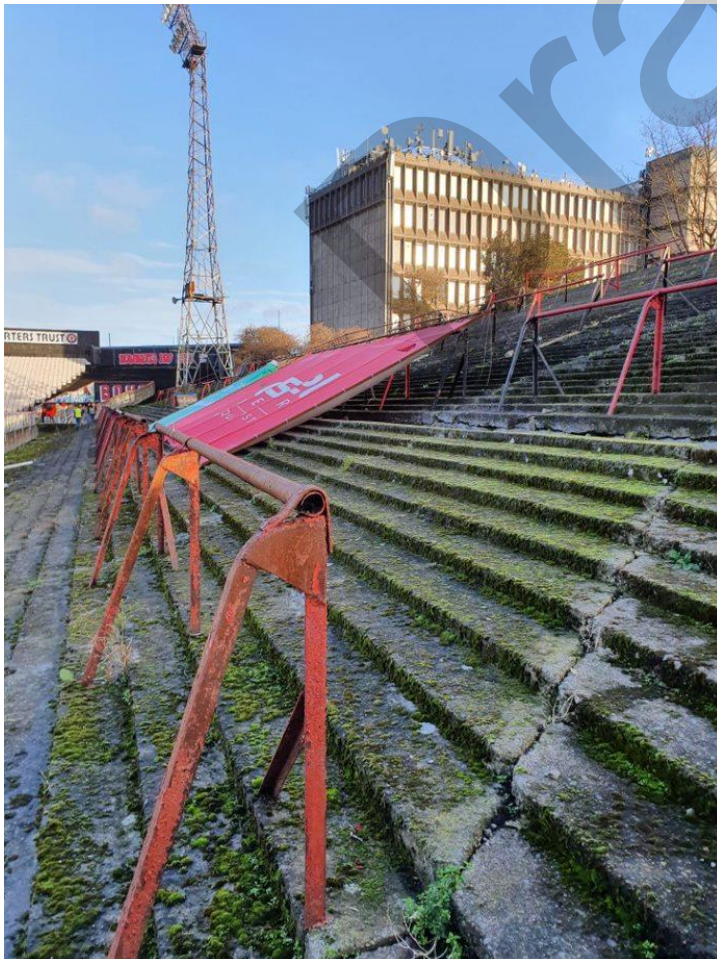
Photo 8: East Stands

- Two (2 No) floodlight towers are located to the centre right and centre left in the stands.
 - There was some waste present (i.e., bottles, paper wraps) and some cracks on the hardstanding, however, they appeared to be in fair condition with no obvious signs of staining or odour present. See Photos 8 and 9.

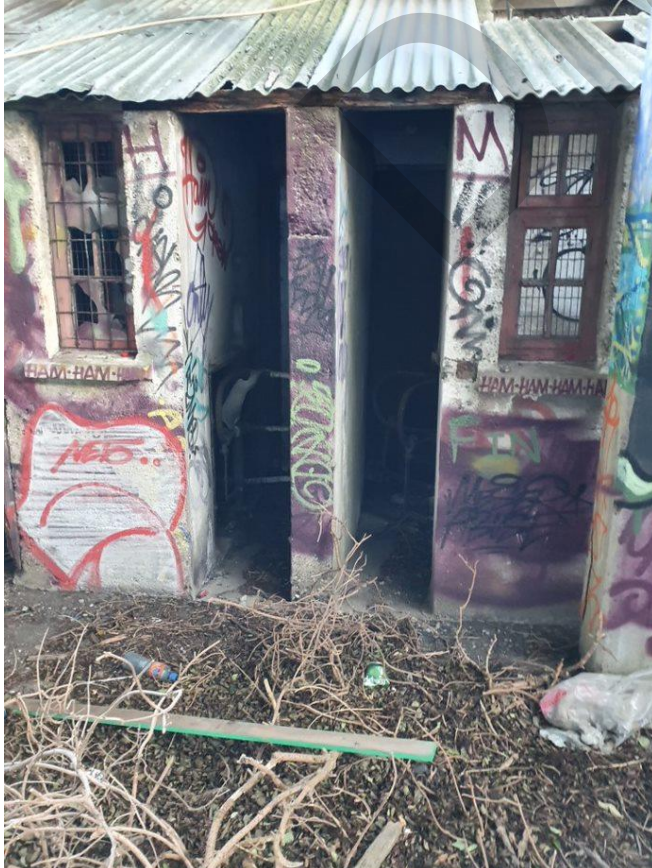
Photo 10: Turnstiles under North Stands Seating Area

- The north stands (Connaught Street Stands) are also not accessible to the public and comprise of the seating area and a series of entrances leading below the stands to a long semi-indoor corridor area, which extends the entirety of the area below the stands. This area appeared to be an old and disused entrance to the stadium, as there were a number of turnstiles and covered/sealed doors, which would have exited onto Connaught Road (See Photo 10). In the north stands area, the following was observed:

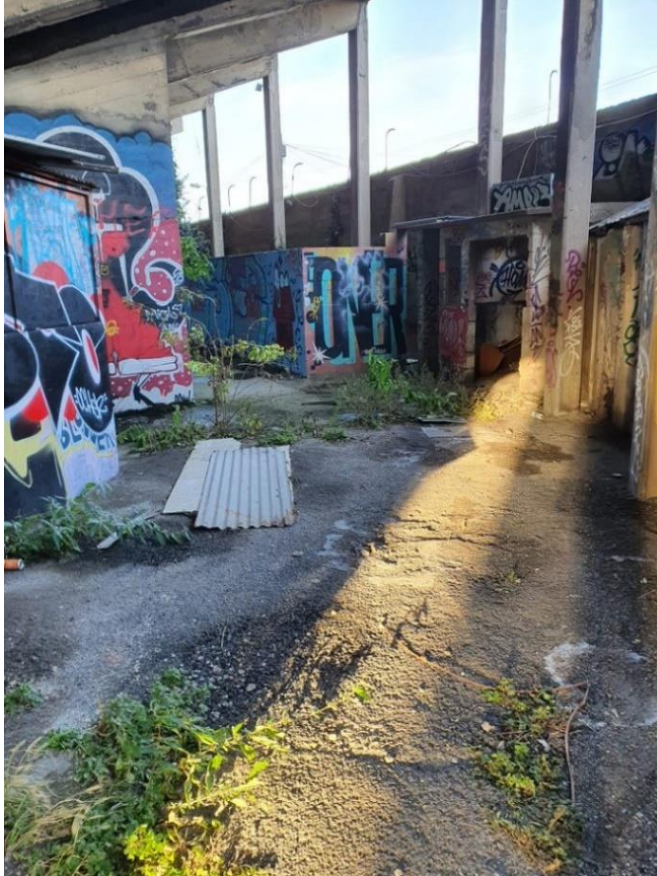
Photo 11: Corridor under North Stands Seating Area

- Debris was identified on the ground in the corridor area (See Photo 11);
 - Wires extended along the back of the wall between the corridor area and the stand that appeared to be loose and hanging down (See Photo 12).

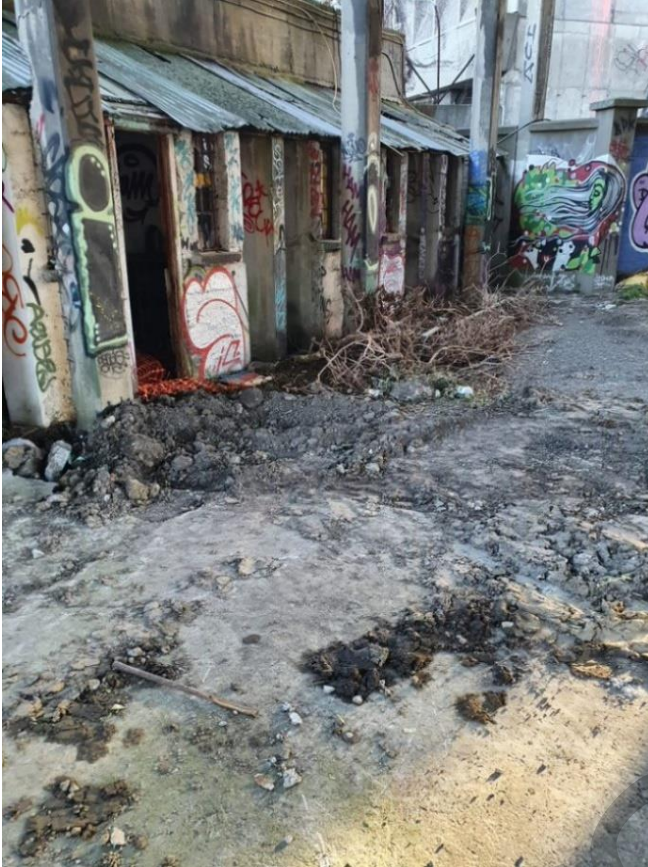
- The ground comprised primarily hardstanding and only a small section comprised hardcore (i.e., crush stones) (See Photo 13).
 - No visual or olfactory evidence of contamination was observed during the site visit.

Photo 13: North Stands Hardstanding and Hardcore with Debris

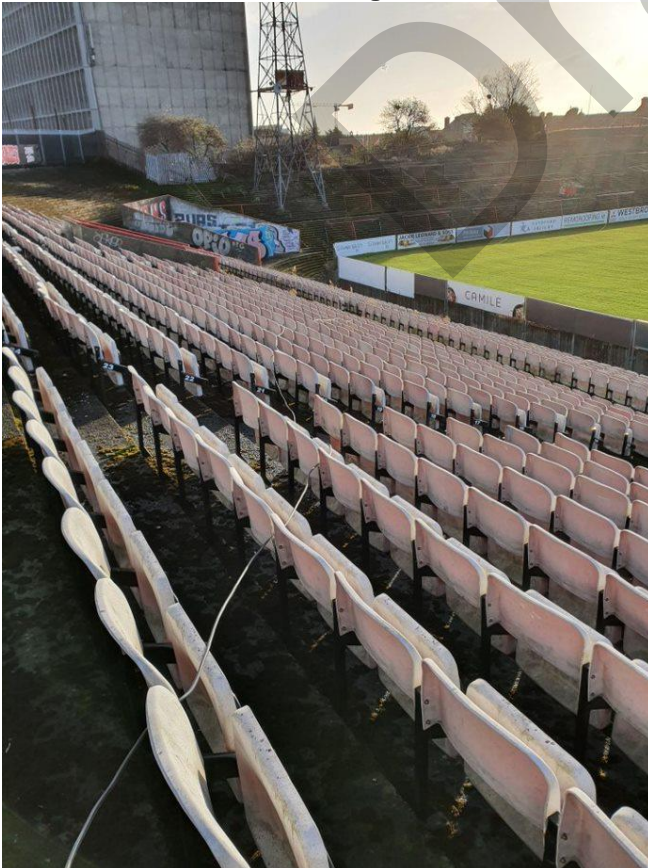
Photo 14: North Stands facing South-East

- The seating area of the stands appeared to be in good condition with rows of seats and railings all present (See Photo 14).
 - A small viewing/commentator's box is located at the top of the north-western side of the stands, which contains numerous cables (See Photo 15).

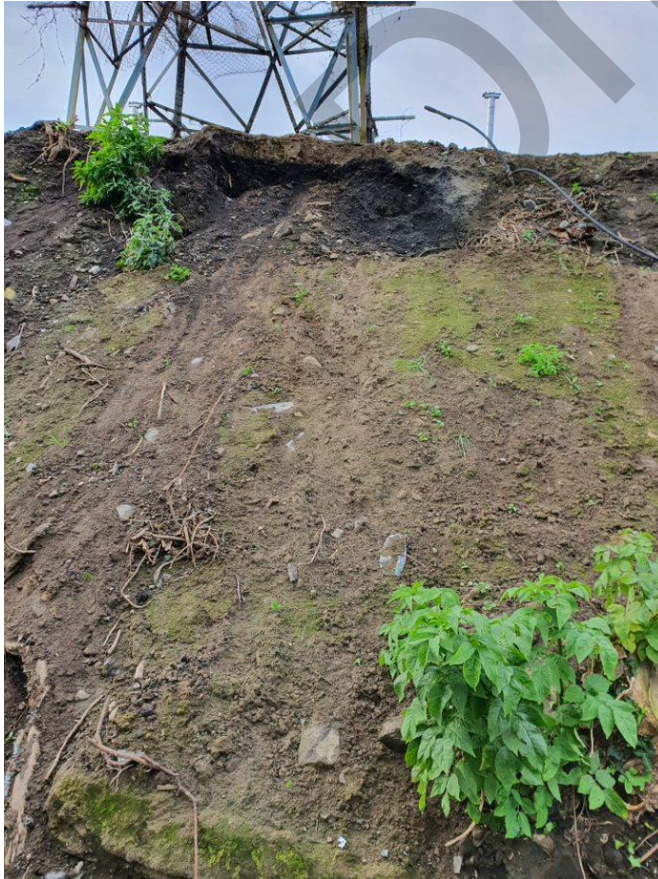
- Visual evidence of potential contamination was observed by the MOR Consultants on sections of the berm, on the exposed soils below the west stands (Des Kelly stands and berm) during the site walkover (i.e., discolouration). In addition, a moderate/strong solvent odour (olfactory evidence) was identified in the boiler room with an oily sheen (visual evidence) also noted in the rainwater within this area.

- Based on the professional judgement of the MOR Environmental consultant who undertook the inspection, there was some visual evidence of potential contamination (i.e., soil discolouration – black colour) identified in the berm located in the west stands (Des Kelly stands) and moderate-strong solvent odour was identified in the boiler room with an oily sheen present in the stagnant rainwater. However, overall, the Site appeared to be maintained in a reasonably good condition, though the following environmental compliances matters were identified:

Photo 18: Soil Discolouration (Berm)

2. The elevated contamination (TPH, lead and zinc) present at specific areas in the berm (Des Kelly stands) would not be suitable for reuse on site and they would need to be removed by a suitable contractor and disposed of in accordance with all relevant legislation. Therefore, the areas of hydrocarbon contamination should be better delineated before sending material off site as hazardous waste.

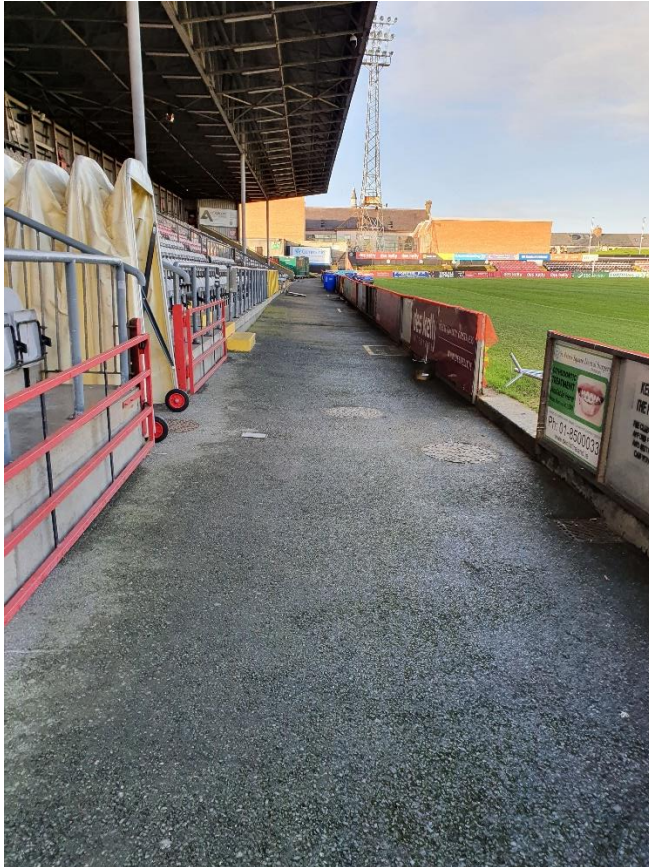
Photo 19: South Stands facing West

- The south stands (Jodi Stands) are the main stand at the football stadium and is roofed. The ground below the stand comprises tarmac (i.e., hardstanding) and the stand itself comprises concrete (i.e., hardstanding), with rows of seats and railings. Two tunnels at the bottom of the stands lead into the indoor area, beneath the seating (See Photo 19 and 20). In the area surrounding the stand the following was observed:

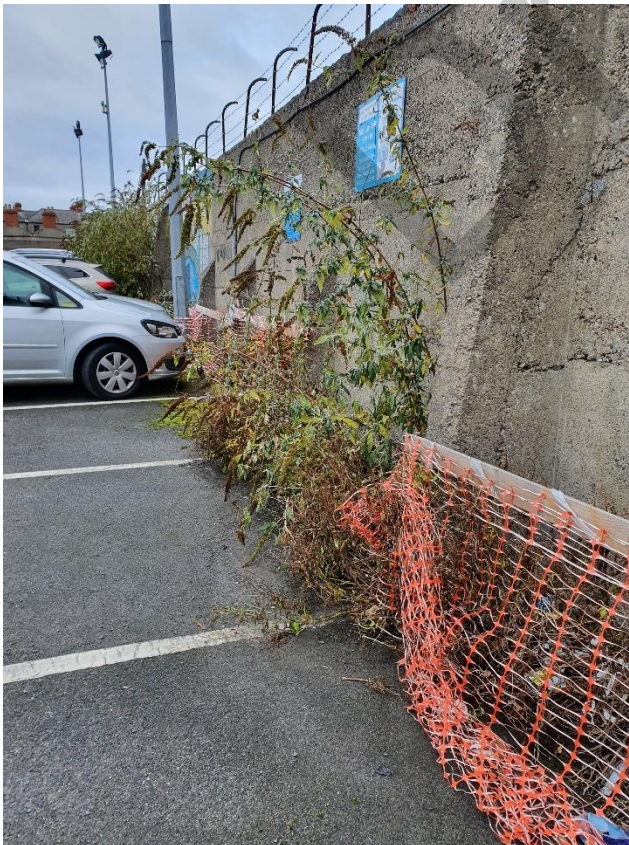
- The car park in the north-western section of the Site was in good condition. The car park slopes towards the east towards the north stands (Connaught Street stands). Storm water drains were not present in this car park to drain rainwater. According to site personnel some areas have been affected by a Japanese Knotweed. However, Dublin City Council have cordoned off these areas, which have been treated for the past number of years (See Photo 28).

Photo 28: Japanese Knot Weed North-West Car Park
