Independent Tree Surveys Ltd

Tree Survey Report Dodder Rapid Deployment Scheme Beaver Row / Beech Hill Dublin

July 2023

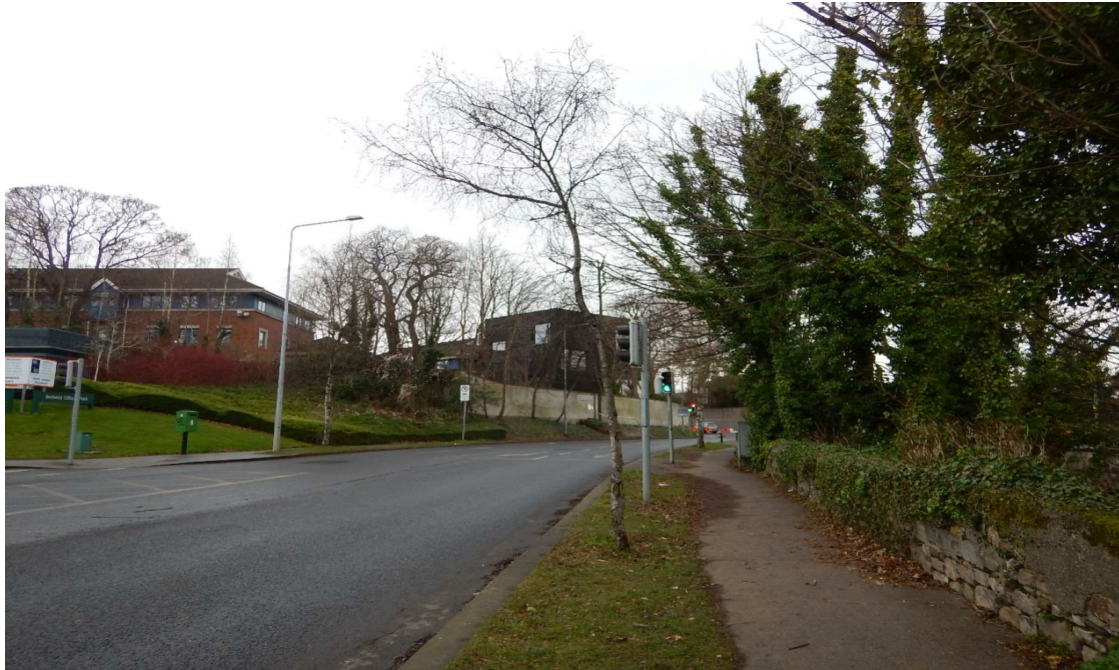
Three Birch trees growing in the roadside verge along Beech Hill Road. Two of the trees are in fair condition and are of moderate value. The smaller middle tree (T2) is in poor condition and is of low value. These trees are scheduled for removal and should be replaced by new planting elsewhere where it is practical..

1. 3. Poor quality Birch tree T2 in verge in the foreground, T3 is further away towards Clonskeagh Road

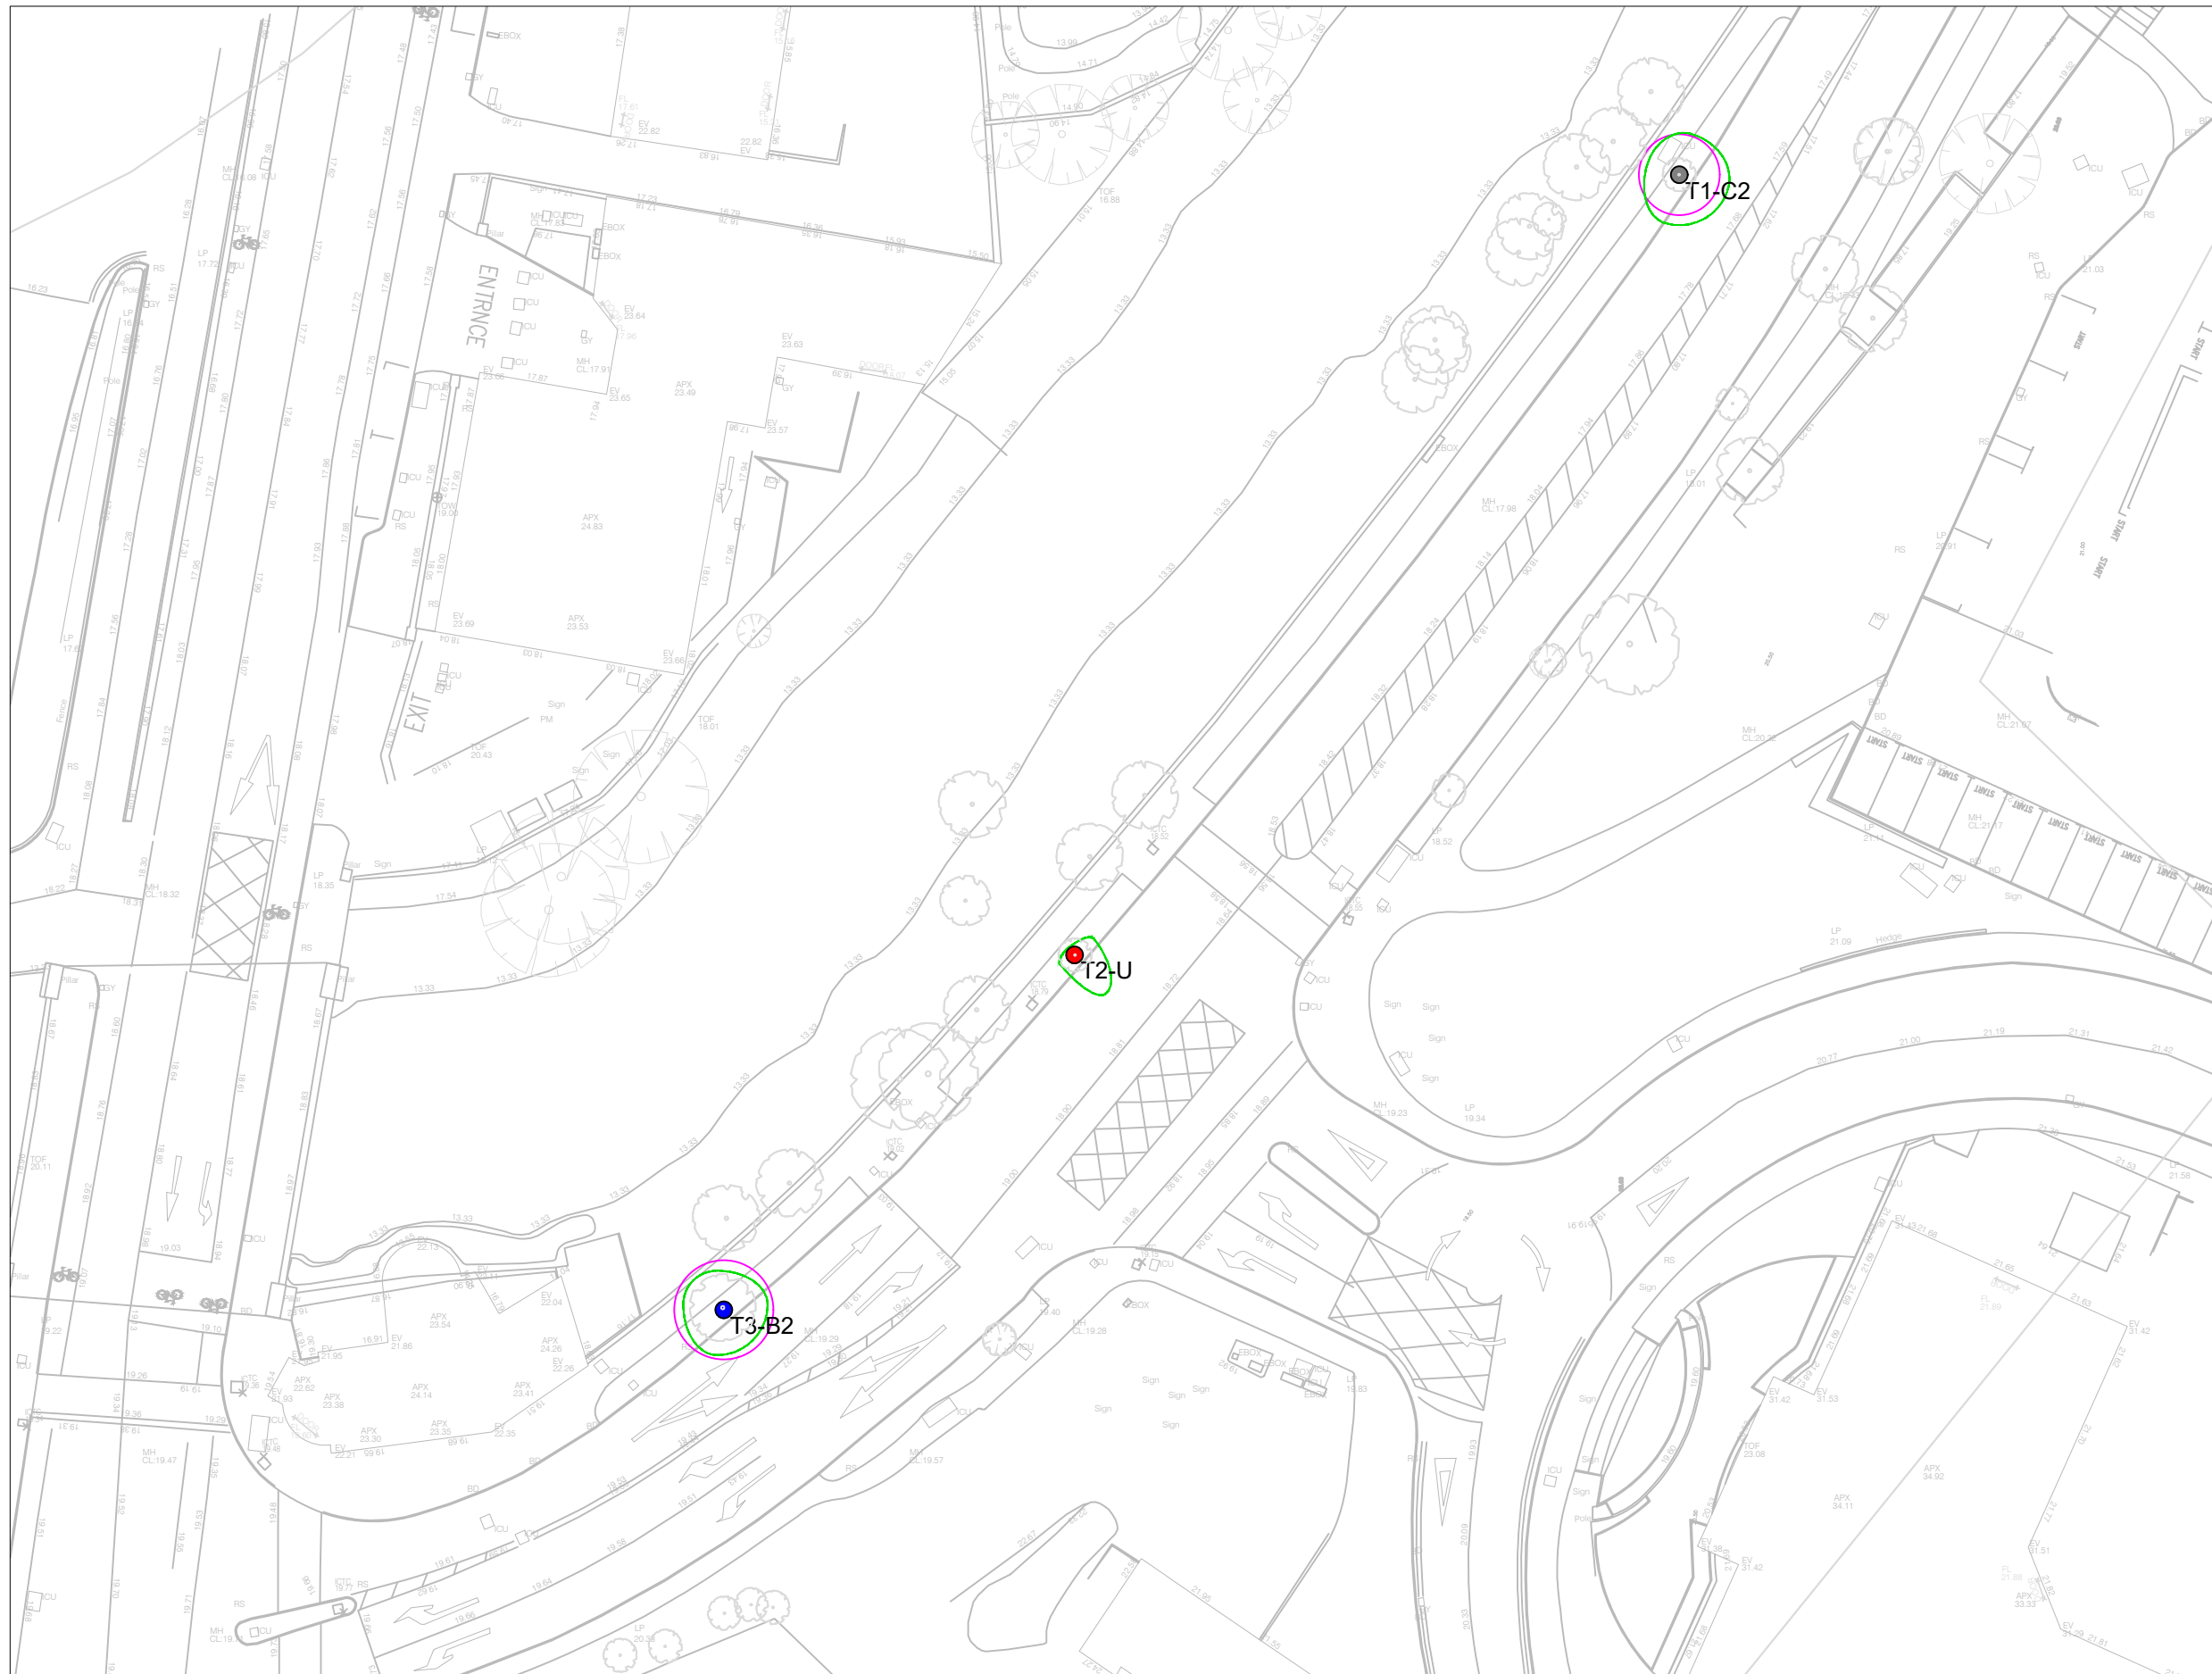
Drawing Number: 23007_TS_Site 3 Beech Hill Road

Type	No.	Species	Age	Ht m	Dbh mm	St	Cr	N	S	E	W	ERC	Phys Cond	Structural Condition/Comments	Preliminary Recommendations	RPA m	Cat
Beech Hill Road																	
T	1	Betula pendula (Silver Birch)	EM	8.2	200	1	2	2.5	3	3	2	10+	Fair	Fair. Birch tree in narrow grass verge. No main leader. Slight lean to stem. Suppressed by neighbouring Sycamore trees.	No urgent works needed.	2.4	C2
T	2	Betula pendula (Silver Birch)	SM	5.5	110	1	2	1.5	3	1	0.5	<10	Poor	Poor. Smaller sized street tree with a poor shape & form. Wood decay in old bark wounds to lower stem. Unbalanced crown shape. Limited value and potential.	Consider removal as part of good management.	1.32	U
T	3	Betula pendula (Silver Birch)	EM	11	245	1	1.5	2	3	3	2	20+	Good	Fair. Medium sized tree tree in grass verge.	No urgent works needed.	2.94	B2
