Griffith Avenue Protected Cycle
Lane Scheme between Walnut
Rise and Charlemont Estate

Stage 3 Road Safety Audit

Document Ref: P21-105-RSA-CT-RP-001

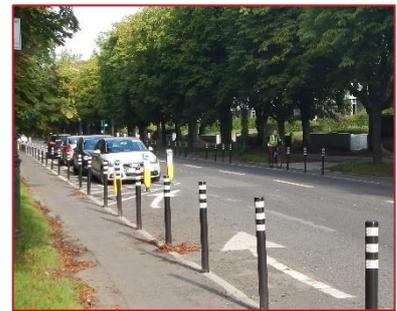
Location: Taper at the start of on-street parking within the Scheme

Summary: The taper at the commencement of sections of on-street parking within the Scheme is short and may result in drivers suddenly changing direction which may not be anticipated by following drivers.

On-street parking has been provided at a number of locations within the Scheme. A taper has been provided at the commencement of the on-street parking to guide drivers around parked vehicles. The length of the tapers is relatively short and, during the site visit, the Audit Team observed drivers moving to the right a significant distance upstream of the taper and encroaching on adjacent hatched road markings or the opposing traffic lane, where there is an increased risk of collisions with oncoming vehicles.

Should drivers suddenly change direction at the taper to avoid the parked vehicles a following driver, who may have reduced visibility to the taper, may not anticipate such a manoeuvre leading to them having insufficient time to react resulting in potential collisions with parked vehicles.

During the site visit, the Audit Team noted that some of the bollards at these tapers had been struck.

The taper at the commencement of on-street parking should be amended to more gradually guide drivers past the parked vehicles.

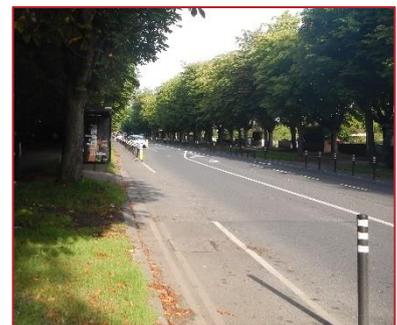
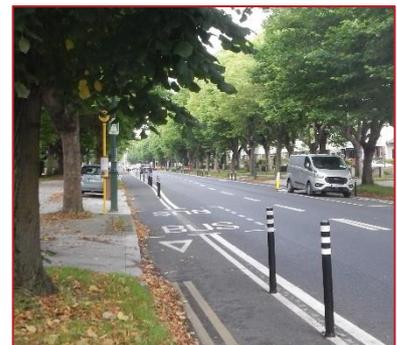
Location: Some bus stop locations within the Scheme

Summary: There is a lack of consistency in relation to the layout at bus stops within the Scheme leading to cyclists being insufficiently aware of the bus stop location in some instances where there is an increased risk of collisions between cyclists and buses pulling in at bus stops.

There is a lack of consistency in the layout of the protected cycle lane at bus stops throughout the Scheme. In some locations, a Yield symbol has been provided in the cycle lane upstream of the bus stop and bus cage road markings have been provided. However, in other locations no road markings have been provided with a gap in the bollards and cycle lane provided only.

Where road markings have not been indicated there is a risk that cyclists, particularly those on electric-powered bikes and scooters who will be travelling at greater speeds than a standard bicycle, may be insufficiently aware of the bus stop ahead and the need to give way to a bus pulling in at the bus stop leading to an increased risk of side swipe, or rear end shunt, collisions between buses and cyclists.

3.1	Yes	Yes		
3.2	Yes	No	The layout of the existing bus stops is not consistent due to the presence of mature trees and driveways. Yield signs will be placed at a consistent distance ahead of all bus stops to alert cyclists to the presence of bus stops.	Yes

The layout of the protected cycle lanes at bus stops within the Scheme should be consistent ensuring that cyclists are sufficiently aware of the location of the bus stop on approach.

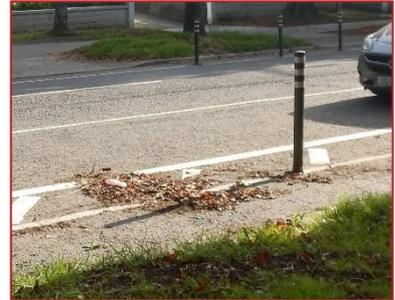
Location: General Problem throughout the Scheme

Summary: Trees overhanging the cycle lane may result in an increase of leaves and detritus accumulating within the cycle lane during the Autumn and Winter months.

Mature trees within the grass verges adjacent the Griffith Avenue carriageway overhang the protected cycle lanes throughout the Scheme. During the site visit, the Audit Team noted leaves and debris at the edge of the kerb and within the hatched road markings adjacent the protected cycle lanes. During the Autumn and Winter months, this is likely to worsen as leaves begin to fall from the trees.

An accumulation of leaves within the cycle lane, particularly during wet weather, may result in a loss of traction for cyclists and an increased risk of loss of control and falls from their bicycle or the potential for cyclists to enter the adjacent traffic lane to avoid detritus resulting in a risk of collisions with vehicles.

Ensure the protected cycle lanes are kept clear of leaves and detritus.

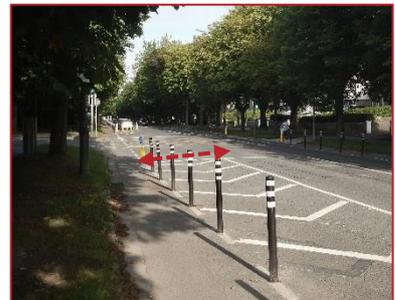
Location: Griffith Avenue/Beresford Avenue signalised junction

Summary: The straight-ahead and left-turn lane is located a significant distance away from the cycle lane which may lead to left-turning drivers having insufficient visibility towards a cyclist approaching from behind them.

A section of on-street parking has been provided at the edge of the westbound traffic lane on Griffith Avenue between the signalised junctions at Grace Park Road and Beresford Avenue. To the west of the on-street parking, hatched road markings have been provided between the parking and stop line at the Beresford Avenue signalised junction, where a straight-ahead and left-turn lane had been previously provided. This results in the new straight-ahead and left turn traffic lane being located a significant distance away from the cycle lane.

As a result, left-turning drivers entering Beresford Avenue may have insufficient visibility to a cyclist approaching the junction from behind them, particularly those on electric-powered bikes and scooters who will be travelling at greater speeds than a standard bicycle, increasing the risk of a driver turning across the path of a cyclist and side-on collisions.

3.3	Yes	Yes		
3.4	Yes	No	The wide buffer between the cycle lane and the left turn lane into Beresford Avenue increases the acuteness of the angle at which left turning motorists cross the cycle lane. This in turn increases the visibility of cyclists for motorists. Red surfacing will be applied to the cycle lane crossing Beresford Road to further highlight the presence of cyclists in the area.	Yes

A short section of hatched road markings should be removed upstream of the stop line and a left-turn lane provided adjacent the cycle lane. This will provide increased awareness of the cycle lane for left-turning drivers and provide greater visibility to a cyclist approaching from behind via the vehicle's wing mirrors.

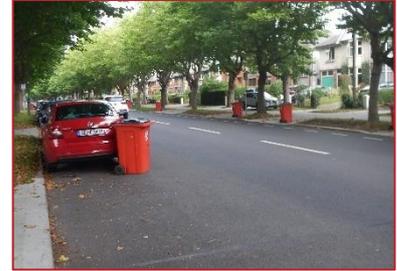
Location: Griffith Avenue between the N1/R132 junction and the Sherkin Gardens side road

Summary: Protected cycle lanes, and associated amendments to road markings, have not been implemented within a short section of Griffith Avenue which may increase the risk of conflicts between cyclists and motorised vehicles over this section.

Between the signalised junction of Griffith Avenue and the N1/R132 and the priority-controlled side road junction at Sherkin Gardens to the west, protected cycle lanes have not been provided on Griffith Avenue. There are no cycle facilities within the westbound carriageway while an eastbound advisory cycle lane is provided. During the site visit, the Audit Team observed vehicles parking at the edge of the westbound traffic lane.

This results in westbound cyclists transitioning from protected cycle lanes to the traffic lane where they must mix with motorised vehicles and are at an increased risk of being struck by a vehicle. This problem is exacerbated by the parked vehicles on Griffith Avenue as cyclists may move into the path of a westbound vehicle to pass parked vehicles, further increasing the risk of collisions.

Protected cycle lanes should be provided on both sides of Griffith Avenue between the N1/R132 junction and Sherkin Gardens.

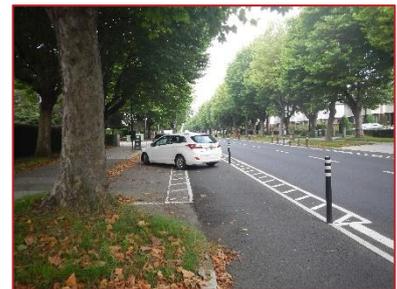
Location: Corpus Christi Roman Catholic Church

Summary: Parking spaces located to the rear of the protected cycle lane may result in an increased risk of vehicle-cyclist collisions as drivers cross the cycle lane to enter/exit these parking spaces.

Parking spaces, inset into the verge, on the southern side of Griffith Avenue on both sides of the Corpus Christi Catholic Church have been retained. This results in these parking spaces being located to the rear of the protected cycle lane. Bollards have also been provided, albeit at increased spacings, between the cycle lane and adjacent traffic lane throughout the length of the parking.

Drivers entering and exiting these parking spaces are required to pass through the spaces between the bollards and cross the cycle lane to complete their manoeuvre, which the Audit Team observed during the site visit. Also, depending on the spaces available, drivers may be required to manoeuvre within the cycle lane when parallel parking. This may lead to an increased risk of rear end shunts as drivers slow down to pass between the bollards or collisions with cyclists when crossing the cycle lane or parallel parking.

The parking spaces and cycle lane at this location should be amended so that the parking spaces are located adjacent the traffic lane and the cycle lane is brought to the rear of the parking spaces.

Alternatively, remove the bollards throughout the length of the parking and provide coloured surfacing within the cycle lane to increase a driver's awareness of the potential for approaching cyclists when entering/exiting the parking spaces.

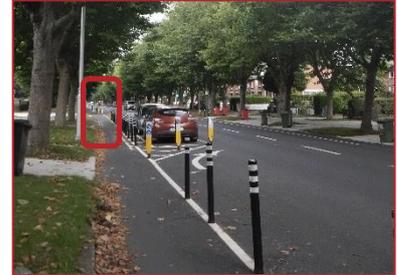
Location: Priority-controlled side road junctions within the Scheme

Summary: The bollards at the edge of the protected cycle lane may align linearly such that a driver approaching a side road may have difficulty locating the junction.

Reboundable bollards have been provided between the protected cycle lanes and the adjacent traffic lanes on Griffith Avenue with gaps provided at accesses and side road junctions. When travelling along Griffith Avenue, the bollards align linearly making it difficult to identify upcoming side roads particularly during the hours of darkness and where these are located downstream of on-street parking as drivers are positioned further from the nearside kerb.

This may lead to drivers overshooting side roads resulting in sudden braking and rear end shunts or potential unsafe reversing or u-turn manoeuvres to enter the side road.

Measures (e.g. different coloured bollards either side of side roads etc.) should be provided to increase a driver's awareness of priority-controlled side roads within the Scheme.

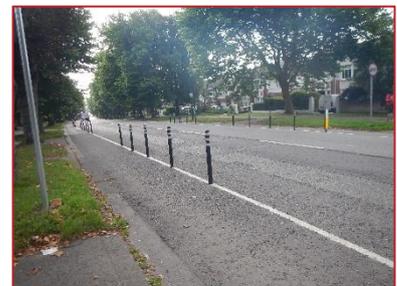
Location: Immediately east of Calderwood Road side road junction

Summary: The bollard at the commencement of the protected cycle lane east of the Calderwood Road junction is not yellow.

A black bollard has been provided at the start of the row of bollards at the edge of the eastbound protected cycle lane downstream of the Calderwood Road side road junction following the gap in the bollards to facilitate the side road. Eastbound drivers, or drivers turning left from Calderwood Road, may be insufficiently aware of the commencement of the bollards, particularly during the hours of darkness, resulting in them colliding with the bollard and knocking it into the cycle lane or traffic lane where it may present an obstacle to other road users.

This bollard should be replaced with a yellow bollard including a blue 'Keep Right' arrow sign for drivers and a blue 'Keep Left' arrow sign for cyclists, as provided downstream of side road junctions elsewhere within the Scheme.

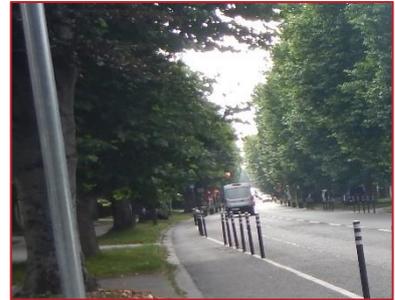
Location: Throughout the Scheme

Summary: Low hanging branches over the cycle lane may present obstacles to cyclists.

Mature trees within the grass verge adjacent the Griffith Avenue carriageway overhang the protected cycle lanes throughout the Scheme. In some locations, the branches are low-hanging such that cyclists were observed stooping on their bicycle to avoid branches during the site visit.

Low hanging branches can present hazards and/or obstacles to cyclists which may lead to personal injuries if struck or to the potential for cyclists to swerve to avoid the branches resulting in collisions with bollards or encroaching into the traffic lane where there is an increased risk of being struck by a vehicle.

Ensure the trees along Griffith Avenue, which overhang the cycle lane, are routinely trimmed to prevent them presenting a hazard/obstacle within the cycle lane.

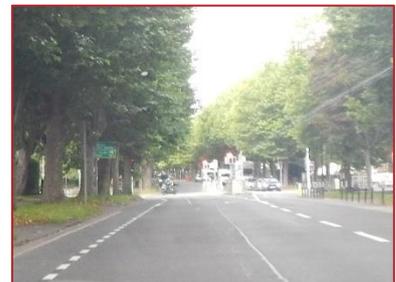
Location: Eastbound approach on Griffith Avenue to N1/R132 Junction

Summary: The upstream protected cycle lane and on-street parking result in an eastbound driver on Griffith Avenue approaching the N1/R132 junction in the right-turn lane or straddling both lanes potentially leading to sudden weaving manoeuvres into the nearside lane and side swipe collisions.

Protected cycle lanes have not been provided on the section of Griffith Avenue between the N1/R132 signalised junction and the priority-controlled side road junction at Sherkin Gardens. Upstream of Sherkin Gardens, in the eastbound traffic lane, on-street parking has been provided which results in drivers being positioned closer to the centreline when passing the parking and subsequently when entering the section of Griffith Avenue where protected cycle lanes have not been provided, and where the traffic lanes are significantly wider.

This results in drivers being positioned in the traffic lane such that they are directed into the right-turn lane at the N1/R132 junction, or straddling this lane and the straight-ahead and left turn lane. Drivers wishing to turn left or proceed straight ahead may undertake sudden manoeuvres to position themselves in the correct lane on the approach to the junction. Following drivers, who may not expect such a sudden manoeuvre, may have insufficient time to react to the vehicle ahead increasing the risk of side swipe or rear end shunt collisions.

3.10	Yes	No	Currently the presence of pedestrian islands on Griffith Avenue on either side of its junction with the Swords Road do not allow the widths to extend the protected cycle lanes right up to the junctions. However designs are currently being finalised for the upgrade of this junction that will include the removal of these islands and allow for the protected cycle lanes to be extended right up to the junction with Swords Road.	Yes

Hatched road markings should be provided within the eastbound lane downstream of the on-street parking directing drivers to the nearside lane with a right-turn lane developed further downstream of the nearside lane.

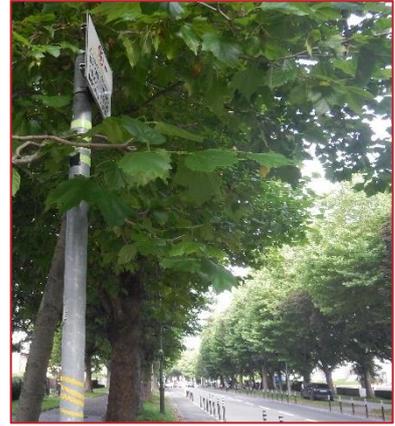
- 4.1 A 'No Parking' sign located to the west of the entrance to Dominican College is no longer necessary due to the protected cycle lane at this location, which now physically restricts parking. This sign should be removed.

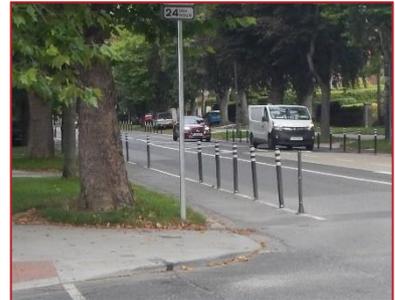
- 4.2 The yellow bollard at the start of the westbound protected cycle lane west of Philipsburgh Avenue has been struck and no longer contains its reflective face. This should be repaired.

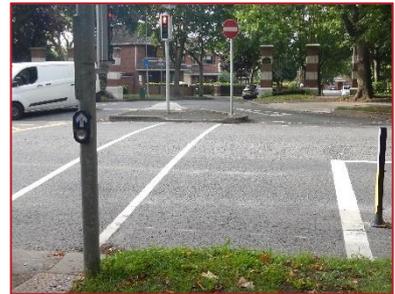
- 4.3 An existing signalised pedestrian crossing is located across Griffith Avenue at its junction with Beresford Avenue. There is no tactile paving provided at the dropped kerb on the northern side of the crossing and the southern side of the crossing is located at a splitter island where the dropped kerb provided has an upstand greater than 6mm. Also, there is no tactile paving provided within the splitter island at the signalised crossing or at the two uncontrolled crossings of Beresford Avenue and the dedicated left-turn exit.

Tactile paving should be provided on both sides of the signalised crossing. The dropped kerb on the southern side of the crossing should be reduced so that its upstand is no greater than 6mm high. Tactile paving should also be provided within the splitter island on the crossing's southern side at the dropped kerbs at the existing uncontrolled crossings.
