Arboricultural Report

Tree Survey,
Arboricultural Impact Assessment &
Arboricultural Method Statement

Social Housing Bundle 5

SHB5-BVF-RP-CMC-L-P3-0031

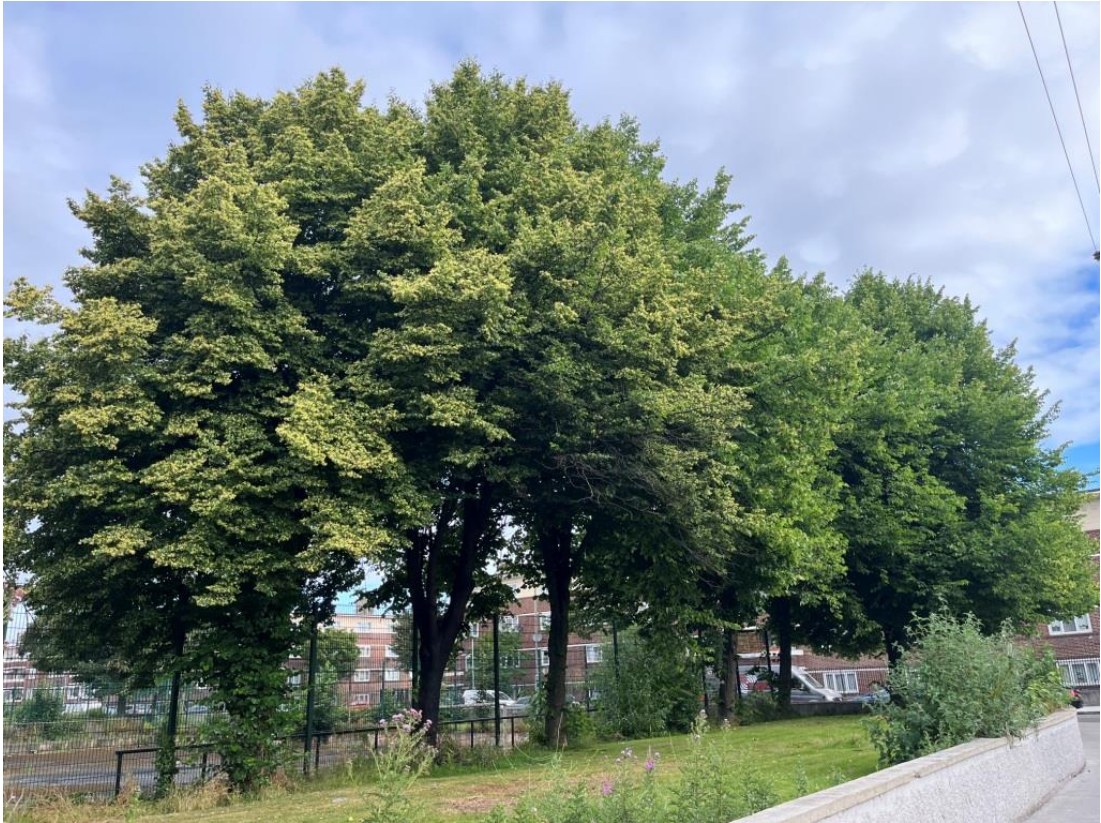
Photo 1: View of the lime trees T527 to T533 within Oisín Kelly Park.

Tree T529	1 Tilia x vulgaris (Common Lime)	16.0	40	1	4.0	7.0	3.0	5.0					3.0		Early Mature	Structural condition Fair. Physiological condition Fair. Competition - Adjacent trees. Deadwood - Minor. Fire damage - Base / bole / principal stems.	26/06/2023	72.4	4.8	10-20	C2
Tree T530	1 Tilia x vulgaris (Common Lime)	16.0	37	1	3.0	7.0	3.0	6.0					2.0		Early Mature	Structural condition Fair. Physiological condition Fair. Deadwood - Minor. Decay / structural defect - Base. Epicormic growth - Base.	26/06/2023	61.9	4.4	20-40	C2
Tree T531	1 Tilia x vulgaris (Common Lime)	16.0	40	1	4.0	7.0	3.5	5.0					3.0		Early Mature	Structural condition Fair. Physiological condition Good. Branch - Broken. Branch - Suspended. Competition - Adjacent trees. Decay / structural defect - Localised.	26/06/2023	72.4	4.8	20-40	B2
Tree T532	1 Tilia x vulgaris (Common Lime)	16.0	37	1	5.5	5.5	4.0	5.5					2.5		Early Mature	Structural condition Good. Physiological condition Good. Arboricultural work - Historic. Competition - Adjacent trees.	26/06/2023	61.9	4.4	40+	B2

Tree ID	No. Species	Height (m)	Stem diameter (cm)	No. of Stems	CROWN SPREAD (m)								Crown clearance (m)	L.B. (m)	Life stage	Condition Notes	Survey date	RPA (m ²)	RPR (m)	Life expectancy (yrs)	BS Category
					N	NE	E	SE	S	SW	W	NW									
Tree T533	1 Tilia x vulgaris (Common Lime)	17.0	52	1	7.0	7.0	6.0	7.0				2.5		Early Mature	Structural condition Good. Physiological condition Good. Arboricultural work - Historic. Competition - Adjacent trees.	26/06/2023	122.3	6.2	40+	B2	
Tree T534	1 Acer pseudoplatanus (Sycamore)	16.5	58	1	7.0	6.0	7.0	7.5				1.5		Mature	Structural condition Good. Physiological condition Fair. Arboricultural work - Historic.	26/06/2023	152.2	7.0	20-40	B1/B2	
Tree T535	1 Acer pseudoplatanus (Sycamore)	14.5	39	1	5.0	5.5	4.0	4.5				1.5		Early Mature	Structural condition Fair. Physiological condition Poor. Bark wound - Major. Die-back - Lower crown. Fire damage - Base / bole / principal stems.	26/06/2023	68.8	4.7	0-10	U

ID	No. / Species	BS5837 Category	Purpose of works Recommended works	Status
S1	1 <i>Buddleja davidii</i> Buddleja	C2	To facilitate development Fell - Ground level.	Proposed
T527	1 <i>Tilia x vulgaris</i> Common Lime	U	To facilitate development Fell - Ground level.	Proposed
T528	1 <i>Tilia x vulgaris</i> Common Lime	B2	To facilitate development Fell - Ground level.	Proposed
T529	1 <i>Tilia x vulgaris</i> Common Lime	C2	To facilitate development Fell - Ground level.	Proposed
T530	1 <i>Tilia x vulgaris</i> Common Lime	C2	To facilitate development Fell - Ground level.	Proposed
T531	1 <i>Tilia x vulgaris</i> Common Lime	B2	To facilitate development Fell - Ground level.	Proposed
T532	1 <i>Tilia x vulgaris</i> Common Lime	B2	To facilitate development Fell - Ground level.	Proposed
T533	1 <i>Tilia x vulgaris</i> Common Lime	B2	To facilitate development Fell - Ground level.	Proposed
T534	1 <i>Acer pseudoplatanus</i> Sycamore	B1/B2	To facilitate development Fell - Ground level.	Proposed

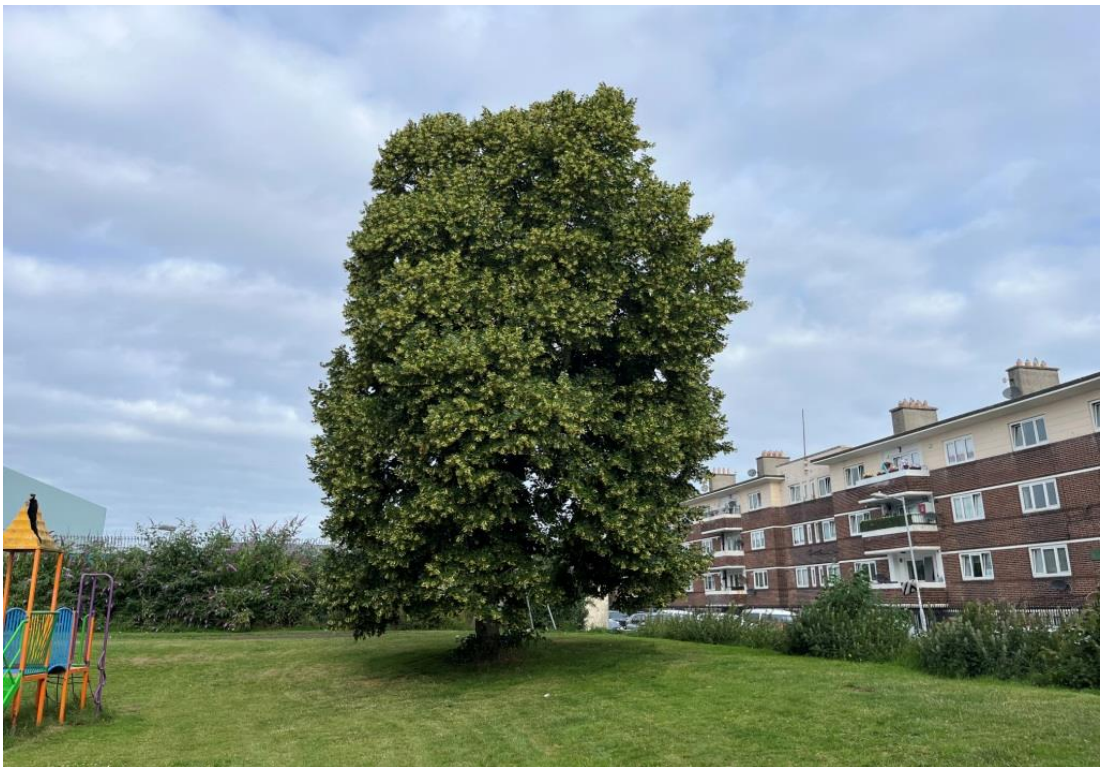
Photo 2: View of the lime tree T537 within Oisín Kelly Park.

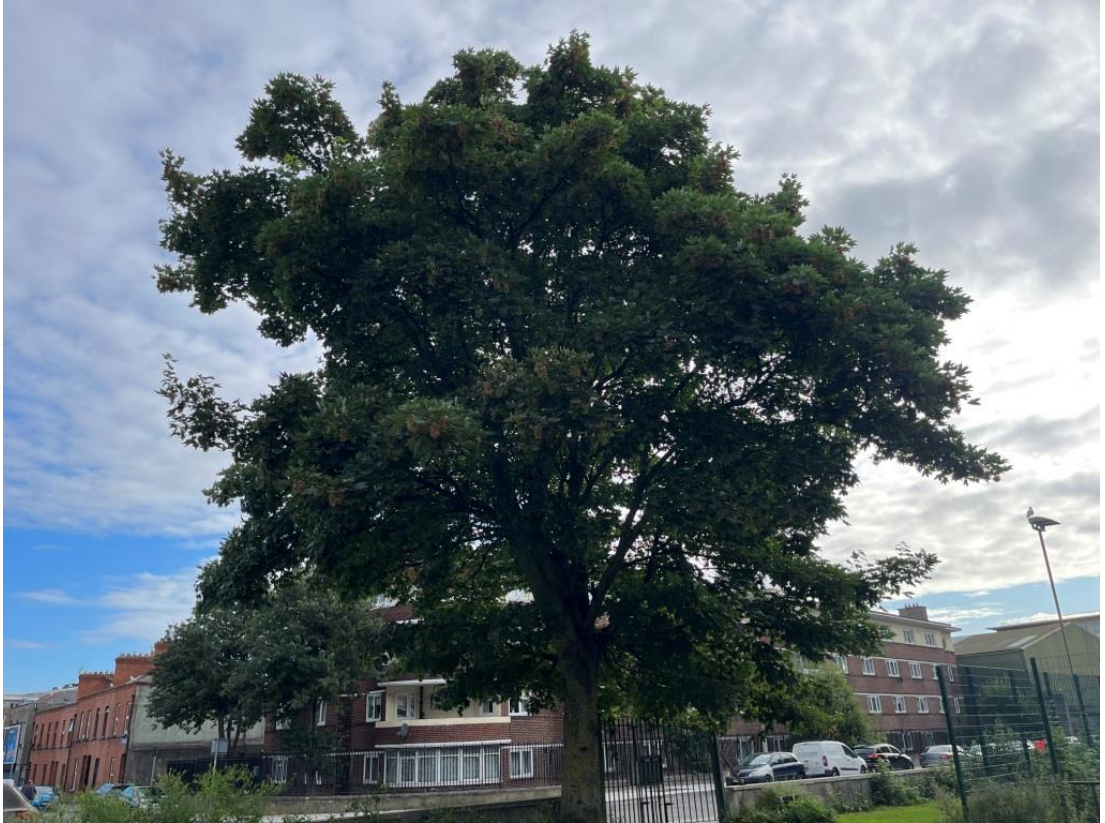
Photo 3: View of the sycamore T534 within Oisín Kelly Park.

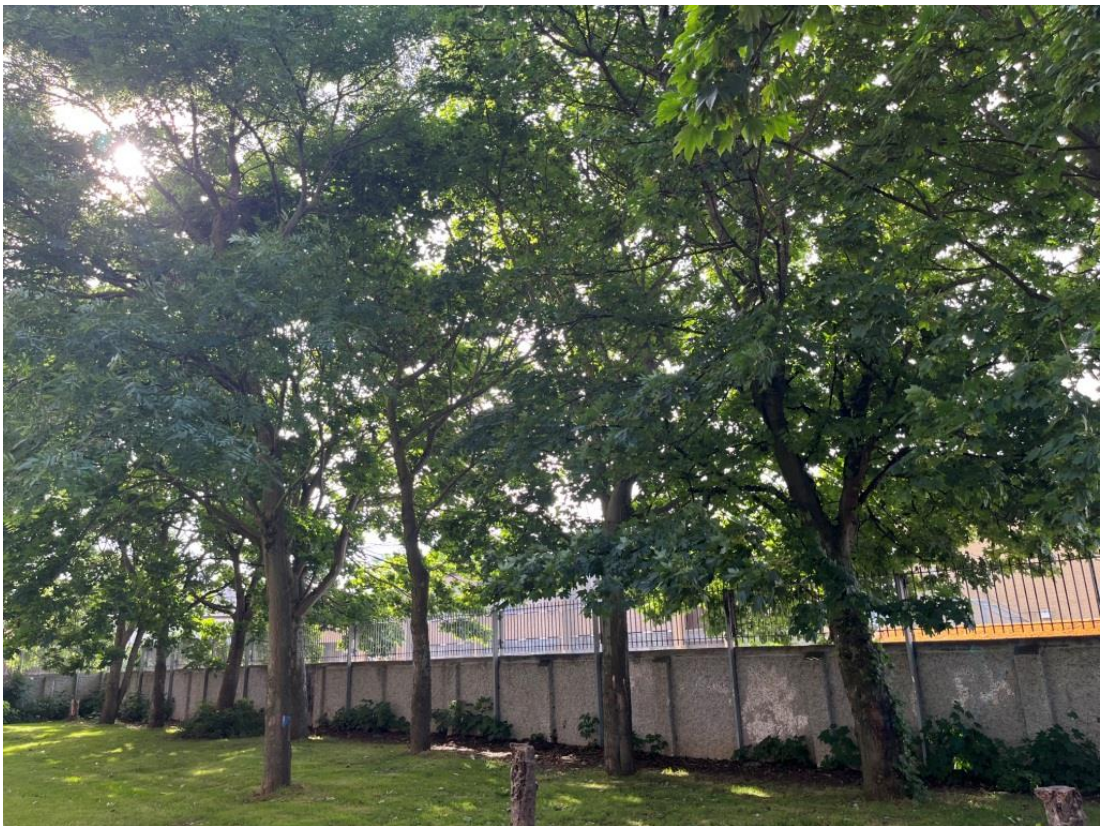
Photo 4: View of ash and Norway maple trees T539 to T549 located along the southern boundary of the site.

Tree T540	1 Fraxinus excelsior (Ash)	16.0	41	1	6.5	4.5	4.5	7.5				2.5		Early Mature	Structural condition Fair. Physiological condition Fair. Bark wound - Major. Competition - Adjacent trees. Deadwood - Minor. Decay / structural defect - Bole. Suppressed crown - Minor. Unbalanced crown - Minor.	26/06/2023	76.0	4.9	10-20	C2

Tree T544	1 Acer platanoides (Norway Maple)	15.0	45	1	8.0		5.0		7.0		5.5		2.0		Early Mature	Structural condition Fair. Physiological condition Fair. Branch - Broken. Competition - Adjacent trees. Deadwood - Minor. Decay / structural defect - Bole.	26/06/2023	91.6	5.4	10-20	C2
Tree T545	1 Acer platanoides (Norway Maple)	15.0	36	1	4.0		3.5		3.5		3.5		6.0		Early Mature	Structural condition Poor. Physiological condition Fair. Deadwood - Minor. Shedding limb / limbs - Historic. Shedding limb / limbs - Major. Unbalanced crown - Minor. Major crown failure has occurred and the existing canopy is considered structurally weak.	26/06/2023	58.6	4.3	0-10	U
Tree T546	1 Fraxinus excelsior (Ash)	16.0	37	1	8.0		6.5		3.5		5.0		2.0		Early Mature	Structural condition Fair. Physiological condition Fair. Bark wound - Minor. Competition - Adjacent trees. Deadwood - Minor. Decay / structural defect - Bole. Suppressed crown - Minor. Unbalanced crown - Minor.	26/06/2023	61.9	4.4	10-20	C2

Tree T547	1 Acer platanoides (Norway Maple)	15.0	39	1	3.5		6.0		6.0		2.0		2.0		Early Mature	Structural condition Fair. Physiological condition Fair. Bark wound - Minor. Coalesced decay seam - Suspected. Competition - Adjacent trees. Deadwood - Minor. Suppressed crown - Minor. Unbalanced crown - Minor.	26/06/2023	68.8	4.7	20-40	C2
Tree T548	1 Acer platanoides (Norway Maple)	16.0	48	1	5.5		4.5		6.0		4.0		2.0		Early Mature	Structural condition Fair. Physiological condition Good. Competition - Adjacent trees. Decay / structural defect in crown limb / limbs - Minor. Deadwood - Minor.	26/06/2023	104.2	5.8	20-40	C2

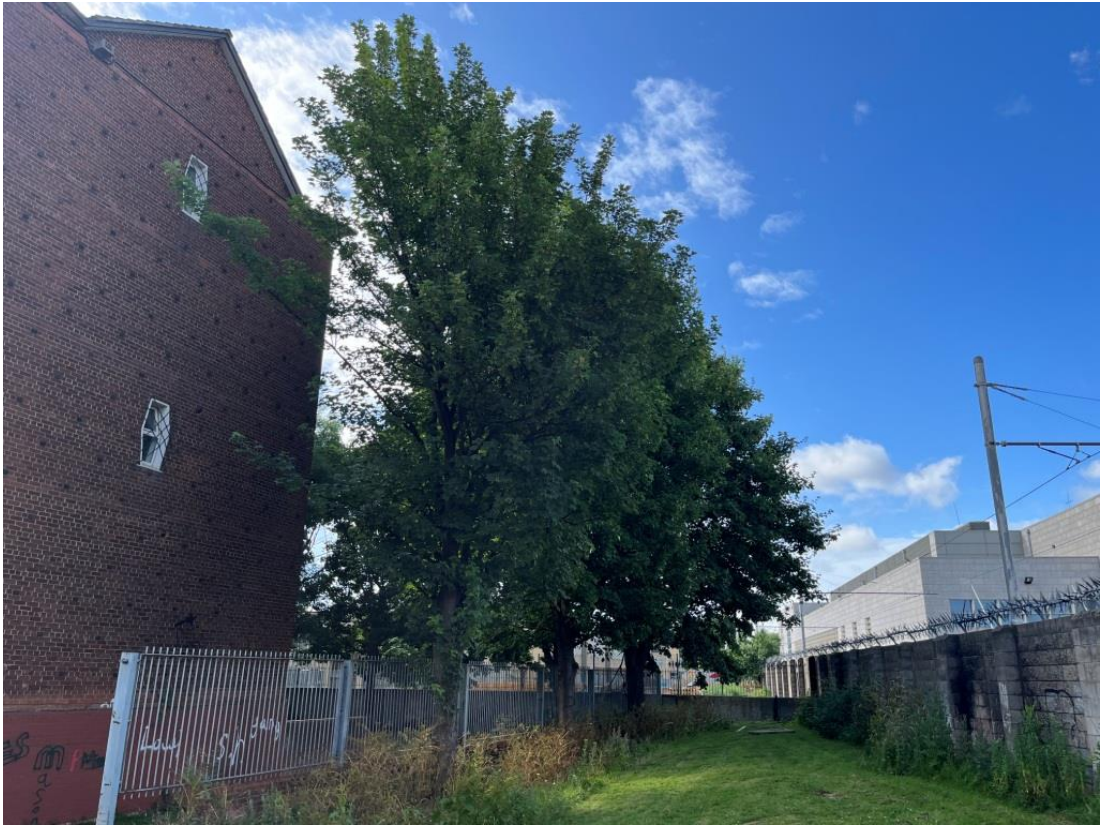
Photo 5: View of the sycamore trees T550 to T552.

Tree T551	1 Acer pseudoplatanus (Sycamore)	16.0	44	1	5.0		5.0		4.5		4.0		2.5		Early Mature	Structural condition Good. Physiological condition Good. Arboricultural work - Historic.	26/06/2023	87.6	5.3	40+	B1/B2
Tree T552	1 Acer pseudoplatanus (Sycamore)	16.0	46	1	6.0		4.0		4.0		4.5		3.5		Early Mature	Structural condition Fair. Physiological condition Fair. Arboricultural work - Historic. Decay / structural defect - Minor.	26/06/2023	95.7	5.5	20-40	C2
Tree T553	1 Acer pseudoplatanus (Sycamore)	16.0	55	1	3.0		6.0		5.0		6.5		3.5		Early Mature	Structural condition Fair. Physiological condition Fair. Access to inspect base - Restricted / obscured. Deadwood - Minor. Fire damage - Crown. Ivy or climbing plant. Unable to inspect tree closely due to ivy cover.	26/06/2023	136.8	6.6	10-20	C2
Tree T554	1 Acer pseudoplatanus (Sycamore)	16.0	40	1	3.5		5.5		3.0		5.0		4.0		Early Mature	Structural condition Fair. Physiological condition Good. Access to inspect base - Restricted / obscured. Arboricultural work - Historic. Bark wound - Minor.	26/06/2023	72.4	4.8	20-40	B2

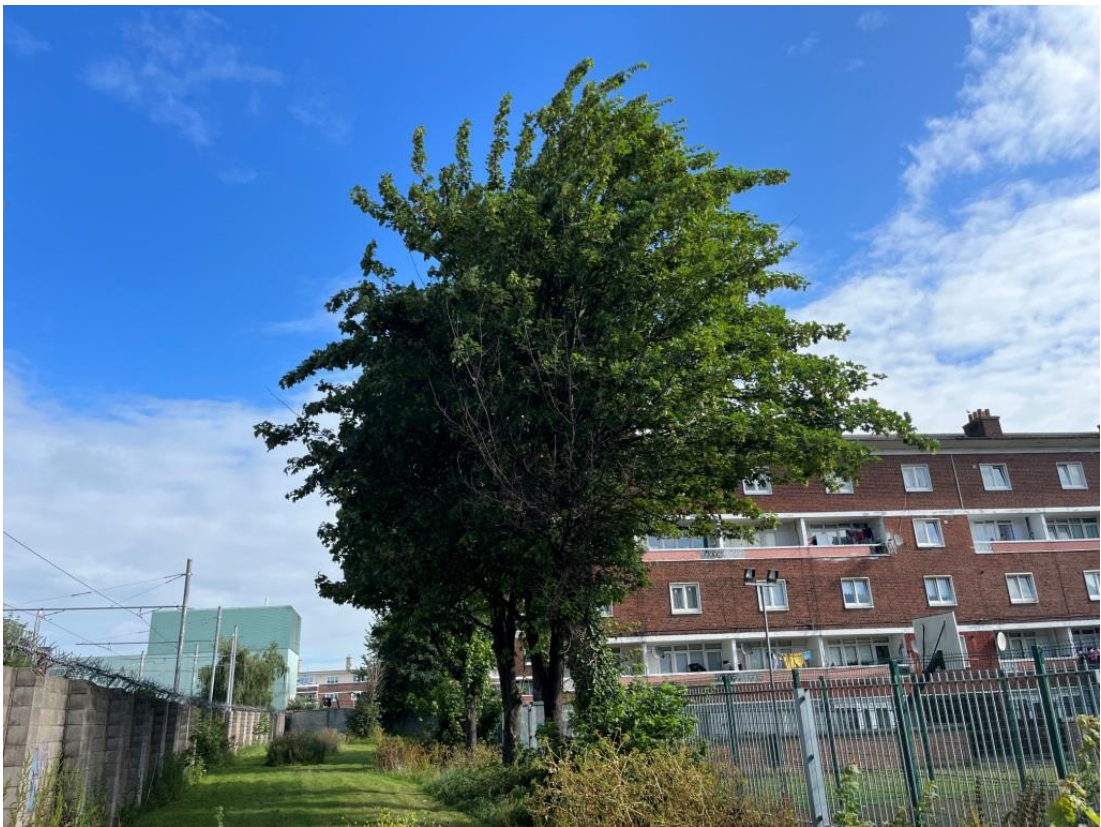
Photo 6: View of the sycamore trees T553 to T556 along the western boundary.

Tree T555	1 Acer pseudoplatanus (Sycamore)	16.0	44	1	5.5		5.5		4.0		5.5		4.0		Early Mature	Structural condition Good. Physiological condition Good. Access to inspect base - Restricted / obscured. Arboricultural work - Historic.	26/06/2023	87.6	5.3	40+	B2
Tree T556	1 Acer pseudoplatanus (Sycamore)	16.0	40	1	4.0		4.5		4.0		5.5		5.5		Early Mature	Structural condition Fair. Physiological condition Fair. Arboricultural work - Historic. Unbalanced crown - Minor.	26/06/2023	72.4	4.8	20-40	C2
