Arboricultural Report

Tree Survey,
Arboricultural Impact Assessment &
Arboricultural Method Statement

In relation to the proposed development at:
Social Housing Bundle 4
Former Bring Centre & Dublin City Depot
Collins Avenue
Whitehall
Dublin 9

230427-PD-41

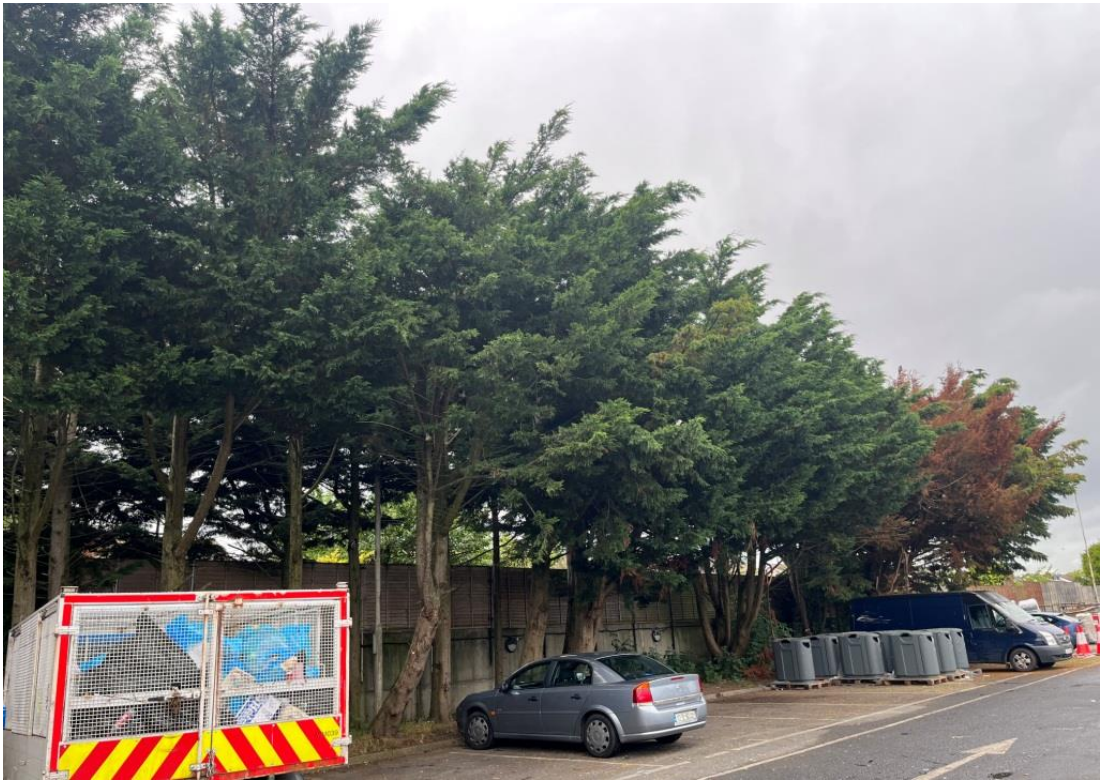
Photo 1: View of the southern boundary Leyland cypress trees G601.

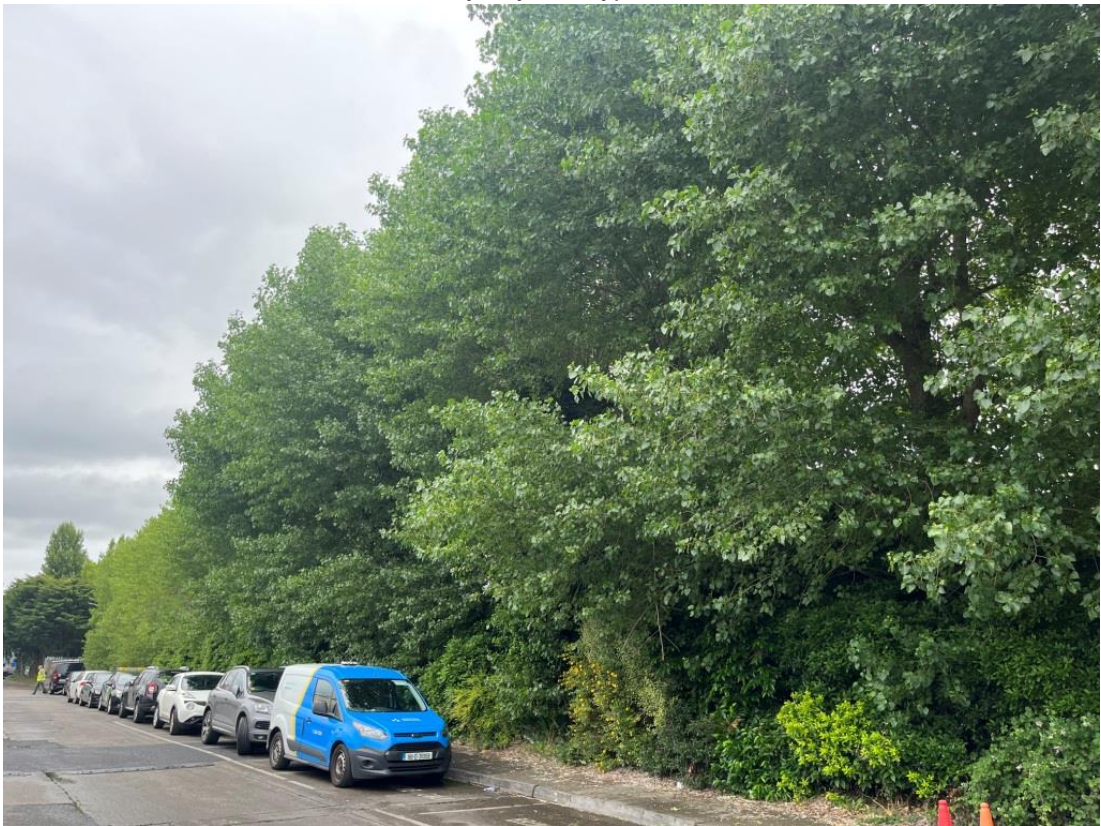
Photo 2: View of the eastern boundary poplar trees T562 to T586.

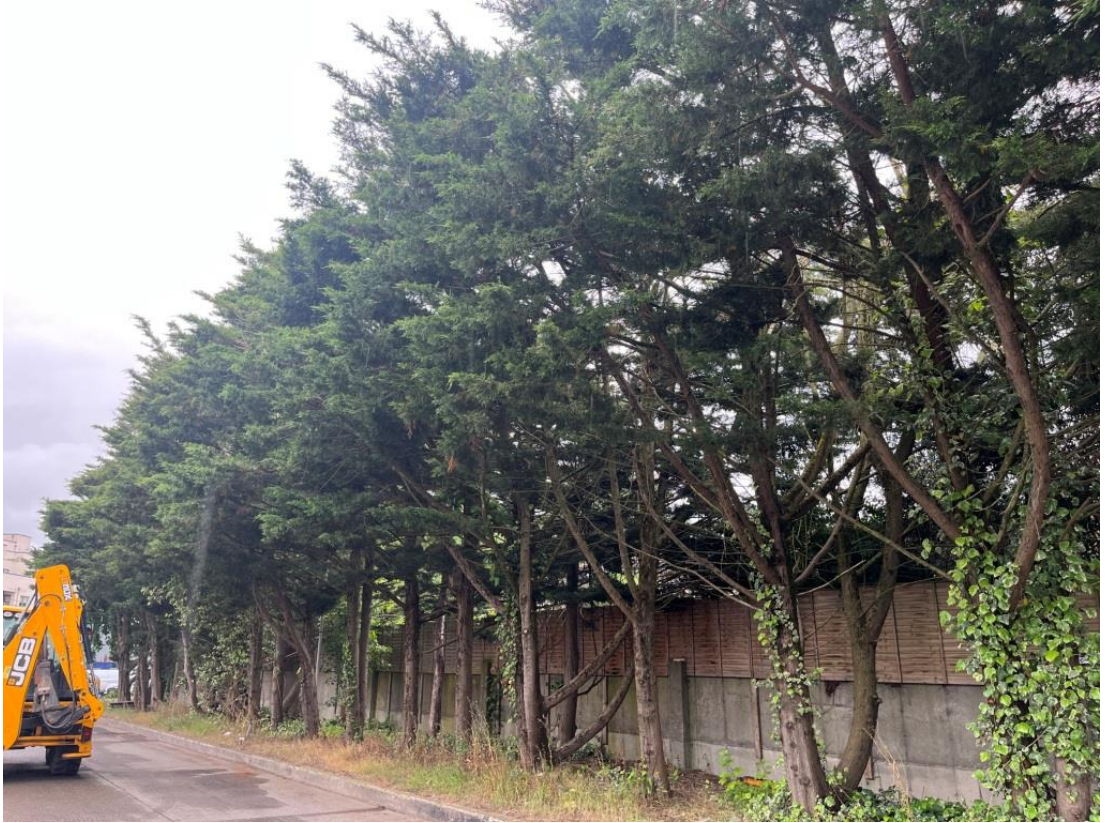
Photo 3: *View of the eastern boundary Leyland cypress G612.*

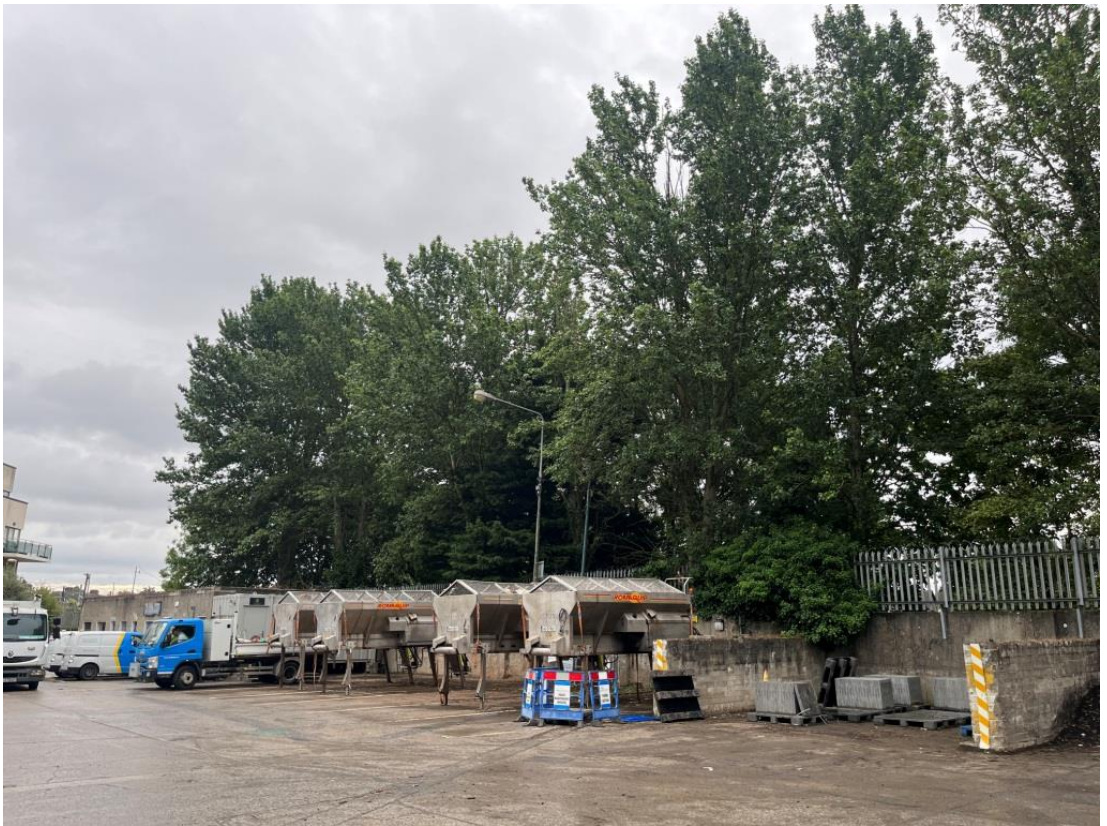
Photo 4: *View of the neighbouring trees located adjacent to the northeastern boundary.*
