Arboricultural Report

Tree Survey,
Arboricultural Impact Assessment &
Arboricultural Method Statement

Islandbridge
Dublin 8

220123-PD-11-B

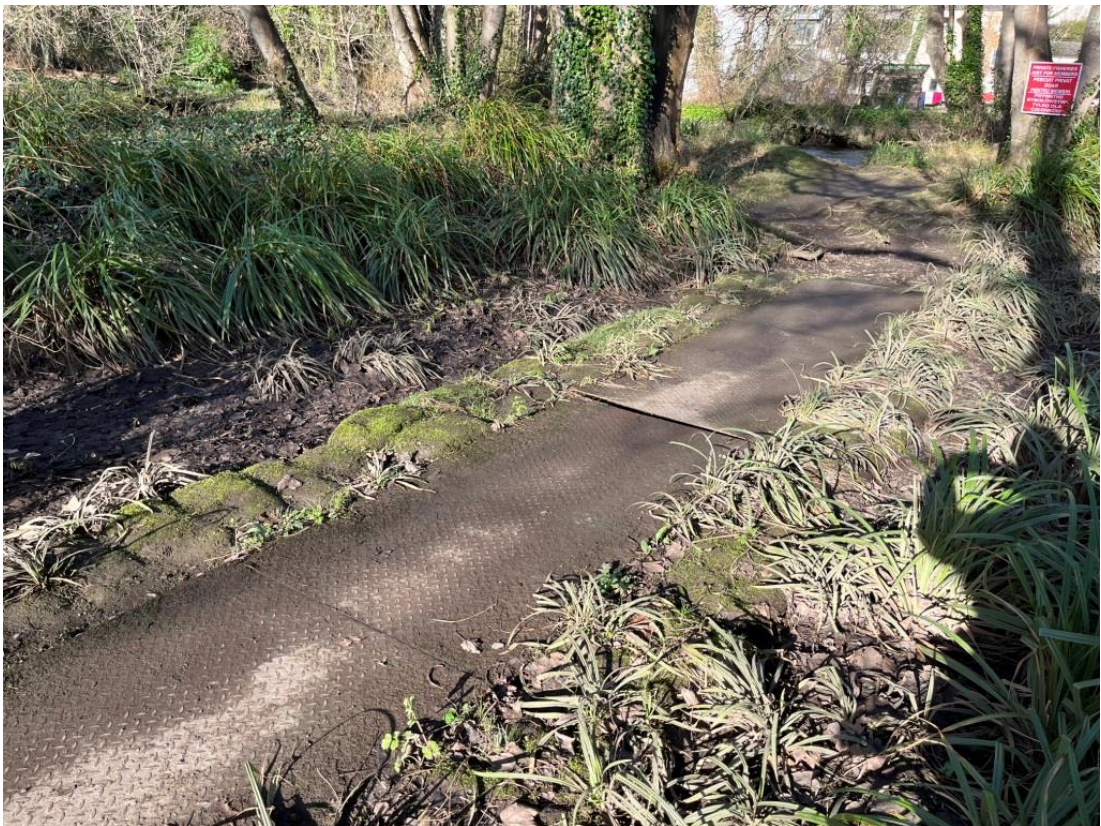
Photo 4: Section of the steel walkway that is required to be removed prior to the construction of the new walkway.

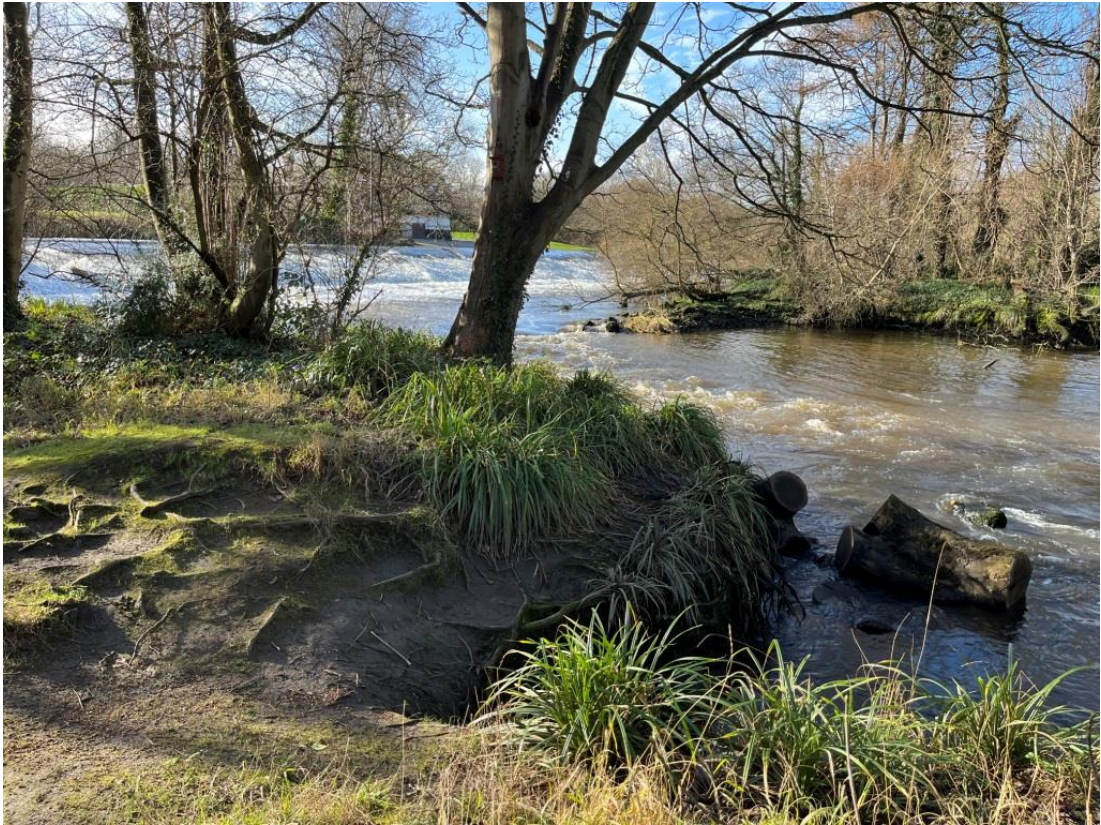
Photo 5: View showing the current point that rowers return to the water on the northern side of the island. Note the surface rooting from the trees.
