**Architectural Heritage Impact Assessment
For Proposed
Universal Access Project at
The Mansion House, Dawson Street, Dublin 2**

November 2023

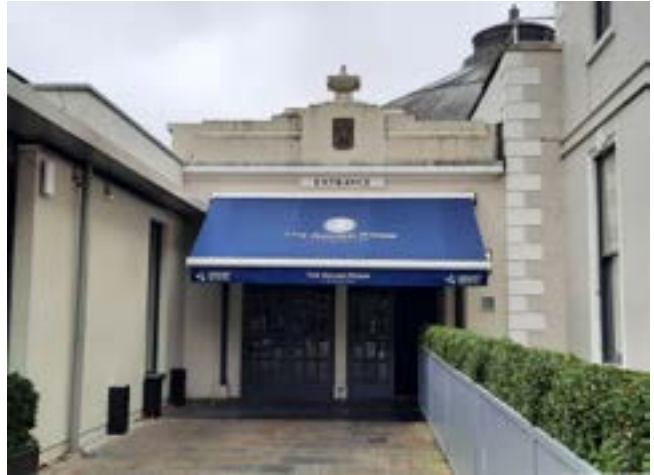
Fig. 4.2 The single-storey 1928 masonry elevation generally appears to be in reasonably good condition. The modern canopy hides much of the architectural detail.

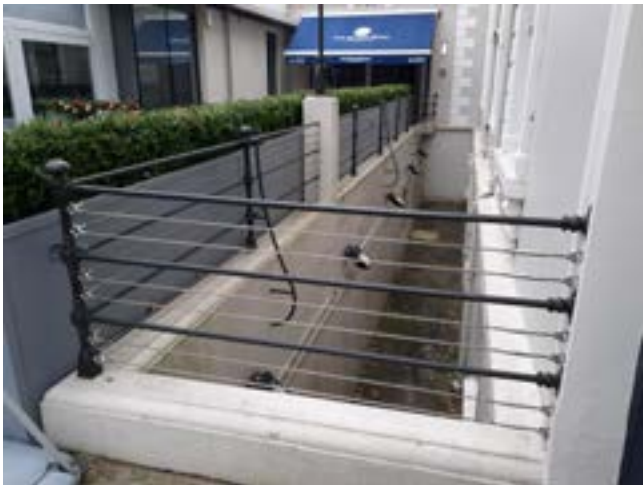
Fig. 4.8 Sections modern stainless steel wire span between the vertical uprights.

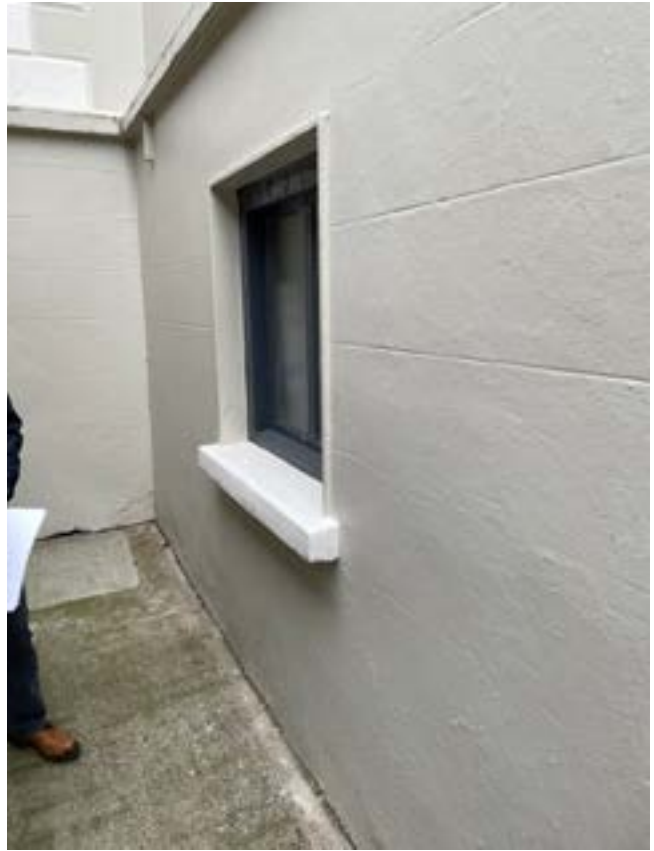
Fig. 4.10 Window to be converted to doorway located along basement northern wall of Mansion House.

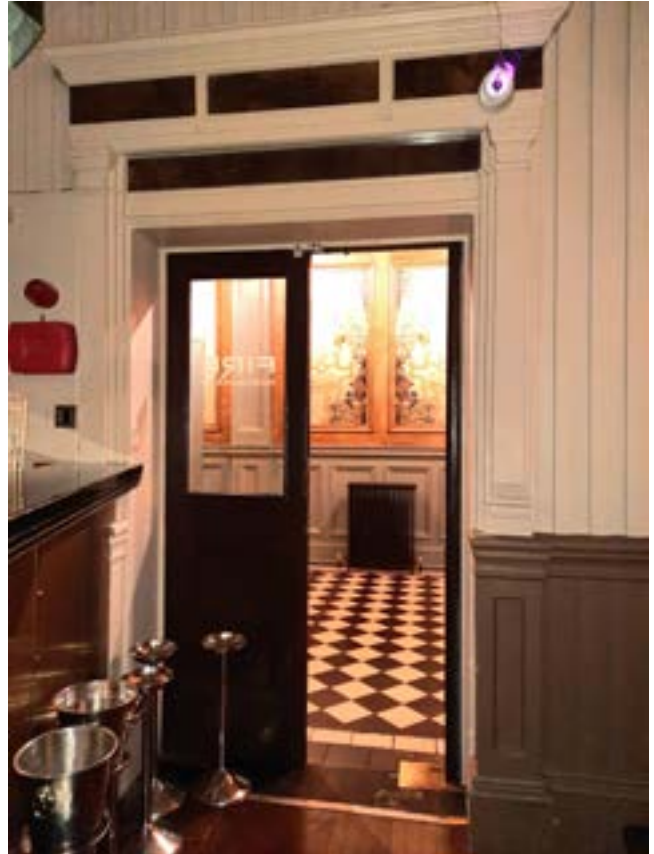
The joinery being altered will consist primarily of the doorset, architraves and decorative joinery around the door between the existing vestibule and the Supper Room. The existing joinery dates from 1928 when the Vestibule was constructed and is all in reasonable condition. The joinery has been over-painted and much of the detail is covered.

Fig. 4.32 Doorset and surrounding joinery between Entrance Vestibule and Supper Room

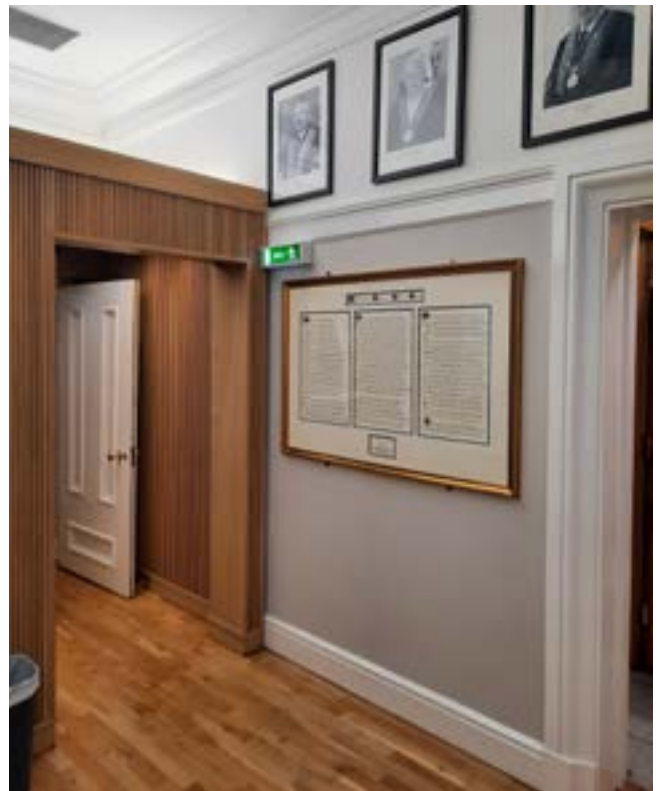
Fig. 4.44 Existing original wall located in the Rear Hall of the Ground Floor to the Mansion House. Wall to be altered to accommodate provision of Lift.

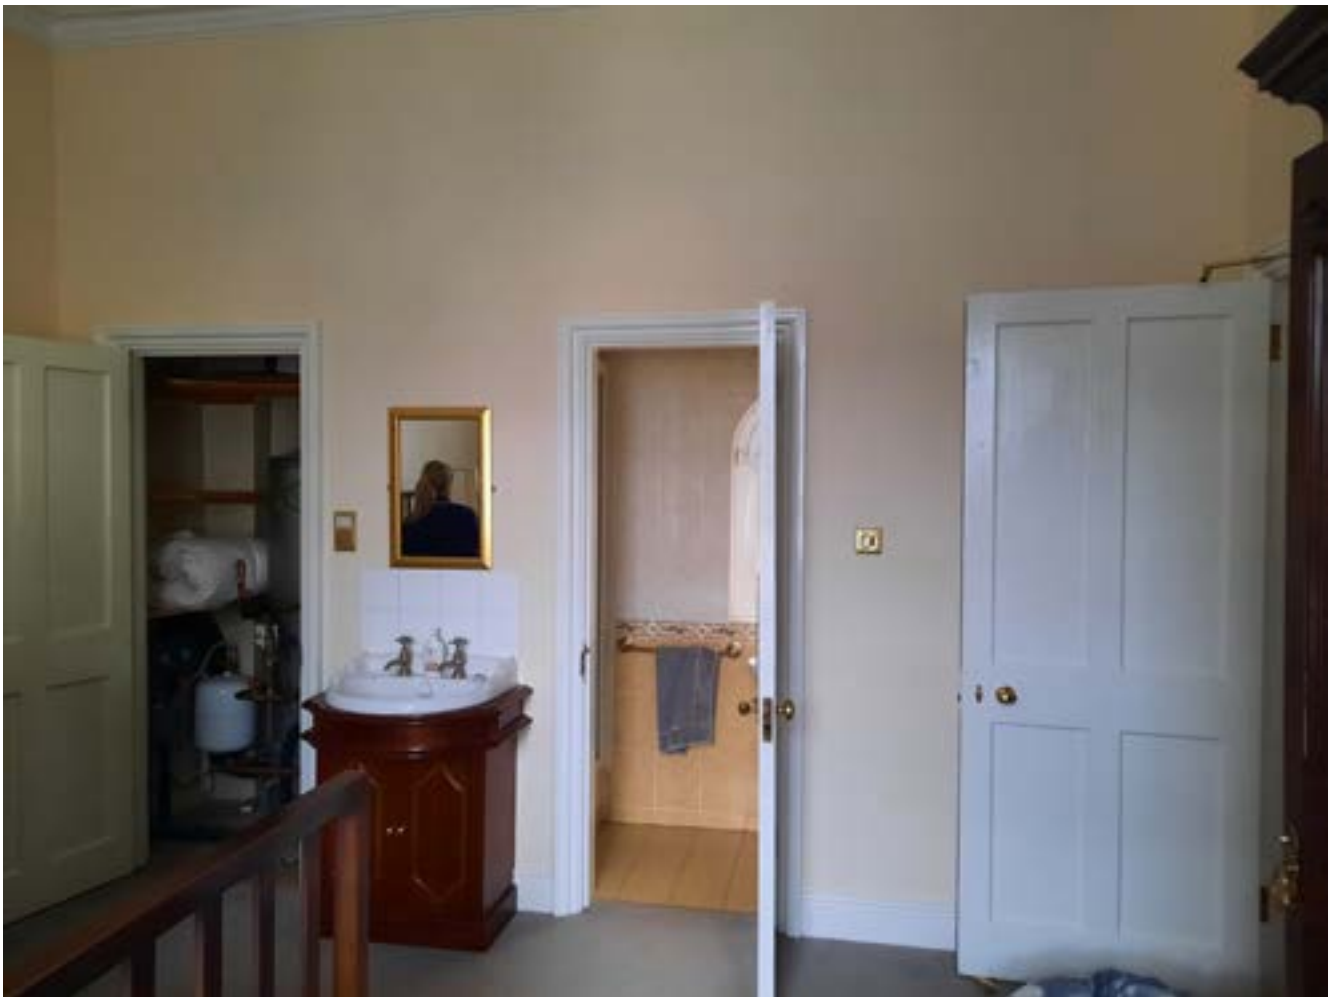
Fig. 4.47 Existing southern wall to the Mansion House, First Floor bedroom. En-suite to be removed to allow for lift access.

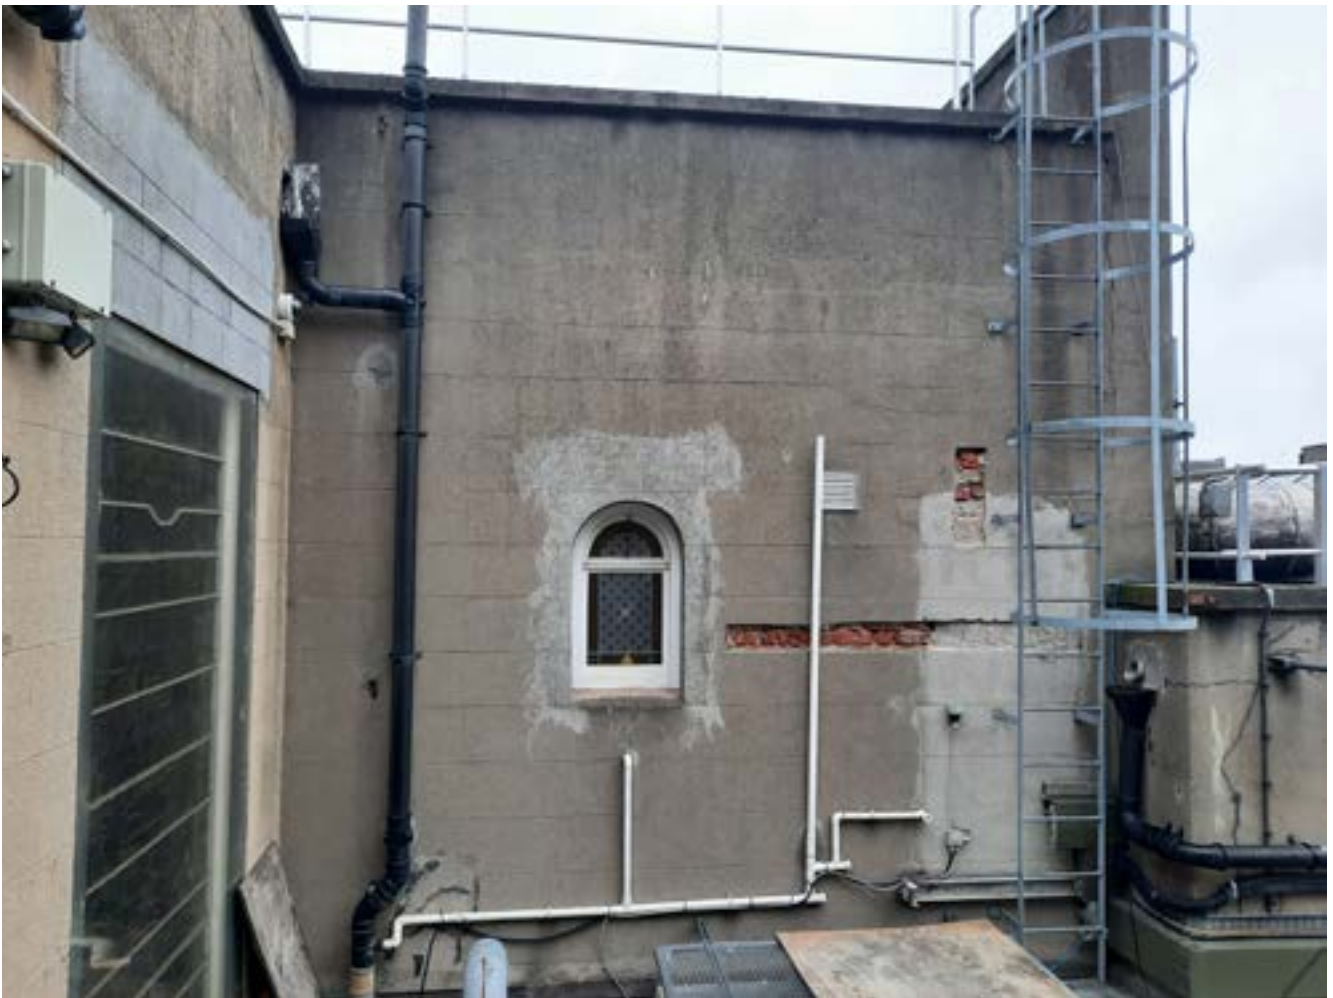
Fig. 4.48 External south facing wall to be modified to allow for provision of lift access door and door access between first floor and external space. Note section of modern block infill is present along the wall. (RHS image)

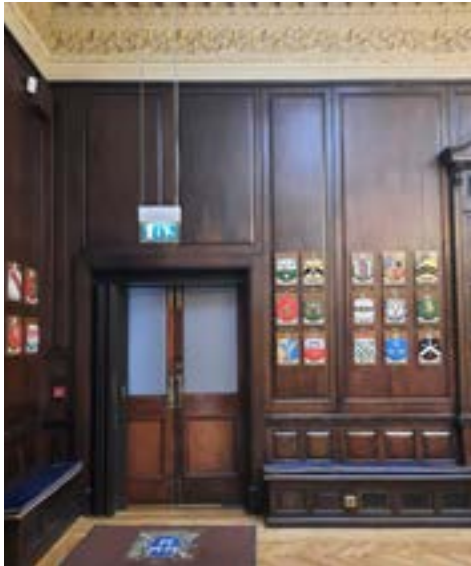
Fig. 4.53 Doors to Entrance Vestibule to be blocked up and clad in Oak panelling which will be taken from opposite end.
