Part VIII Application

Wholesale Fruit and Vegetable Market

Mary's Lane

Photographs

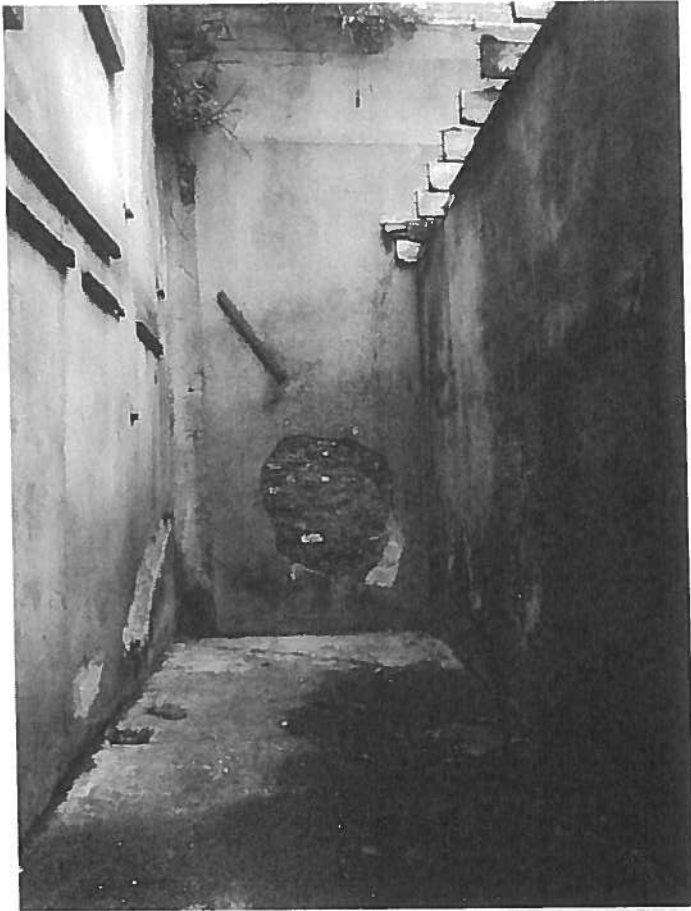
Figs 42, 43 Derelict structures in Chancery Street yard

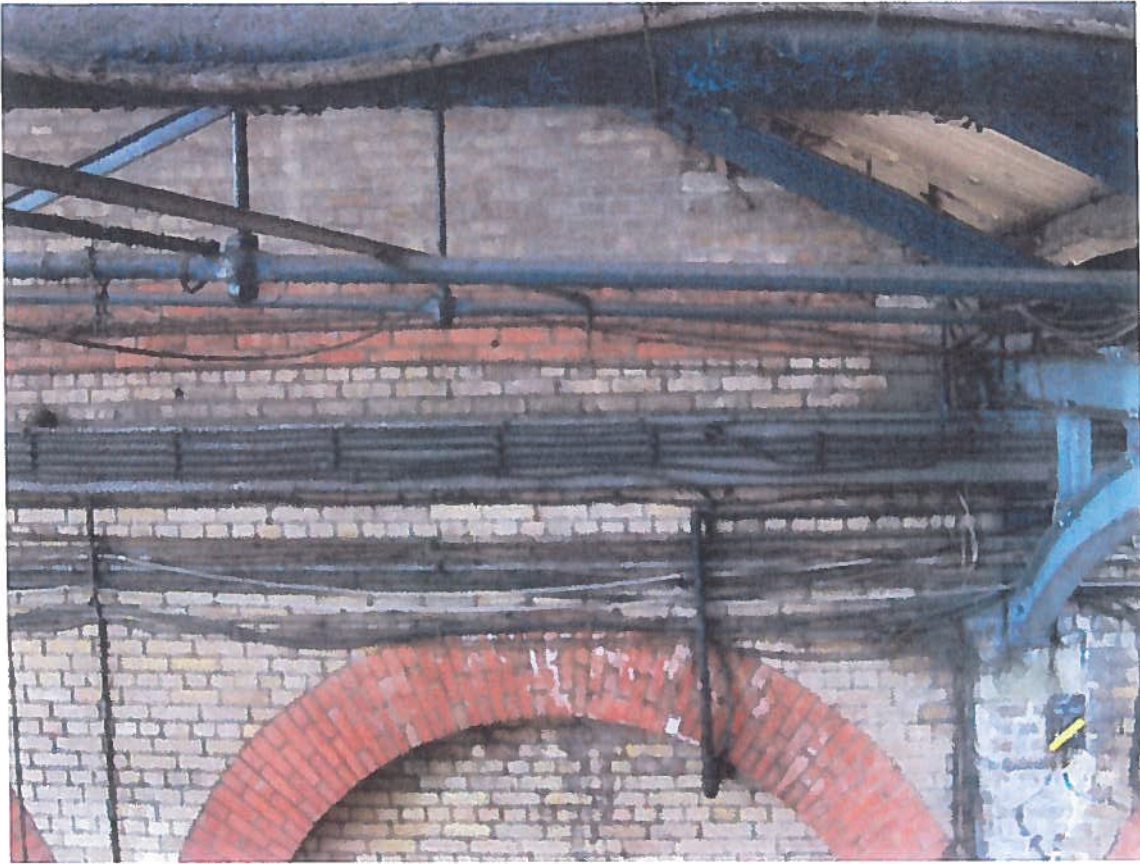
Fig 52 The interior festooned with obsolete electrical cables

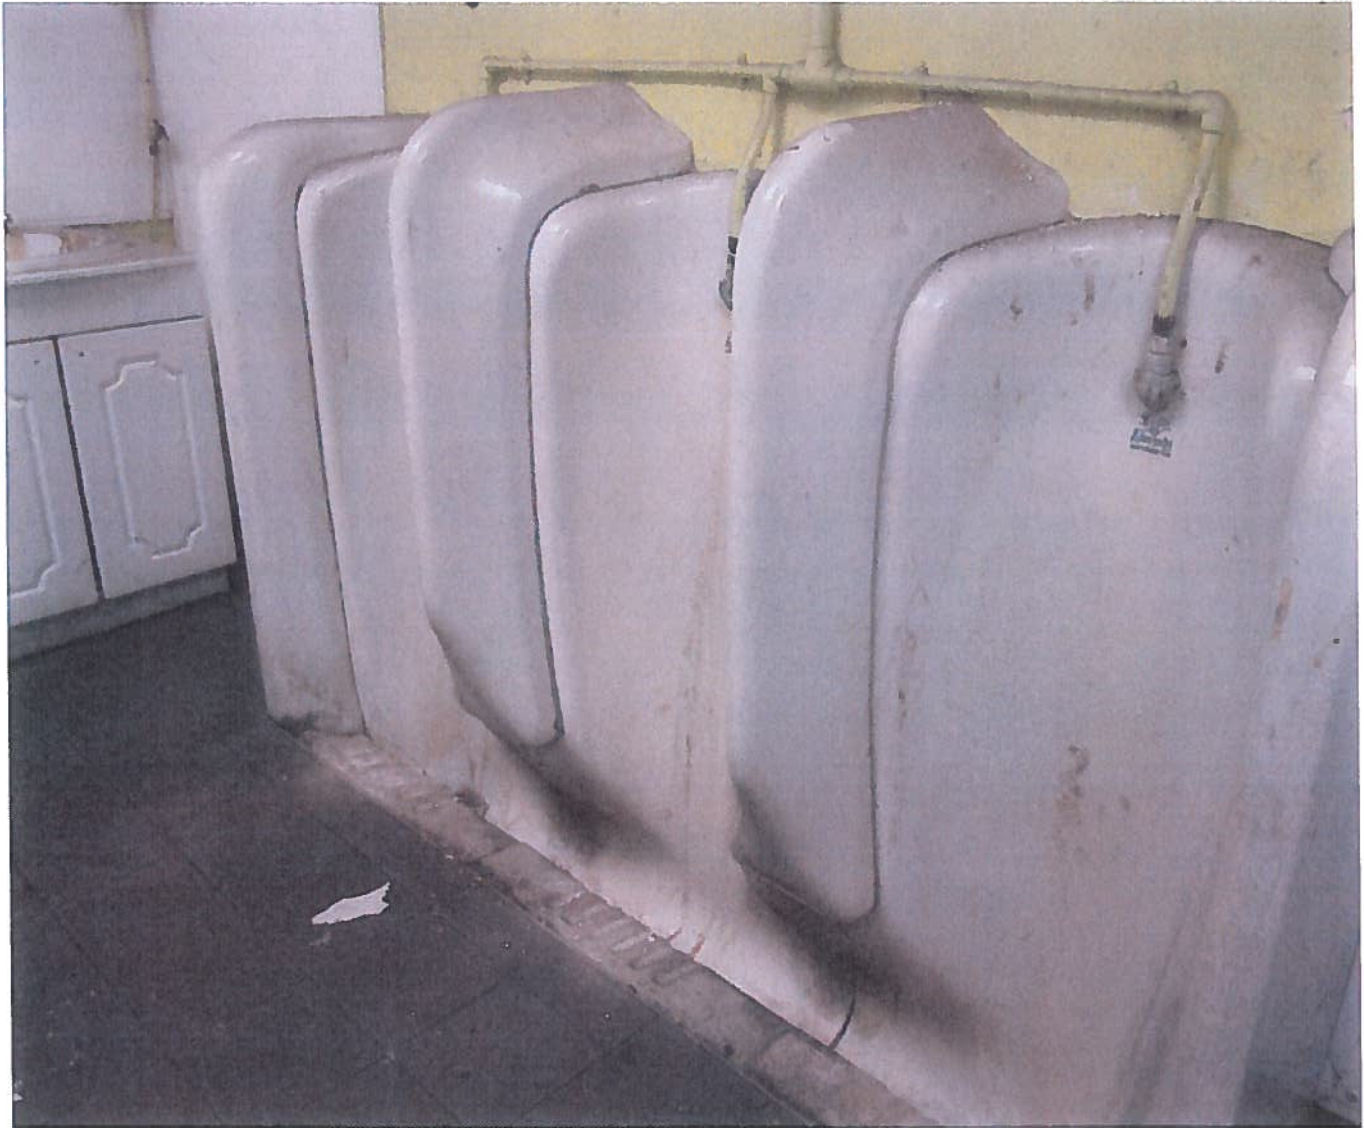
Fig 56 Men's toilets, no longer in use.

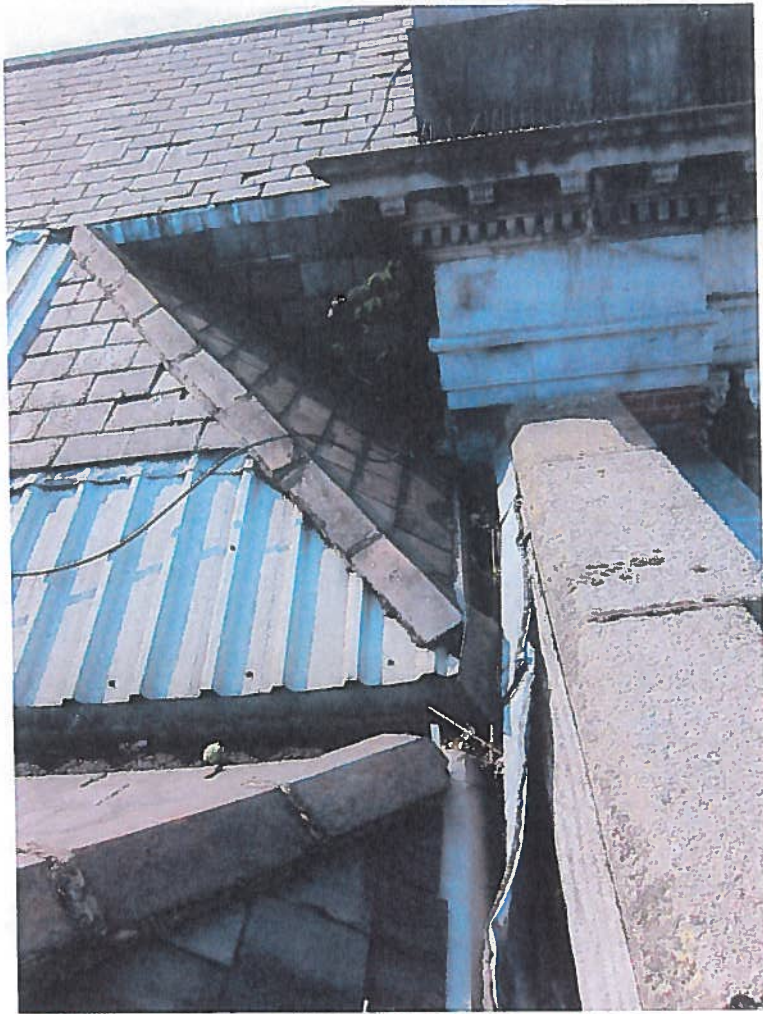
Figs 78 & 79 Roof slates slipping and flashings require

ongoing maintenance

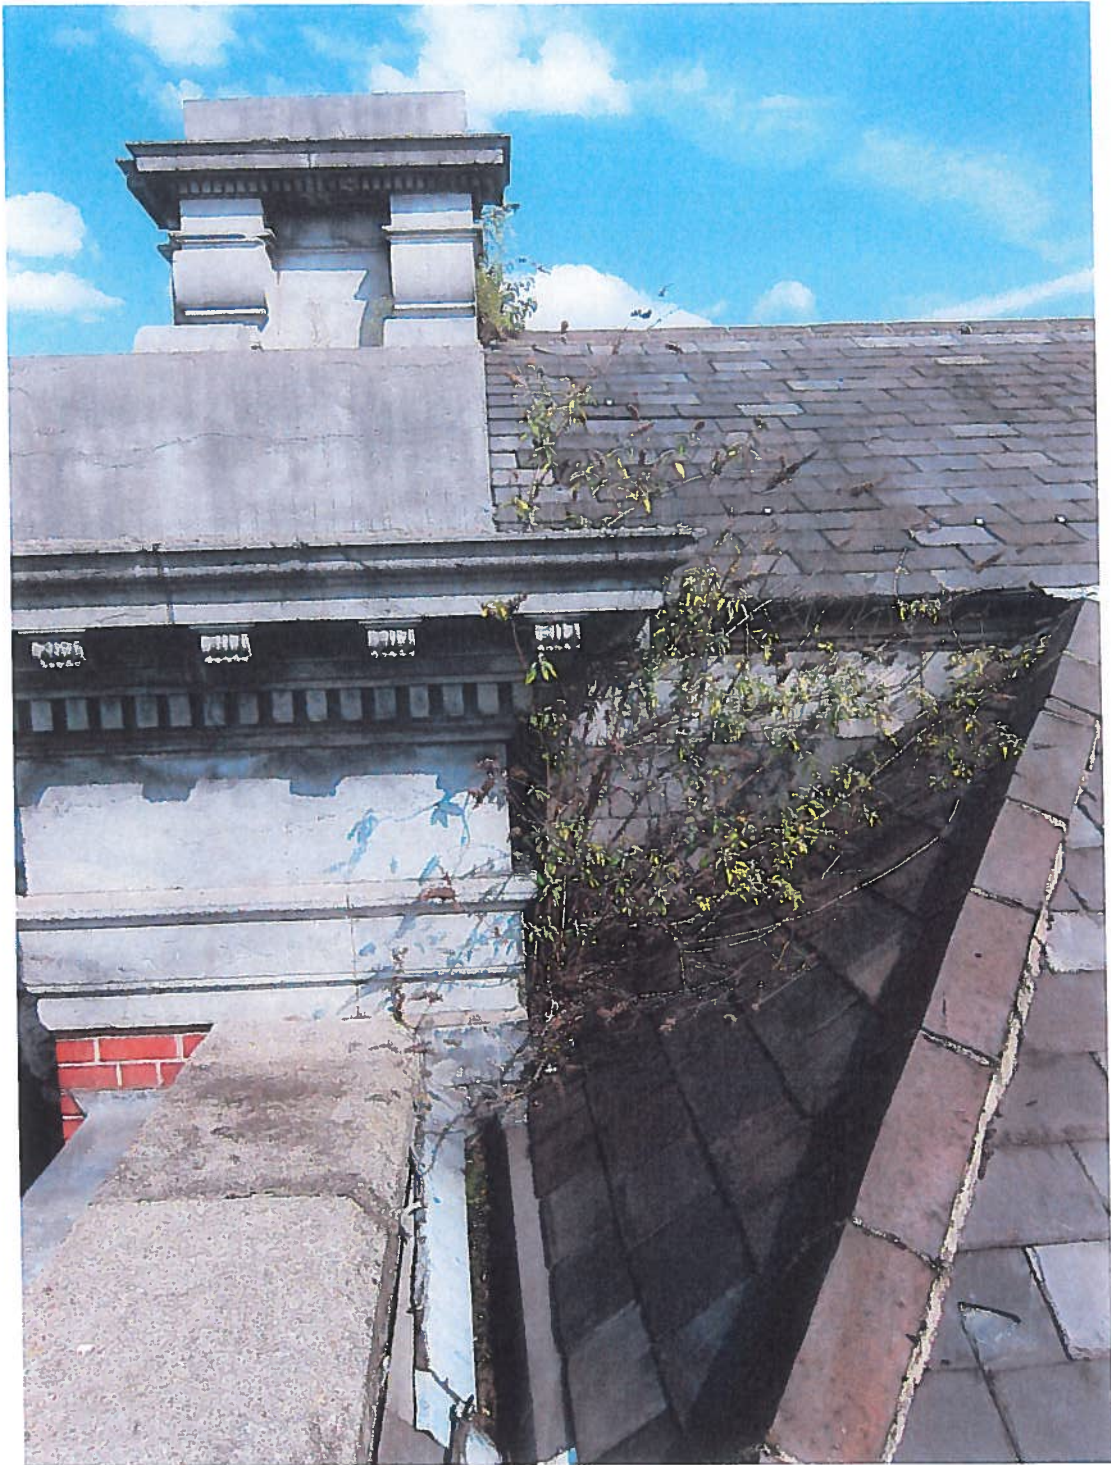
Fig 82 Vegetation rooting in joints

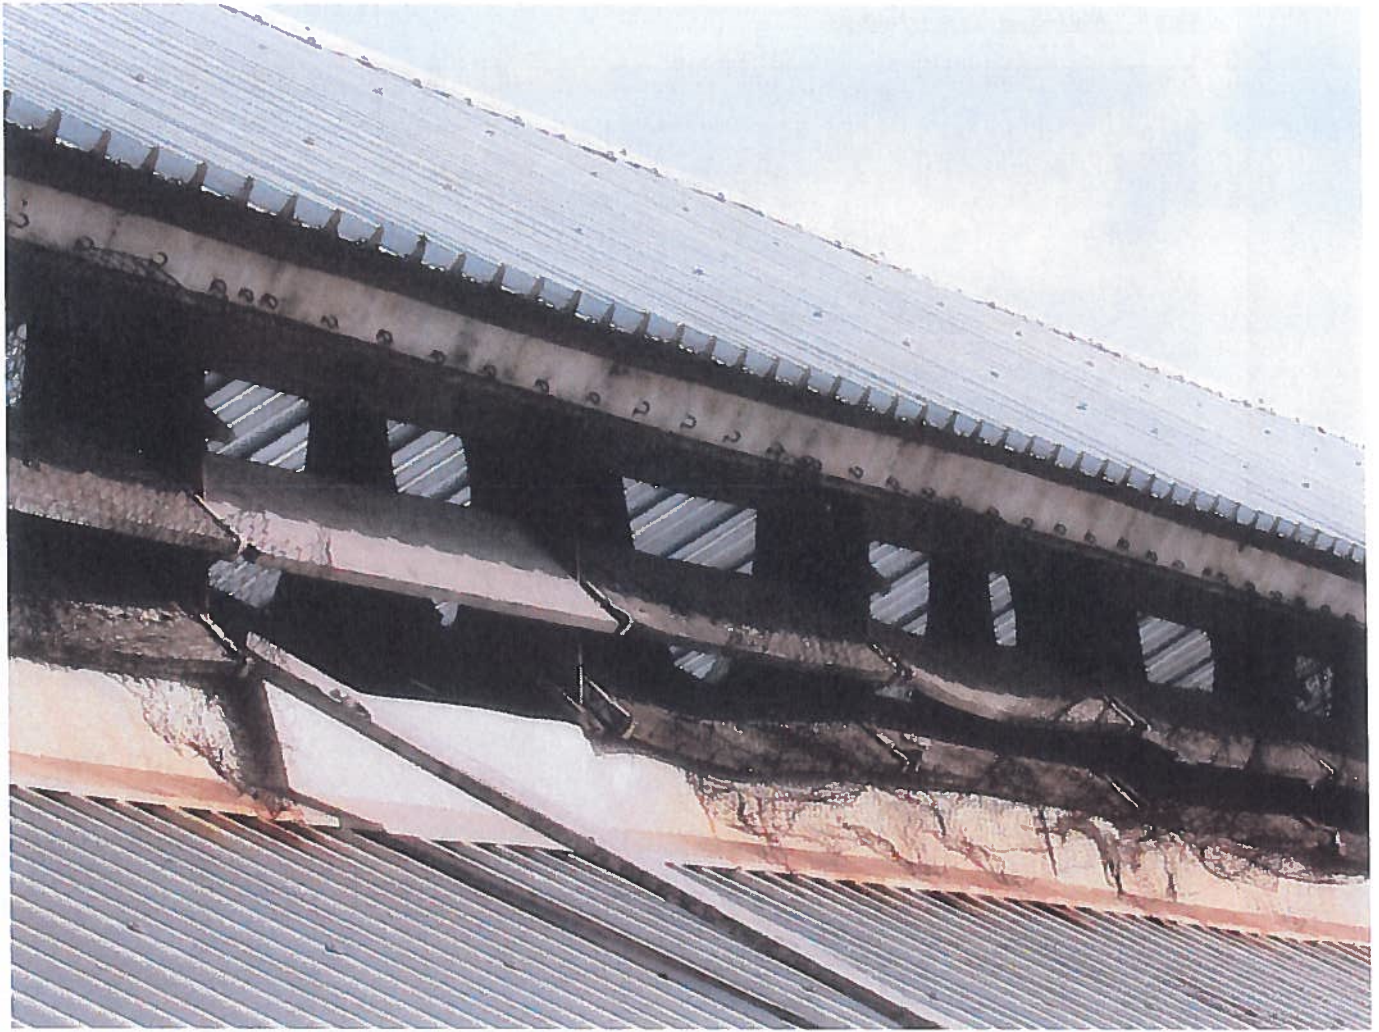
Figs 85 Perspex and corrugated metal from earlier renovations

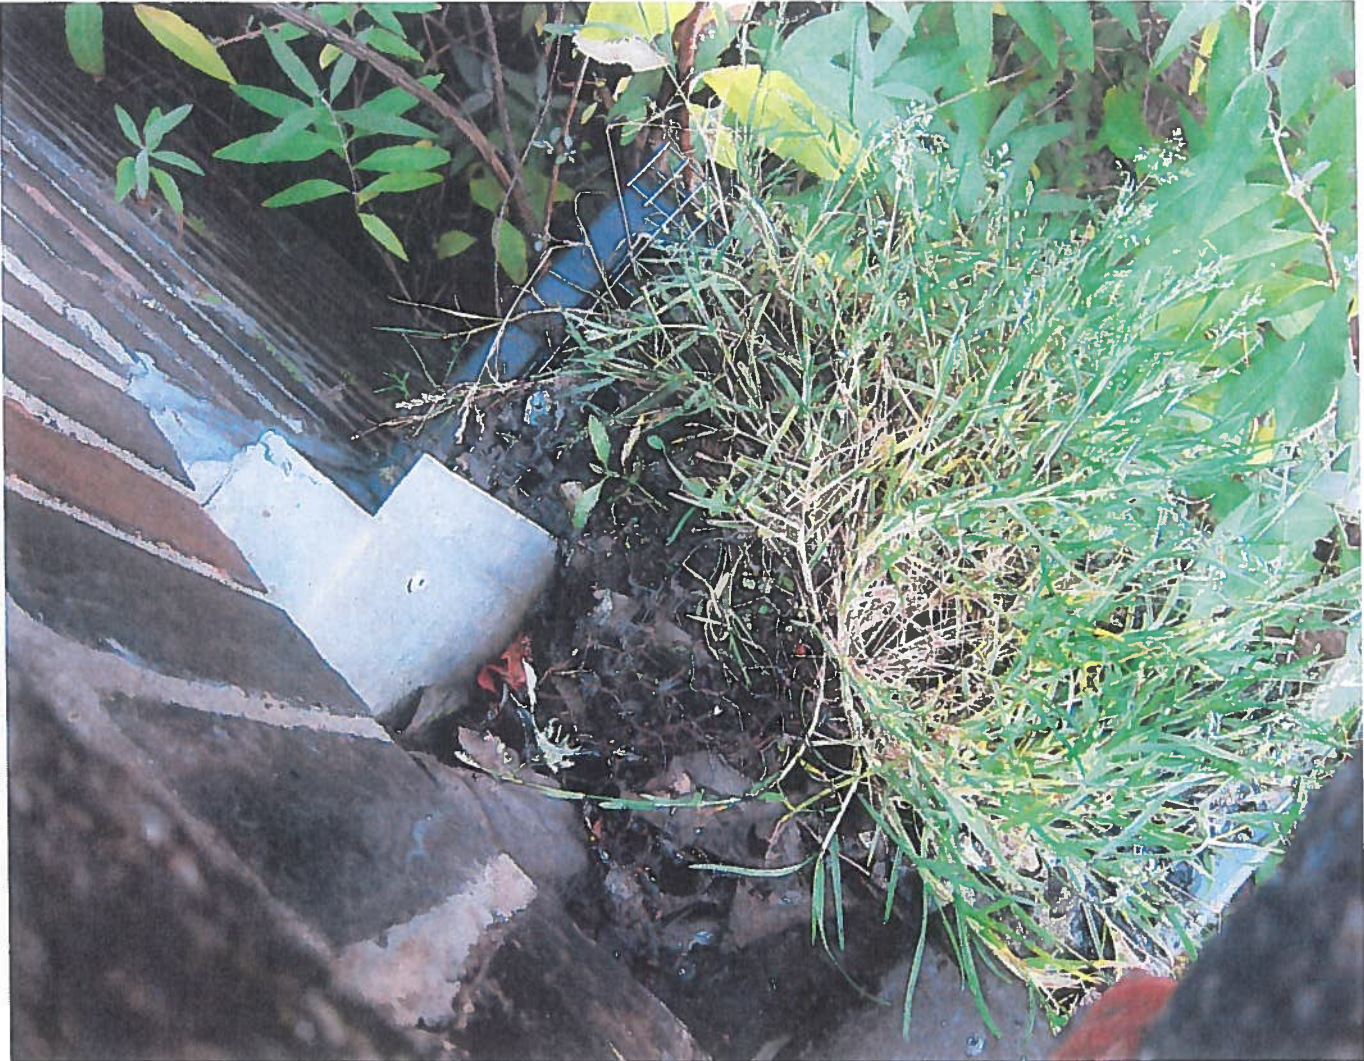
Fig 87 Blocked up rainwater outlets
