Project Newcomen Bank Building 16 Castle Street, Dublin 2		Client Dublin City Council	Drawing Fireplace Relocation First Floor	Project Stage Planning	Date 16.02.2024	Scale Varies@A3	Project No. 0569	Drawing No. C-024	Revision -
Client Howley Hayes Cooney 19 Rock Hill, Blackrock, Dublin, A94 D235 01 278 4644 hharchitecture.ie

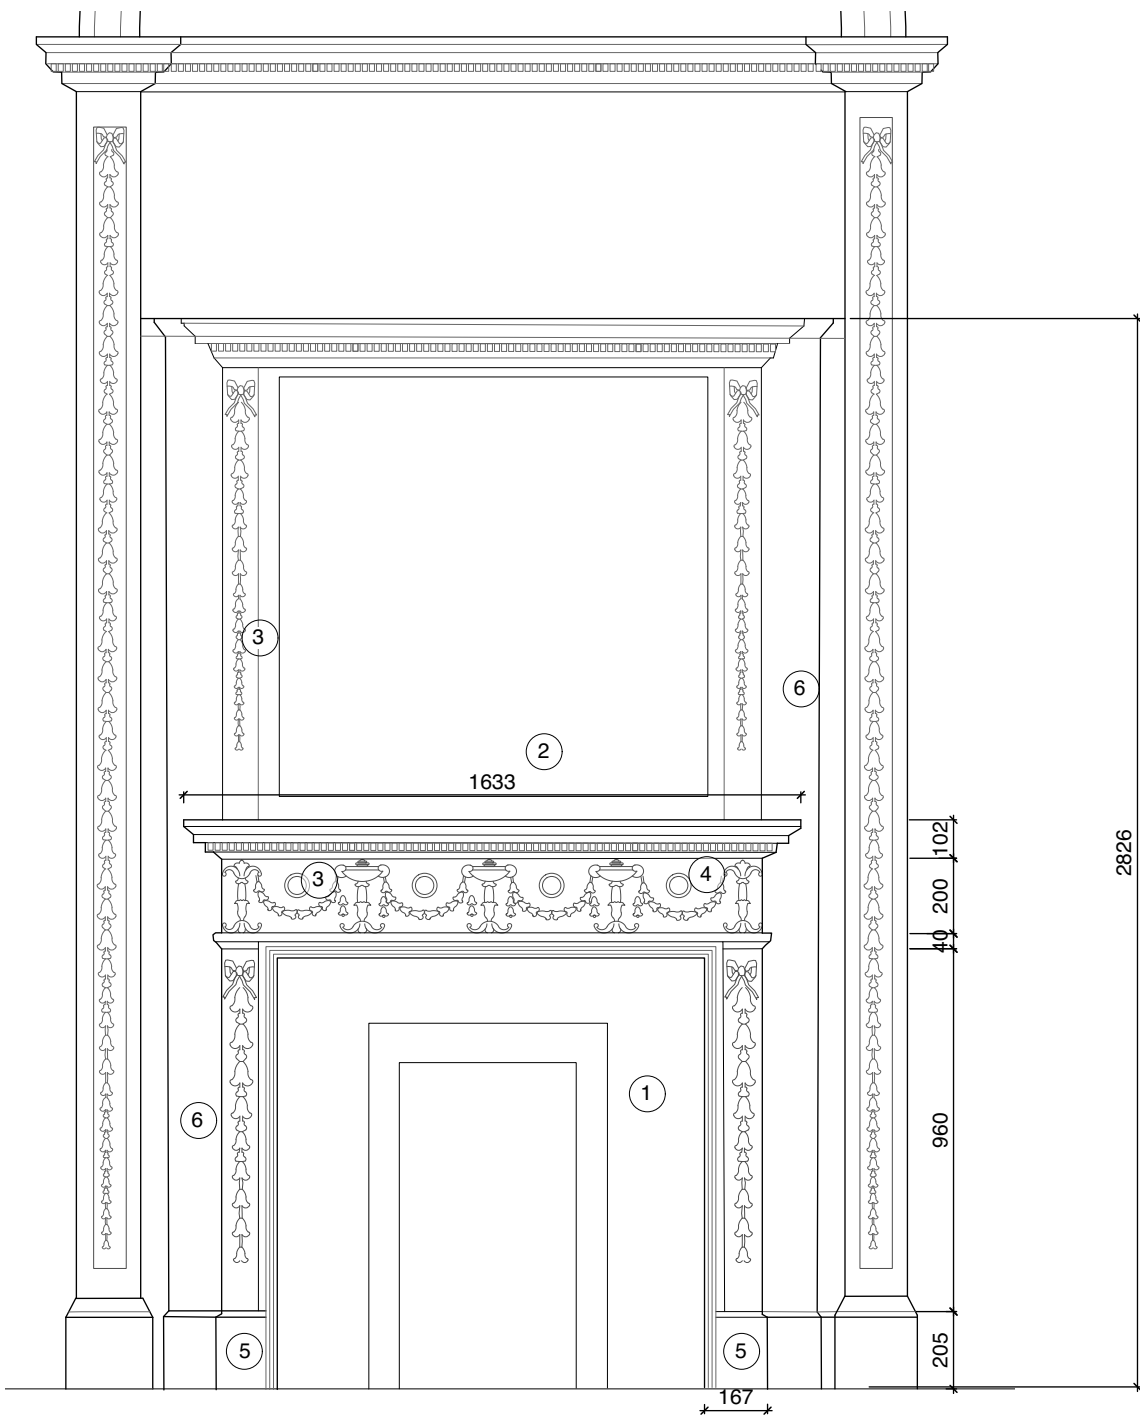
Fireplace in room 1-06 - Existing location

Scale 1:20
 Painted timber and gesso chimneypiece not original to the room probably installed in early 20th century. See page 84 of the photographic report for further details of the fireplace.

1. Remove modern insert.
2. Remove beading from around mirror, take out mirror and set aside.
3. Carefully dismantle timber surround to mirror and fireplace. An experienced joiner should undertake this work. Paint to be stripped back to determine location of all joints between timber pieces/elements.

4. Paint analysis scrapplings to be taken.
5. Carefully lift off skirting pieces and set aside.
6. Modern timber build out to house fireplace to be removed no decorative detail here - it has likely added to create a squared face for the fireplace to be attached to it.

7. Reassemble in room 1-08
8. Remove insert to stone fireplace and set aside. To be replaced with Georgian insert.
9. Carefully tag all individual stone elements and experienced masonry contractor to dismantle the fireplace and set aside for reinstatement. Note there is evidence to the rear of the fireplace that it has been removed previously.

10. Insert replacement piece of carrara marble.
11. Reassemble stone fireplace surround in room 1-06 in the position of the timber fireplace.

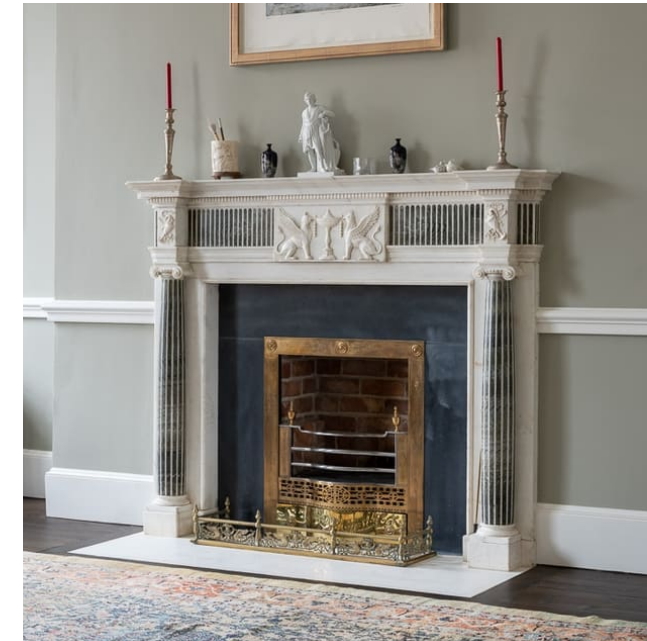
Example of the new grates to be inserted in the fireplaces without grates

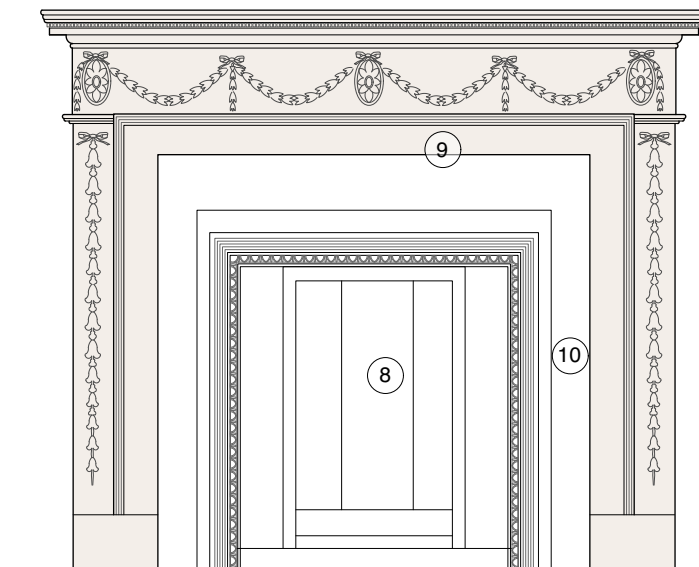
Fireplace in room 1-08 - Existing location

Scale 1:20
 Late eighteenth century neo-classical statuary carrara marble chimneypiece by George and Hill Darley. Probably original to the building but moved from a different location, with an Edwardian period tile insert. See page 85 of the photographic report for further details of the fireplace.
