Archaeological impact assessment for refurbishment works at Newcomen Bank, Dublin 2

on behalf of Howley Hayes for Dublin City Council
by Aisling Collins
June 2023

Archaeological impact assessment for Newcomen Bank, Castle Street, Dublin 2

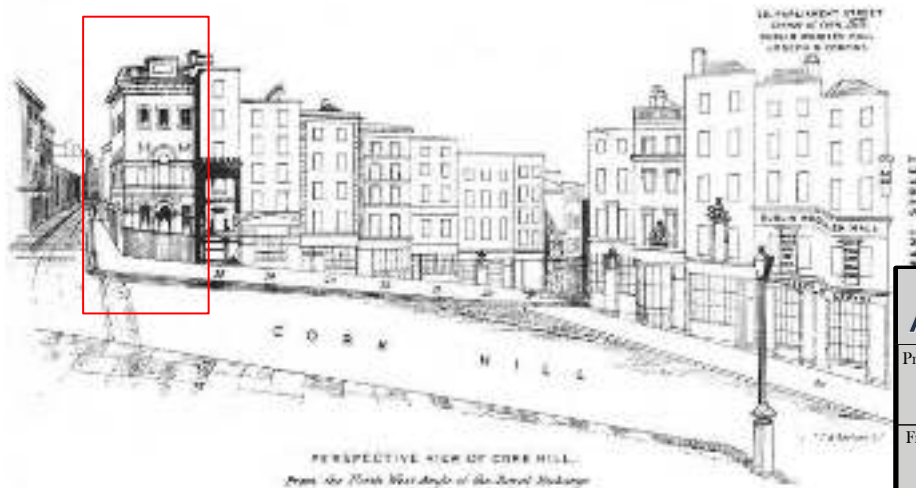
Newcomen bank (south facing facade c 1850)

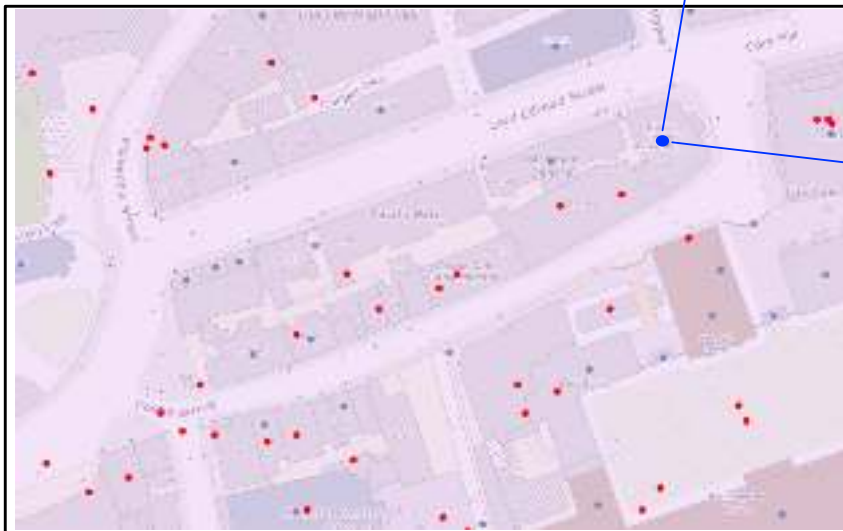
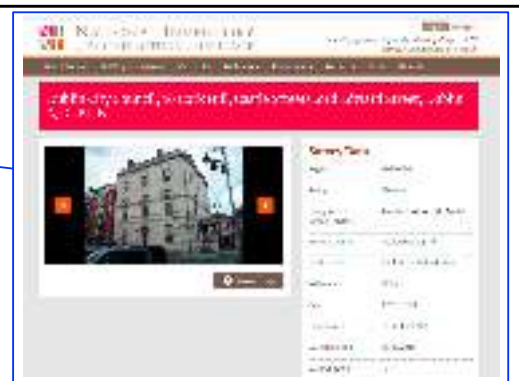
RMP MAP

- National monuments service (record of monuments & places) zones of notification
- national inventory of architectural heritage
- archaeological sites
- zone of notification

The site is within the zone of archaeological potential of the RMP (DU018 020 Dublin City) Dublin city centre which is subject to statutory protection under Section 12 of the national Monuments (Amendment) Act 1994. DU018-020620.

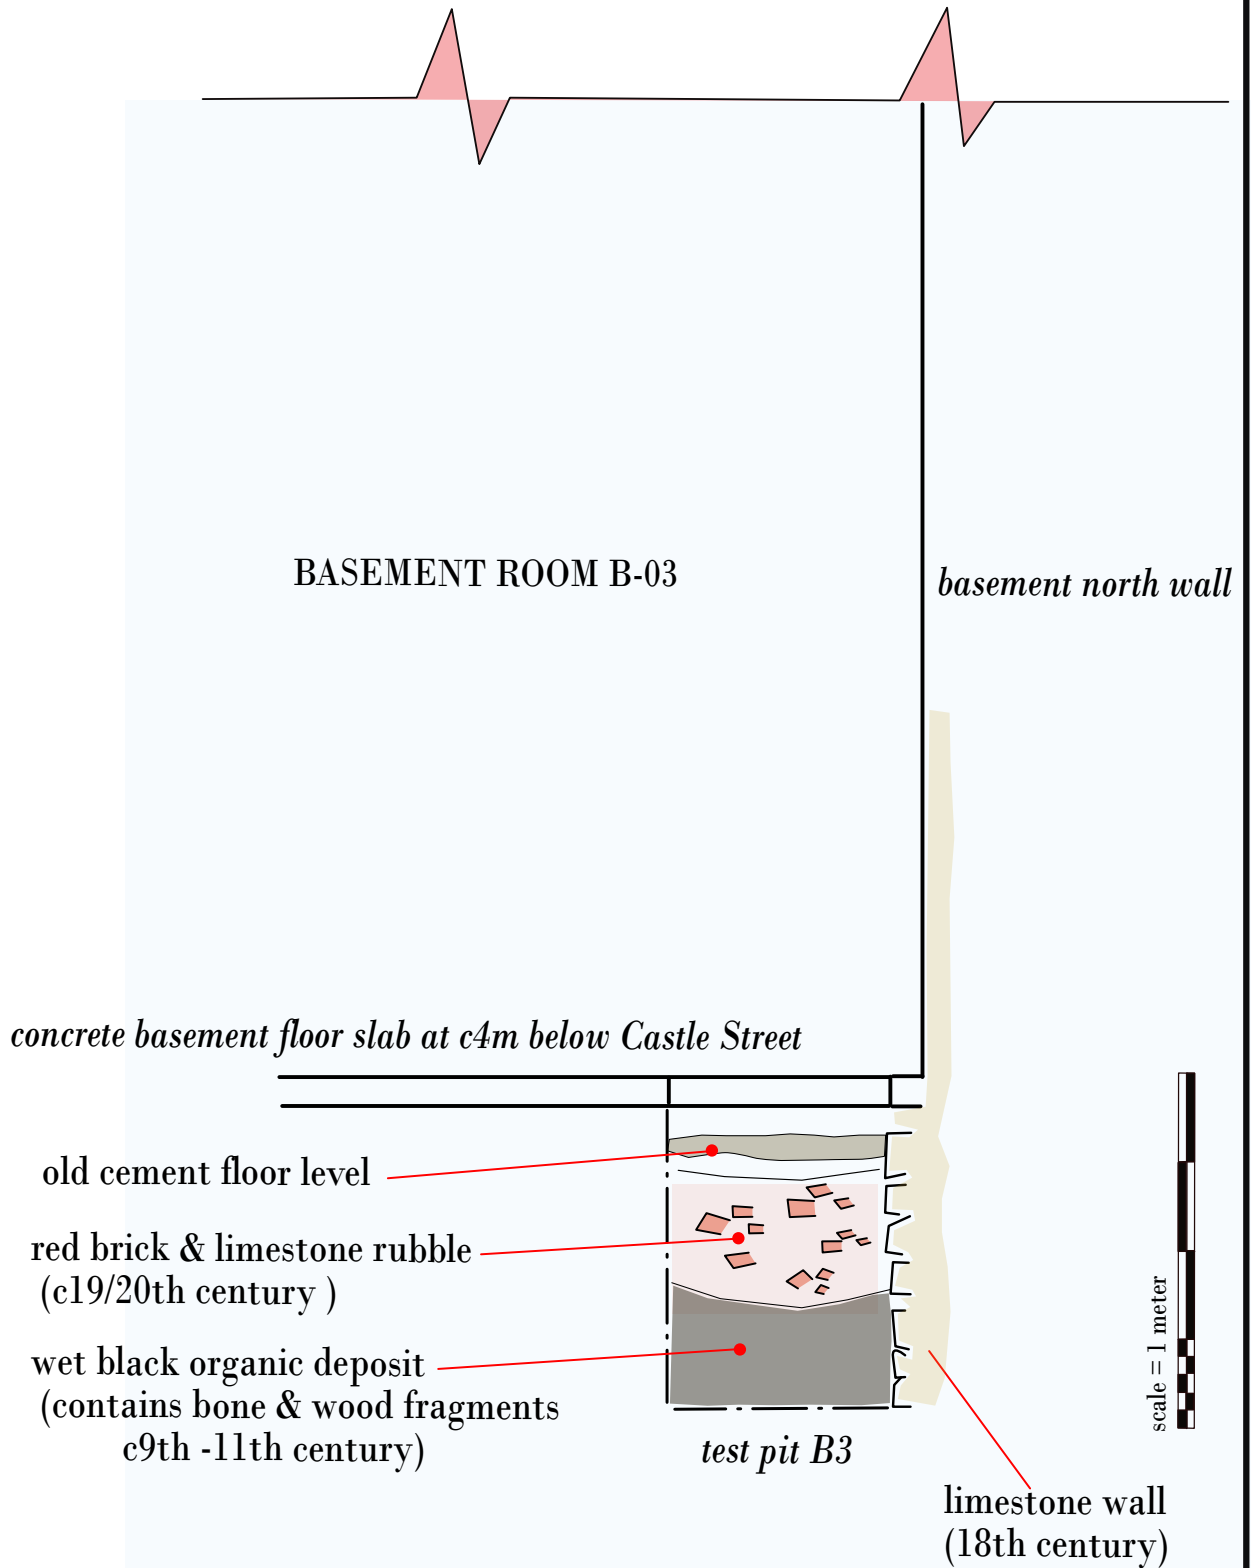
TEST PIT B3 - EAST ACING PROFILE A-A

ACAS		
Aisling Collins Archaeology Services		
Project Name		NEWCOMEN BANK
Figure 7		Newcomen Bank - test pit B3 profile A-A
Address	16 Castle Street Dublin 2	Client Ref. Howley Hayes/DCC
Date	14/6/2023	Dwg by/amended ; Kevin Weldon
	Scale As indicated

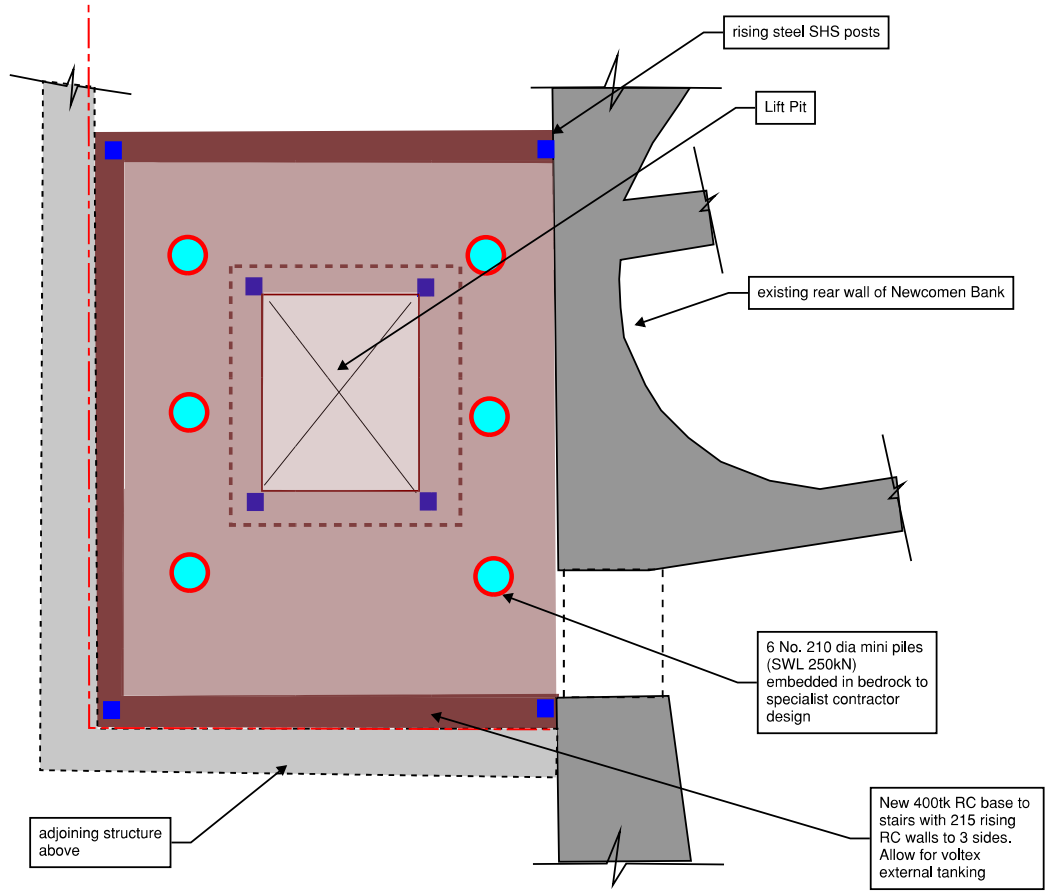
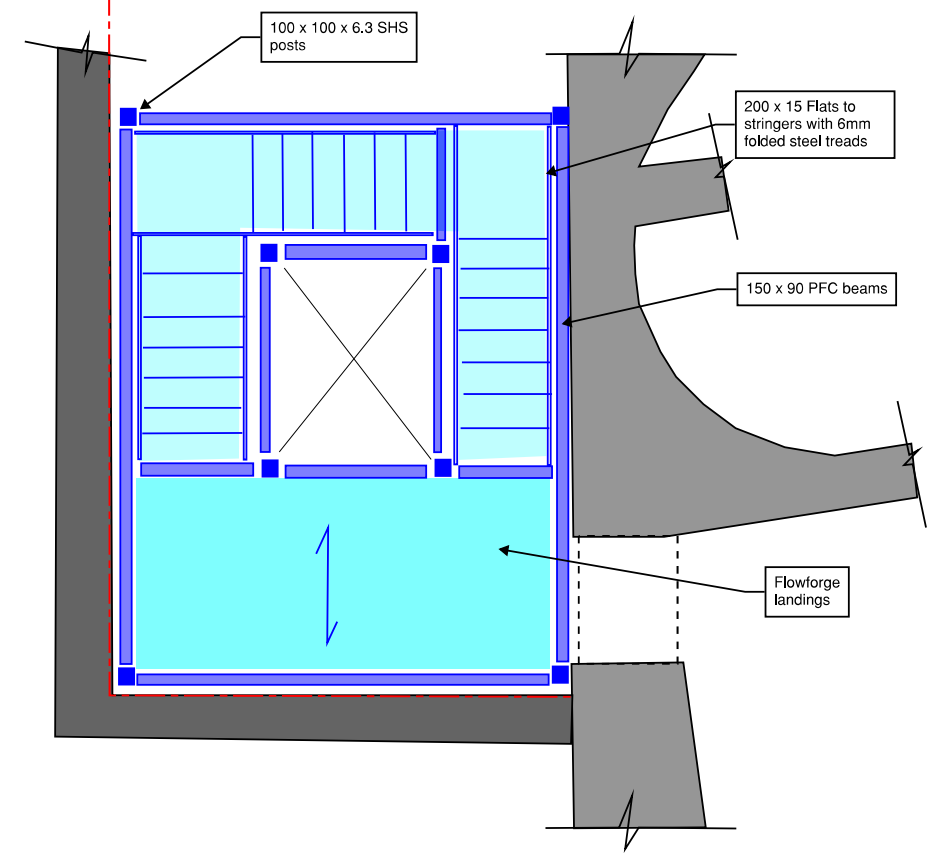
ACAS		
Aisling Collins Archaeology Services		
Project Name NEWCOMEN BANK		
Figure 9 proposed Lift plan		
Address 16 Castle Street Dublin 2		Client Ref. Howley Hayes/DCC
Date 14/6/2023	Scale As indicated	Dwg by/amended ; Kevin Weldon

BASEMENT LEVEL PLAN

TYPICAL FLOOR LEVEL

Phase 1: Demolition of the existing four storey lift and stair structure to the west façade of Newcomen Bank and construction of a new five storey lift and stair structure. This new lift pit will measure 2.7m x 2.7m and will require excavation to a depth of 1.8m deep below the existing basement floor level. (Previous monitoring for site investigations in room B3 identified organic material at a depth of 75cm below existing basement level). The excavated area will then be infilled and 6 x 210 dia mini piles will be inserted and embedded to bedrock by specialist's contractor design (bedrock estimated 7.5-8m below ground level). Figure 8-10.

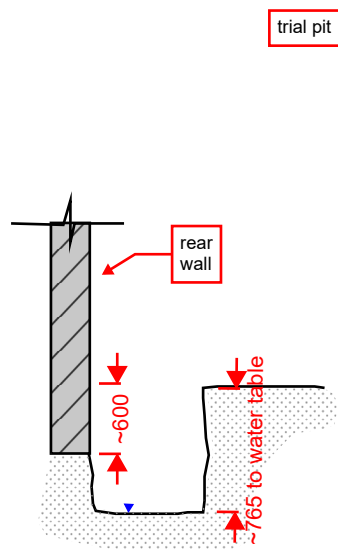
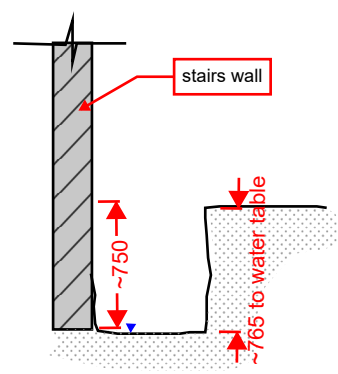
Assumed demolition process is to carefully take down the walls and stair-flights & landings using a combination of hydro-demolition and saw cuts to form small sections that can be safely removed from site.

SECTION 1-1

SECTION 2-2
