Dolphin House Regeneration

Bat Survey 2020

Final Report

14th November 2020

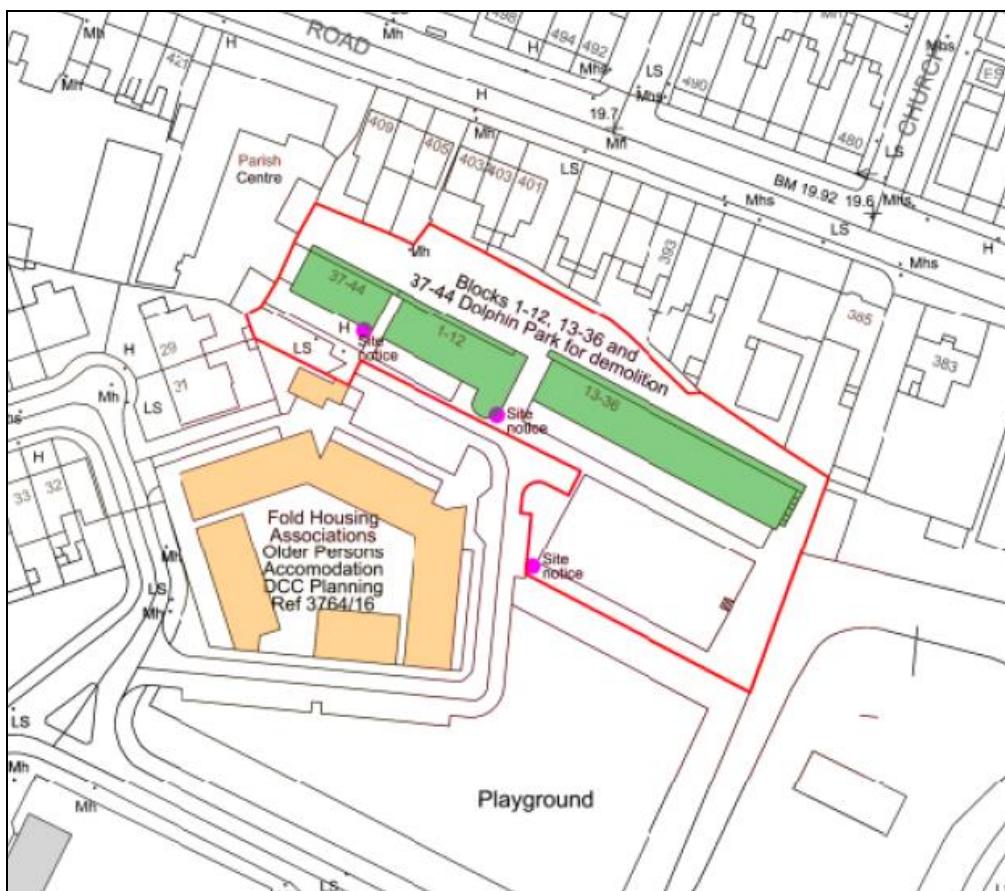
Figure 1. Overview of the Dolphin Park Senior Citizen Development buildings scheduled for demolition shown in green.

Dublin City Council is proposing to demolish three buildings (the Dolphin Park Senior Citizen Development) at Dolphin House as illustrated on **Figure 1** above. The buildings proposed for demolition are mostly vacated with only a very small number remaining in use as residences.

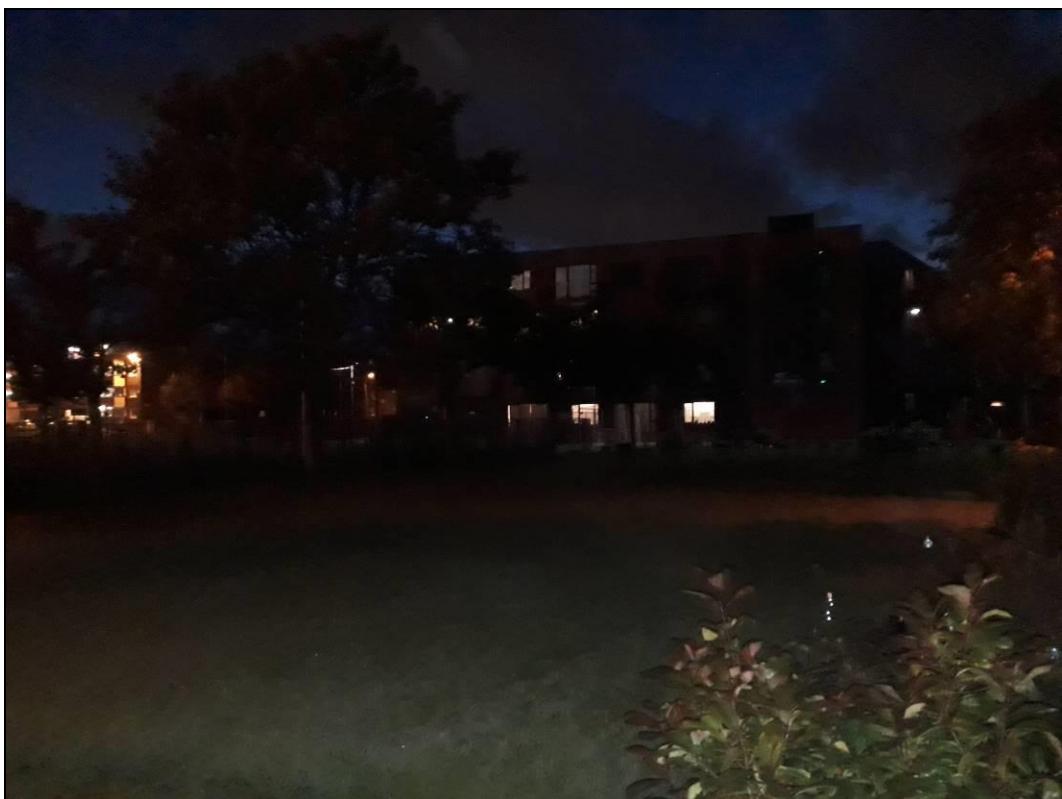
Plate 3. The small formal garden area to the front of the property has some potential for bat activity as it is relatively dark with some semi-mature trees.

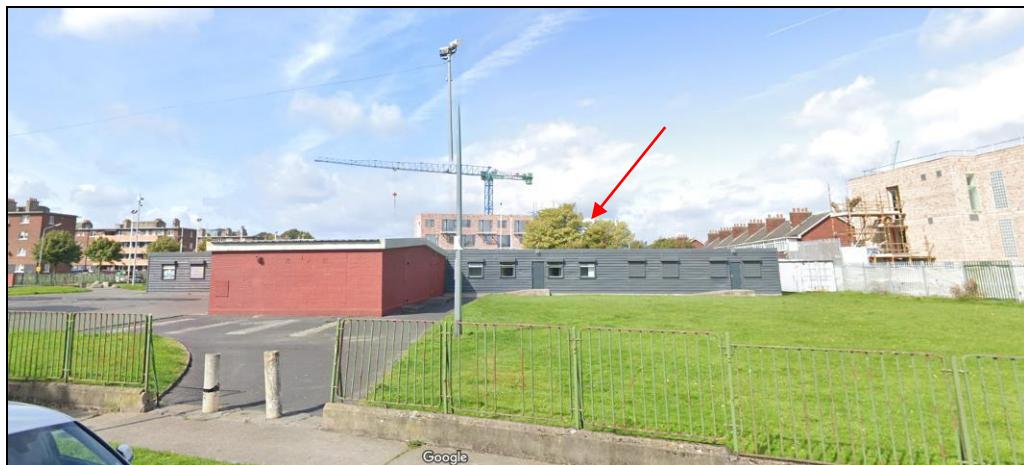
There are no trees on or near the site that offer roosting potential for bats. The sycamore trees at the front of the buildings are too immature and do not

contain any crevices/cavities which would offer bats a roosting opportunity but they do provide shelter, support insects and may act as an important corridor for foraging and commuting bats.

Plate 4. Trees adjoining the buildings proposed for demolition (Google street view).

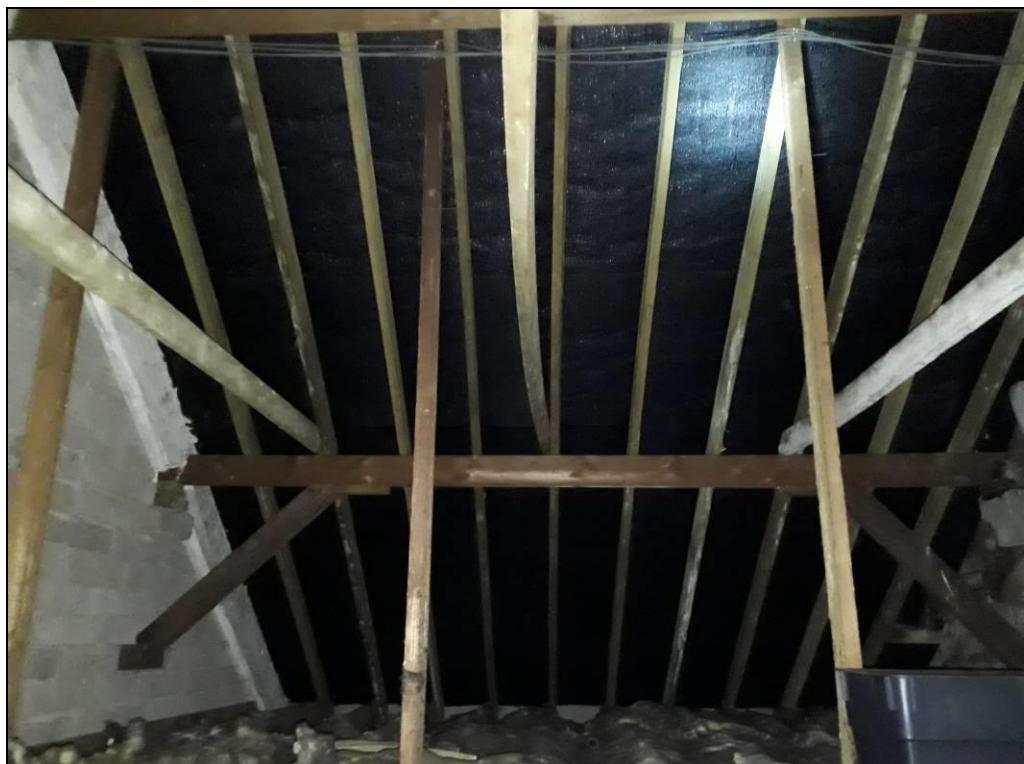
There are numerous opportunities for bats to roost in the buildings as they have a large number of individual attic spaces, many of which were upgraded recently in terms of energy retention measures with insulation and fire stopping.

Plate 5. Attic space.

Any demolition works should be done carefully as there is a low possibility that individual bats may be found for example in the attics, between the tiles and felt, in vents, between window frames and walls, etc.

This essentially requires the removal of such features by hand, checking for the presence of bats behind/under these structures. If discovered, the animals shall be retained in a box until dusk and released on site. Please inform a bat specialist and ask for further advice.

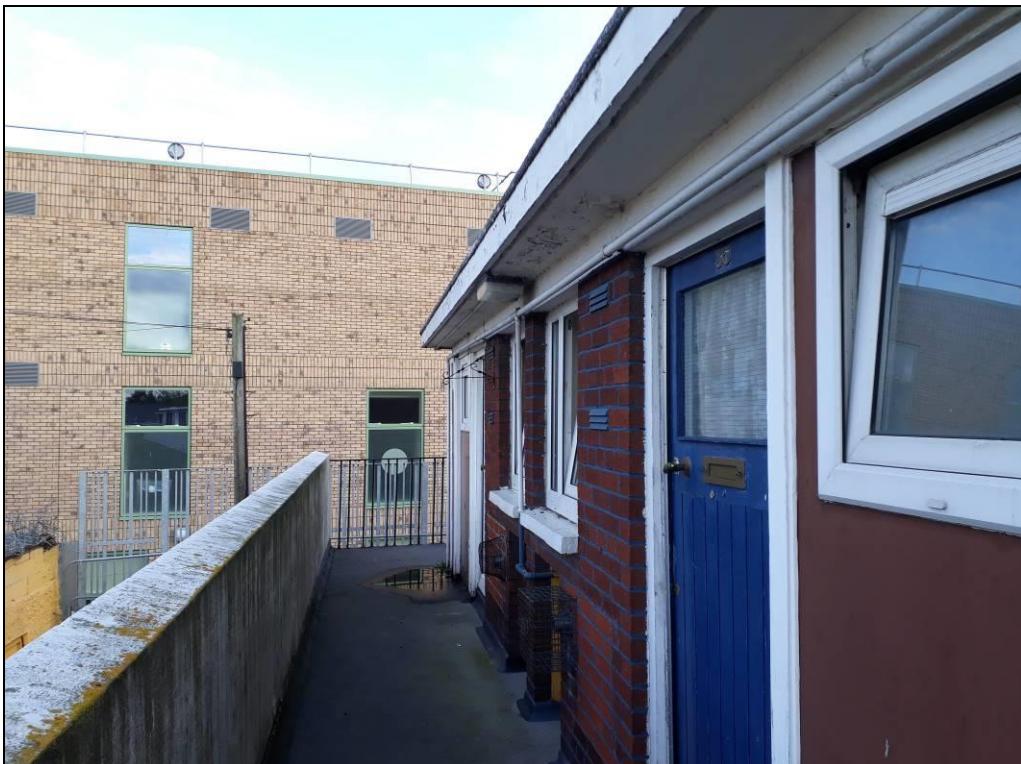
The buildings are roofed with tiles, underlain with felt on the roof battens. The fascia's of the buildings are constructed of solid concrete and hence do not offer any roosting potential. The majority of the flats have been vacated and are secured. There was no evidence of use by bats of any of the buildings in Dolphin House which were examined and are scheduled for demolition.

Plate 6. Concrete fascia.

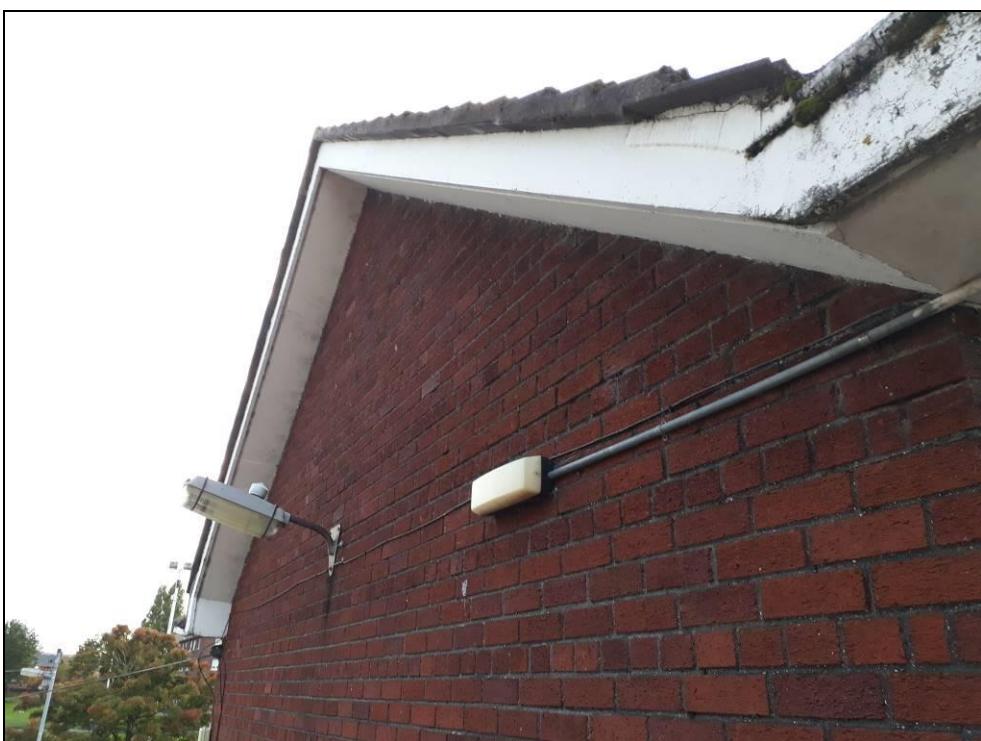
Plate 7. Concrete fascia at gable end of building.

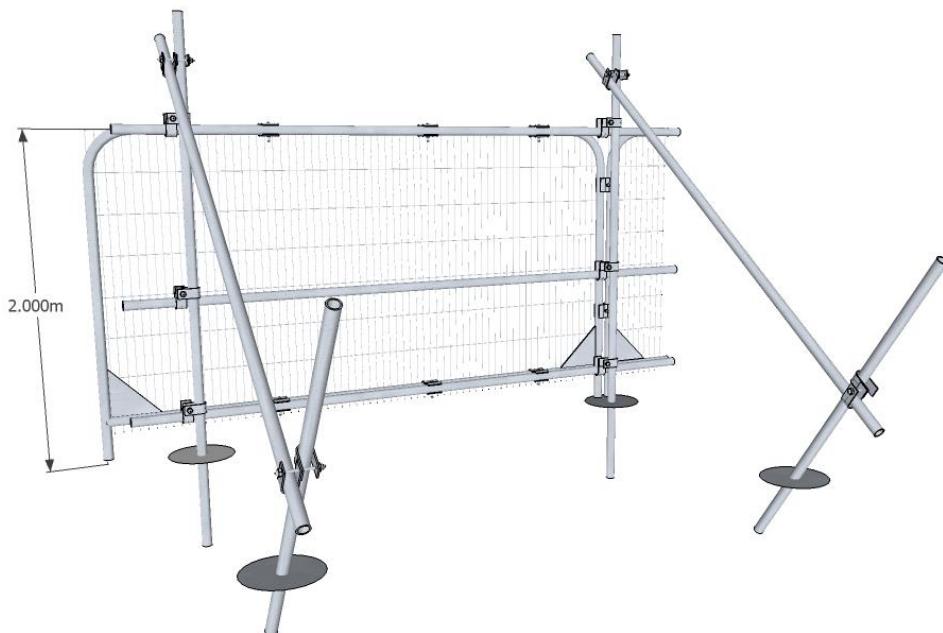
Sturdy protective fencing should be erected outside the drip line of the canopy of the trees prior to any soil disturbance and excavation work starting; this is essential to prevent any root or branch damage to the retained trees. The British Standard BS 5837:2012 *Trees in relation to design, demolition and construction – Recommendations* specifies appropriate fencing; see below.

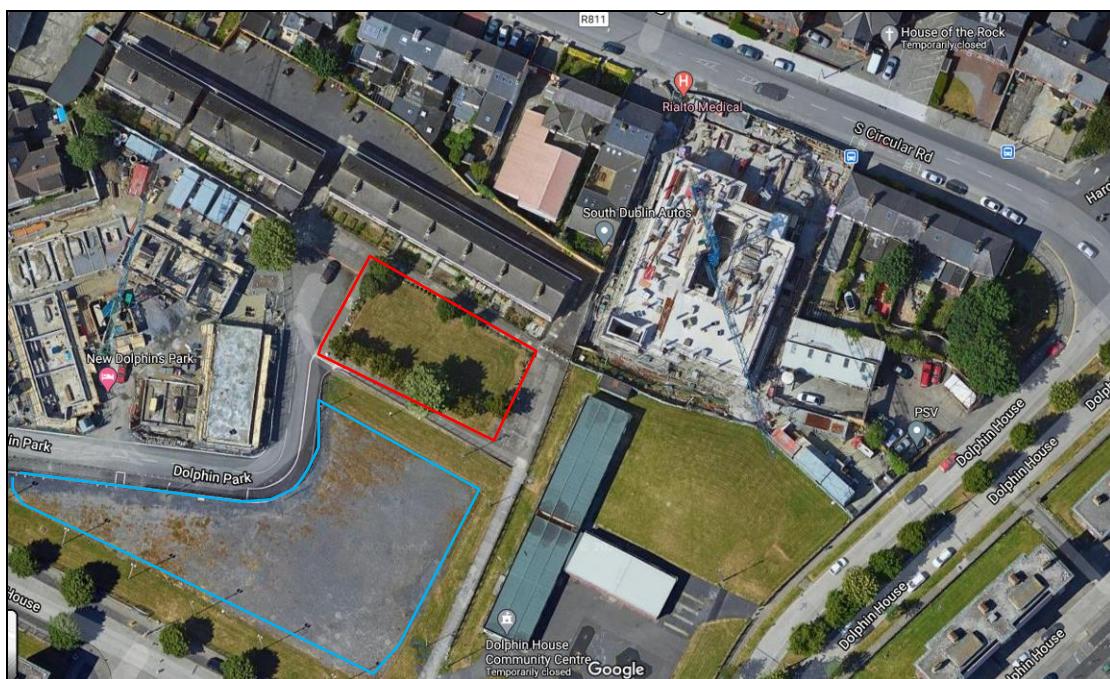
Figure 2. Trees to be retained and protected during the works (red line) (Google maps).

Trees being retained on the site as shown on **Figure 2** below should be protected from unnecessary damage during the construction process by effective construction-proof barriers that will define the limits for machinery drivers and other construction staff. Ground protected by the fencing will be known as the Construction Exclusion Zone (CEZ).

- Care will be taken when planning site operations to ensure that wide or tall loads or plant with booms, jibs and counterweights can operate without coming into contact with retained trees. Such contact can result in serious damage to them and might make their safe retention impossible.
 - Materials, which can contaminate the soil, e.g. concrete mixings, diesel oil and vehicle washings, will not be discharged within 10 m of a tree stem.
 - Fires will not be lit in a position where their flames can extend to within 5 m of foliage, branches or trunk. This will depend on the size of the fire and the wind direction.
 - Notice boards, wires and such like will not be attached to any trees.
 - Site offices, materials storage and contractor parking will all be outside the CEZ. A suitable area for same is indicated in blue on **Figure 2** above.
