Social Housing PPP Programme Bundle 3
Former Readymix site, East Wall Road, Dublin 3
Archaeological Impact Assessment

Client: Coady Architects

Report Date: 15th January 2021

Our Ref: 2021_03

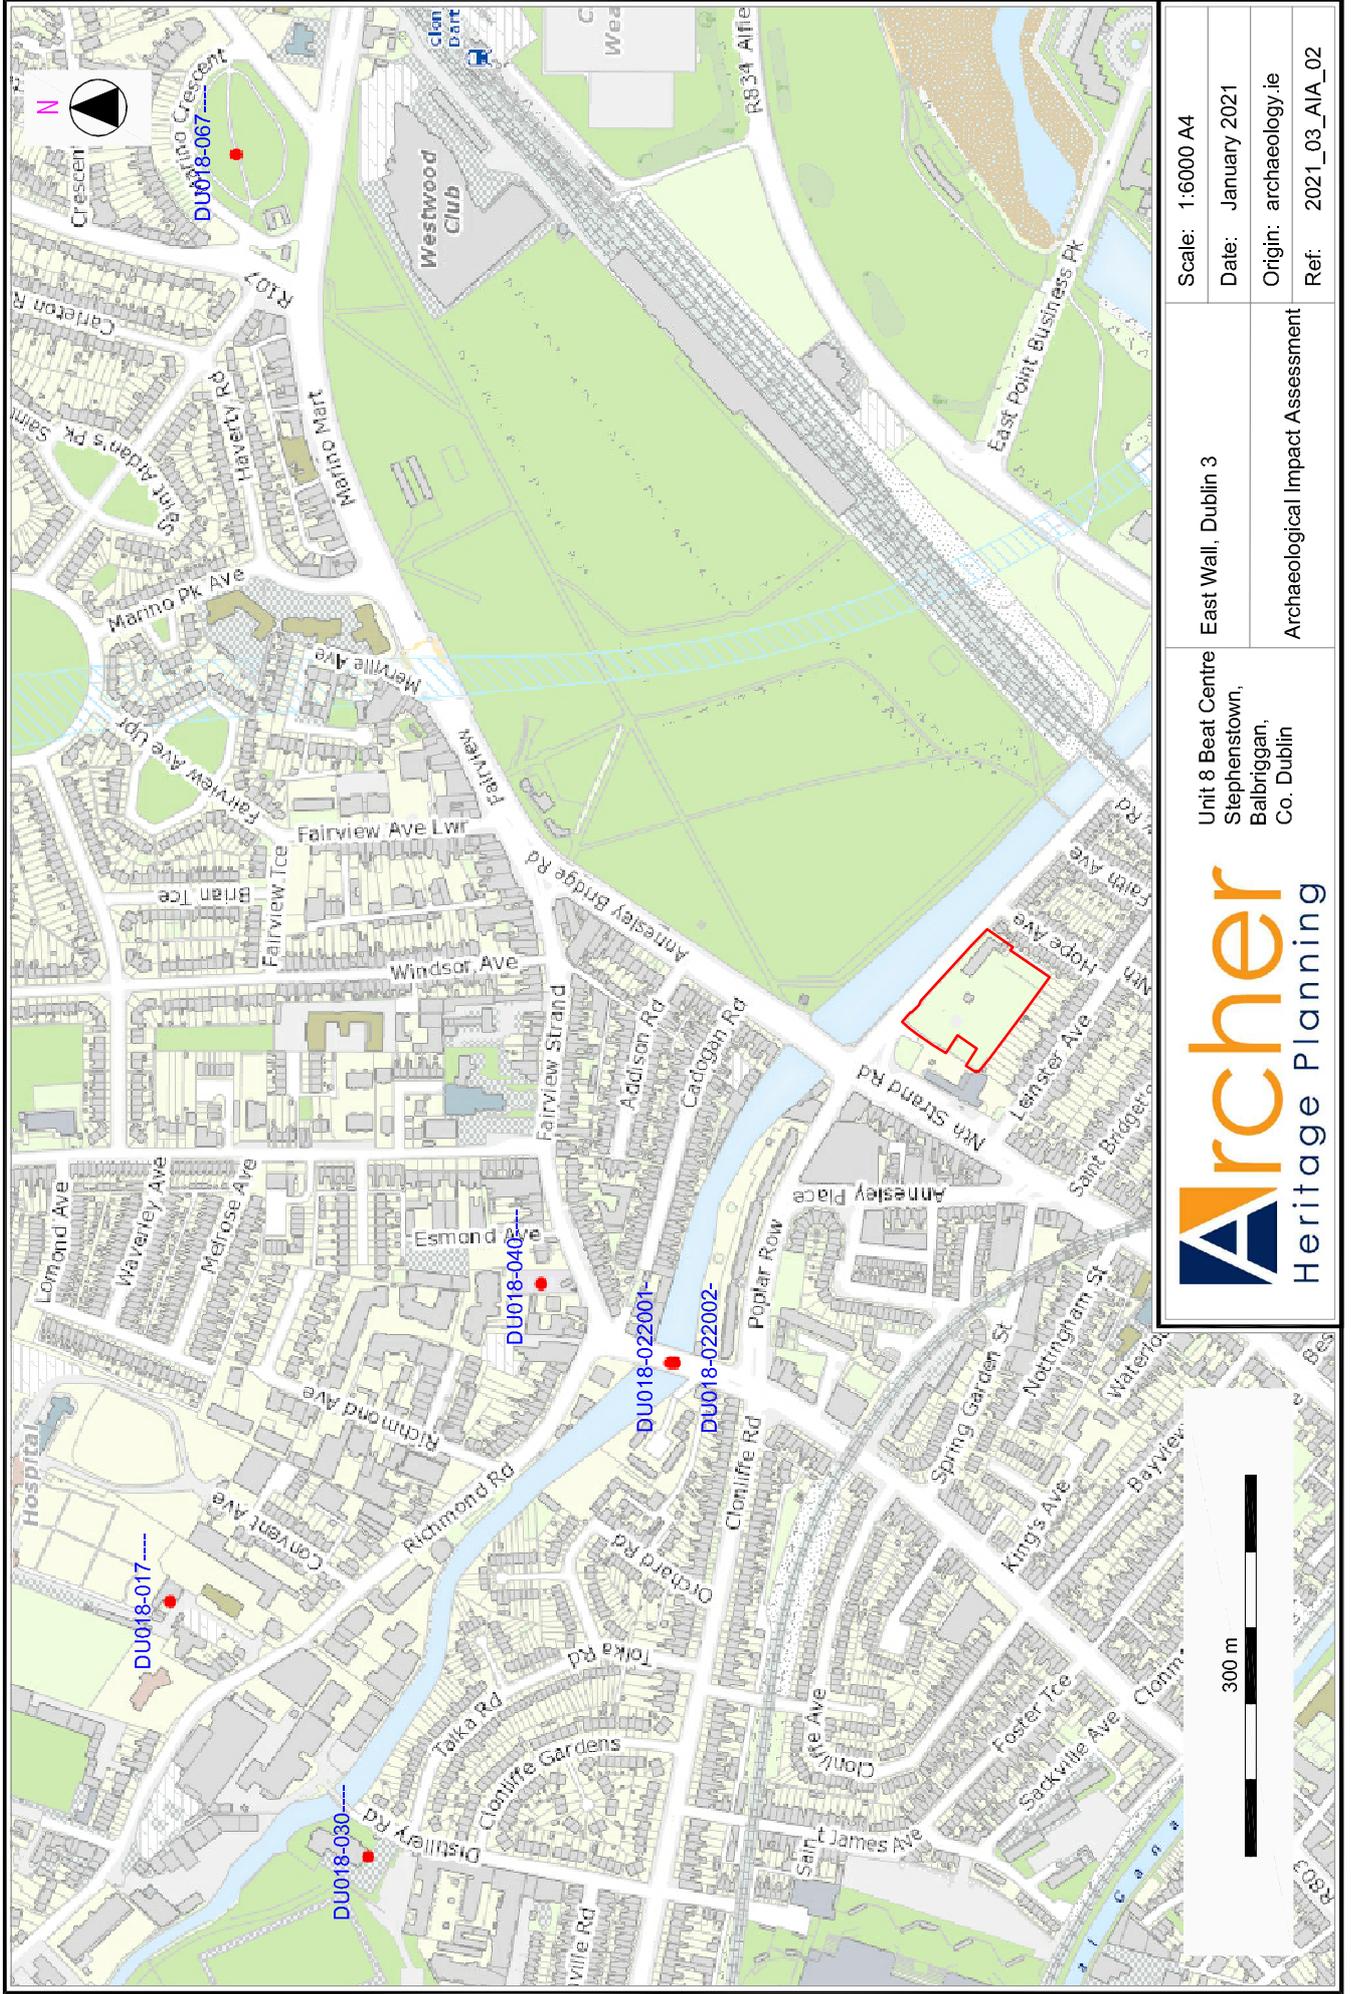
Figure 2: Site location with surrounding RMPs

There are no recorded monuments located within or near the site. The closest RMP site, DU018-022002- Fish weir, lies c. 300m to the north-west. The subject site lies c. 980m north-east of the Zone of Archaeological Potential for Dublin City DU018-020

SMR No	Class	Townland	ITM
DU018-017----	Castle - unclassified	Dublin North City	716796, 736468
DU018-022001-	Bridge	Dublin North City	716983, 736078
DU018-022002-	Weir - fish	Dublin North City	716983, 736074
DU018-030----	Water mill - unclassified	Dublin North City	716594, 736313
DU018-040----	Burial ground	Dublin North City	717046, 736179
DU018-067----	Burial	Dublin North City	717935, 736417

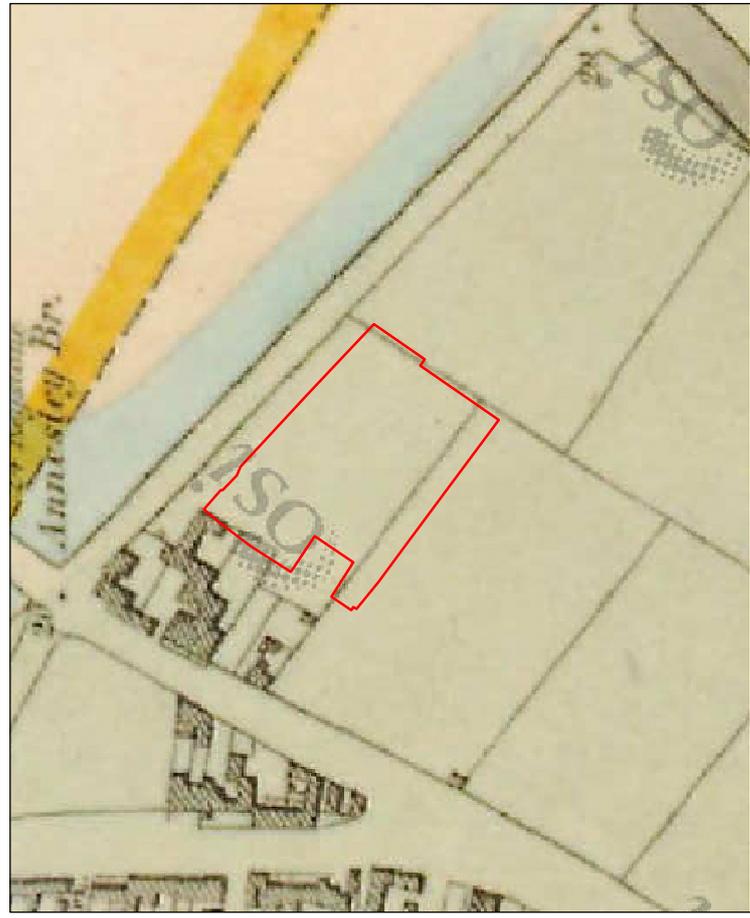
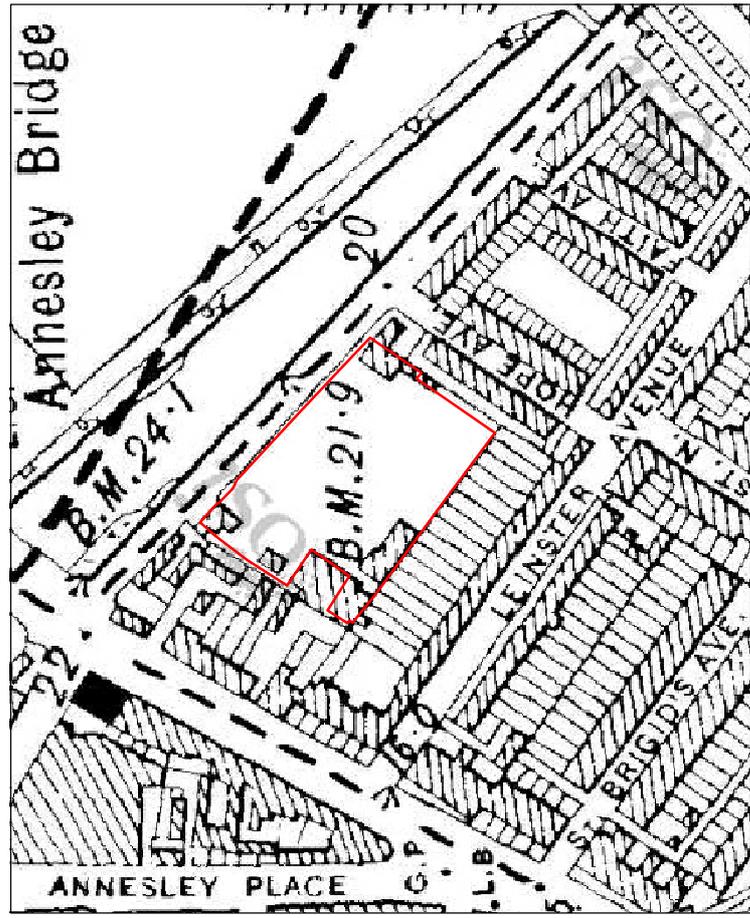
Figure 3: Extracts from early historical maps

Map	Date	Description
Rocque	1757	The East Wall area has been laid out but none of the plots north of Sherriff Street appear occupied. The Tolka is named the Ballybough River and what will become North Strand Road is simply 'The Strand'. Annesley Bridge is yet to be constructed
Historic 6inch	1837	Annesley Bridge has been constructed and while there is much more occupation of the lands around North Strand Road most of the East Wall area is sparsely inhabited. There is a cluster of buildings around the junction of North Strand Road and East Wall Road adjacent to the subject site
Historic 25inch	1888-1913	The area is significantly more developed with Leinster Avenue to the south now laid out. The subject site appears still to be open ground.
Cassini	1930-40's	The area has taken on its modern layout with residential streets surrounding the subject site. The site appears to have been a single unit for business or industry by this stage with several buildings within the bounds of the site

(l) 1st edition OS - 1844
(r) Cassini - 1930's

Analysis of historic mapping can show human impact on landscape over a prolonged period. Large collections of historical maps (pre- and early Ordnance Survey maps as well as estate or private maps) are held at the Glucksman Map Library, Trinity College and other sources (UCD Library, Ordnance Survey Ireland, local libraries and published material). The development of the site and its vicinity recorded through the eighteenth to twentieth century cartography are described in Table 1 below (Figure 3). **No potential archaeological features were recorded within the subject site.**

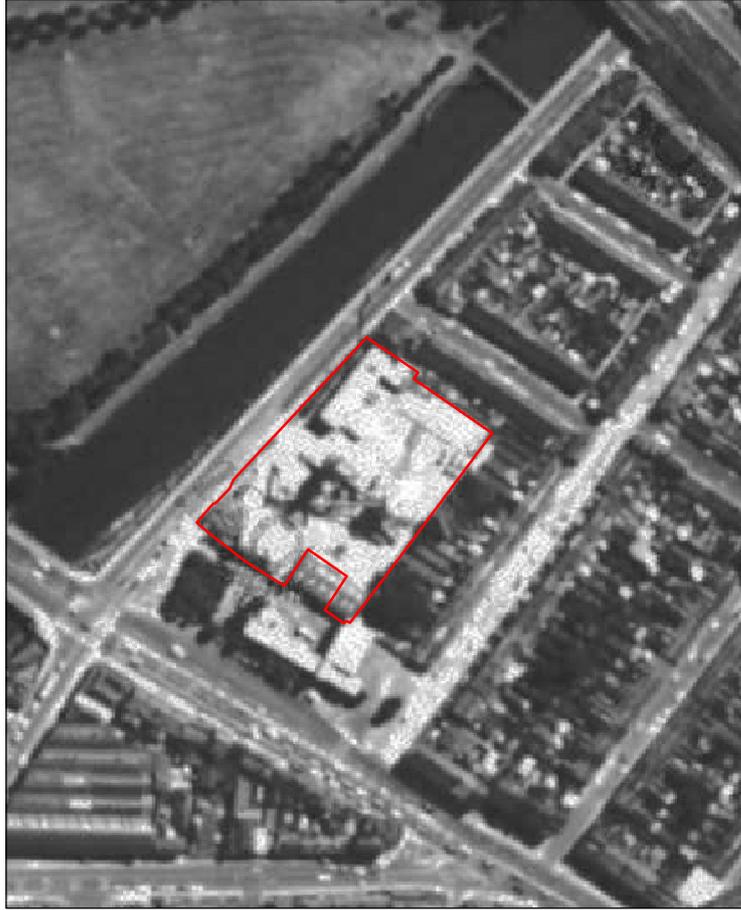
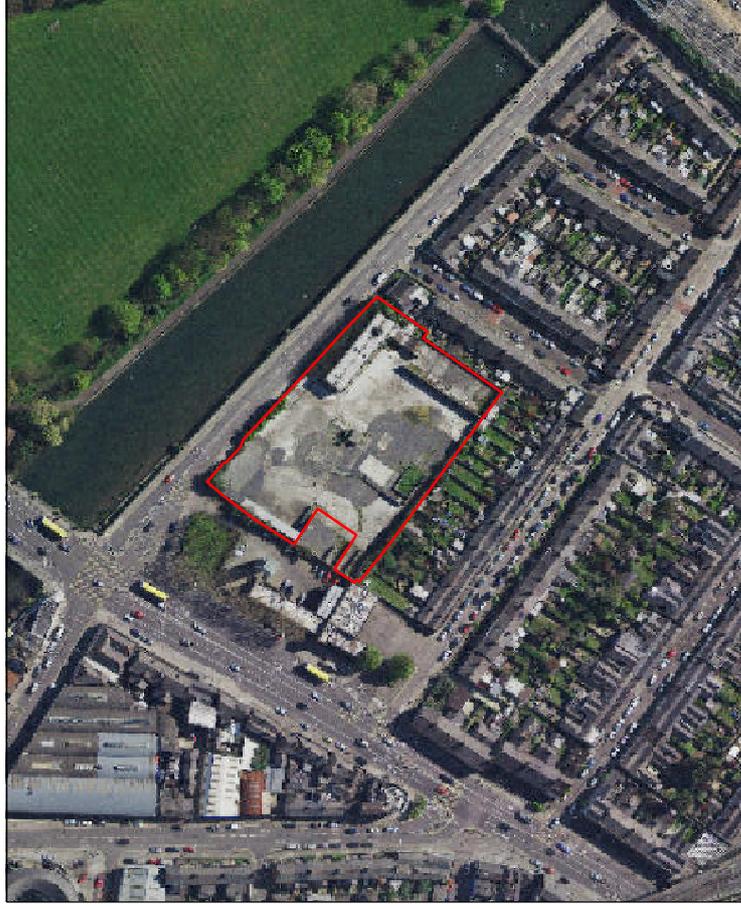
Figure 4: Extracts from aerial photography

Aerial Photograph	Date	Description
OSi	1995	Black and white image, poor resolution compared to modern imagery. Site in use as industrial site, surrounding area built up except for Fairview park on the north side of the Tolka.
OSi	2005	Colour image, little change in site details, Port Tunnel under construction in Fairview Park to the north.
OSi Premium	2013-18	Little change from earlier image, site apparently not in use by this stage.

(l) 1995
(r) Premium

Aerial photography (or other forms of remote sensing) may reveal certain archaeological features or sites (earthworks, crop marks, soil marks) that for many reasons may not be appreciated at ground level. Online orthostatic photographs of the site were examined (Ordnance Survey Ireland 1995, 2000 & 2005; Google/Bing Maps 2018). As the site has been in use as an industrial site (with concrete yard) in modern times, no worthwhile archaeological information could be discerned from the study of aerial photography. Details are shown Table 2 below and in Figure 4.

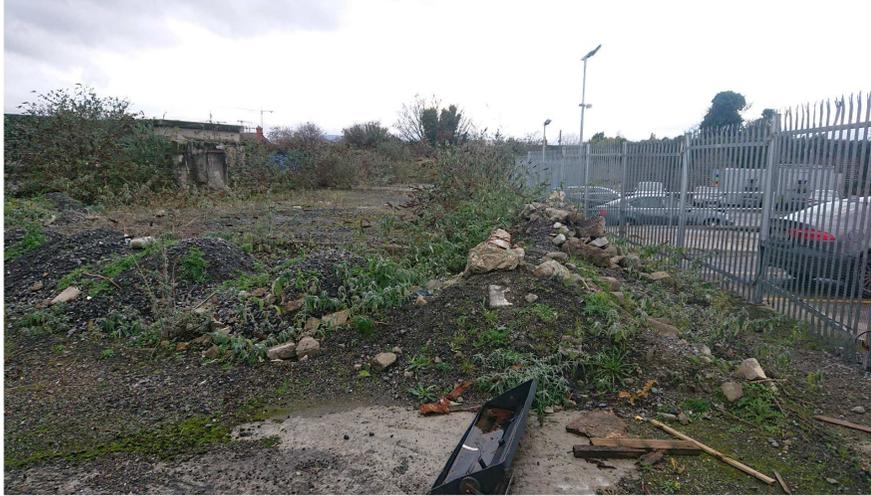
The site was visited by Liam Coen of Archer Heritage Planning Ltd on 30th Nov 2020 in dry, overcast conditions (Plates 1–4). This site is the former location of a business, Readymix concrete, and is now derelict and entirely covered in a concrete yard. The c. 0.62 ha site is roughly rectangular in plan, orientated north-west/south-east, bounded by the East Wall Road to the north-east, the rear of North Strand Fire Station to the north-west, and the boundary walls of rear gardens elsewhere. The boundary consists of a mixture of block walls, palisade fencing or a block wall and fence combination. A two-storey building lies in the north-eastern corner of the site. Debris in the form of tyres, pallets and other industrial materials alongside domestic rubbish has accumulated in places with occasional self-seeding vegetation established. **No increased archaeological potential was identified.**

Plate 1: North-western margin of site from northern corner

The site is proposed to be developed for residential housing but no detailed design proposals are currently available. If significant ground reductions (>1m below present ground level) are to take place under the development proposals then it is recommended that the groundworks be monitored by a suitably qualified archaeologist.

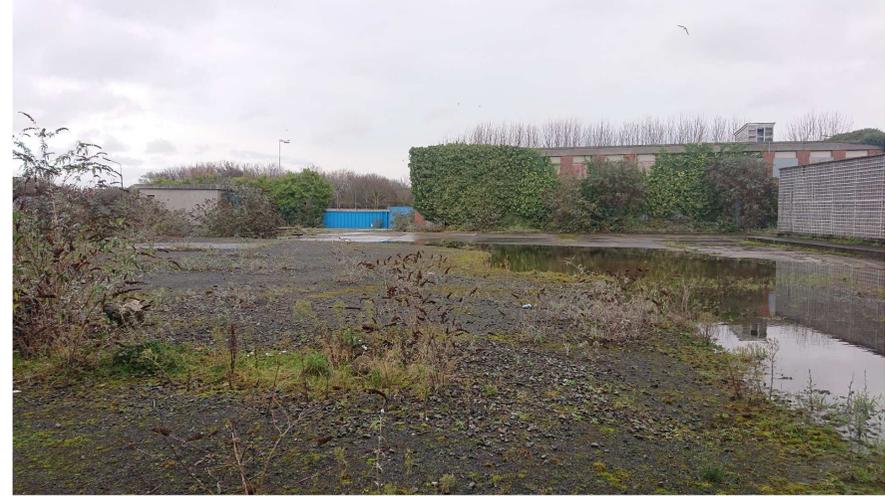
Plate 2: View of site from south

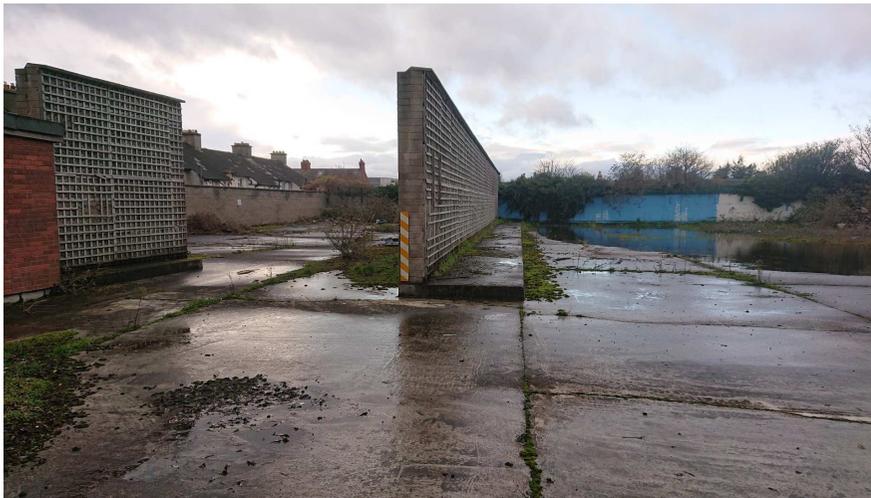
Plate 3: South-eastern part of site from shed area

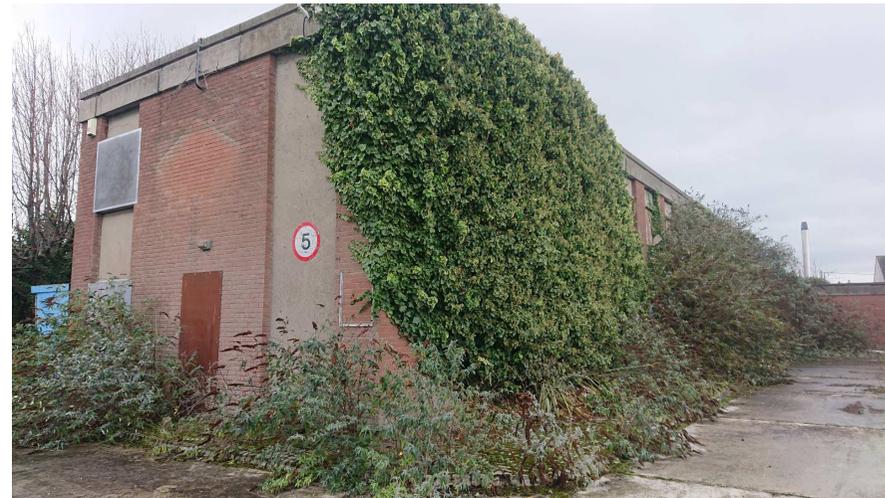
Plate 4: View of shed in north-eastern corner
