## Stage 1 Quality Audit

(Incorporating a DMURS Street Design Audit, and Audits of Accessibility, Cycling, Walking and Road Safety)

<b>Project Title</b>	Proposed Residential Development at Forbes Lane, Dublin
<b>Project No.</b>	24050-07
<b>Client</b>	Malone O'Regan
<b>Document Title</b>	Stage 1 Quality Audit
<b>Document No.</b>	24050-07-001

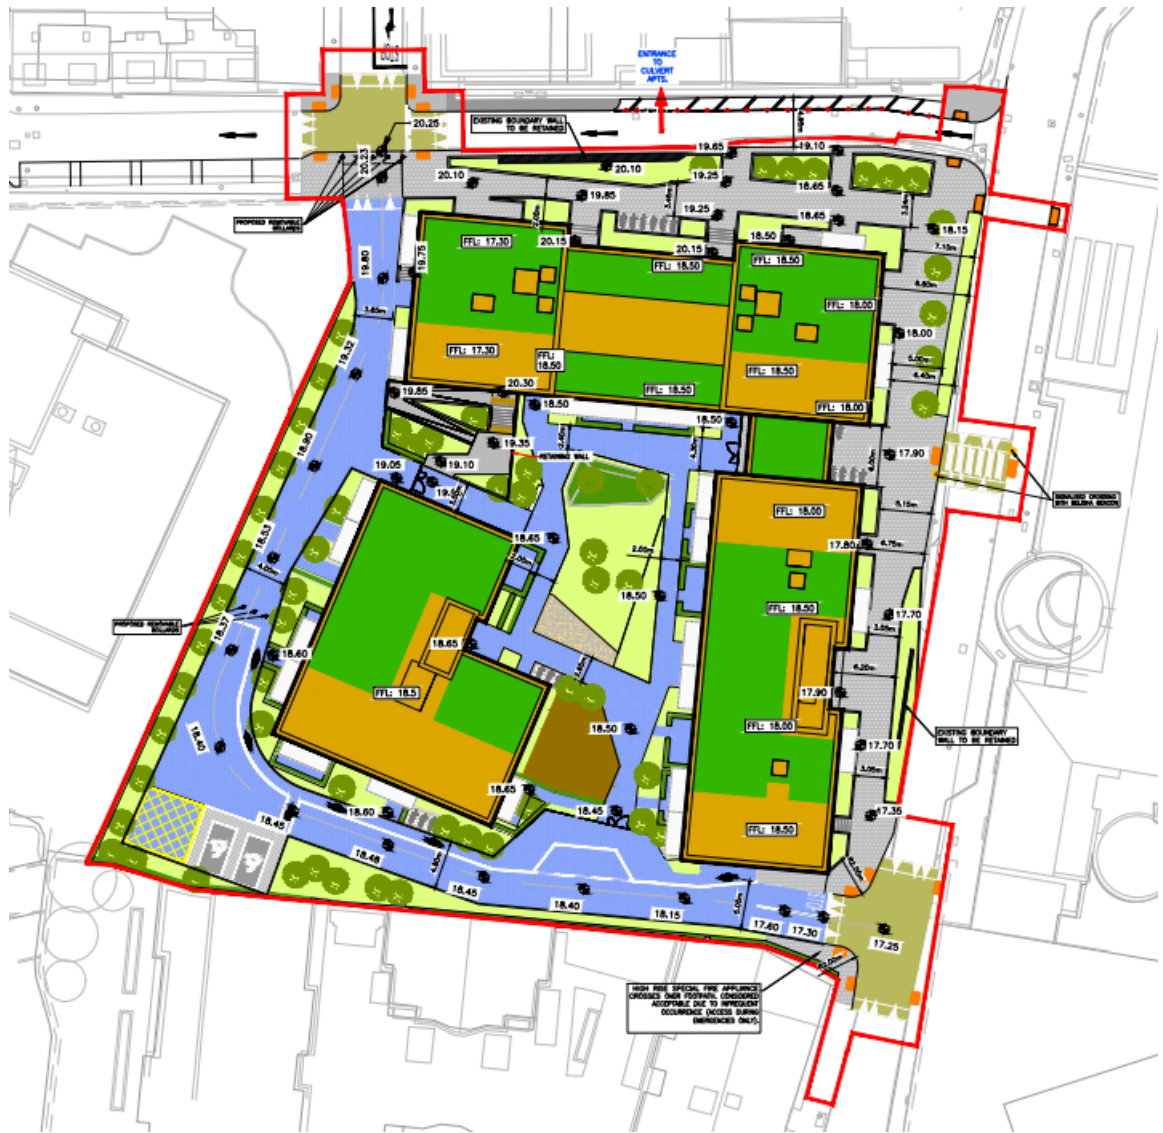
Figure 1.1 – Site Location Map and Site Layout for the development

- 1.4 Figure 1.1 below is a layout drawing of the development. Forbes Lane and Marrowbone Lane have posted speed limits of 30 km/h and 50 km/h respectively.

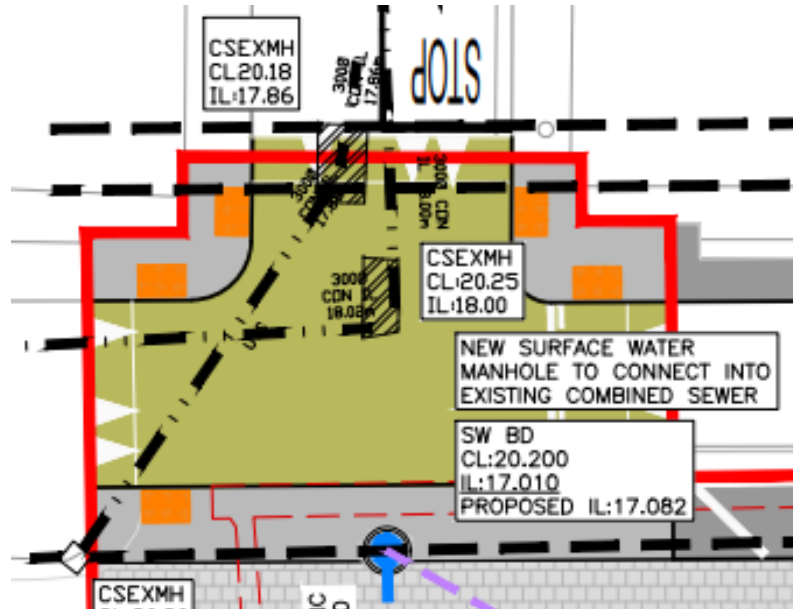
Figure 5.1 – Raised Crossings without drainage detail

It is noted that the proposed raised tables and grade changes throughout the development (Figure 5.1 to Figure 5.3), do not feature drainage measures on all sides of continuous ramps. This lack of drainage may result in ponding water, and/or associated silt forming, which may result in cyclists slipping and falling onto the road with associated injuries.

Ensure that adequate drainage measures are included for all such grade changes throughout the development.

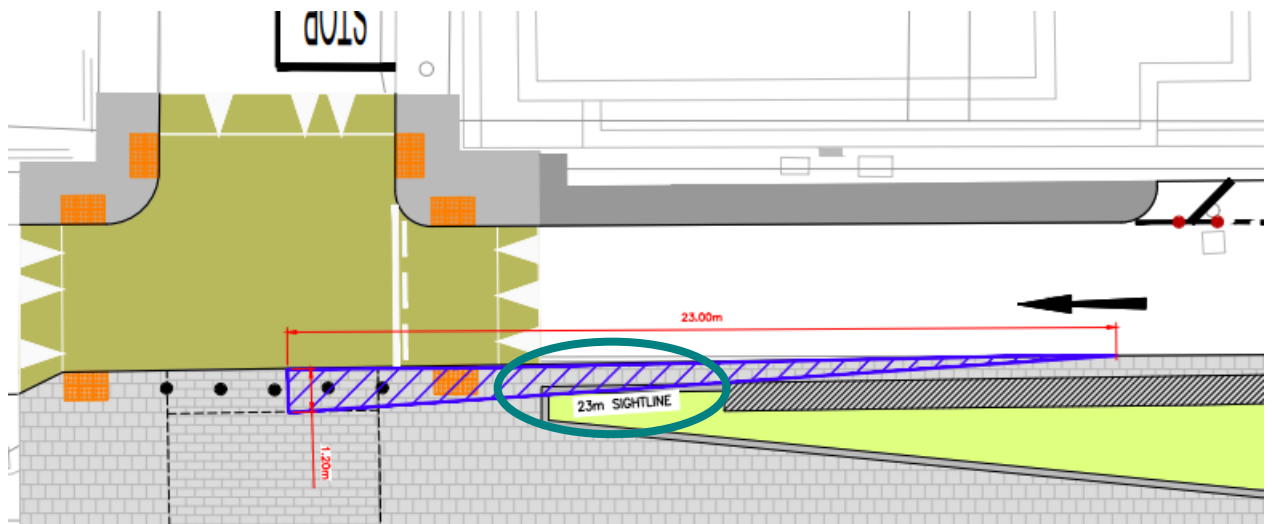
Figure 5.4 – Visibility Splay potentially interrupted by landscaping

Sightlines at the priority junctions in Figure 5.4 and 5.5 may be impacted by planting in the landscaped areas. This may increase the likelihood of vehicle collisions due to the reduced sightlines.

Ensure adequate visibility splays at all junctions from edge of carriageway.

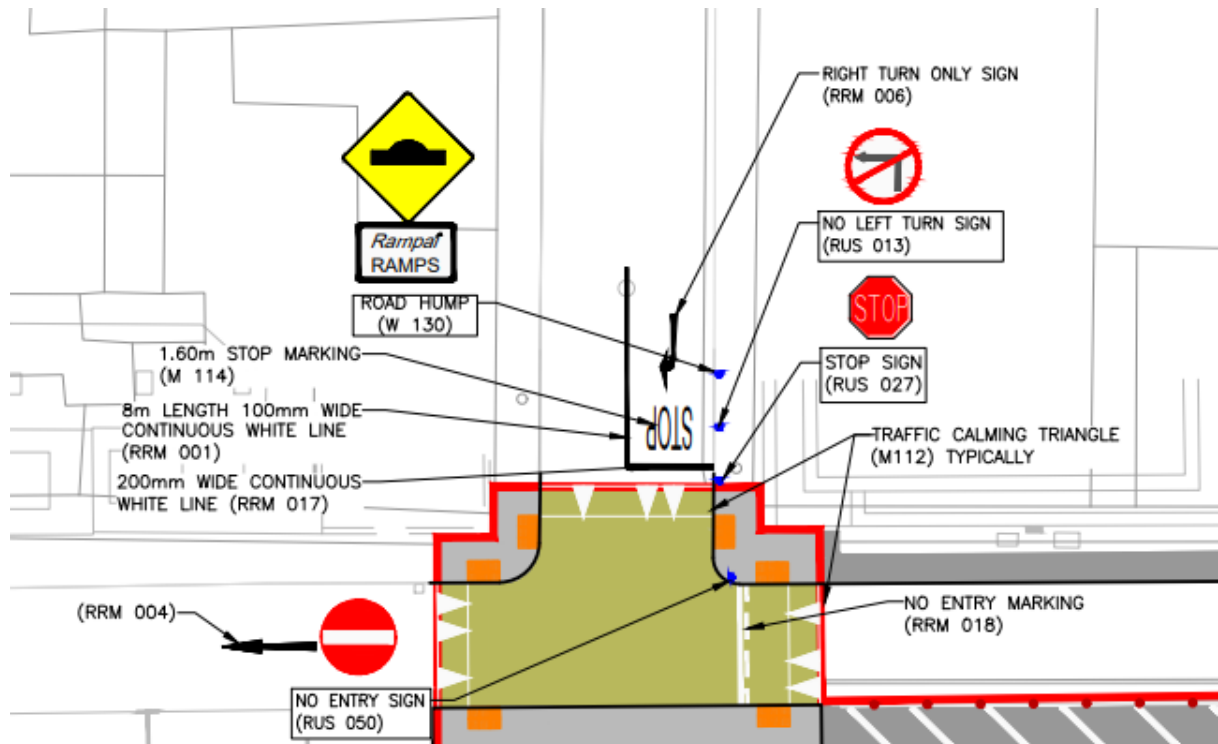
Figure 5.6 – Sign Clutter

It is proposed to erect three signs in close proximity to one another on Pim Street approach to its junction with Forbes Lane. It is likely that the Ramps sign may obscure visibility of the No Left Turn sign while both may obscure visibility of the Stop sign. A lack of adequate visibility of signage may increase collision risk.

Ensure that adequate visibility is provided to each sign.

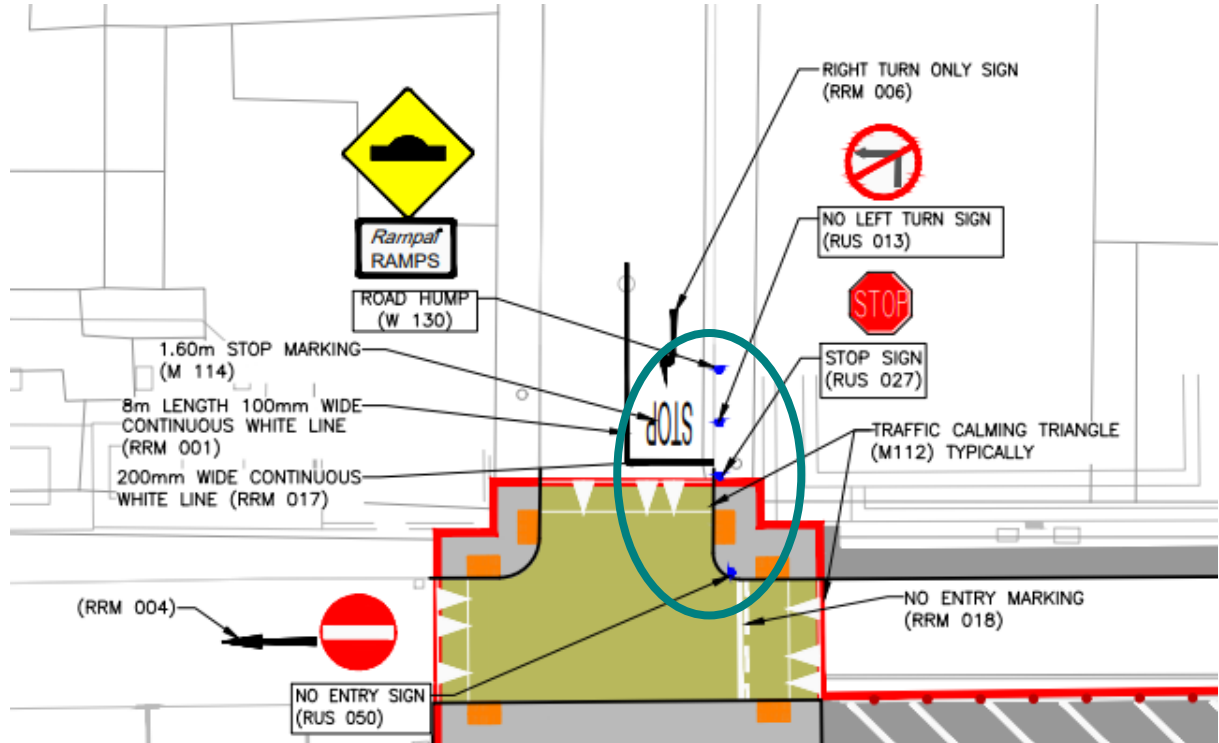
Figure 5.7 – Position of Signage

A number of signs appear to be located close to the carriageway edge where they would be at risk of being struck by a passing vehicle. Moving these signs further into the footpaths may also reduce the effective footpath width in particular for mobility impaired pedestrians.

Ensure that any proposed signage is located so as to avoid being struck by passing vehicles and does not reduce the effective footpath width in particular for mobility impaired pedestrians.

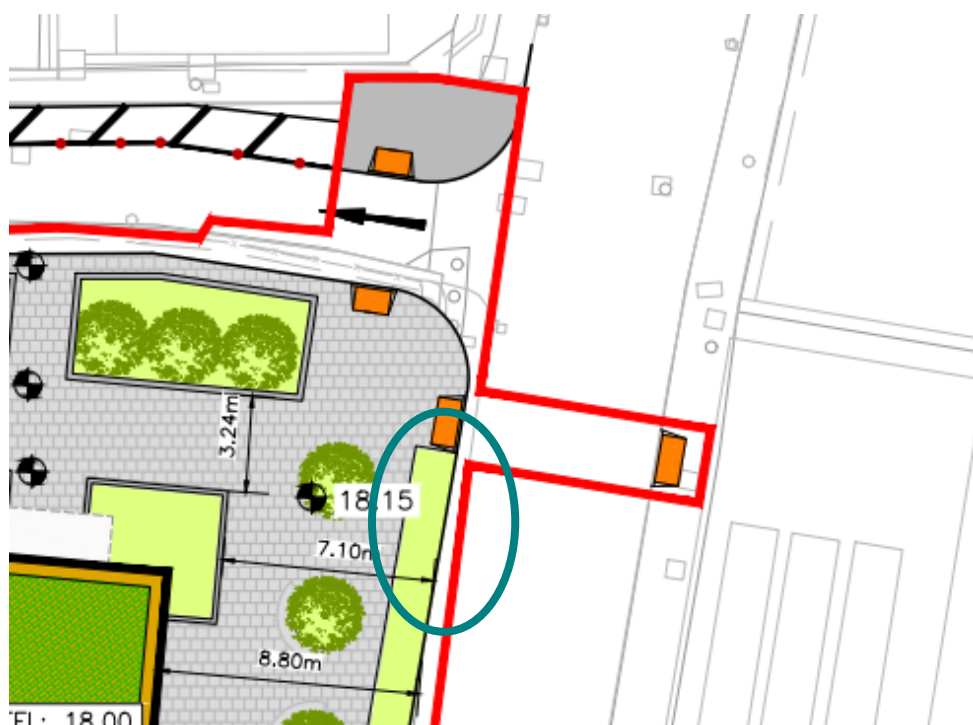
*Figure 6.1 – Pedestrian Intervisibility*

Landscaping is proposed to the south of the pedestrian crossing on Marrowbone Lane. It is unclear as to the heights of landscaping proposed in this area. Intervisibility between pedestrians crossing at this location and approaching northbound vehicles may be restricted by high planting within the landscaped area. A lack of adequate intervisibility may increase the likelihood of pedestrians being struck by approaching vehicles at this crossing.

Ensure adequate intervisibility is provided between pedestrians crossing at the pedestrian crossing and approaching northbound vehicles. Revise the landscaping area if necessary.

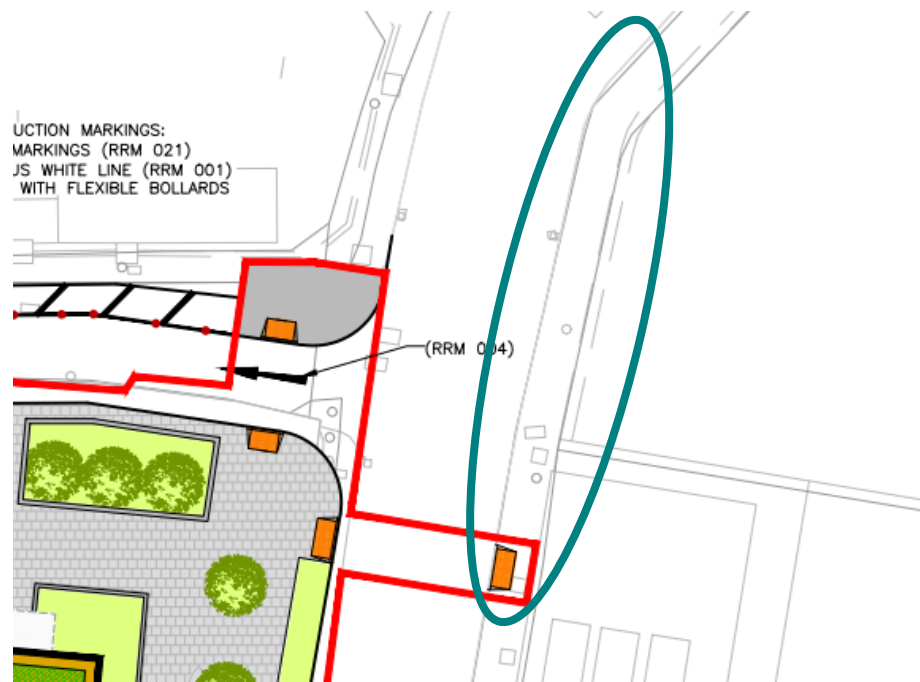
*Figure 6.2 – Proposed pedestrian crossing*

Intervisibility between pedestrians crossing the proposed crossing on Marrowbone Lane and approaching southbound vehicles may be restricted by the existing boundary wall and railings on the east side of the carriageway (Figure 6.3). A lack of adequate intervisibility may increase the likelihood of pedestrians being struck by approaching vehicles at this crossing.

Ensure adequate intervisibility is provided between pedestrians crossing at the pedestrian crossing and approaching southbound vehicles.

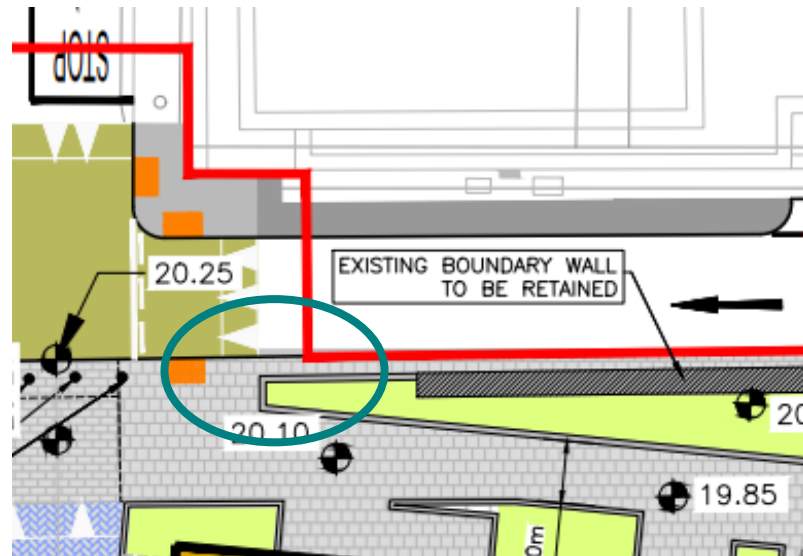
*Figure 6.4 – Pedestrian Intervisibility*

Landscaping is proposed to the east of the pedestrian crossing on Forbes Lane. It is unclear as to the heights of landscaping proposed in this area. Intervisibility between pedestrians crossing at this location and approaching westbound vehicles may be restricted by high planting within the landscaped area. A lack of adequate intervisibility may increase the likelihood of pedestrians being struck by approaching vehicles at this crossing.

Ensure adequate intervisibility is provided between pedestrians crossing at the pedestrian crossing and approaching westbound vehicles. Revise the landscaping area if necessary.

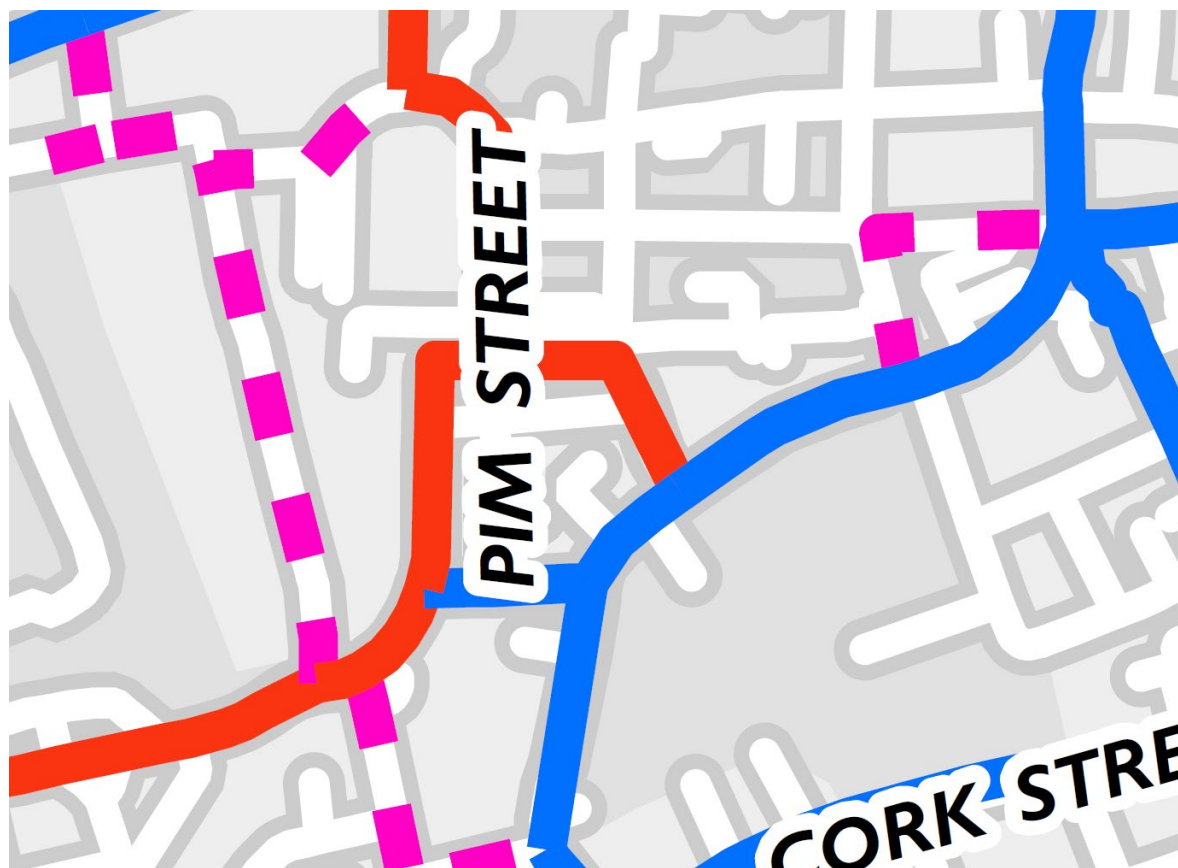
**Figure 7.1** – GDA Cycle Network ([www.nationaltransport.ie/wp-content/uploads/2023/01/2022-GDA-Cycle-Network.pdf](http://www.nationaltransport.ie/wp-content/uploads/2023/01/2022-GDA-Cycle-Network.pdf))

While there is no proposed cycle infrastructure in the development, it is not clear however how the development will tie into the proposed 'Primary Orbital' Cycle Route (red in Figure 7.1) along James Walk, the 'Secondary' Route (blue in Figure 7.1) on Marrowbone Lane, or the 'Feeder' Route (dashed pink line in Figure 7.1) on Basin View. A lack of coordination may reduce the effectiveness of these schemes, proposed by Dublin City Council and National Transport Authority, and undermine potential to achieve cyclist desire lines.

Consider wider network impacts of future schemes to support a network of segregated cycleways through the development. Consult with Dublin City Council Active Travel to ensure the development is futureproofed.

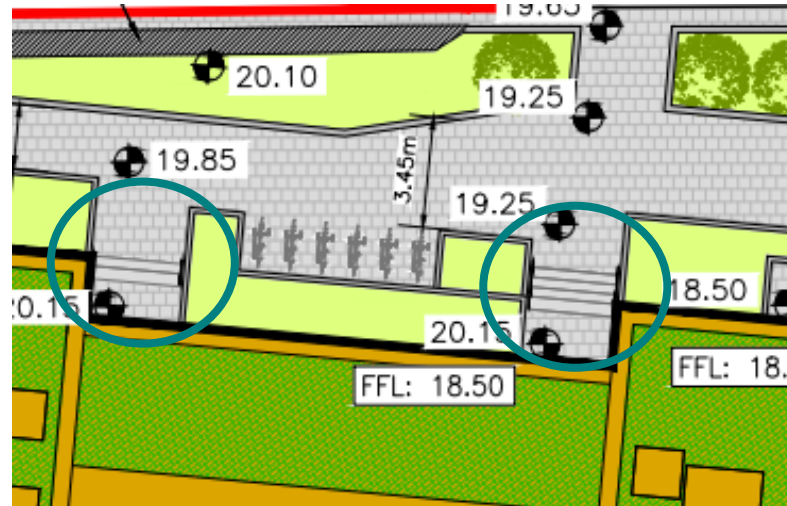
Figure 8.1 – Pedestrian Steps

Sets of steps in the development do not feature tactile paving. It is unclear if proposed steps feature railings. Lack of railings and tactile paving may increase the likelihood of injuries for pedestrians with mobility impairments or vision impairments respectively.

Ensure all steps throughout the development feature railings and appropriate tactile paving.

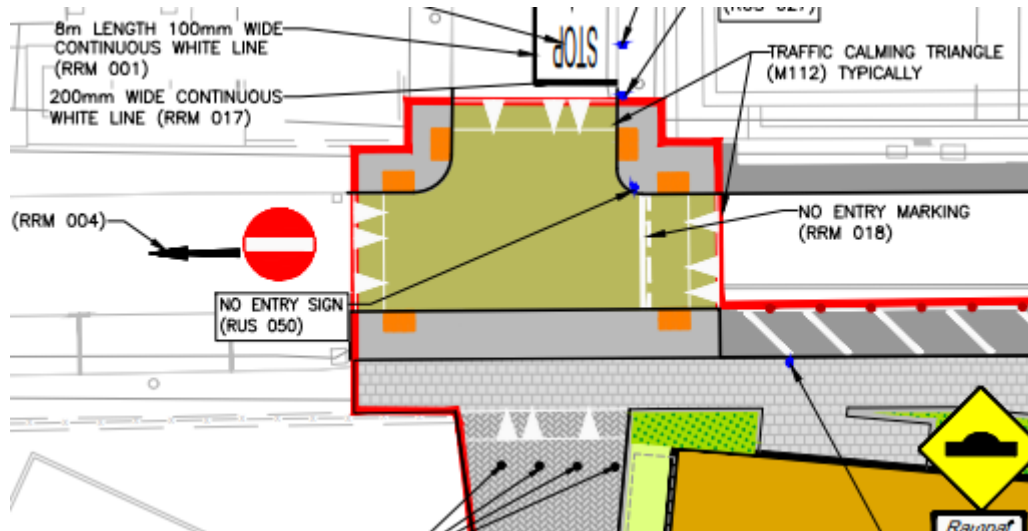
**Figure 8.3 – Interrupted Tactile Paving**

Some Existing Tactile Paving at the junction location in Figure 8.3 is interrupted by chamber lids (Figure 8.4). This may result in user confusion for pedestrians with vision impairments.

Relocate all chamber lids away from tactile paving locations or use recessed drainage lids.
