**Stage 1 Quality Audit Report  
Social Housing Bundle 4,  
Development at Church of the  
Annunciation, Finglas, Dublin City  
Council**

<b>Client:</b>	Malone O'Regan Consulting Engineers
<b>Document No:</b>	231860-ORS-XX-XX-RP-TR-13g-004

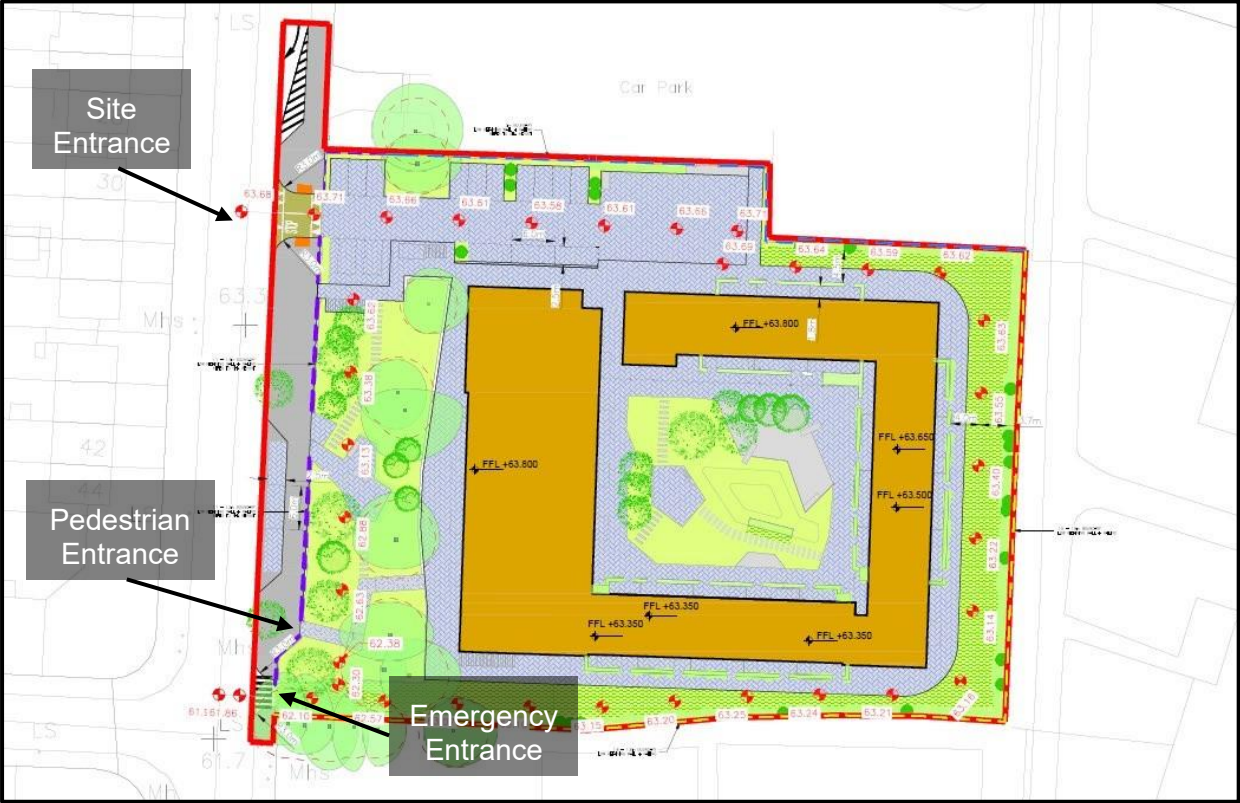
**Figure 2.2:** Site Layout (cropped) (Source: Malone O'Regan Consulting Engineers)

**Figure 2.2** shows the proposed site layout provided by Malone O'Regan Consulting Engineers.

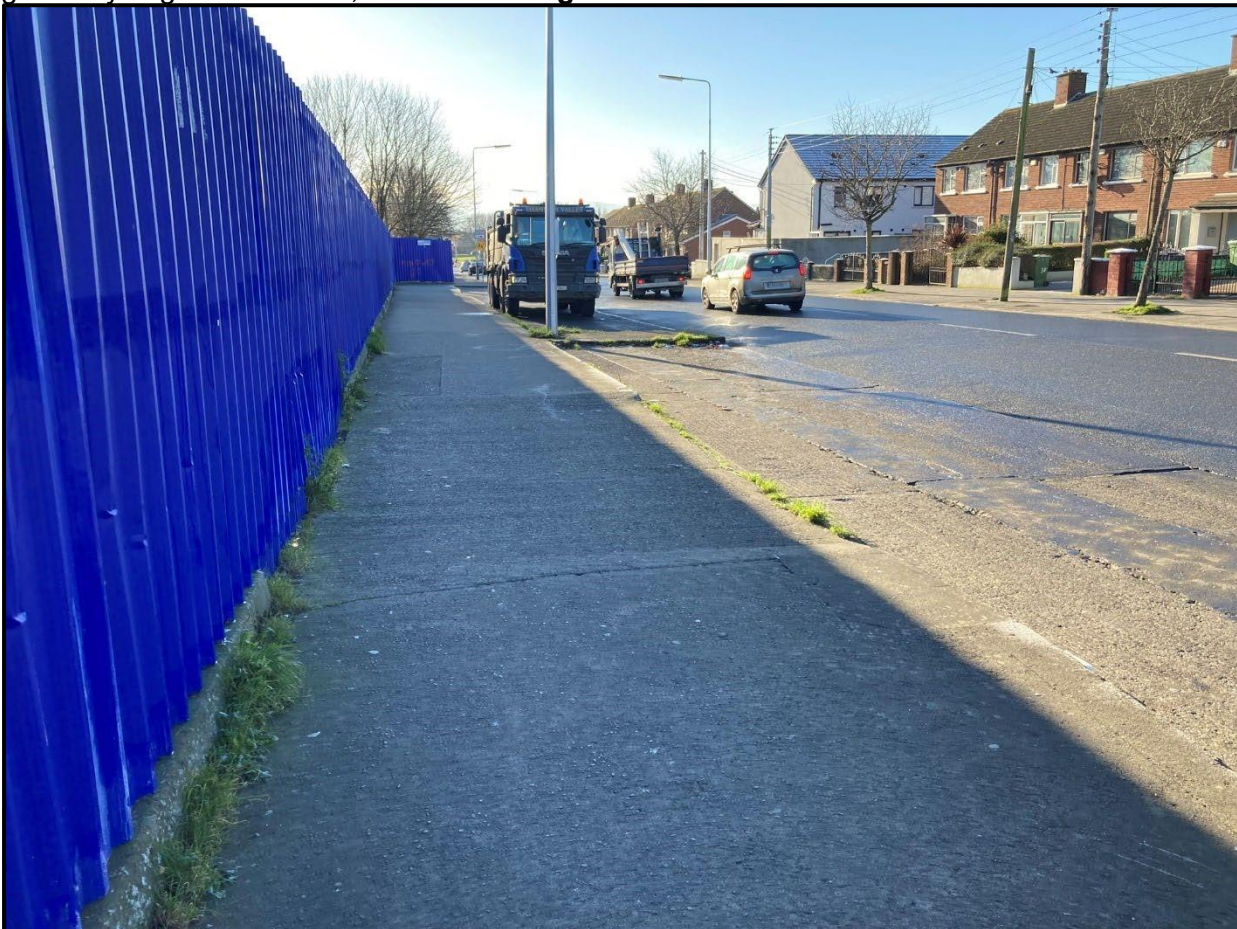
**Figure 2.3:** Cardiffsbridge Road at the site frontage (Source: ORS, January 2024)

The existing road network is equipped with road markings and signage, while the pavement is generally in good condition, as shown in **Figure 2.3**.

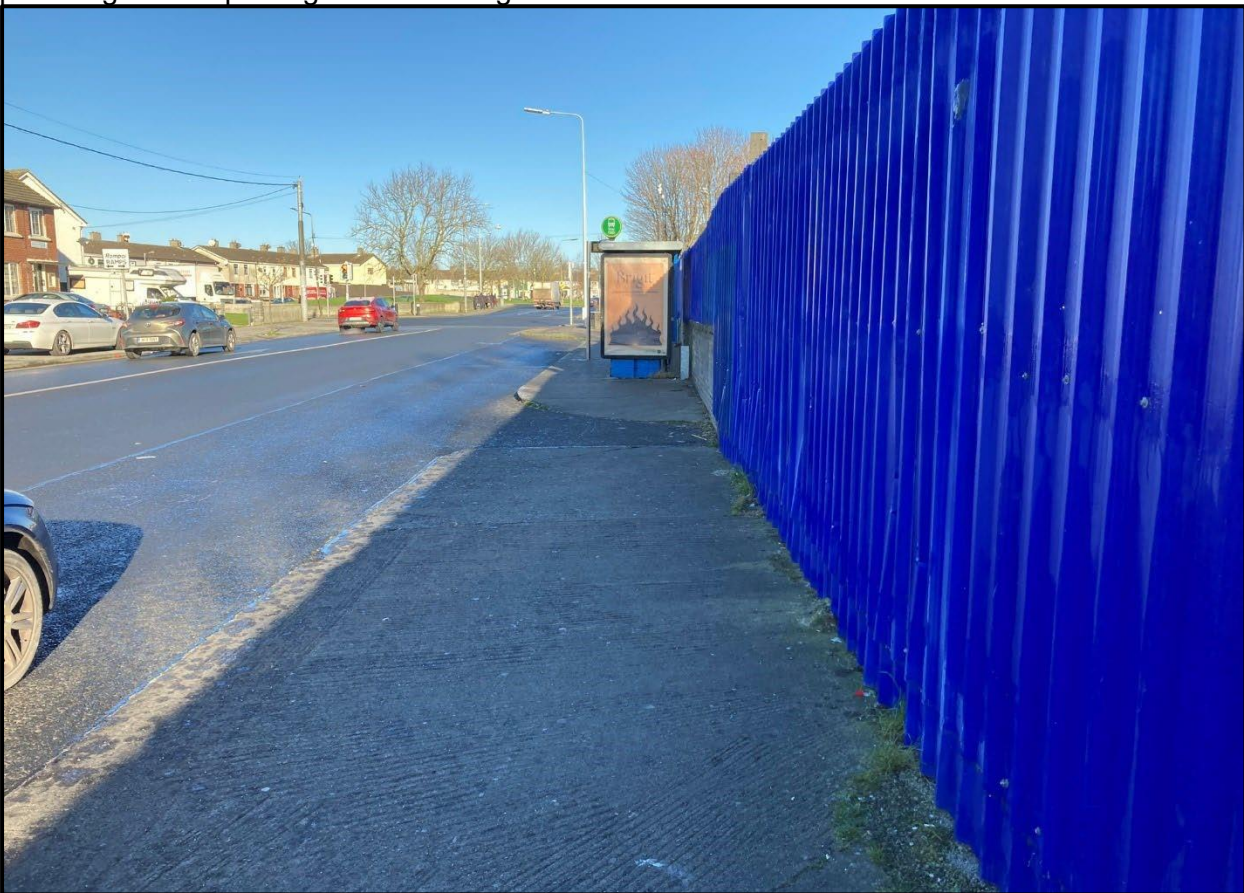
**Figure 5.1:** Existing footpath and bus stop location along the western site boundary (Source: ORS, January 2024)

The proposed upgrade on the footpath running along the western boundary of the development will link to existing adjacent footpaths (please refer to **Figure 5.1**). Currently, raised concrete footpaths are present on both sides of the road. Designated cycle facilities are absent along Cardiffsbridge Road and its vicinity. Consequently, the site does not include dedicated cycling facilities. Furthermore, the majority of the junctions in the area provide good pedestrian crossing facilities in the form of puffin pedestrian crossing with dropped kerbs such as the one at the junction between Cardiffsbridge and Cappagh Road at the north of the site entrance, providing a safer passage towards Finglas centre.

The bus stop provided adjacent to the entrance has the provision of a bus shelter with a bench and the bus cage is clearly marked, as shown in **Figure 5.1** above. The bus stop located to the other side of the site entrance does not provide a bus shelter or bench for its users. None of the bus stops were designed for disabled users with Kassel kerbs. **Table 5.1** overleaf outlines the available bus services in the area.

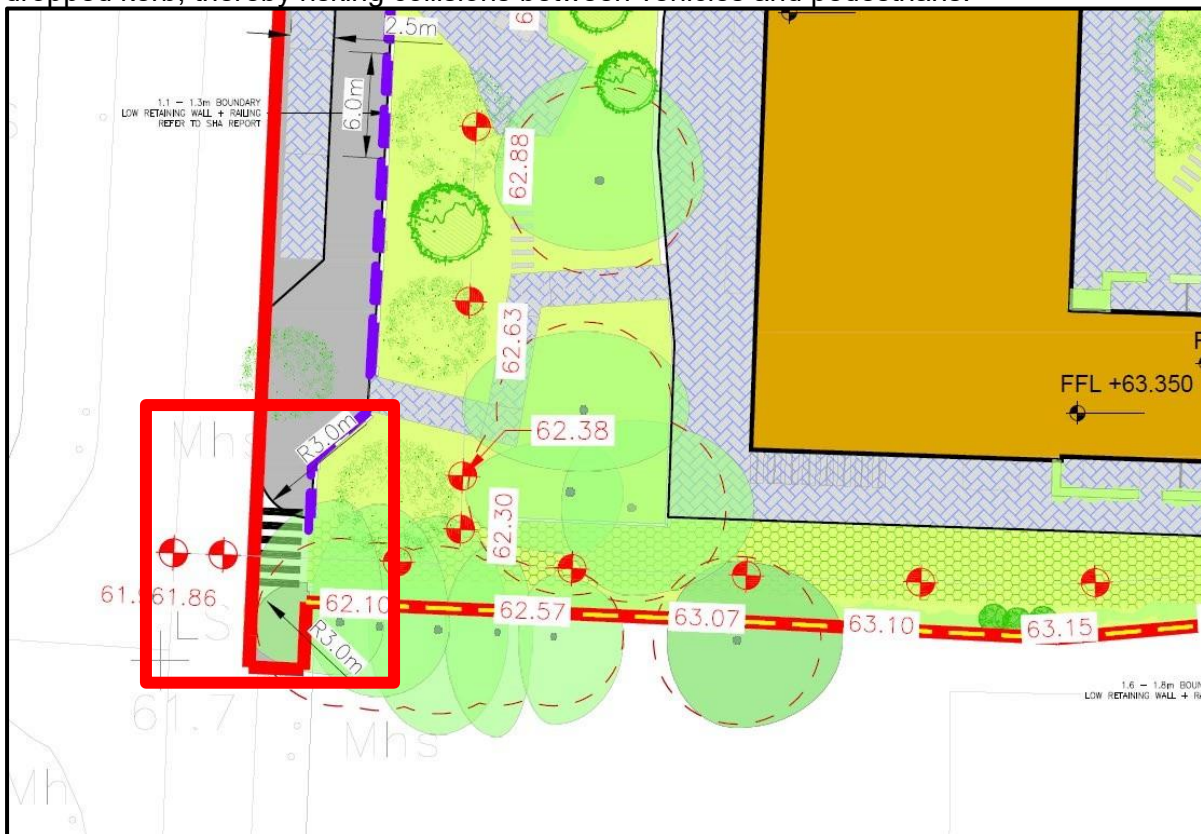
## Problem No.2: Vulnerable User Permeability – Dropped Kerbs

The audit team note from the drawings that there is a new uncontrolled crossing proposed at the southwestern corner of the site boundary. However, it is not evident from the provided drawings whether the necessary dropped kerbing is incorporated to enable users to access both sides of the footpath. The team expresses concern that wheelchair users may encounter difficulties accessing the footpath, potentially resorting to using the road to reach the nearest dropped kerb, thereby risking collisions between vehicles and pedestrians.

The design team should ensure that details and locations of dropped kerbs, connecting footpaths as well as tactile paving are provided for.

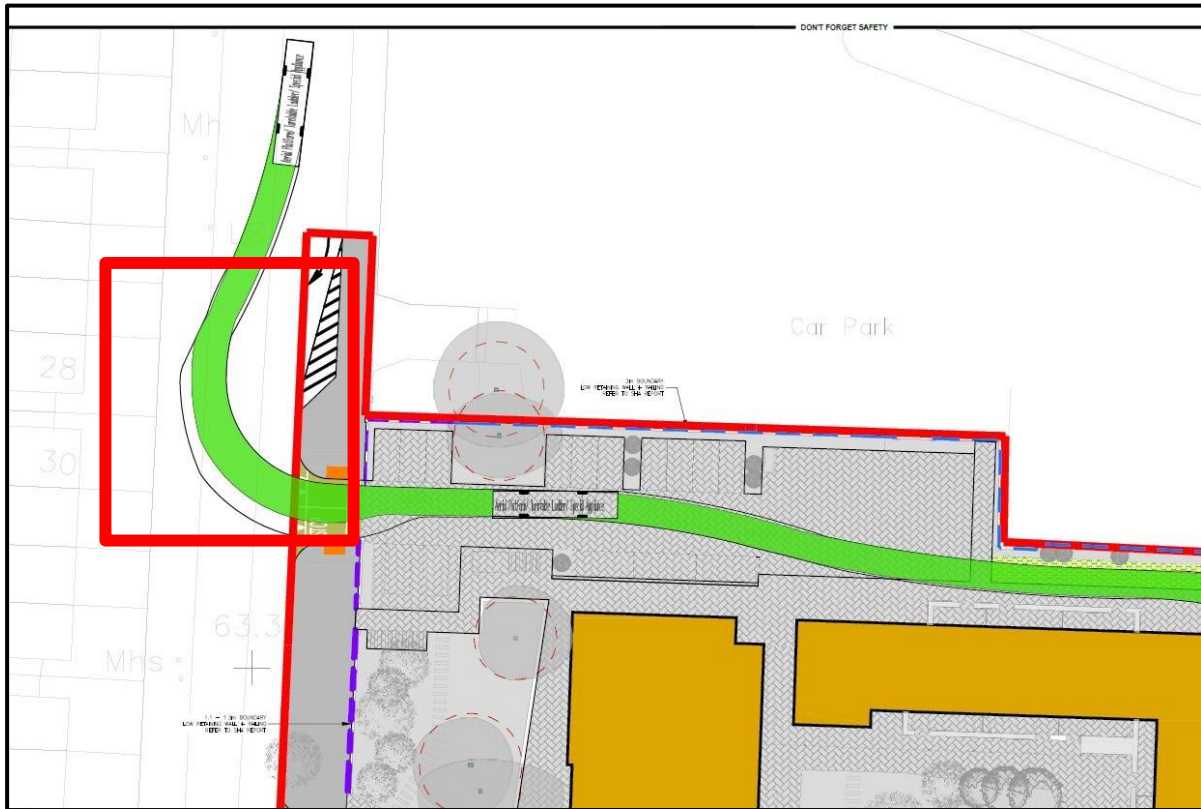
## Problem No.3: Swept Path Analysis

The audit team note from the Autotrack analysis provided for aerial platforms that the vehicle mounts the public footpath on the opposite side of Cardiffsbridge Road which poses a direct threat to pedestrian safety, as pedestrians may be at risk of collisions with these vehicles. Additionally, during the site visit, the audit team observed the presence of trees and instances

of illegally parked vehicles on the footpath, further exacerbating the risk of accidents, if these vehicles attempt multiple manoeuvres in order to exit the site.

The design team should ensure that all vehicles can safely enter/exit the site, without obstructing the safe passage of pedestrians or increasing the risk of collisions and accidents.

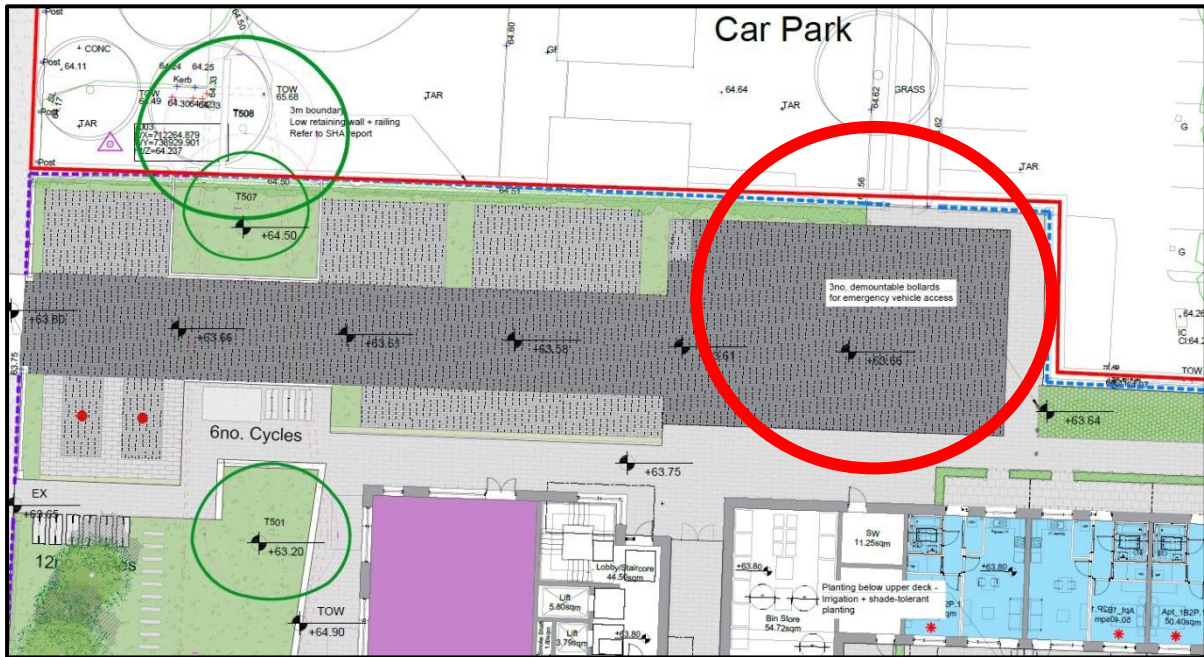
**Problem No.4: Open Space Leading to Illegal Parking**

The audit team note from the plans provided that there is a large open area identified below next to the proposed carpark area which could result in illegal parking. This could potentially result in an increased risk of vehicle conflict which could result in injury.

The design team should incorporate measures at the area identified, such as a hammerhead to facilitate turning vehicles within the development.

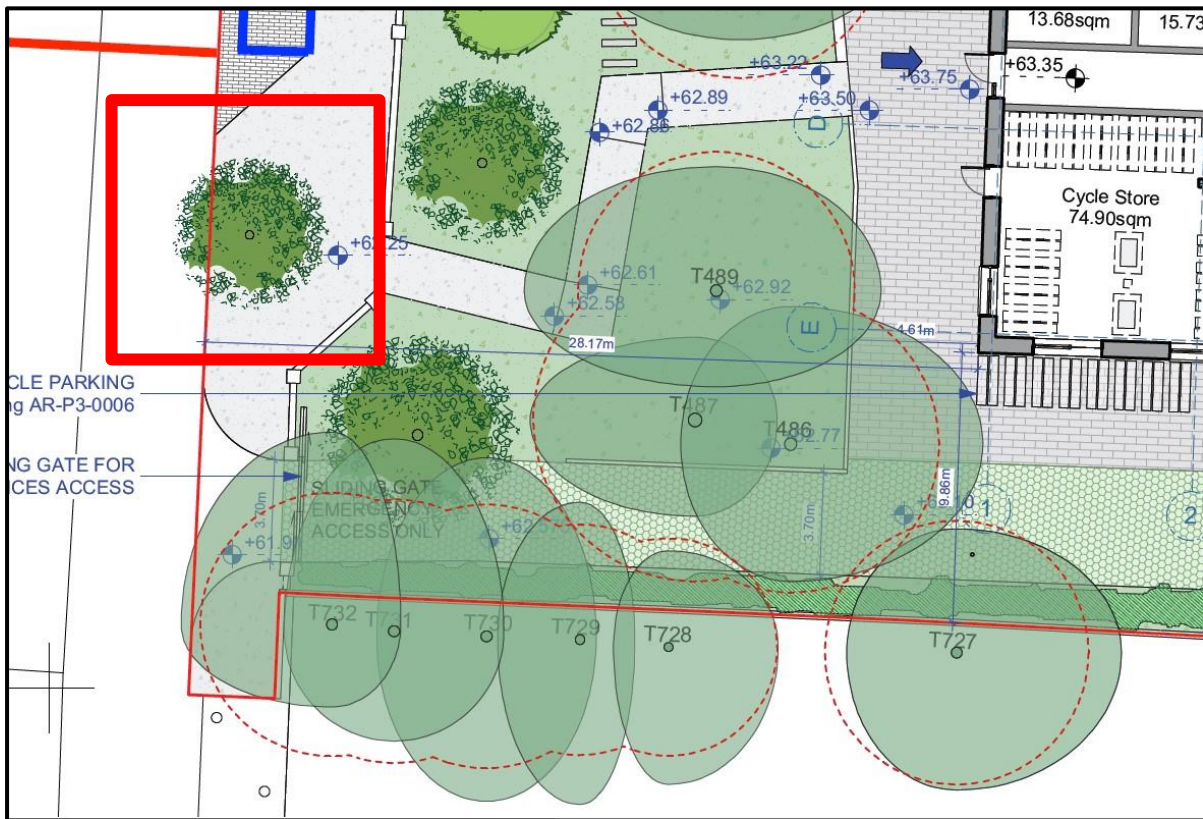
**Problem No.5: Sightlines**

The audit team note from the plans that while adequate sightlines are initially provided for emergency vehicle access, concerns arise due to the presence of existing trees that are being retained and the proposed addition of another tree near the on-street parking spaces. These trees could potentially hinder visibility if they become overgrown. Inadequate visibility splays for emergency vehicles pose a significant risk, potentially leading to side impact or rear-end shunt-type vehicle collisions, resulting in injuries.

The design team should carefully assess the proposed landscaping plans to ensure that the type and placement of trees does not compromise visibility for emergency vehicles. If necessary, consider relocating or adjusting the placement of trees to maintain adequate sightlines.

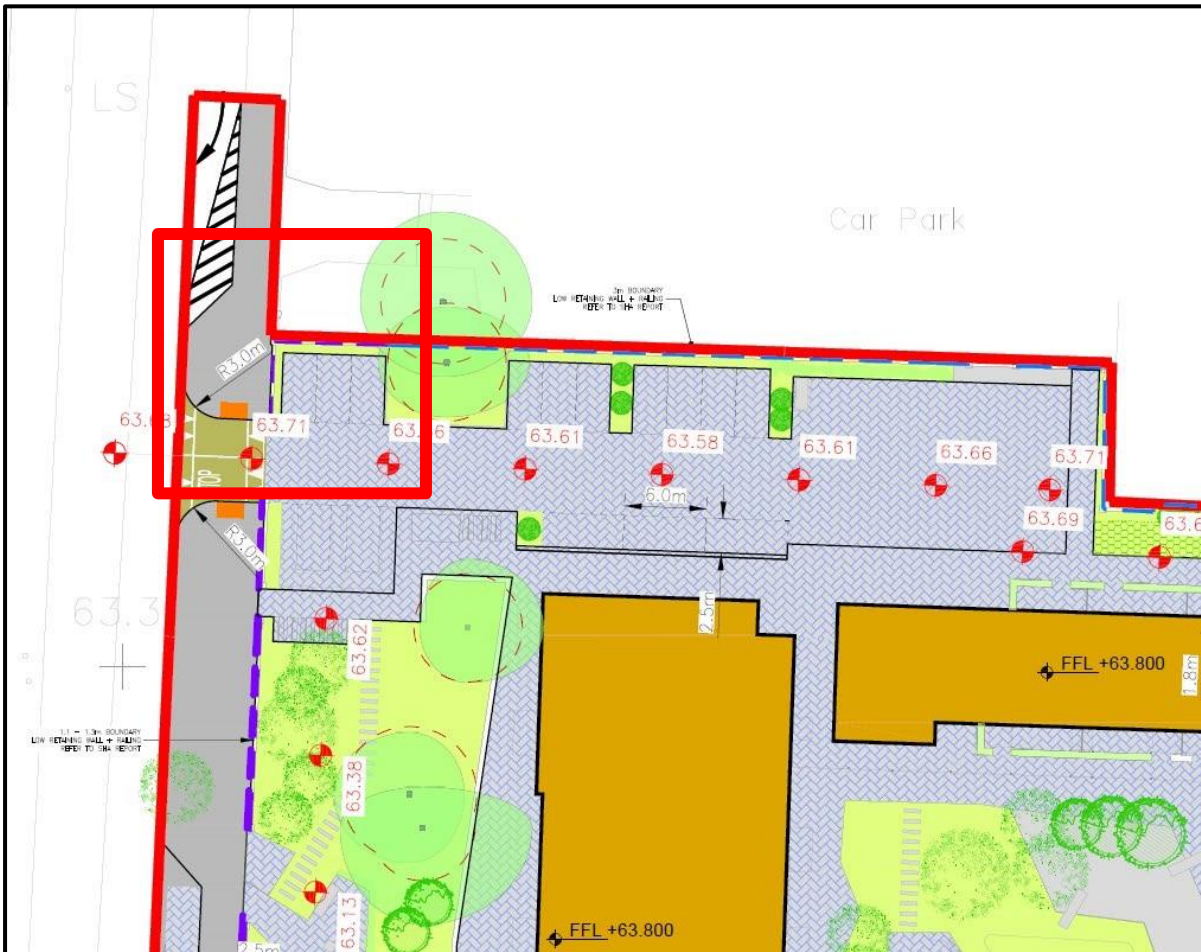
**Problem No.6: Parking at Main Entrance**

The audit team note from the drawings provided that there are car parking spaces proposed in close proximity to the main access point. The audit team is concerned that vehicles entering and exiting these parking spaces may hinder the movement of traffic into and out of the development. This could potentially lead to collisions at the main access point and may result in vehicles straddling the footpath while waiting for vehicles to negotiate the parking areas.

The design team should review the possibility of relocating these parking spaces to the large turning area within the development where there appears to be ample space to provide parking.
