IGSL Ltd

**NDA Social Housing
Bundles 4/5
Lot 3 – Croke Villas**

**Ground Investigation
Report**

Project No. 25000-3

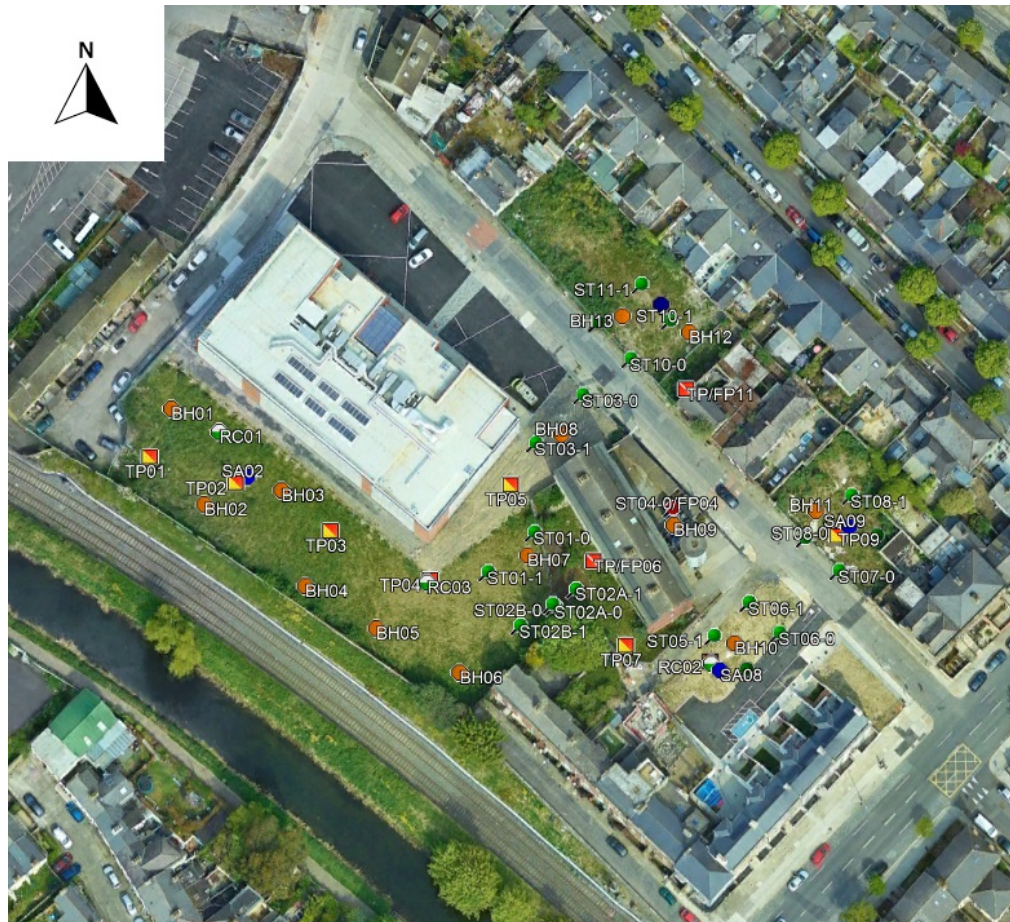
Figure 1 - Location Plan (Site Investigation Points overlain)

An investigation of subsoil conditions was undertaken by IGSL Limited at the site of a proposed social housing development at Croke Villas, Sackville Avenue, off the Ballybough Road, Dublin 3. The works were undertaken for Malone O'Regan Consulting Engineers [MORCE] on behalf of the National Development Finance Agency (the "NDFA"). The site formerly comprised four 5-storey local authority flat blocks (Figure 1). Croke Villas is one of the Strategic Development and Regeneration Areas identified in the Dublin City Development Plan 2016-2022. The intention is to provide new high quality residential / office development combined with enhancing the access to Sackville Avenue from Ballybough Road and re-develop Sackville Avenue as a high-quality public domain space (Dublin City Council, n.d.).

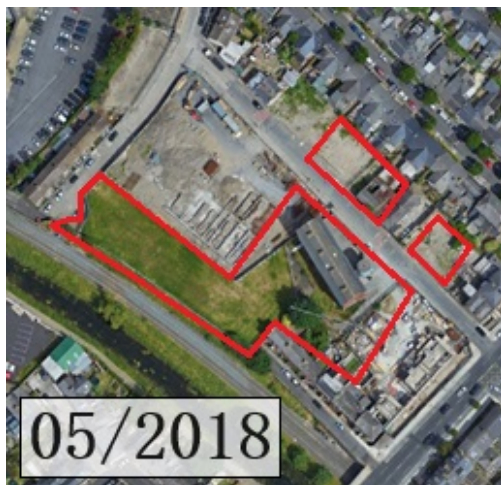
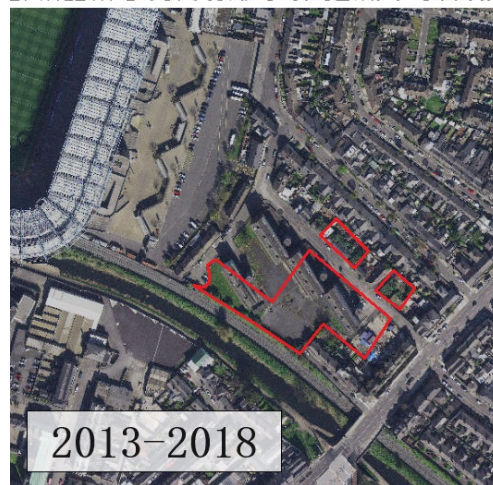
Figure 2 – Tailte Éireann historic OSI and Cassini drawings with OSI 2013-2018 and Google Earth imagery from 2018 showing the evolution of the site.

The 2013-2018 orthophotograph shows the four blocks in place, three of which were demolished by Tinnelly Group in late 2017 / early 2018. (See Fig 3A & 3B - Tinnelly Group, 2018). The Google Earth Professional image dated 05/2018 shows the footings for the new GAA Hand Ball Centre.

Google Earth Professional image dated 05/2018

Images taken from Tailte Éireann 'Townland and Historical Map Viewer'

and its line of terraced houses which made way for the Corke Villas development of the later 1950's (See Figure 2).

- Trial pit TP07 was positioned in an area of grass cover in the shadow of the last remaining block of flats. The location places it close to the corner of the former Love Lane North roadway and its adjoining terraced houses (See Figure 2). The Made Ground content appeared compositionally finer with only cobble-sized fragments noted. It was determined through visual pitside examination, that the Made Ground extended to a depth of 1.60m (2.46m OD).

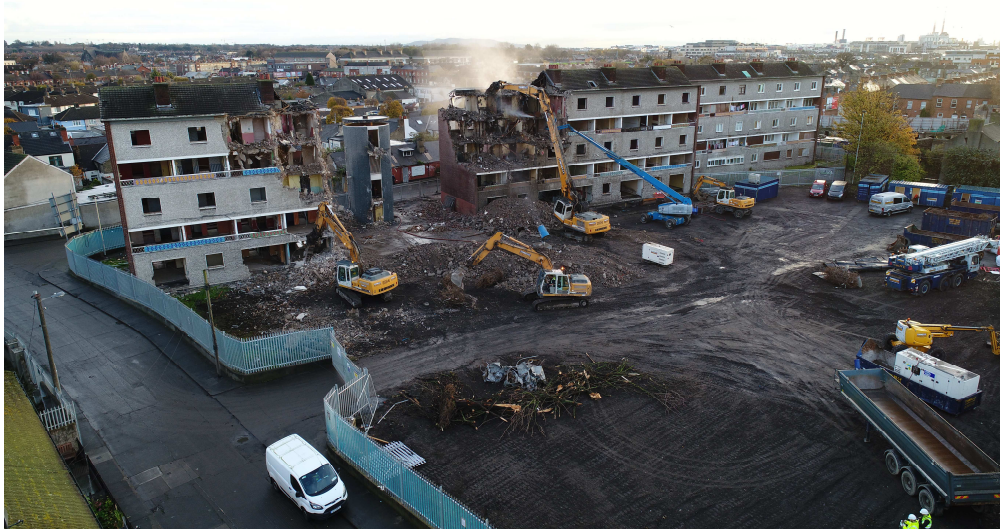
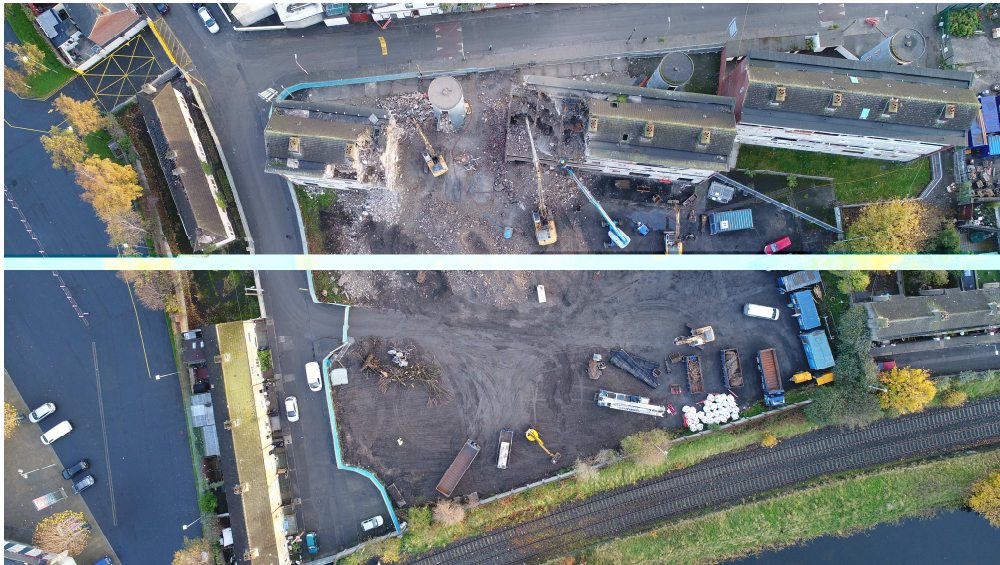
Figures 3A & 3B – Demolition underway at the Croke Villas Site (Tinnelly Group, 2018). Fig 3A ‘Back Block’ removed (foreground) with work underway on two other blocks (No.s 1-21 & No.s 22-42). **Fig 3B** Aerial view of works with Sackville Avenue to the top of the photo and Ardilaun Square to the left. The Ballybough Railline and Royal Canal run to the bottom of the photo.

- In each of TP01-TP04, the Made Ground was encountered beneath an initial cover of placed Topsoil measuring 200mm thick. It is likely this was placed directly on the hardcore gravel which was draped across the area during demolition (See Figures 3A & 3B). This layer forms part of the initial Made Ground consisting largely of dark brown and grey sandy slightly gravelly CLAY with red bricks and plastic. At TP01, the Made Ground extended to a mere 1.30m bgl (2.56m OD). However, in the case of TP02, a base was not found to the Made Ground with a concrete slab exposed at 2.0m depth (2.12m OD). This may be a relict feature of the ‘Back Block’ foundations. Figure 6 suggests TP02 was positioned close to if not on the ‘Back Block’ footings. This would imply the Made Ground from 0.20-2.0m comprised trench backfill.

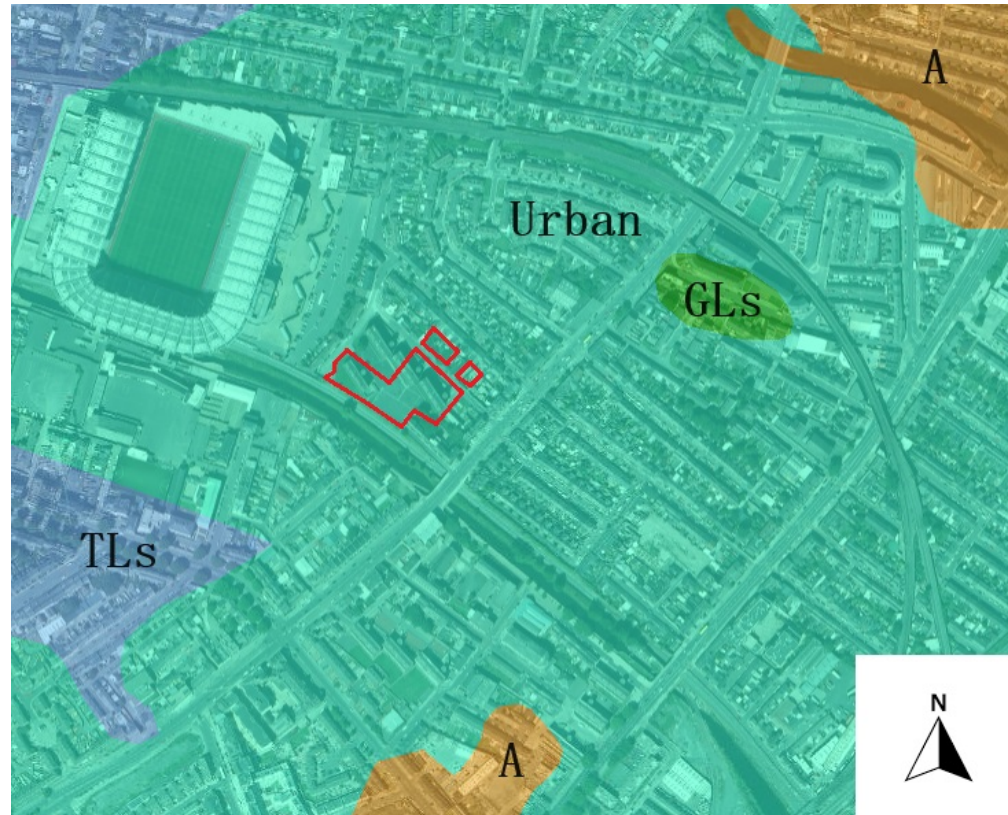
Figure 4 – Quaternary Soils Plot for the Croke Villas Site (Site investigation area outlined)

Map Key	Urban	- Unclassified – Urban Cover
	A	- Alluvium
	TLs	- Till derived from Limestones
	GLs	- Gravels derived from Limestones

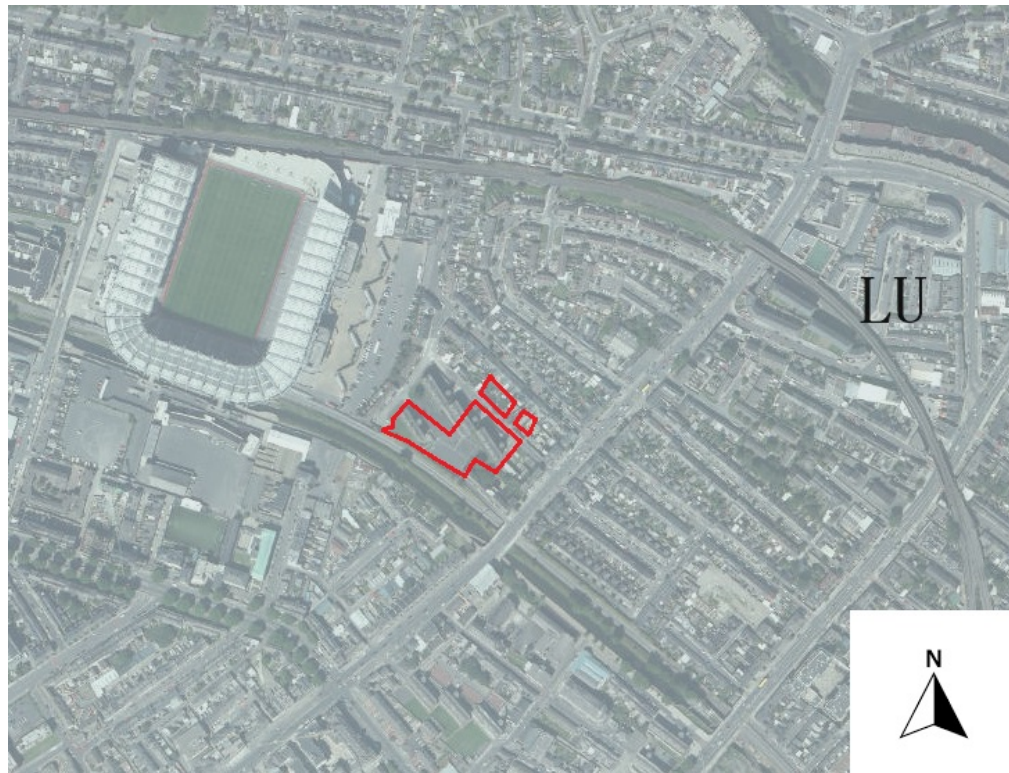
Figure 5 - Bedrock Geological Map for the Croke Villas Site (Site investigation area outlined)

Key: LU = Lucan Formation

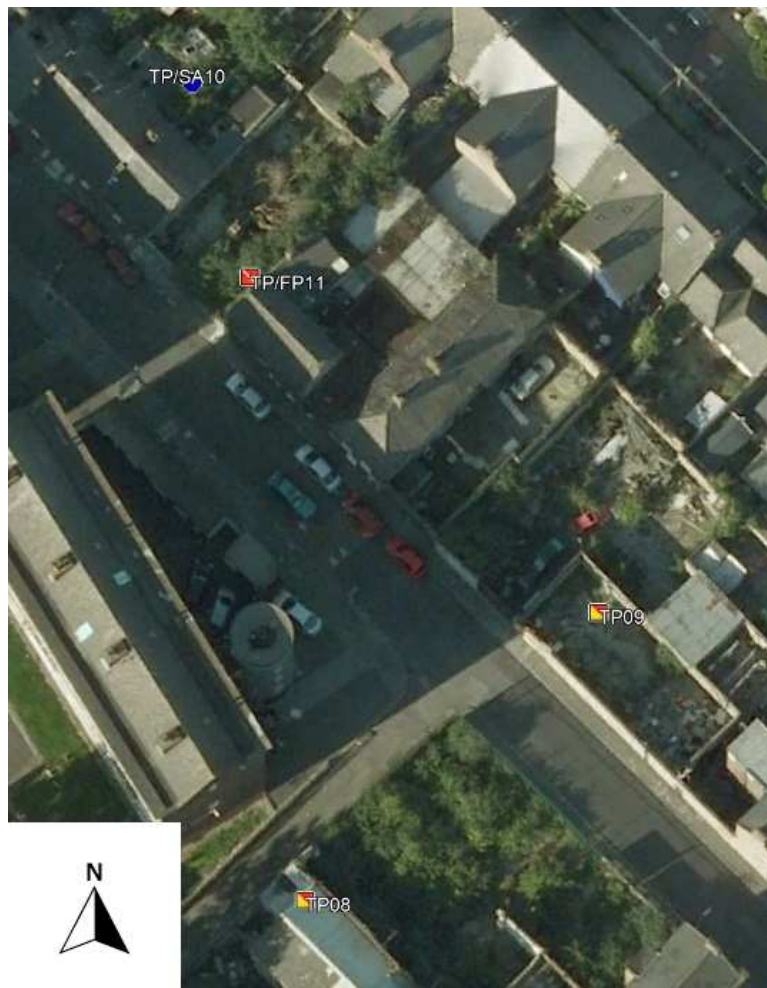
Figure 8 – Trial Pit locations TP08-TP11

- The sewage main found in TP11 at 1.60m bgl (2.63m OD) prevented further excavation.

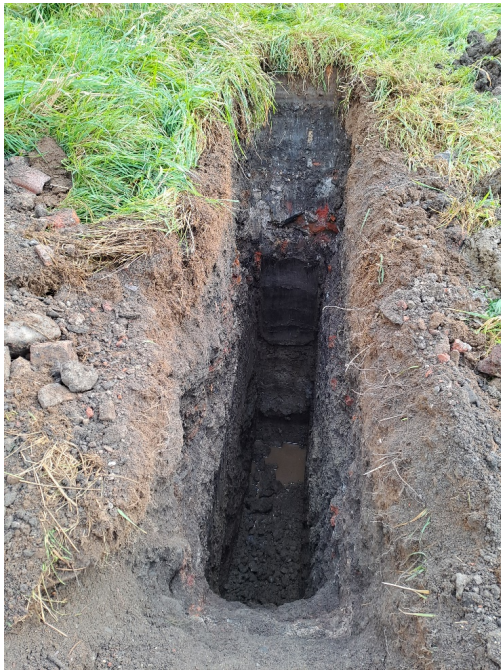
Figures 9A & 9B – Sidewall profiles photographed during trial pitting. Fig 9A TP03 Gravelly Made Ground to 1.30m (2.83m OD) meeting natural stiff black sandy gravelly CLAY with a low cobble content underlain by stiff grey mottled light brown sandy slightly gravelly CLAY from 2.0m to 2.90m bgl. Pit ended in stiff brown sandy gravelly CLAY at 3.10m (1.03m OD). Moderate water ingress at 2.80m. **Fig 9B** In TP05, Made Ground extended to the base of the pit at 3.0m (1.08m OD). It was described as a dark brown gravelly Sand with a low cobble content, red brick fragments, plastic and cobble-sized concrete fragments.

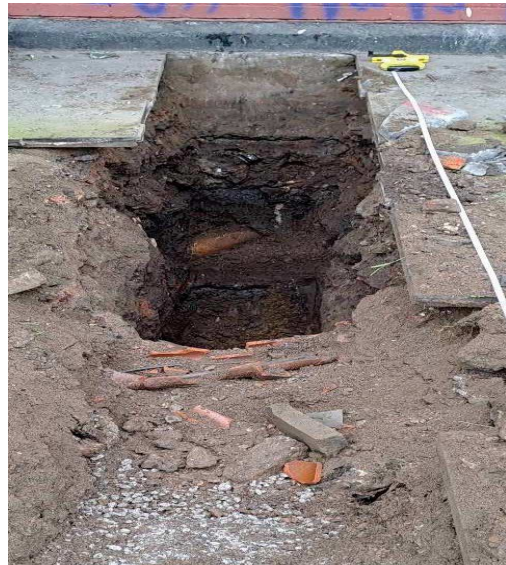
TRIAL PIT NO. **FP04**

from	to	Description	Ground water
0.00	0.06	Concrete slabs	DRY
0.06	2.00	MADE GROUND: Firm dark brown to black sandy gravelly CLAY with a low cobble content, red brick fragments, plastic and concrete.

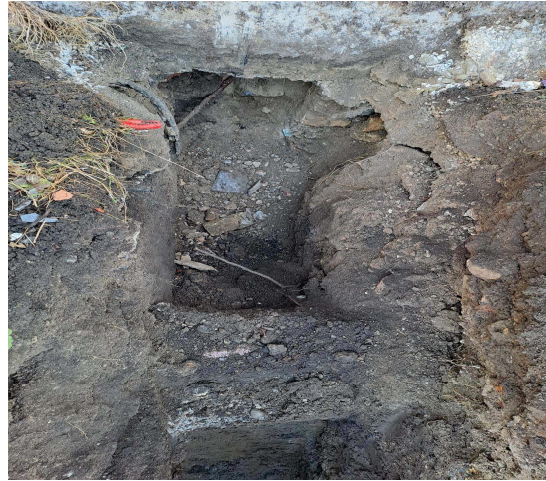
from	to	Description	Ground water
0.00	0.10	TOPSOIL	DRY
0.10	0.50	MADE GROUND: Dark brown/black sandy slightly gravelly CLAY with red brick fragments	
0.50	0.90	MADE GROUND: Brown sandy gravelly CLAY with red brick fragments, plastic and cobble-sized concrete fragments	
0.90	1.60	MADE GROUND: Dark brown/black sandy slightly gravelly CLAY with red brick fragments	
1.60	1.90	(Dense) Light brown clayey sandy GRAVEL with a low cobble content

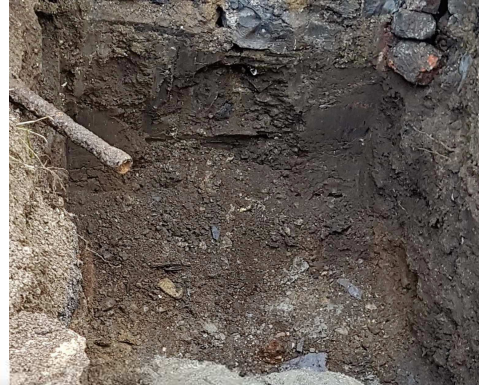
TRIAL PIT NO. **FP11**
SHEET Sheet 1 of 1

from	to	Description	Ground water
0.00	1.60	MADE GROUND: Brown to grey sandy gravelly CLAY with red brick fragments, plastic and cobble-sized concrete fragments	DRY

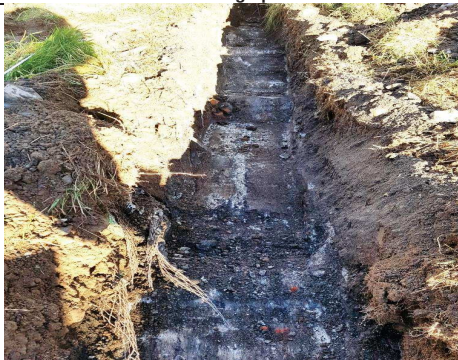
From (m)	To (m)	Soil Description	Photograph
0.00	0.10	TOPSOIL

0.10	1.80	MADE GROUND (comprised of dark grey/black/brown sandy gravelly clay, cobbles, boulders, heavy concrete rubble, red brick, timber pieces, occasional plastic rubbish, roots, old tarmac, mortar, concrete blocks)

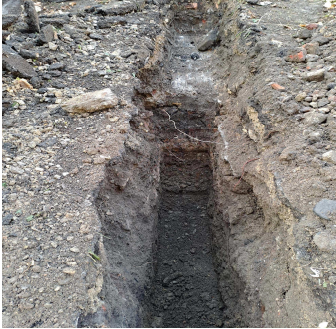
Ground Conditions			Photograph
From (m)	To (m)	Soil Description	
0.00	0.08	TARMAC

0.08	2.00	MADE GROUND: Soft to firm brown sandy gravelly CLAY with a low cobble content and red brick fragments, plastic and concrete.

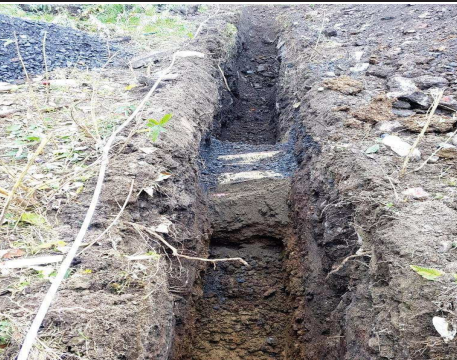
From (m)	To (m)	Soil Description	Photograph
0.00	0.10	TOPSOIL

0.10	2.00	MADE GROUND comprising dark grey/black/brown sandy gravelly clay, cobbles, boulders, concrete rubble, red brick, timber pieces, occasional plastic rubbish, roots, old tarmac, mortar, old clay pipe pieces and rebar

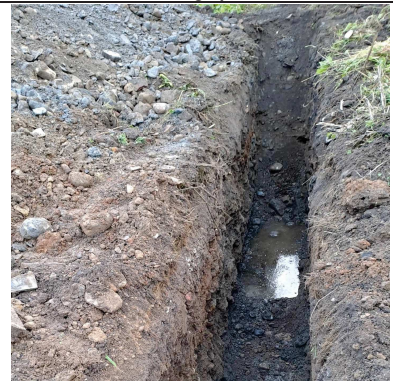
Ground Conditions			Photograph
From (m)	To (m)	Soil Description	
0.00	0.10	TOPSOIL: Soft brown sandy gravelly CLAY. Sand is fine to medium. Gravel is subangular to subrounded fine to medium.

0.10	2.00	MADE GROUND: Firm dark brown to black sandy gravelly CLAY with a low cobble content and red brick fragments, plastic and concrete. Sand is fine to medium. Gravel is subangular to subrounded fine to medium. Cobbles are subrounded.
