Proposed Redevelopment at the Stanley Street Depot
Stanley Street
Dublin 7

SHB4-SSD-RP-MA-AR-P3-001
Preliminary Heritage Impact Assessment Report

September 2024

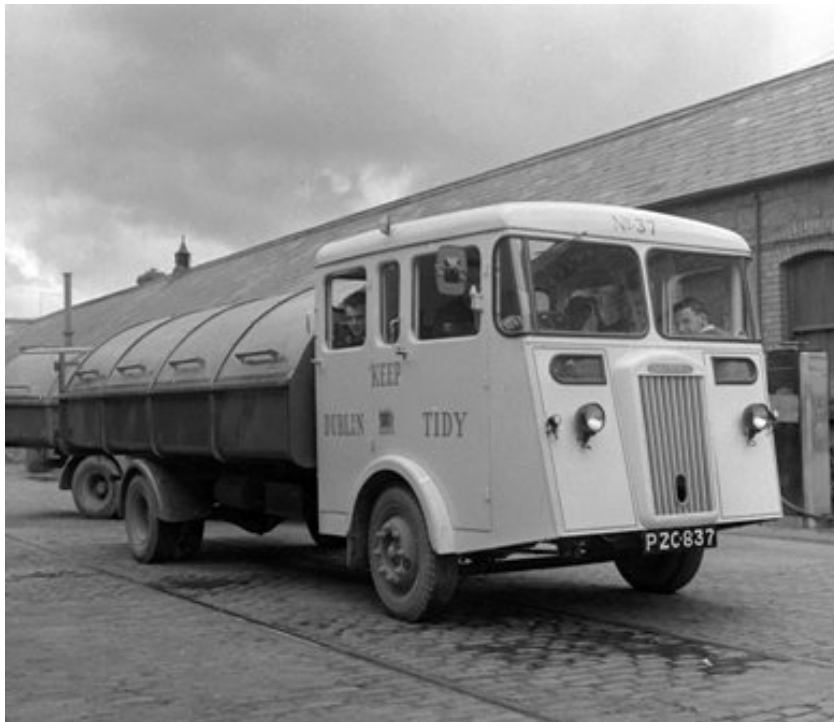
Plate No. 1. Historic photo showing an electric bin lorry in the Scavenging Depot around 1970. The structure to the rear is likely one of the large 19th century structures that stood at the centre of that depot, before being replaced by the currently existing maintenance garage.

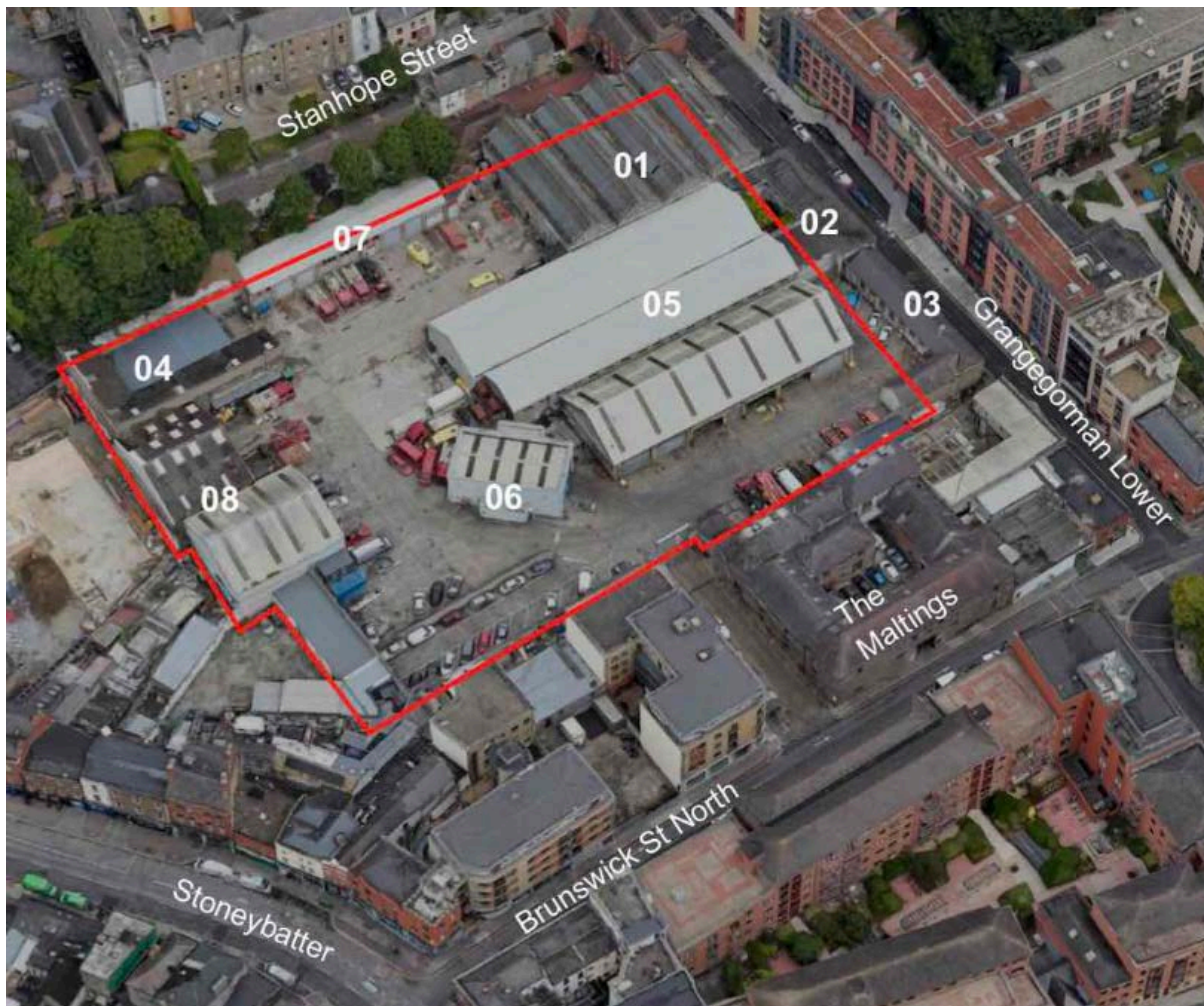
Plate No. 8. Recent aerial view of the site of the proposed development, showing all of the structures currently standing in the depot. This image is included in the Sean Harrington Architect's Architectural Design Statement, included in the current application. The buildings are numbered for reference in that report, and the following report will make reference to those numbers for clarity and continuity between those reports.

In this photo, Grangegorman Lower is seen on the upper right, forming the eastern edge to the depot site. Brunswick Street North runs east-west at the lower right, and Stanley Street is the short street beside The Maltings building.

In comparing this aerial view to the Ordnance Survey map shown on the previous page, there only a few changes to the site over the last half century. Building No. 06 has been built to replace an earlier structure of similar size. The large Building No. 05 is shown here as consisting of three long narrow sections, all covered with modern steel cladding materials. The southern part of Building No. 05 has been largely rebuilt, replacing whatever remained of the late 19th century Scavenging Depot main building. Also, a large five-storey structure that stood at the north-west corner of the large Building No. 05 was removed around 2010-2015.

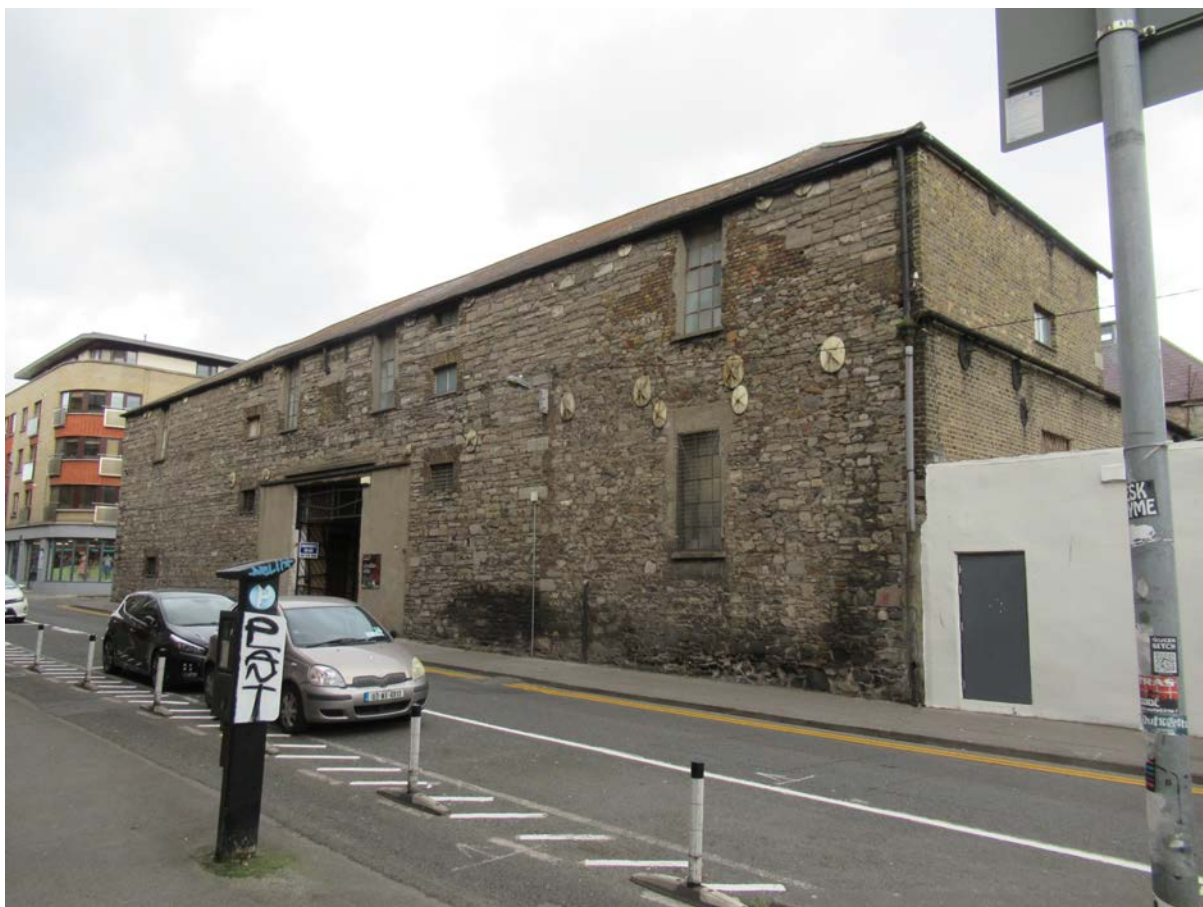
Plate No. 9. South elevation of the former Malting House, on Brunswick Street North. This view shows the principal south elevation, with the central access arch at the centre of the structure, providing access to a central courtyard.

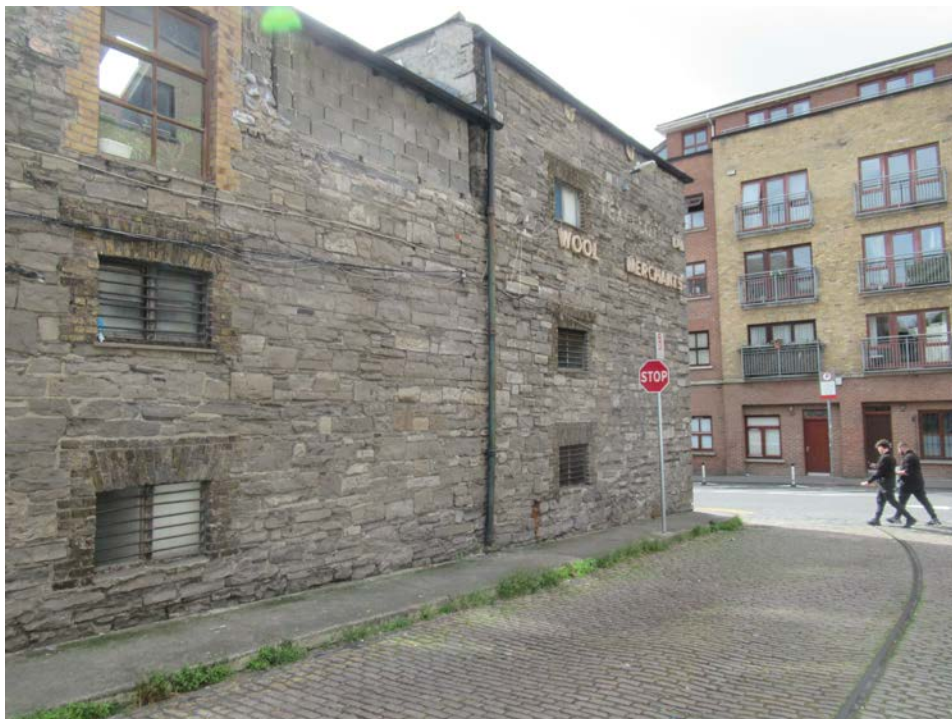
Plate No. 10. West side elevation of the former Malting House, showing its relationship to Stanley Street at right.

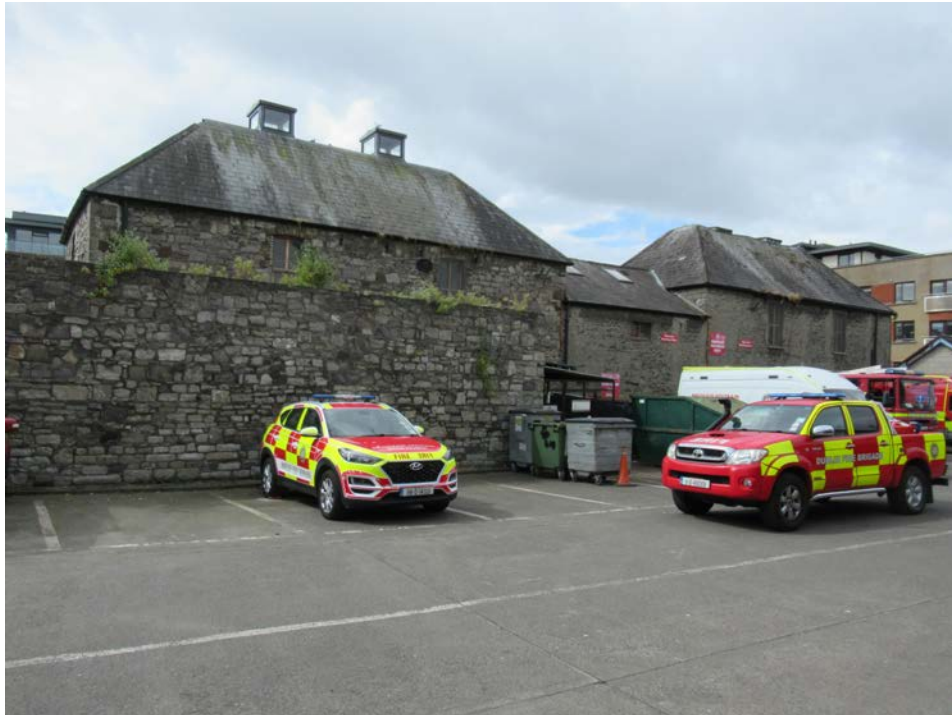
Plate No. 11. Rear north elevation of the former Malting House, showing the characteristic roof forms over the drying kilns, required to dry out the freshly malted barley, to prevent it from continuing to grow. This elevation will continue to be visible from within the proposed development. The length of limestone rubble masonry behind the red and yellow car is the remaining south wall of the L-shaped single storey structure that was part of the Scavenging Depot.

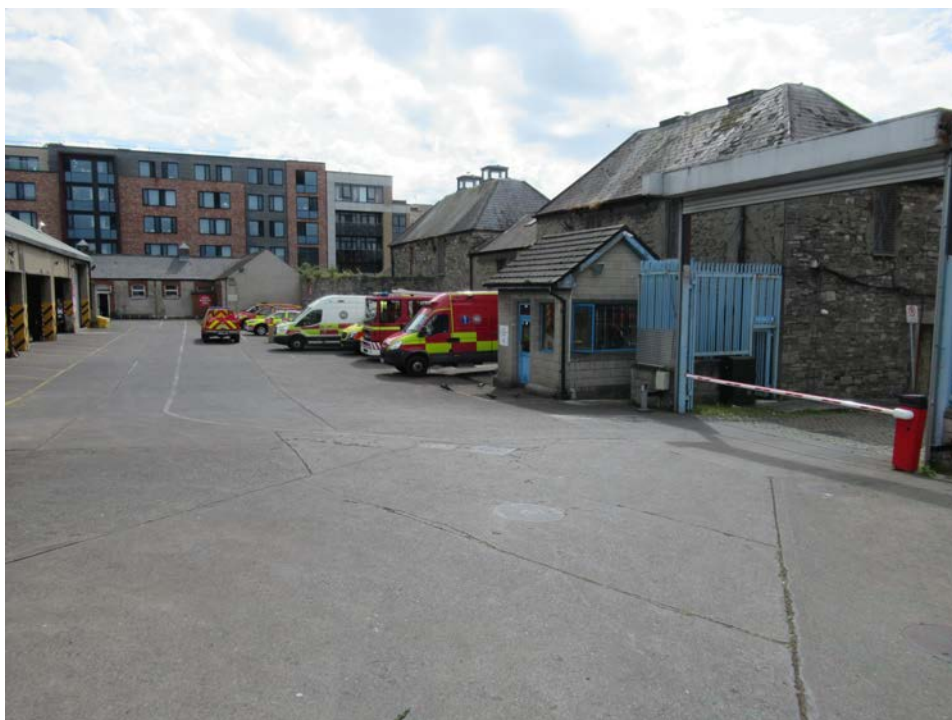
Plate No. 12. General view looking east across the depot, showing the north side of the former Malting House, as well as the remaining corner of the L-shaped structure in the distance.

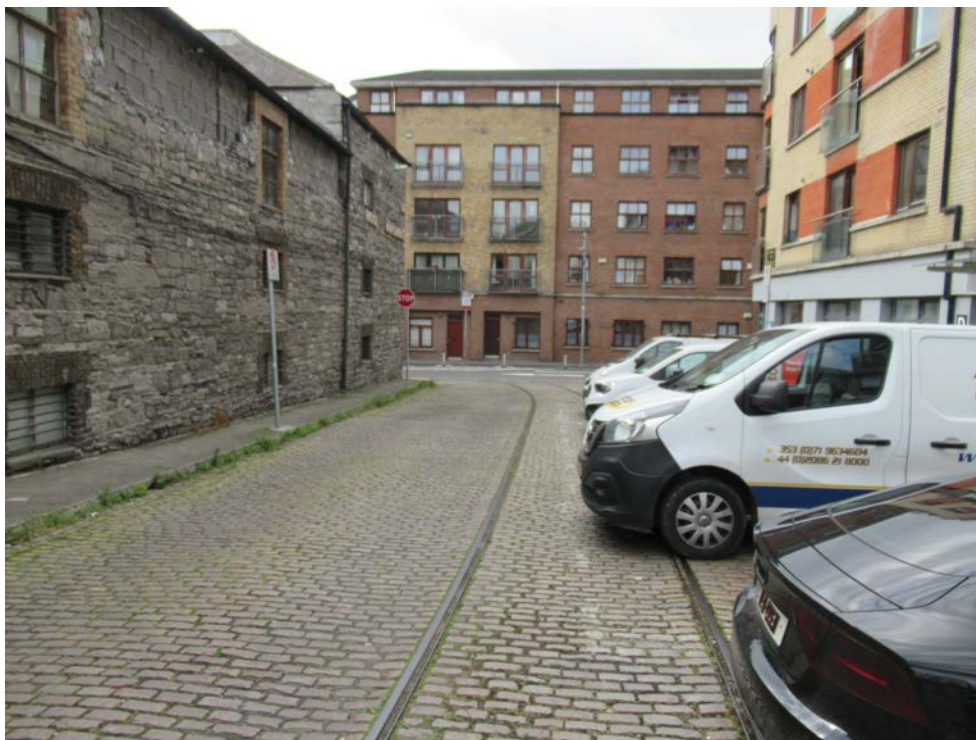
Plate No. 13. General view looking south showing Stanley Street, with its historic iron tram tracks and stone paving sets. The former Malting House is at the left of this photo.

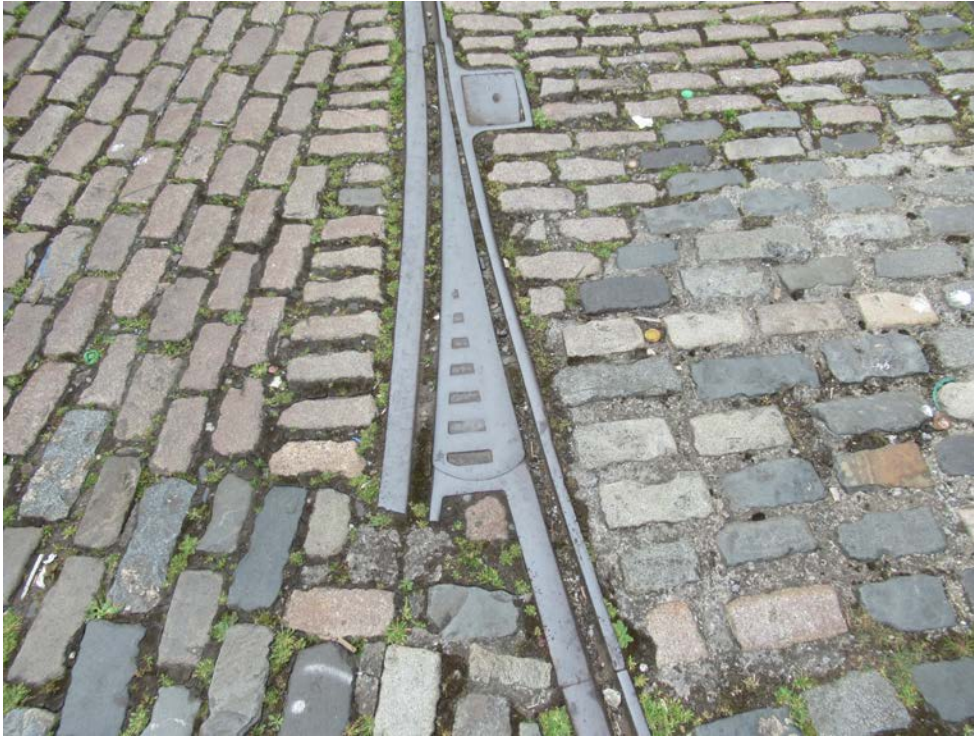
Plate No. 14. Detail view showing the early 20th century tram track and colourful paving setts in the north end of Stanley Street. The section of poorly laid setts at the right of the photo are evidence of a poorly crafted repair to the paving. It appears that the setts have been placed on their sides instead with on their edges, and setts from different sources have been introduced that are of different colours and sizes.

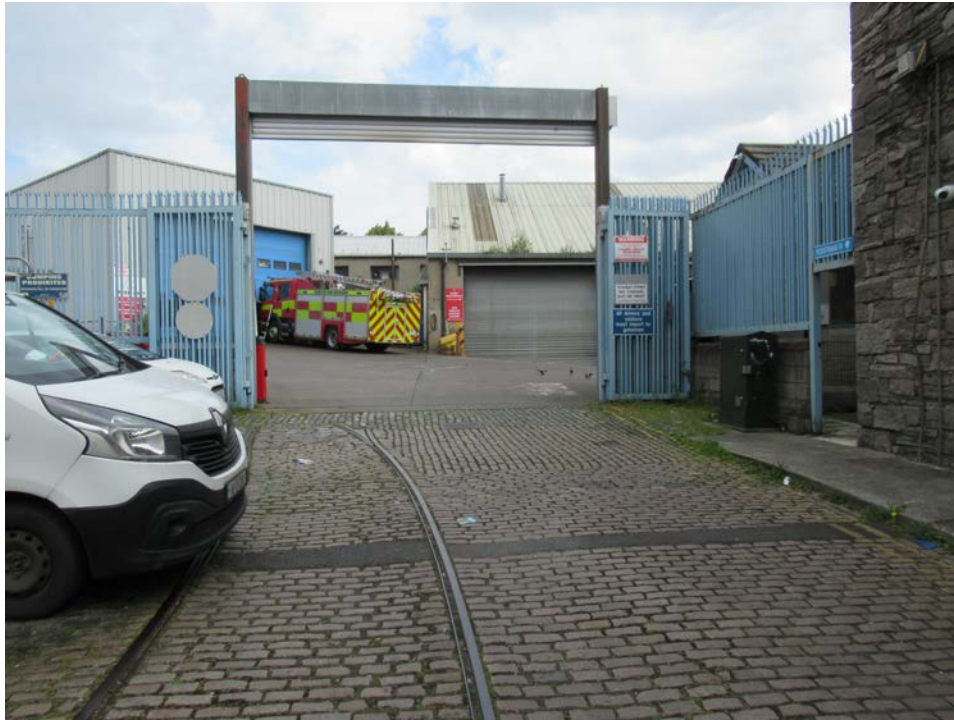
Plate No. 15. General view looking north at the top of Stanley Street, showing the current appearance of the entrance into the development site. The north west corner of the former Malting House can be seen at the right.

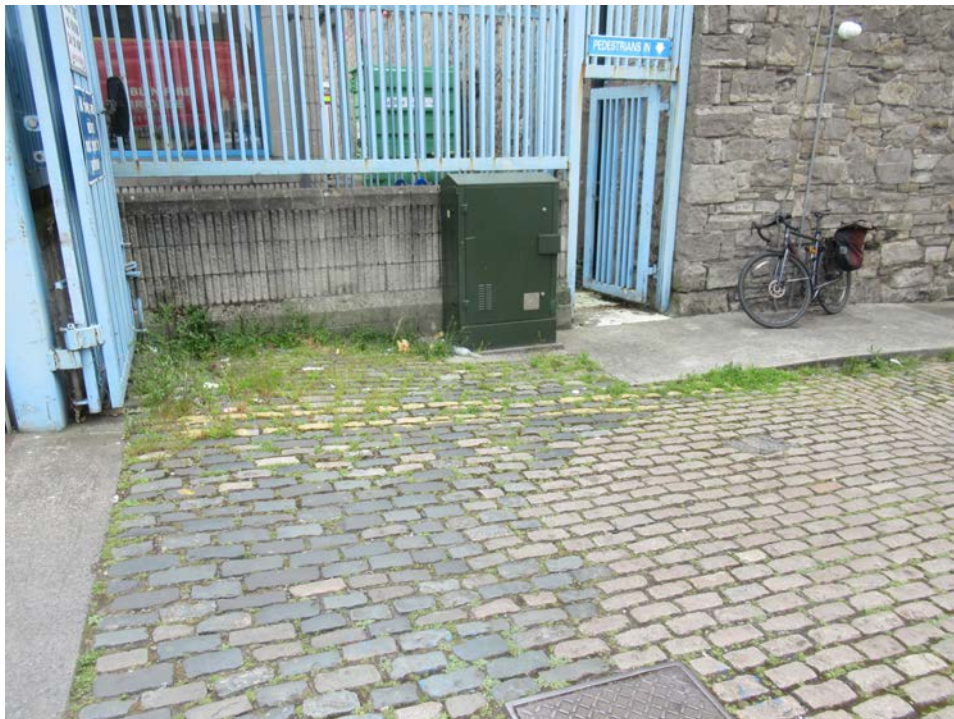
Plate No. 16. Detail view showing evidence of changes to the the original stone setts at the north end of Stanley Street. Different types of stone, of different colours, can be seen. Most of the setts are pinkish granite, with black basalt stones seen in other areas such as above. The proposed extension of the public footpath on the east and west edges of Stanley Street, will improve accessibility into the new development.

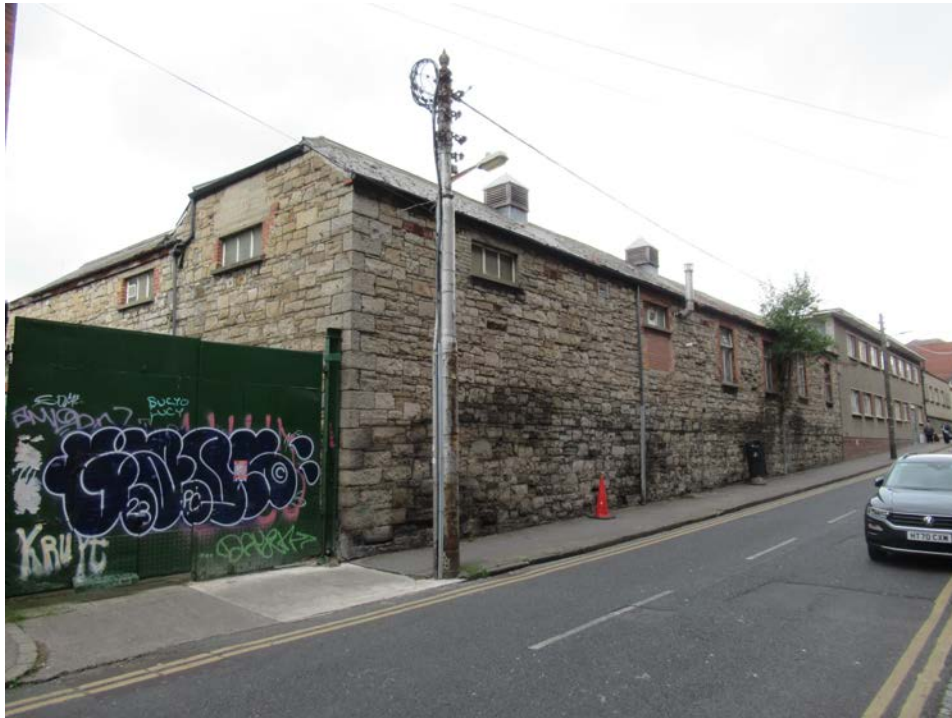
Plate No. 17. General view showing the south-east corner of the 19th century L-shaped structure and its relationship to Grangegorman Lower. The gate at the left blocks the former entrance to Fountain Place, now in private ownership. Note the massive limestone quoins in the corner, compared to the finer grain of the coursed rubble masonry on the rest of the walls.

The current development proposals, as designed by the project architects, will retain the south and east elevations of the L-shaped structure, with some modifications to the eastern elevation to accommodate a new entrance into the lower ground floor of the apartment block in the south-east corner of the development. The new entrance will provide access to the main stairwell in the block of apartments, as well as access to two communal spaces. New window openings will also be created through the rubble stone wall to provide light, ventilation and connection to the public street for the communal spaces. The rubble stone masonry will be repaired and repointed following conservation best practice, and all interventions to accommodate the new development will carefully detailed and executed, to recognise that those are contemporary interventions to the historic architectural fabric.

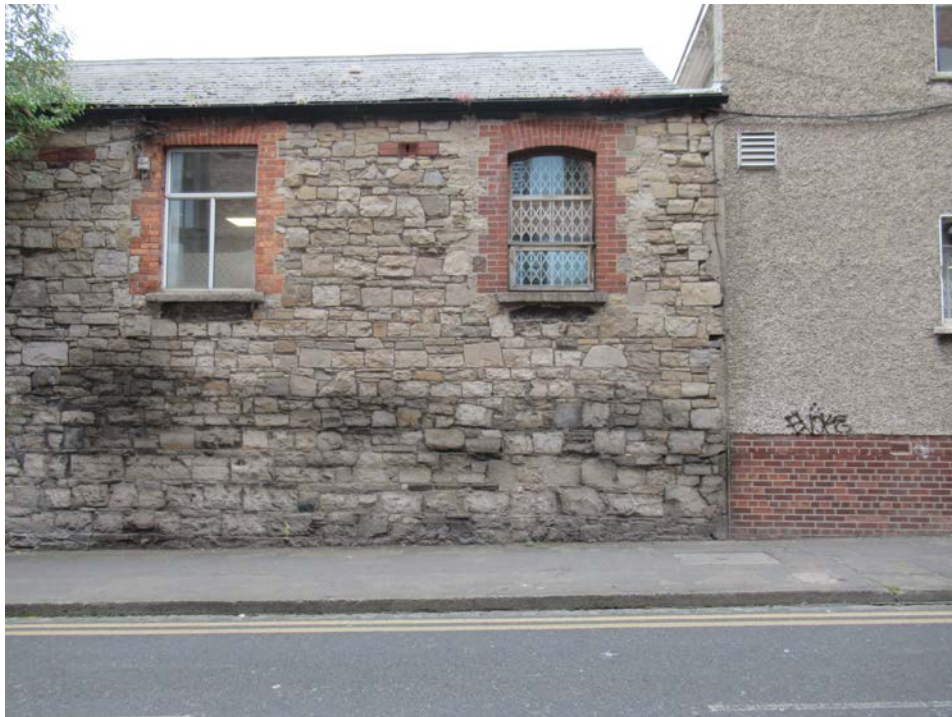
Plate No. 18. Detail view showing the northern end of the east elevation to the L-shaped building, where it abuts the mid-20th century offices. The L-shaped building originally extended further to the north prior to the middle of the 20th century. Note the brick surrounds to the windows and simple slated roof.

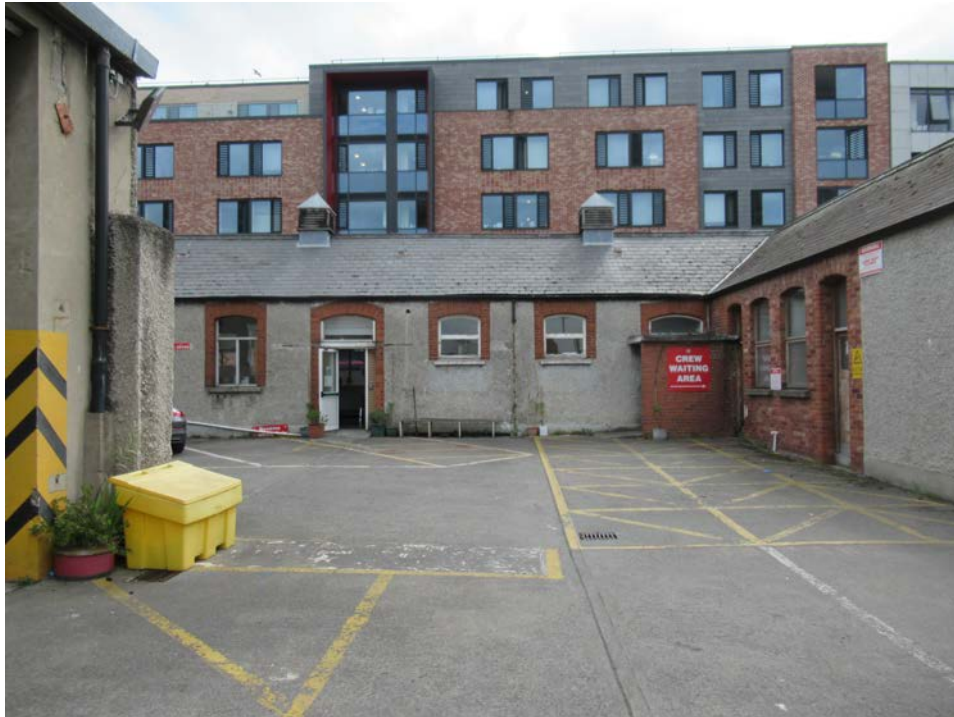
Plate No. 19. General view looking east from within the depot, showing the south-east corner of the L-shaped building in its reduced size. The doors and windows were detailed the same as the openings on the east elevation, as shown in the previous photo.

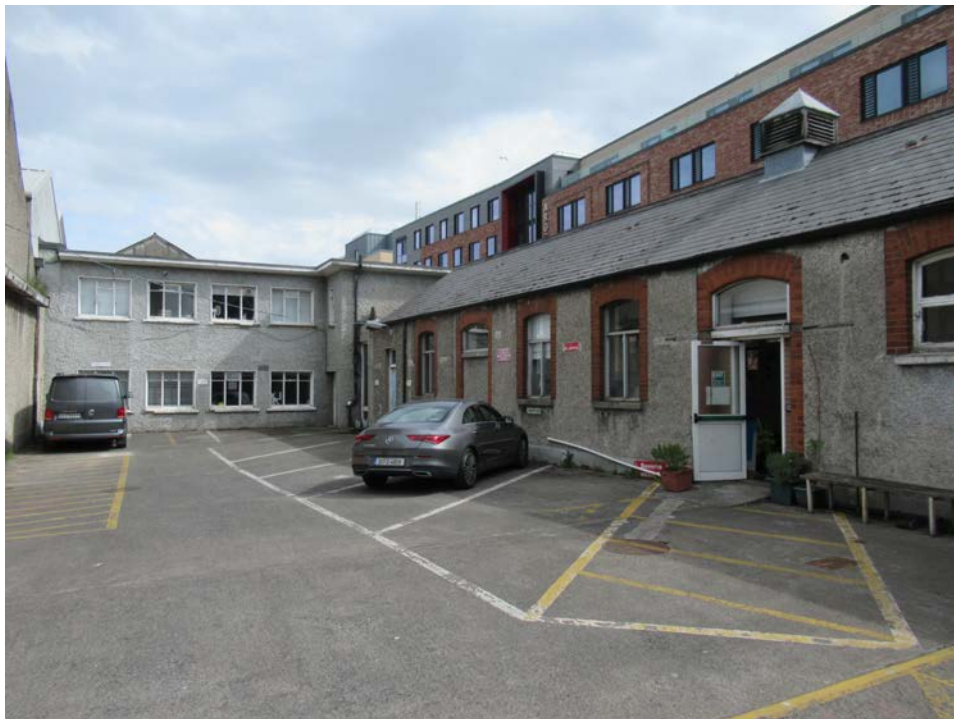
Plate No. 20. General view looking north-east, showing the east range of the L-shaped building in its current reduced form. There are no historic doors or windows remaining in the structure and the stone masonry on the elevations facing into the depot are covered with dashed render.

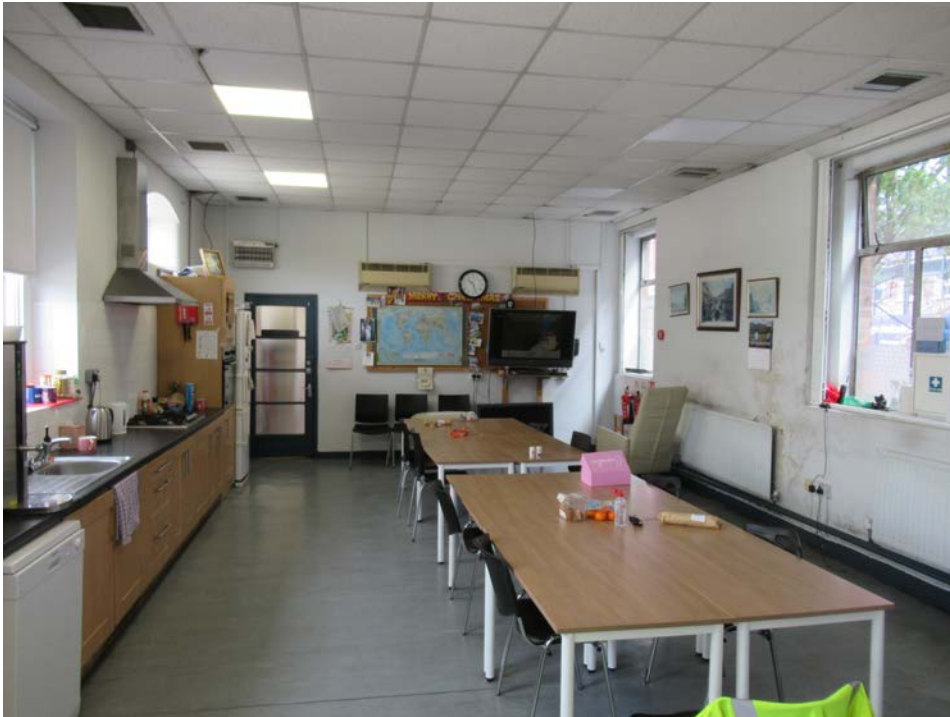
Plate No. 21. General internal view showing the staff break room in the east range of the L-shaped building. Note the extent of modernisation that has occurred to this typical internal space.

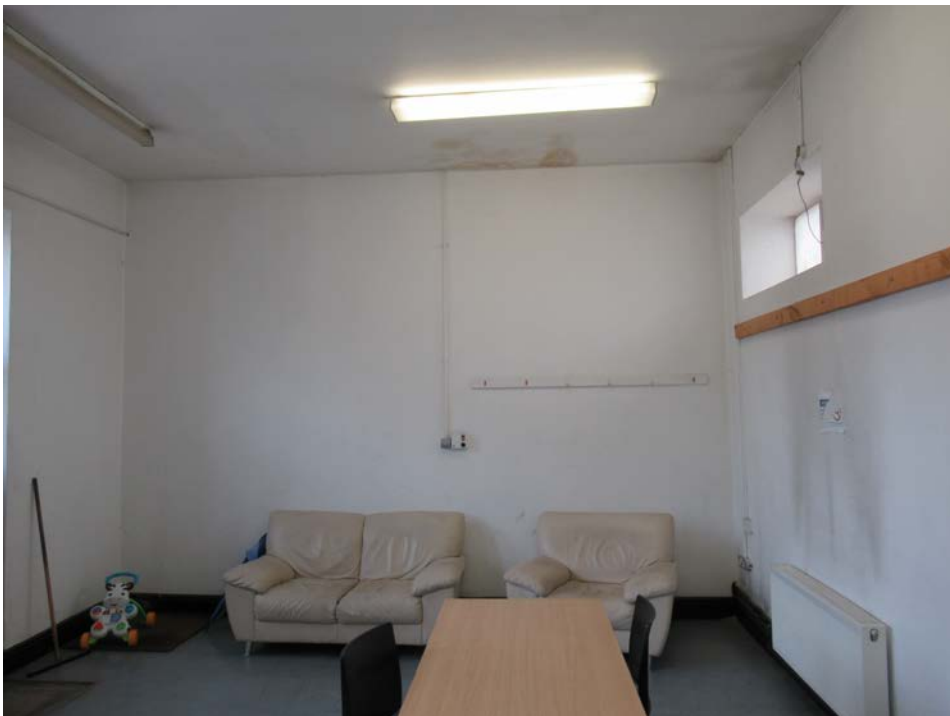
Plate No. 22. General internal view showing the staff lounge in the south-east corner of the L-shaped building, showing its current appearance.

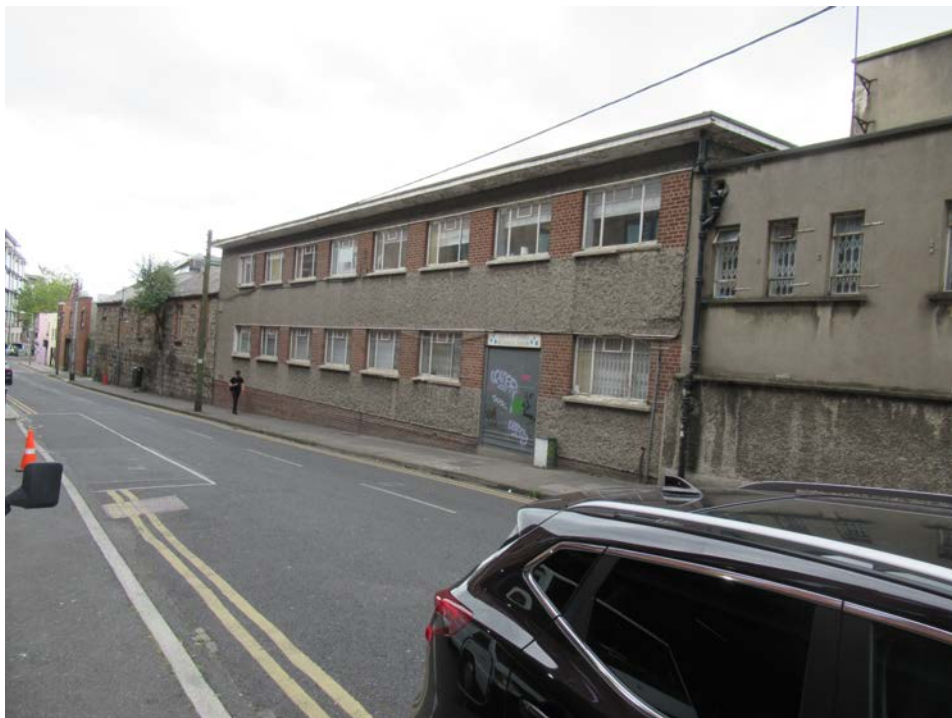
Plate No. 23. General view looking west along Grangegorman Lower, showing the 1950-60s office buildings that form the east edge to the current depot. The simple modernist design is notable, but not particularly significant in its architectural quality.

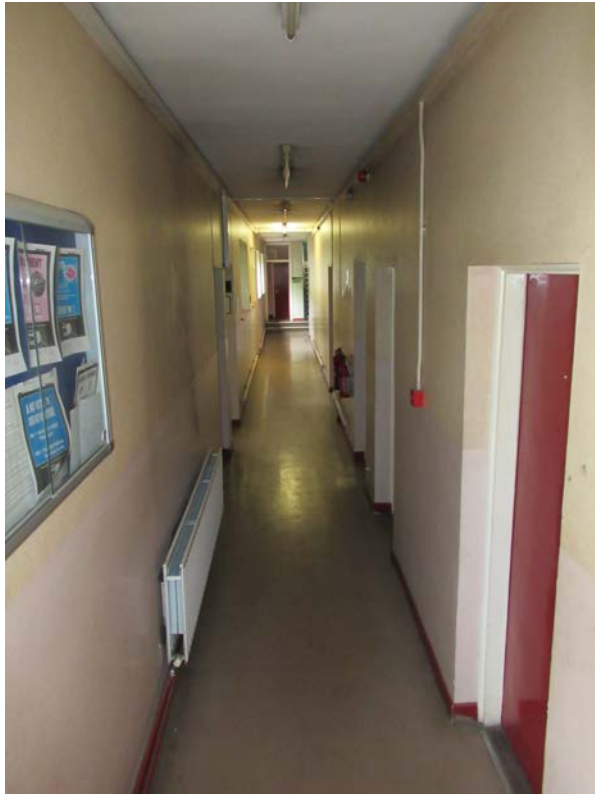
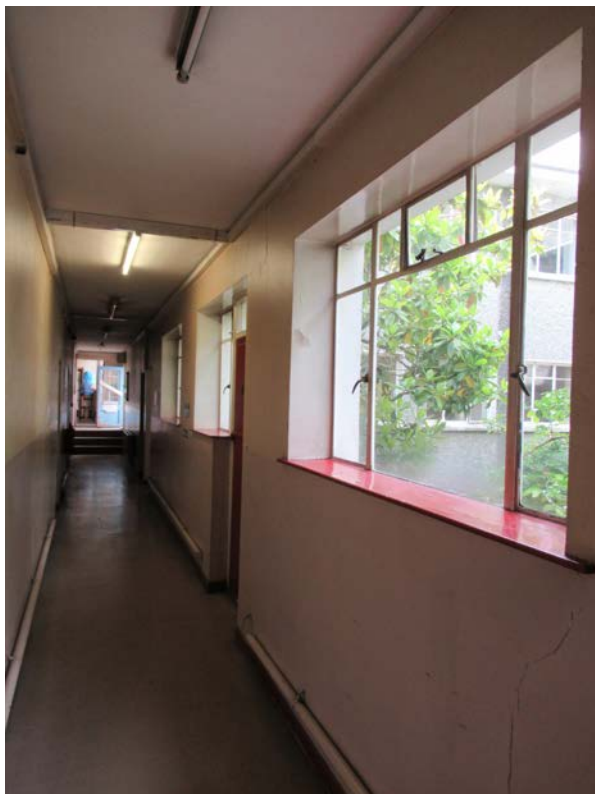
Plates No. 24 and 25. General internal view looking down the internal corridors in the mid-20th century offices. The steel windows are notable but also quite typical of mid-20th century Irish commercial structures. Otherwise there is nothing remarkable in the design or construction of this structure.

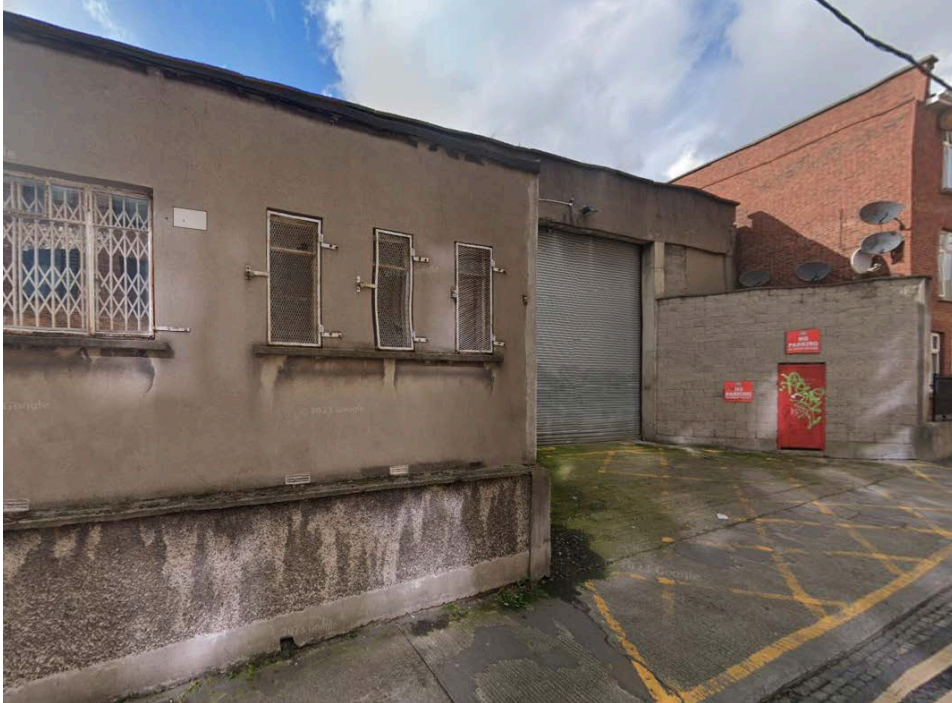
Plate No. 26. General view looking west along Grangegorman Lower, showing Building No. 01, the large storage depot that forms the north-east corner to the current depot. This simple industrial structure is shown on the 1970s OS map, showing that it was in place by at least 1972.

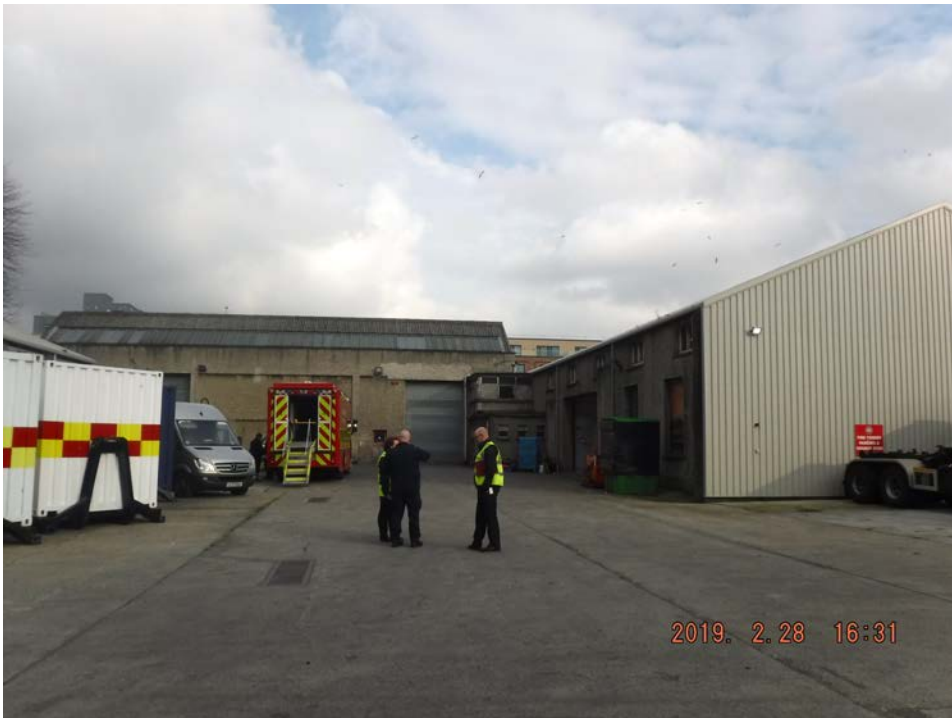
Plate No. 27. General view showing the west elevation to Building No.01.

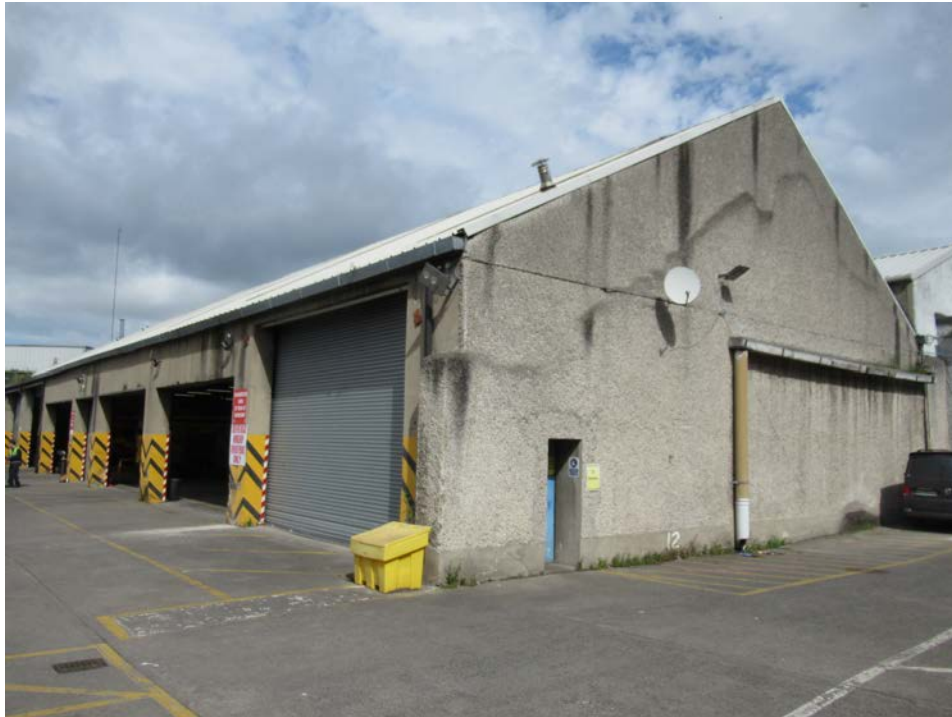
Plate No. 28. General view looking north-west showing the south and east elevations to Building No.5, the main repair garage in the centre of the depot. This structure appears to date largely from the early years of the 21st century, and stands in the location of the original 19th century main Scavenging Depot structure. It has a large open plan internally and has minimal architectural or historic significance. The thickness of the east gable wall shown above, and the outline of a smaller gabled building suggests that at least some of the fabric from the late 19th century depot structure has remained in place. To the rear of this structure, just visible to the right of the gable, are two other long narrow structures that appear to contain fabric from earlier 20th century building periods, now covered with modern metal cladding.

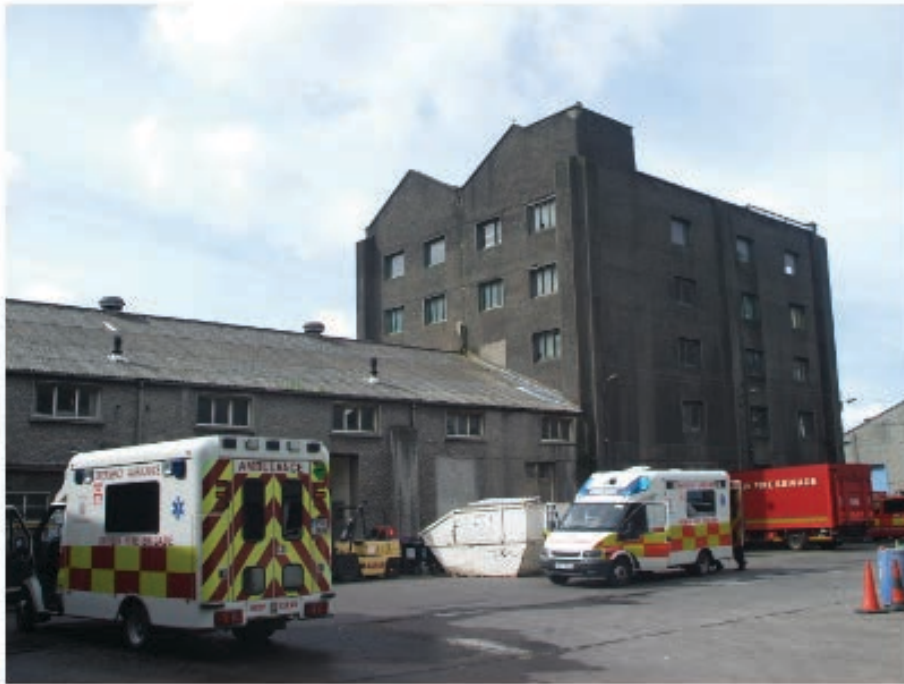
Plate No. 29. General view looking south-west around 2008, showing the long narrow two storey range along the north side of the central block of garages, along with its original early 20th century five-storey western block, later demolished around 2010-2015. No trace of this structure currently survives on the site.

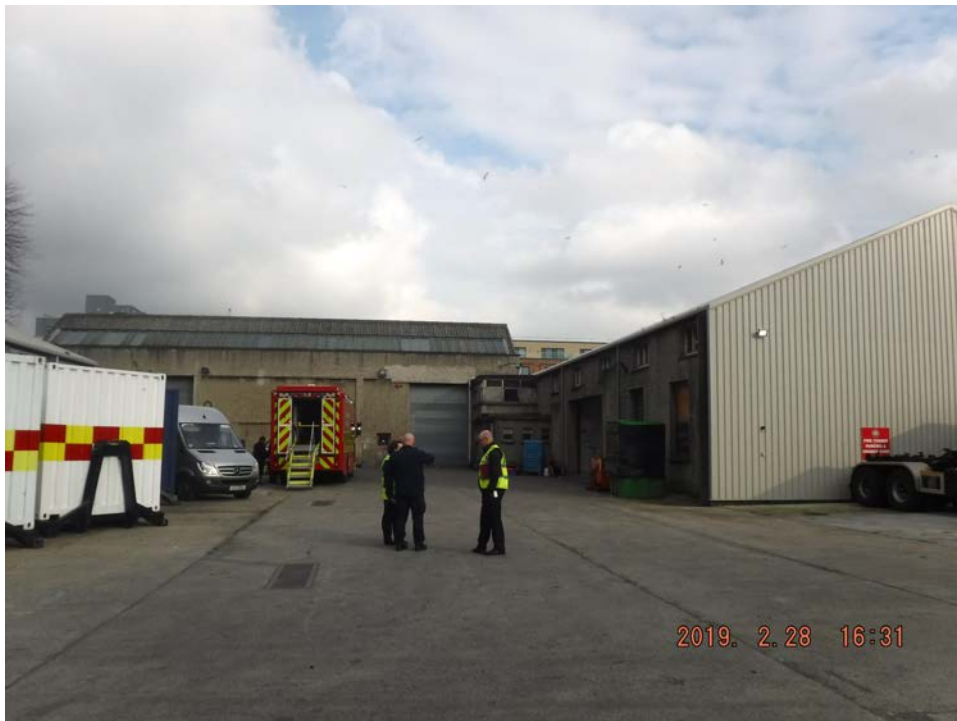
Plate No. 30. General view looking east showing the same early 20th century two storey range of stores in 2019, after the demolition of the five storey block that was shown in the previous photo. The structure in the distance to the left, is a large concrete framed storage shed that has an entrance from Grangegorman Lower, and was shown on the 1972 Ordnance Survey map.

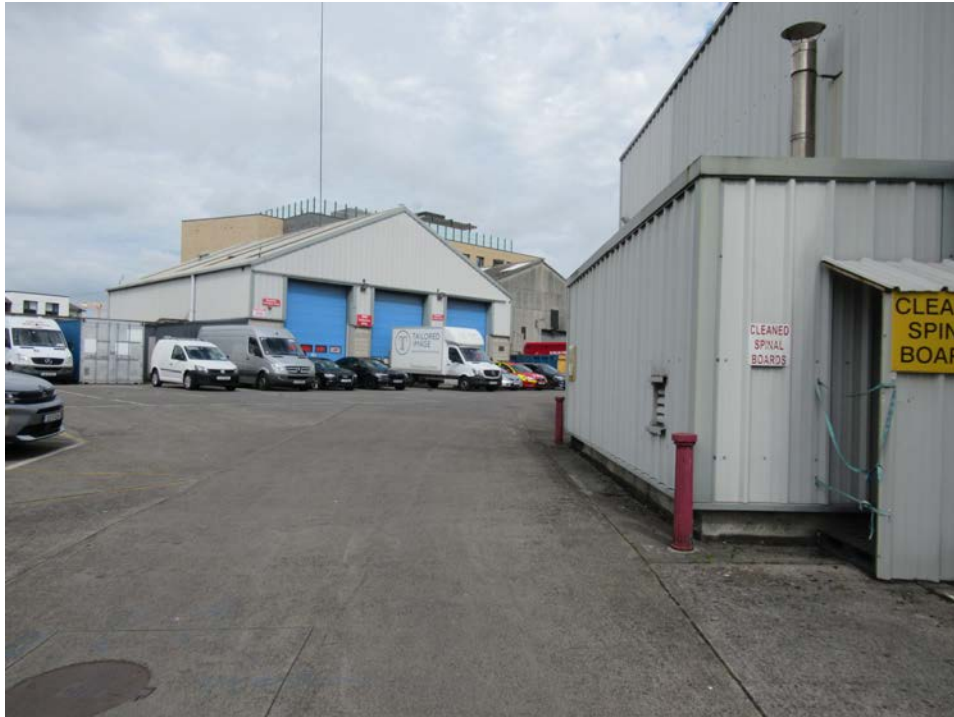
Plate No. 31. General view looking west across the depot, showing Building No. 6, a medium sized steel clad garage for storing emergency vehicles. This structure dates from the early 21st century and has no particular architectural or historical significance.

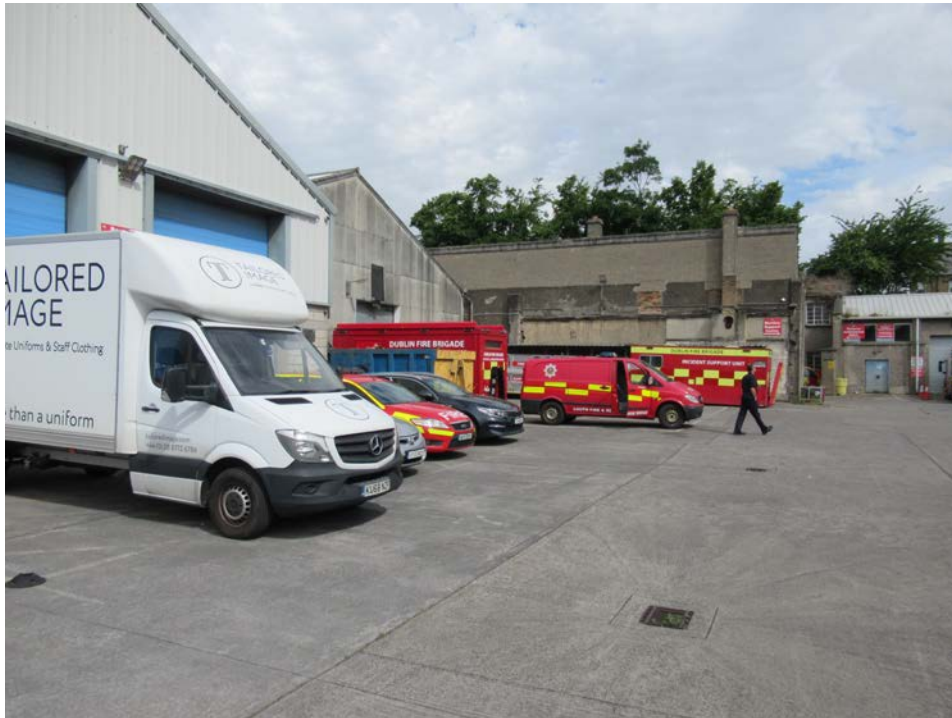
Plate No. 32. General view looking north across the depot site. The large gabled garage structures to the left, referred to as Building No. 08, date from the second half of the 20th century, and their rear west elevations form the site boundary in that location.

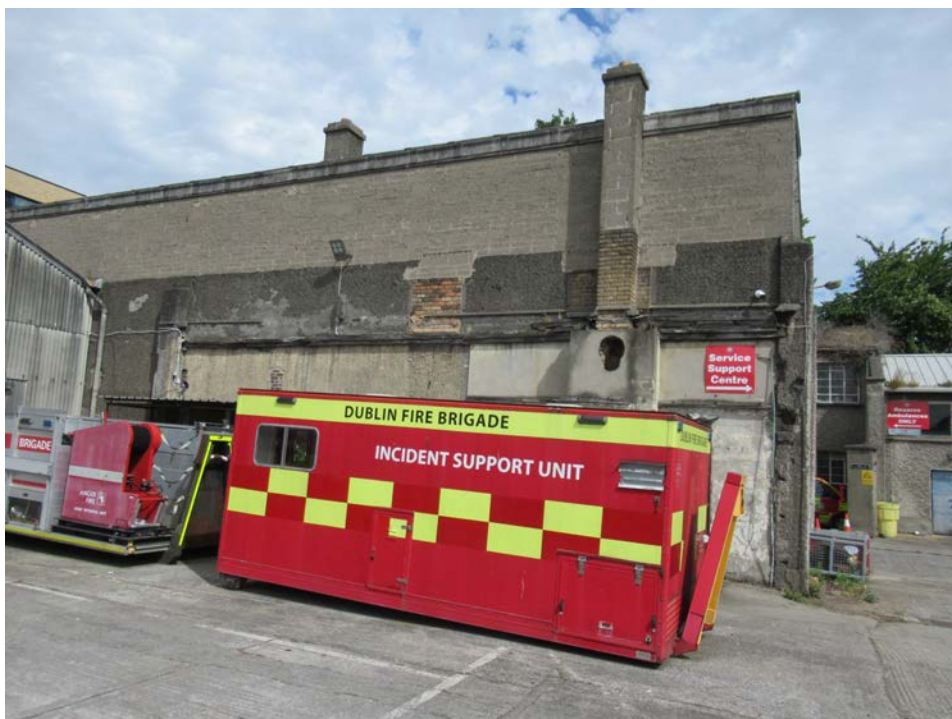
Plate No. 33. General view looking north the rear of the south range of Building No.04. The following photos show the other elevations to that early 20th century range of structures.

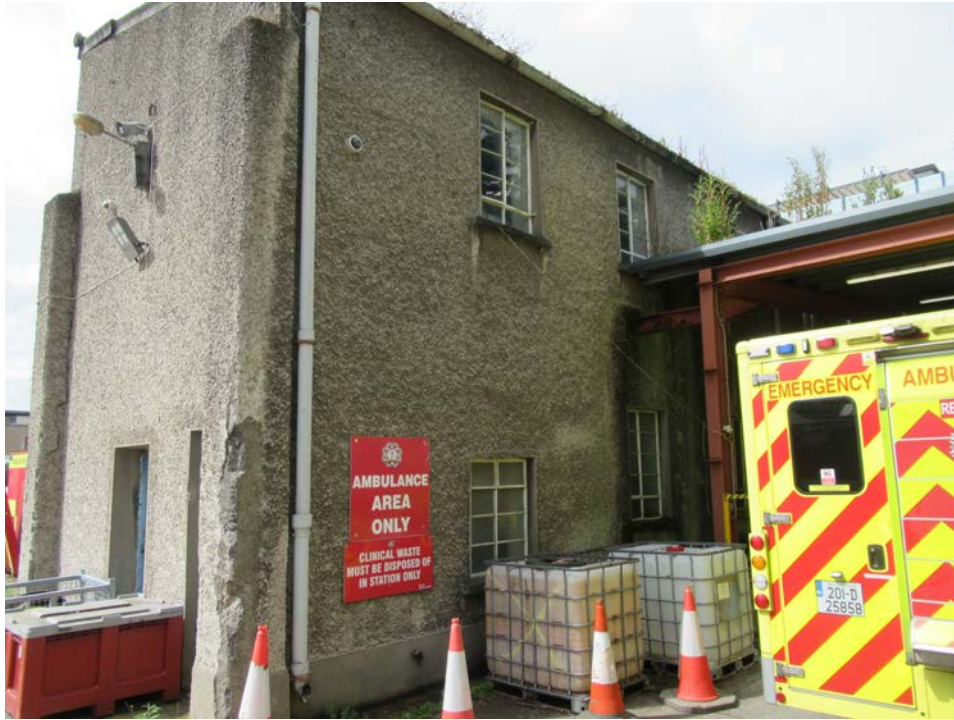
Plate No. 34. General view showing the north elevation of Building No. 04, the Scavenging Depot structure from the previous photo. This is a simple utilitarian structure of the 1930s without any particular architectural or historical significance. This structures in this photo and the following photo are shown in the north-west corner of the Scavenging Depot in the OS map shown in Plate No.6, showing the area in 1936.
