Proposed Redevelopment at the Stanley Street Depot
Stanley Street
Dublin 7

SHB4-SSD-RP-MA-AR-P3-001
Preliminary Heritage Impact Assessment Report

September 2024

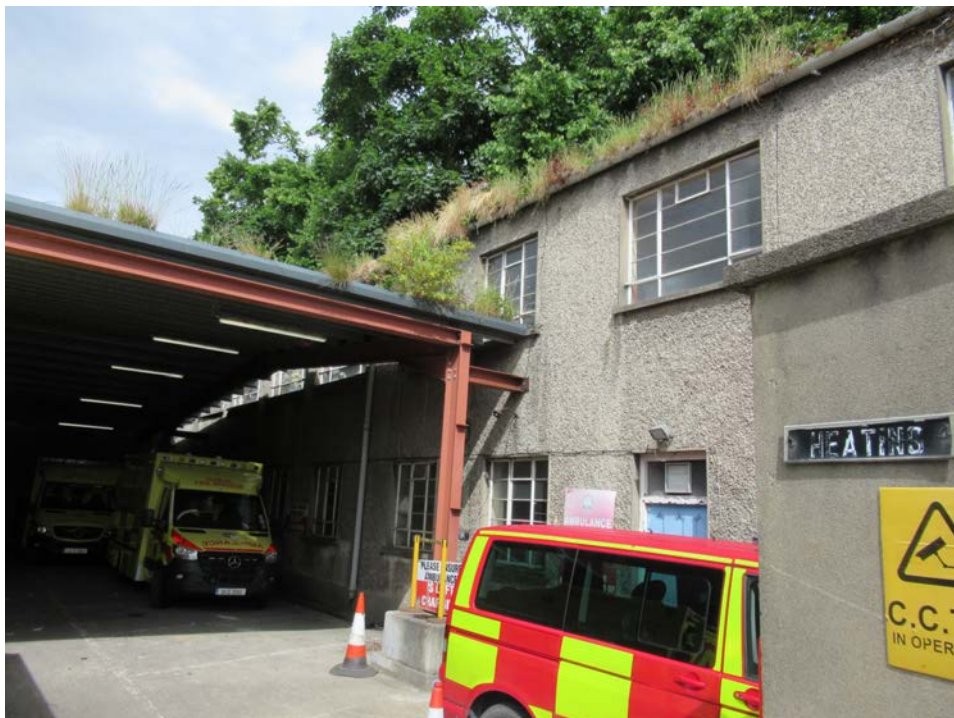
Plate No. 35. General view looking north-west showing the poorly maintained range of offices that forms the northern perimeter to the depot. This structure was shown in the early 20th century OS map, as surveyed in 1936. The steel framed windows are notable in their design, but are generally representative of typical commercial construction of the time.

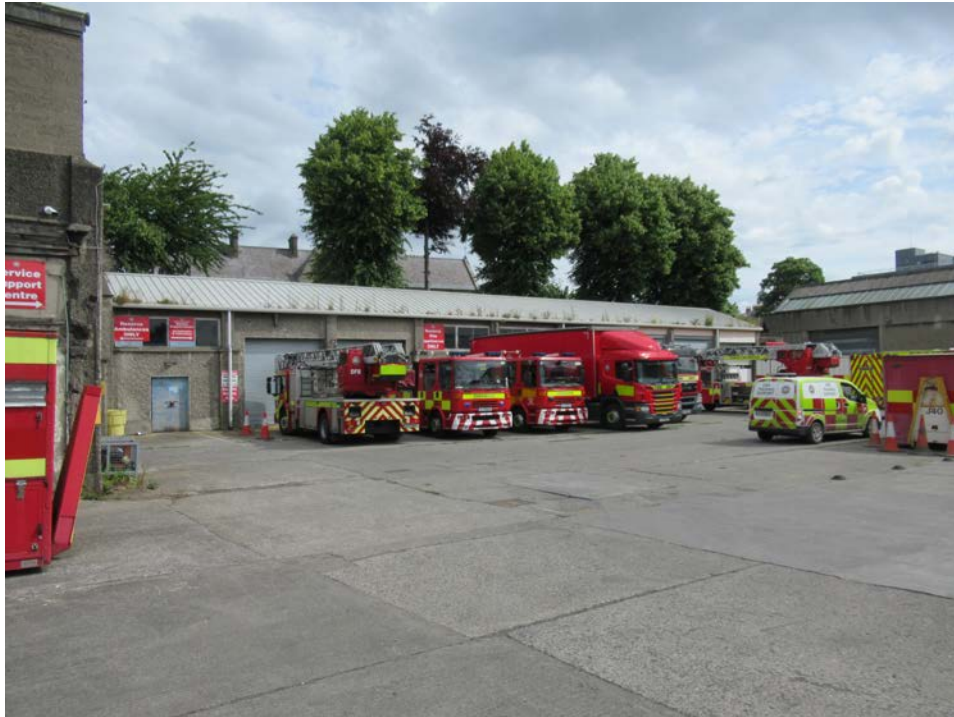
Plate No. 36. General view looking north, showing the repair shops and stores along the northern boundary to the development site, referred to as Building No. 07. This structure dates from the late 20th or early 21st century, and were built to serve the Fire Services Dept. None of these structures have any architectural or historical significance and their demolition for the new development will have no negative impact of the historic setting of any protected or otherwise significant structures.

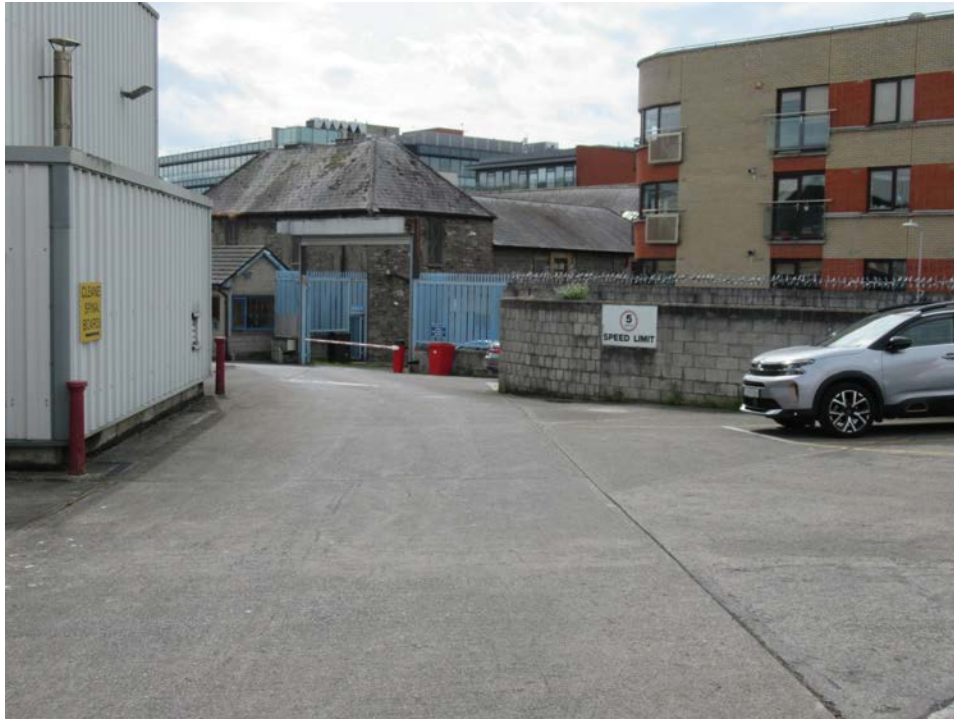
Plate No. 37. General view looking south-east, showing concrete block site boundary wall along the west end of the south boundary. This wall has no architectural or historical significance.

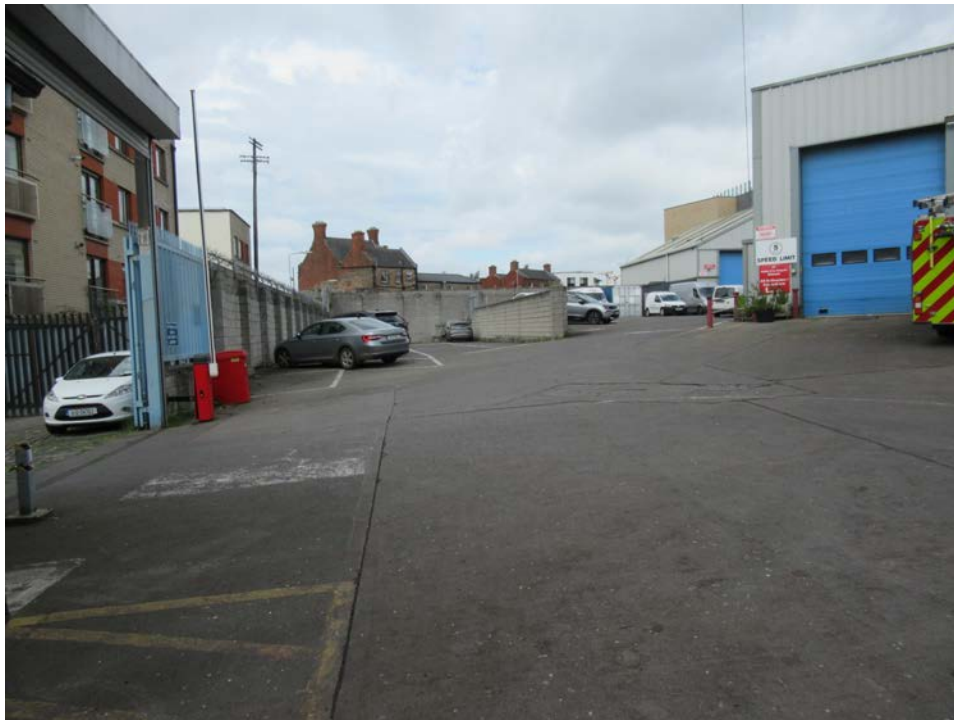
Plate No. 38. General view west, showing the concrete block site boundary wall on the southern edge of the site, as it turns the corner and forms part of the western boundary. .

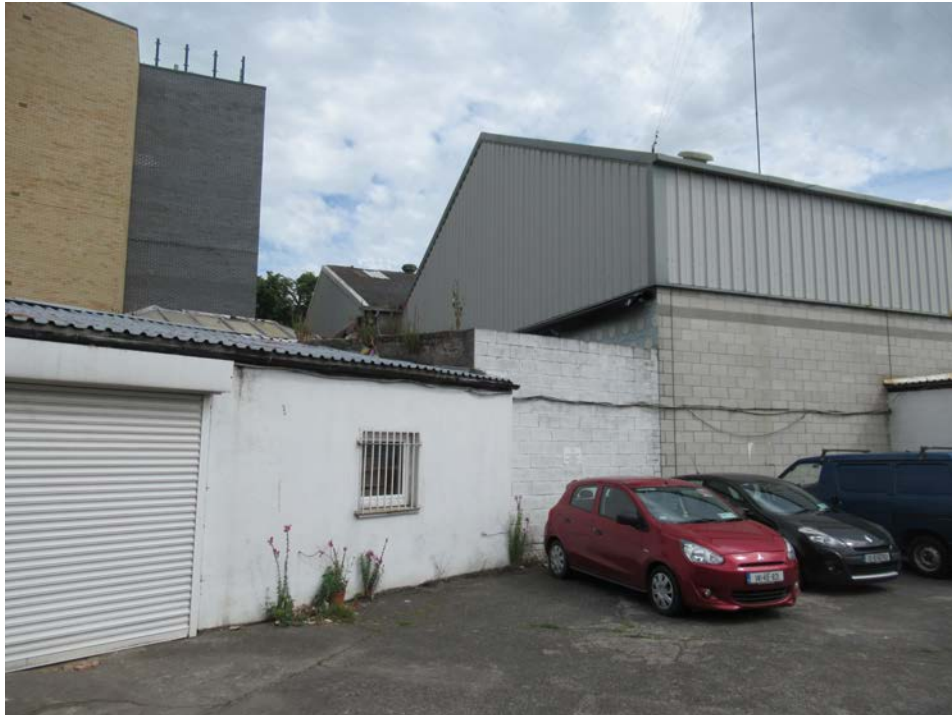
Plate No. 39. General view looking north-east from outside of the project's site, showing outer elevations to some of the late 20th century garages in the depot, where as they appear from outside of the development site. This photo was taken from a semi-public car park that is access off the southern end of Stoney Batter. The concrete block walls have no architectural or historical significance, however they form the physical boundary to the neighbouring properties.

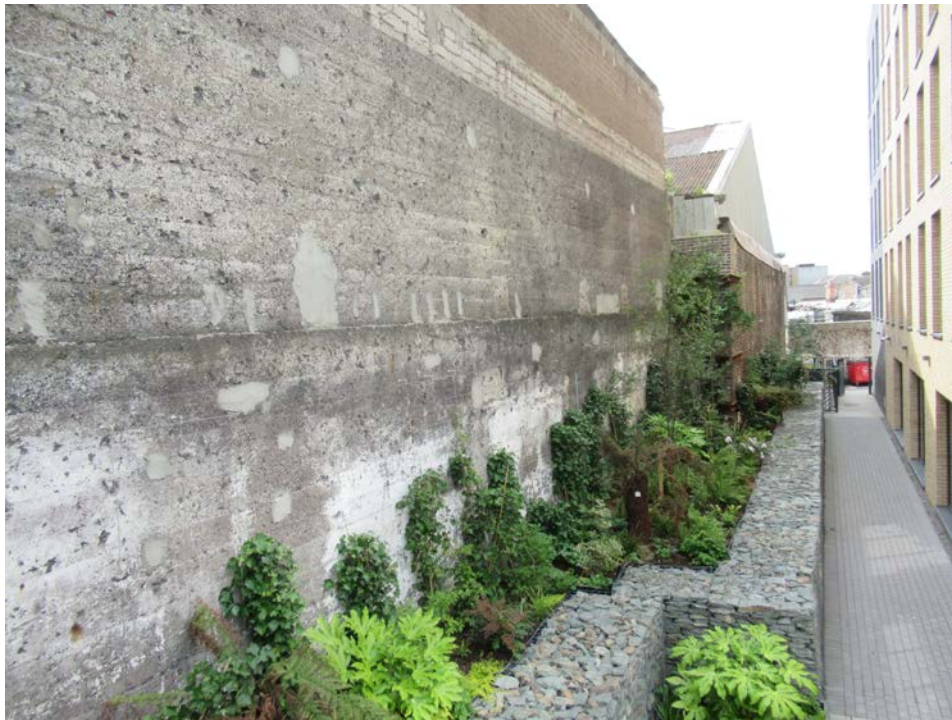
Plate No. 41. General view looking south, showing concrete boundary wall along the northern end of the west site boundary as it appears from the adjacent site.

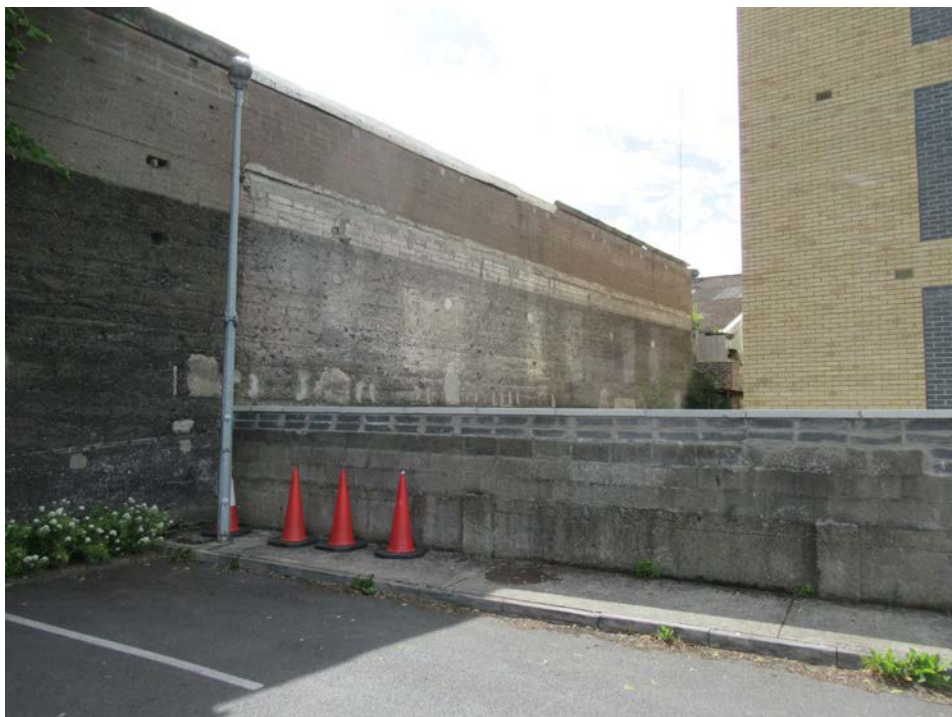
Plate No. 42. General view looking south-east, showing same cast concrete site boundary wall at the north-west corner of the development site, as it appears from the adjacent school car park. It is proposed to retain this wall, because it is now a party structure, but to reduce its height as part of the demolition of the 20th century industrial structures in the north-west corner of the development site.
