**Stage 1 Quality Audit Report  
Social Housing Bundle 4, Development  
at the Stanley Street Depot, Dublin 7**

<b>Client:</b>	Dublin City Council
<b>Document No:</b>	SHB4-SSD-RP-ORS-CS-P3-0001

This report documents the findings of a Stage 1 Road Safety Audit (RSA) carried out with respect to the proposed Social Housing Bundle 4, Development at the Stanley Street Depot, Dublin 7.

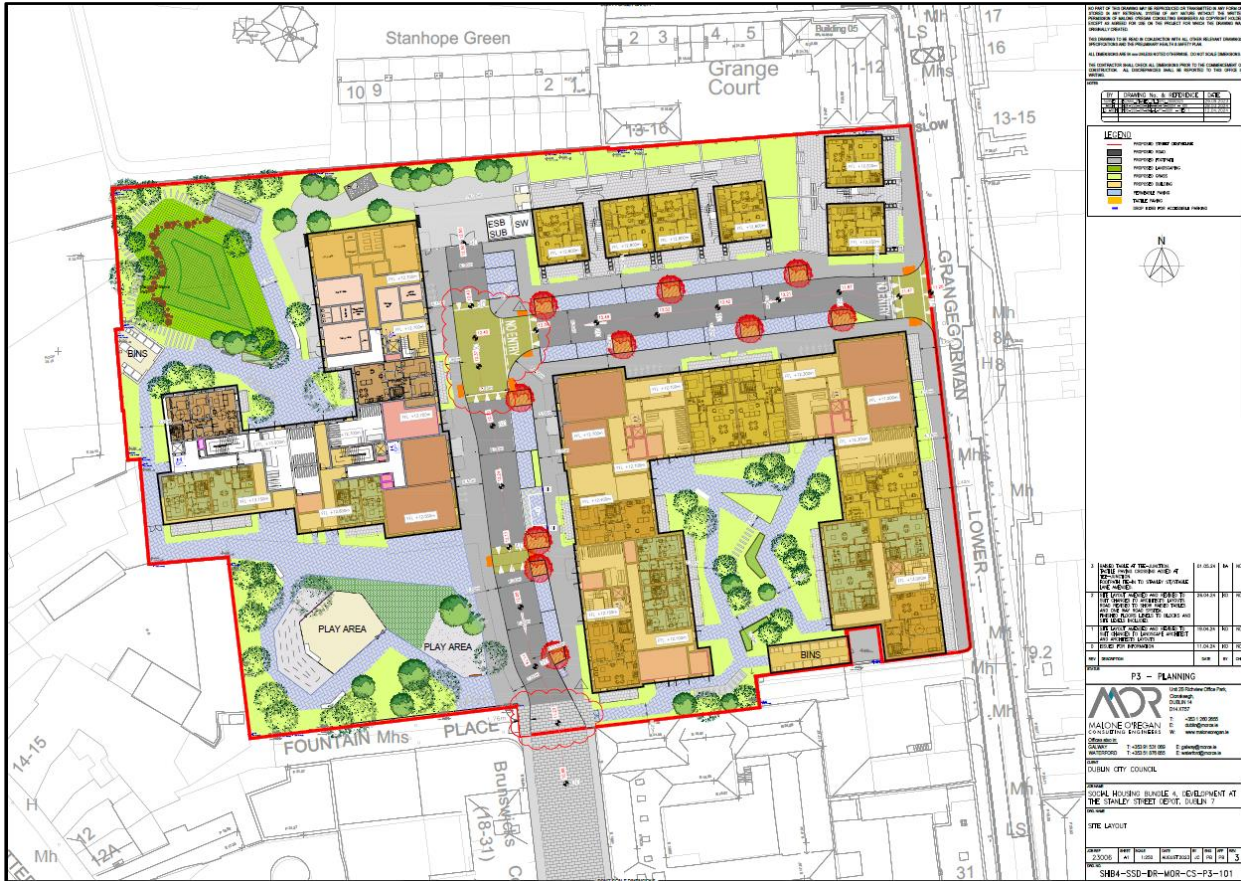
Figure 2.2: Site Layout (Source: Malone O'Regan Consulting Engineers)

Figure 2.2 shows the proposed site layout provided by Malone O'Regan Consulting Engineers.

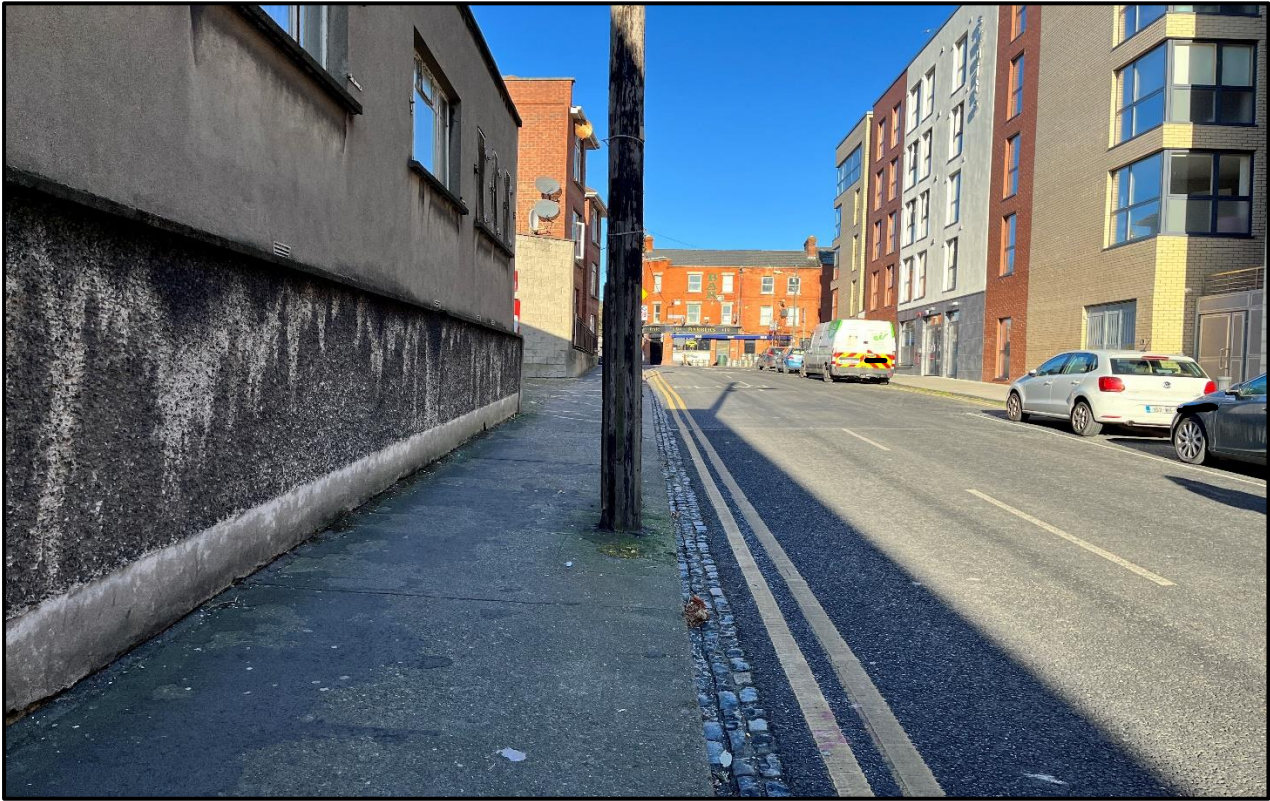
**Figure 2.3:** Pedestrian facilities along Grangegorman Lower Road (looking north) (Source: Google Maps)

The Grangegorman Lower Road is a two-way road with single lane in each direction with some parallel parking spaces provided in front of the retain units adjacent to the site (**Figure 2.3**).

Along the frontage the road has no uncontrolled crossings noted on site. The overall width of the vehicular carriageway is approximately 6.0 metres with footpaths and streetlights on either side of the carriageway as shown in Error! Reference source not found..3. No cycling facilities are observed along the road.

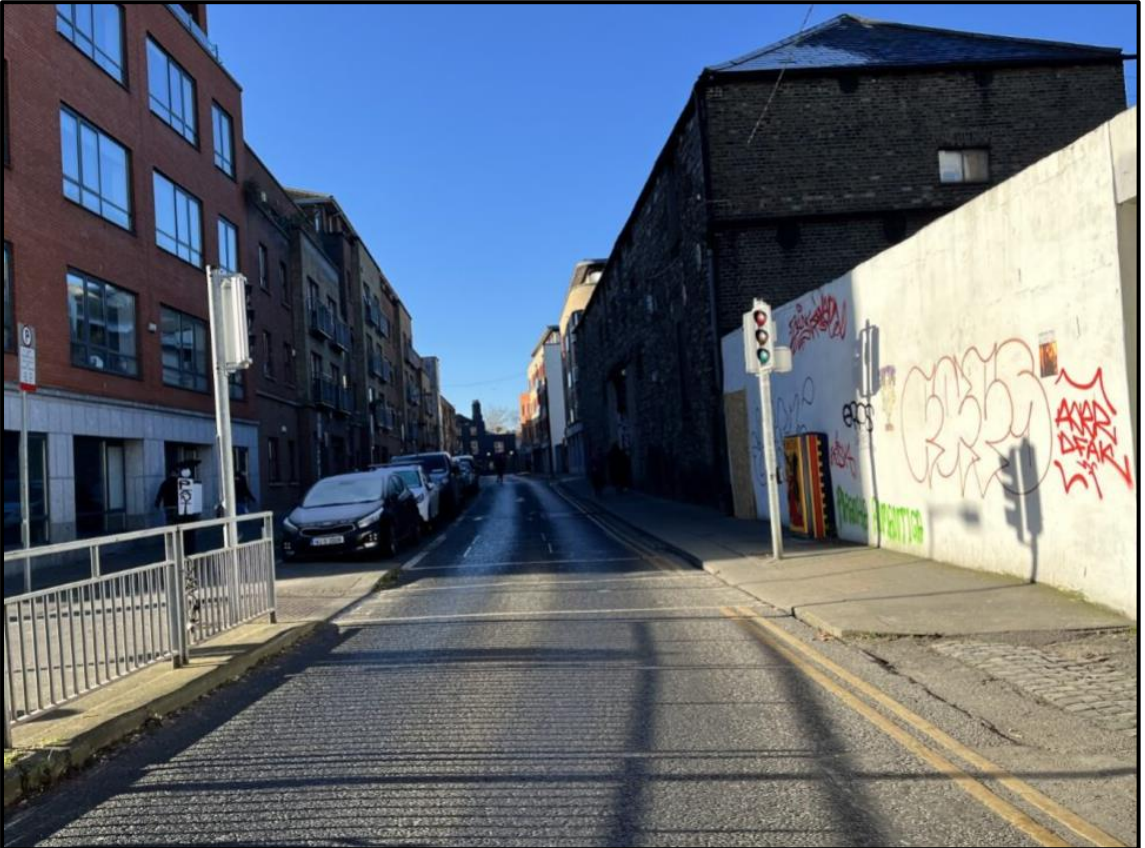
Figure 2.5: Pedestrian/Cycle facilities along Brunswick Street North (looking west) (Source: Google Maps)

Along the frontage the Brunswick Street North there is one controlled crossing to the east noted on site. The overall width of the vehicular carriageway is approximately 6.5 metres with footpaths and streetlights on either side of the carriageway as shown in Error! Reference source not found..5. There is also a single lane on road cycle lane provided on Brunswick Street North that discontinues at the signalised junction on the R805 to the south.

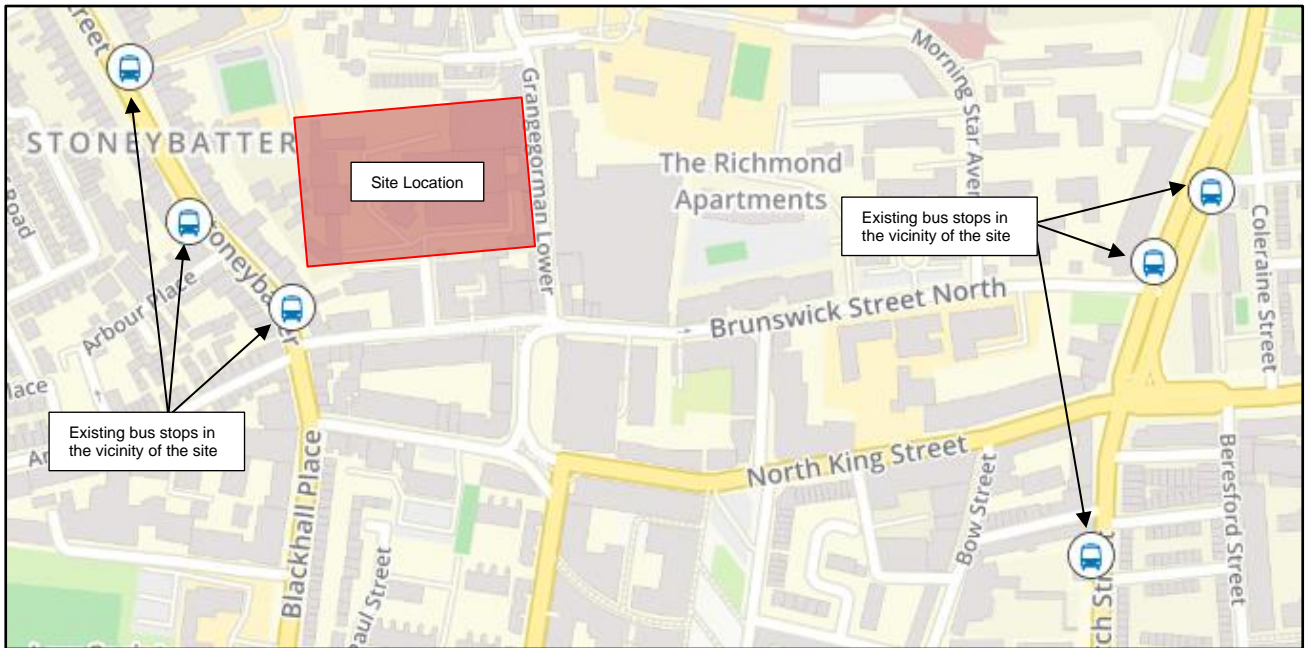
**Figure 5.1:** Bus stops in the vicinity of the development (Source: TFI)

There are 6 No. bus stops located in the vicinity of the site out of which 3 No. are located on R805 (Stoneybatter) and 3 No. are located on Church Street and Church Street Upper. All the bus stops are located ca. 200 to 600 metres from the application site. Heuston Railway Station is located 1.8km to the southwest of the site.

There are continuous footpaths leading the site to the bus stops located adjacent to the west of the site on the R805. The footpaths are deemed to be in good condition and of appropriate width in the vicinity of the site entrance. Two bus stops provided in the vicinity of the site in Stoneybatter have the provision for bus shelters and benches as well as one with a shelter and bench on Upper church street. **Table 5.1** overleaf outlines the available bus services in the area.

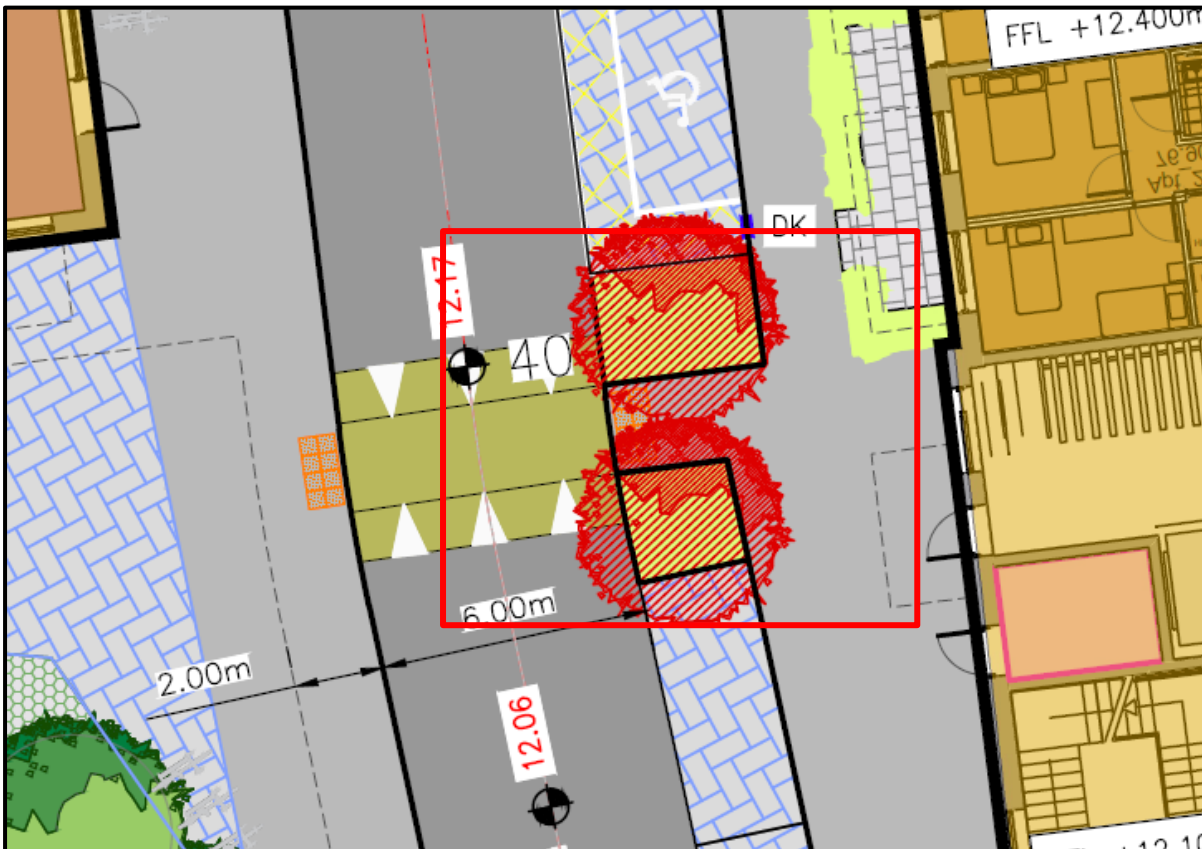
##### Location: Within Scheme

The audit team is concerned about visibility at the proposed crossing points within the scheme due to the proposed landscaping proposed next to the crossing points. The audit team is concerned that the proposed landscaping may impact the visibility of users utilising the crossing and may also restrict visibility of vulnerable users for motorists approaching the crossing points.

The design team should ensure that proposed landscaping does not restrict the visibility for vulnerable users at crossing points.

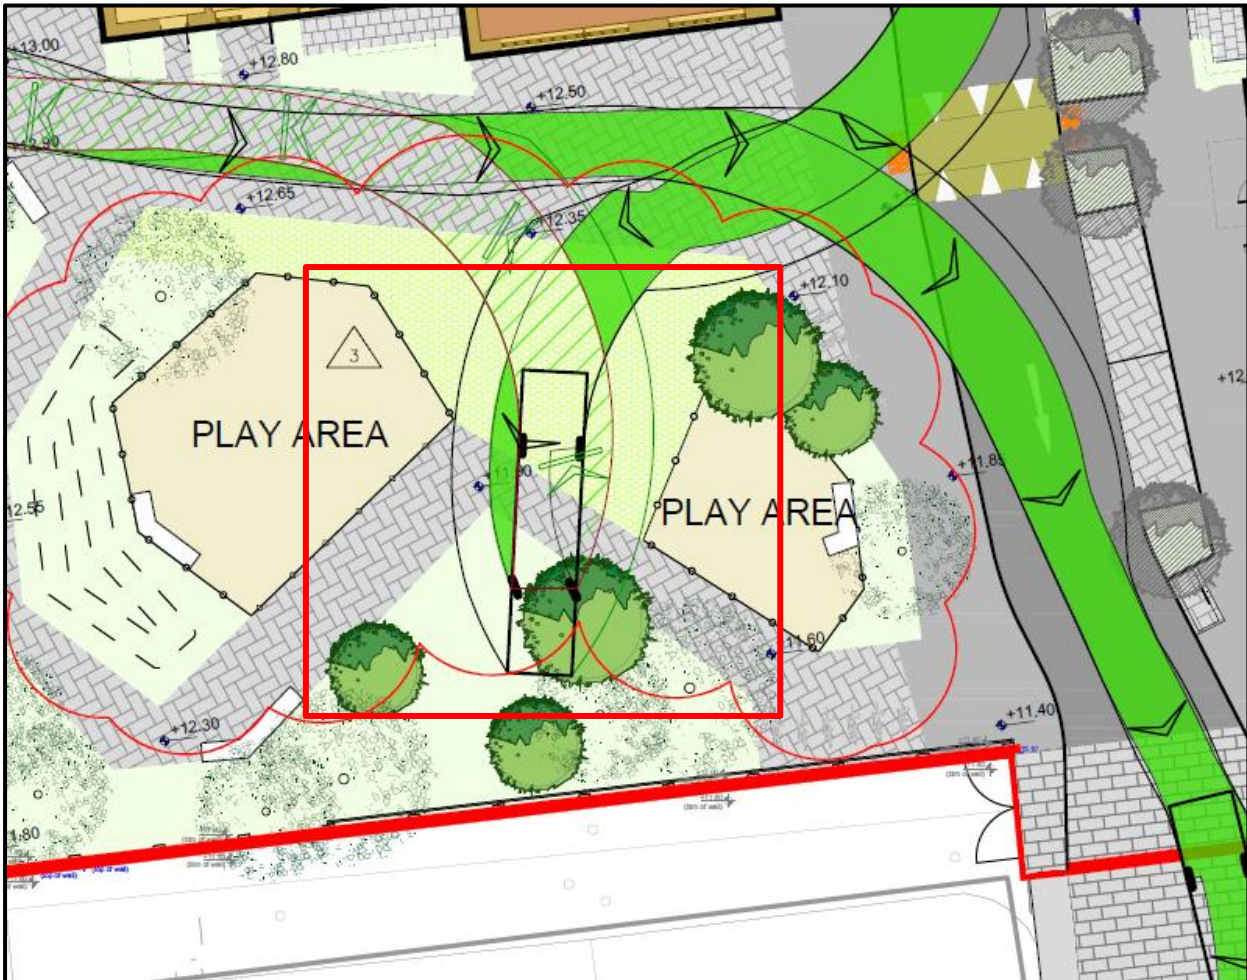
### Location: Play Area to Southwest

The audit team is concerned about the availability of the turning area at this location due to a play due to proposed landscaping in the area. The audit team is concerned the location of landscaping, and any proposed street furniture could impact the turning manoeuvre of the fire tender entering and exiting the area.

The design team should ensure that landscaping and street furniture do not impact of the turning manoeuvre by a fire tender.

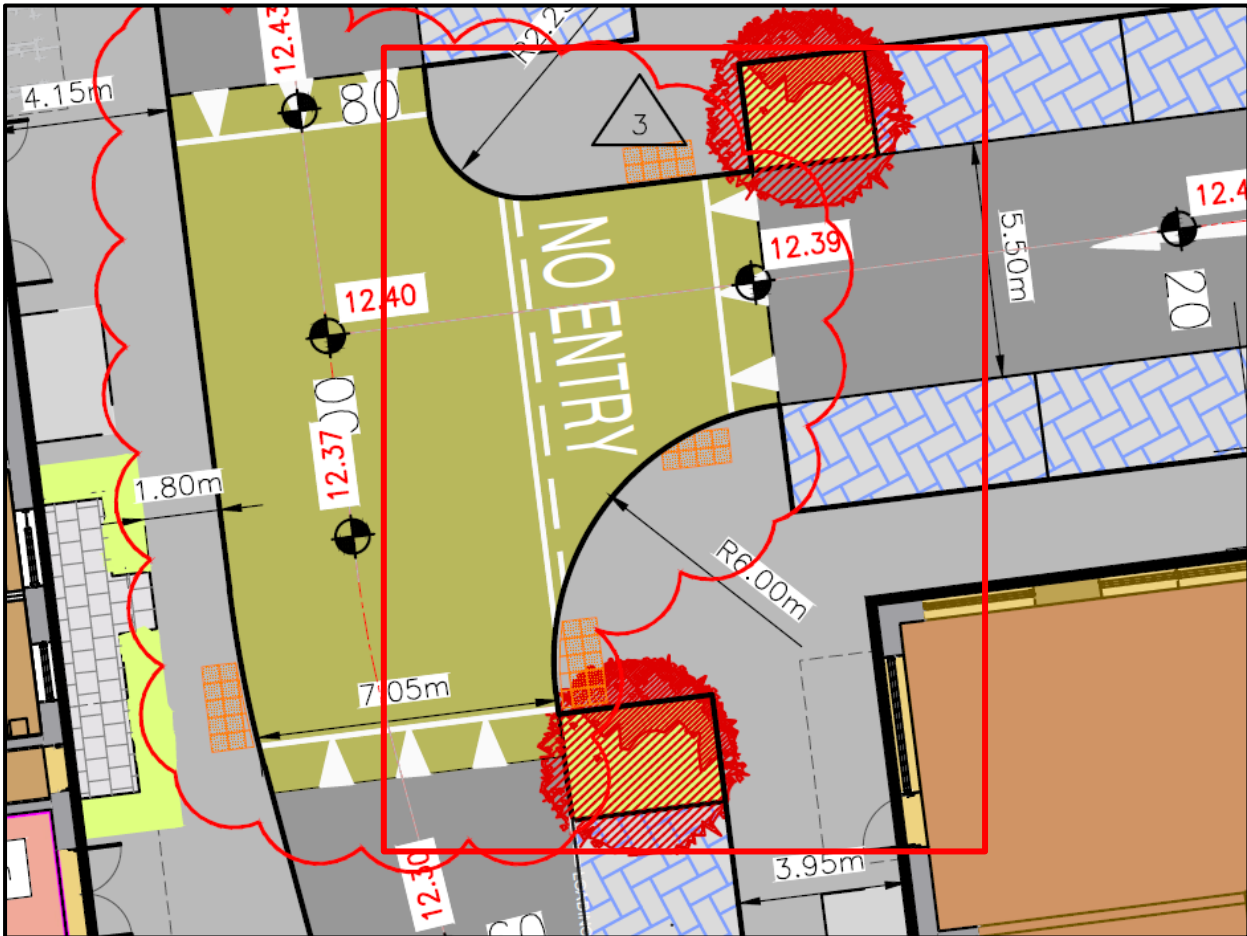
### Location: Within Scheme

The audit team is concerned about visibility at the proposed crossing points within the scheme due to proposed carparking proposed in close proximity to the crossing points. The audit team is concerned that parked cars may impact the visibility of users utilising the crossing and may also restrict visibility of vulnerable users for motorists approaching the crossing points.

The design team should ensure that parked cars in the proposed parking spaces do not restrict the visibility for vulnerable users at crossing points.

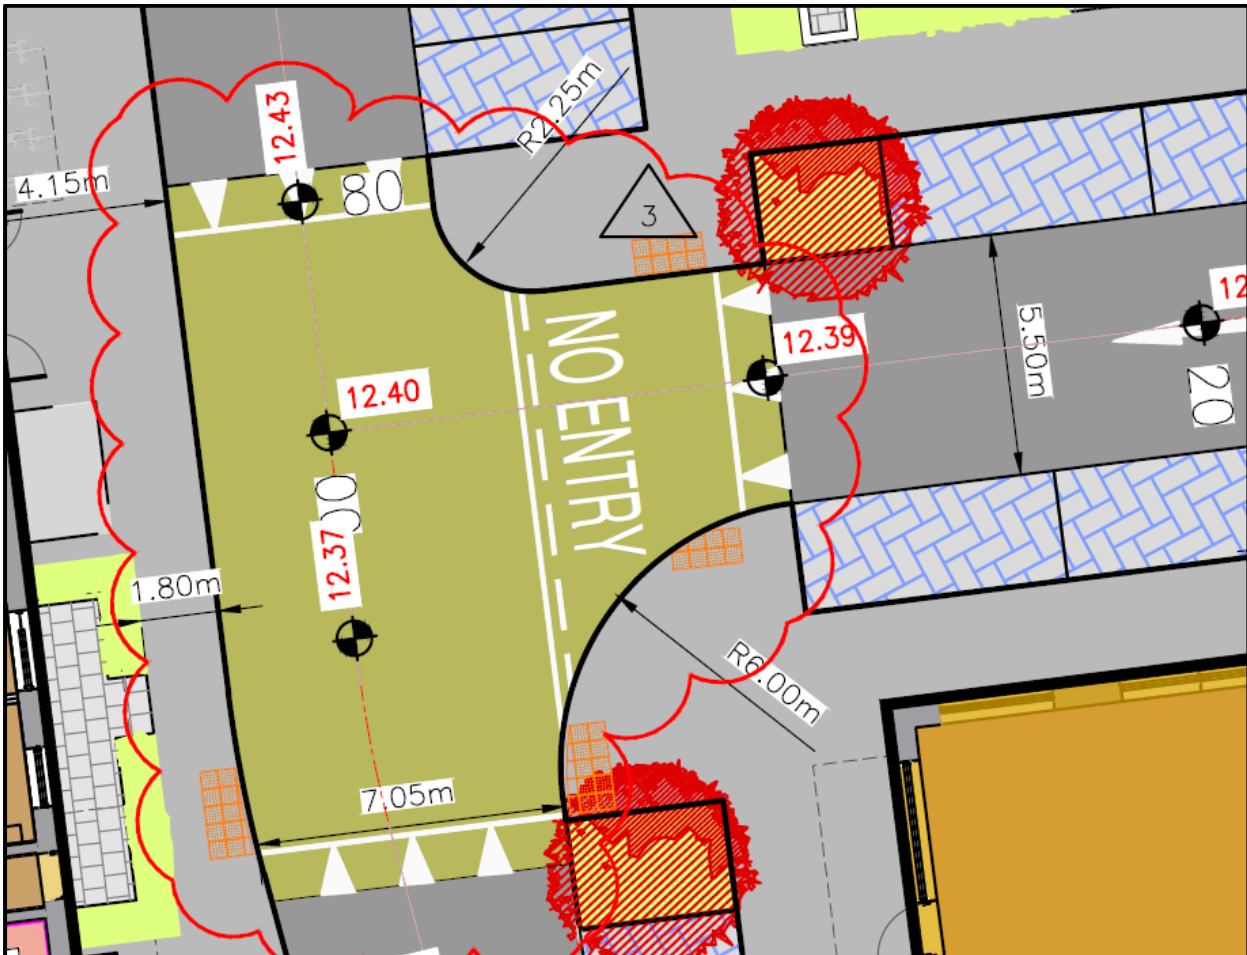
### Location: Identified Location

The audit team note that there is no proposed control for vehicles travelling west along the one-way street at the internal junction arrangement which could lead to vehicles failing to stop at the junction which could potentially result in conflicts on the two-way street.

The design team should ensure that a stop control arrangement is proposed at this junction for vehicles travelling west from Grangegorman Lower Road.

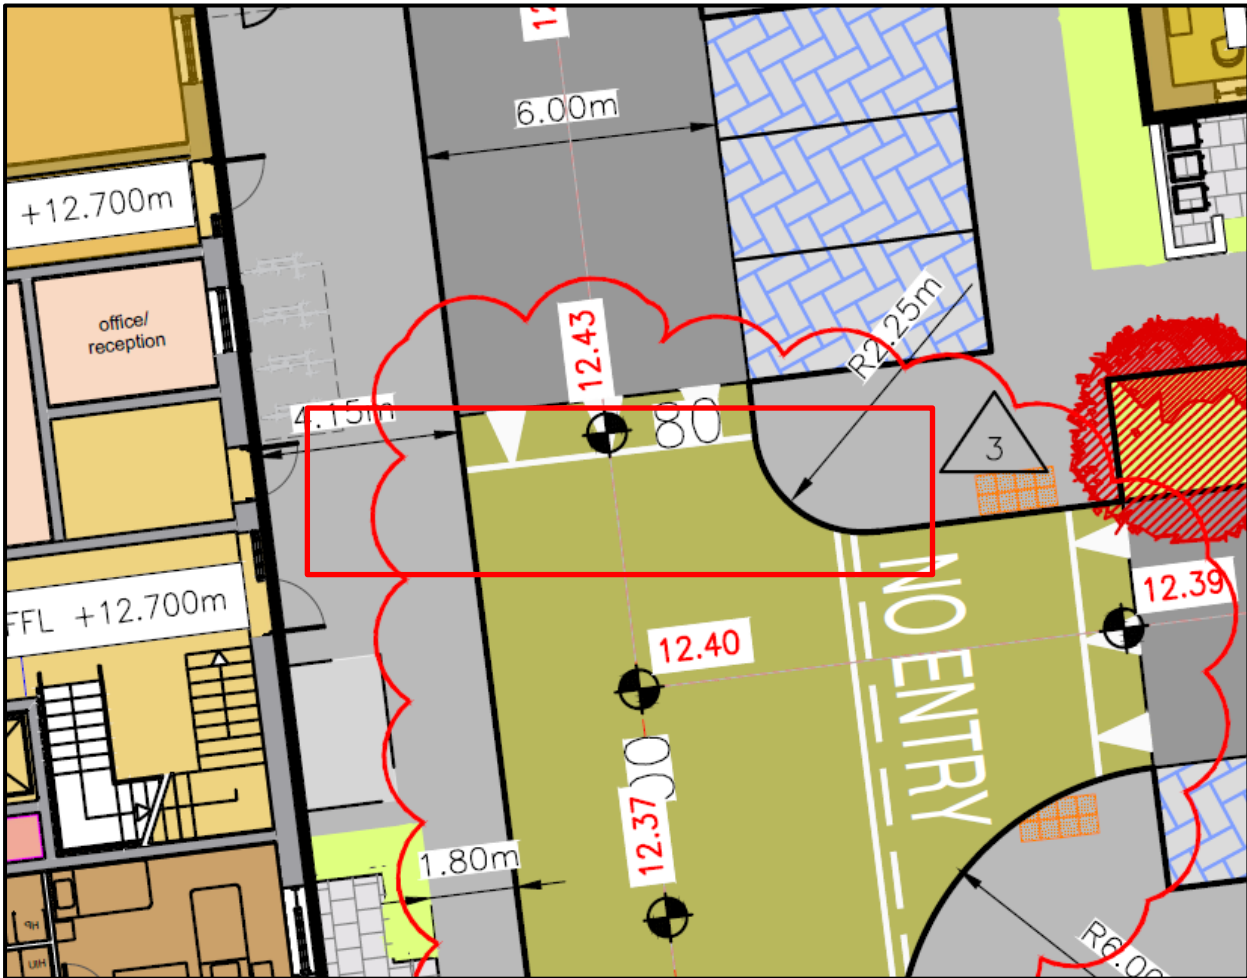
### Location: Location Identified

The audit team note from the provided drawings that there is not crossing point at the identified location to allow users in the northern units to cross the carriageway in the direction of Stable Lane. This could result in users crossing the carriageway in undesigned location which could result in potential vehicle collision with vulnerable users.

The design team should ensure that there is a dedicated crossing point at this location to allow users to safely crossing the carriageway.

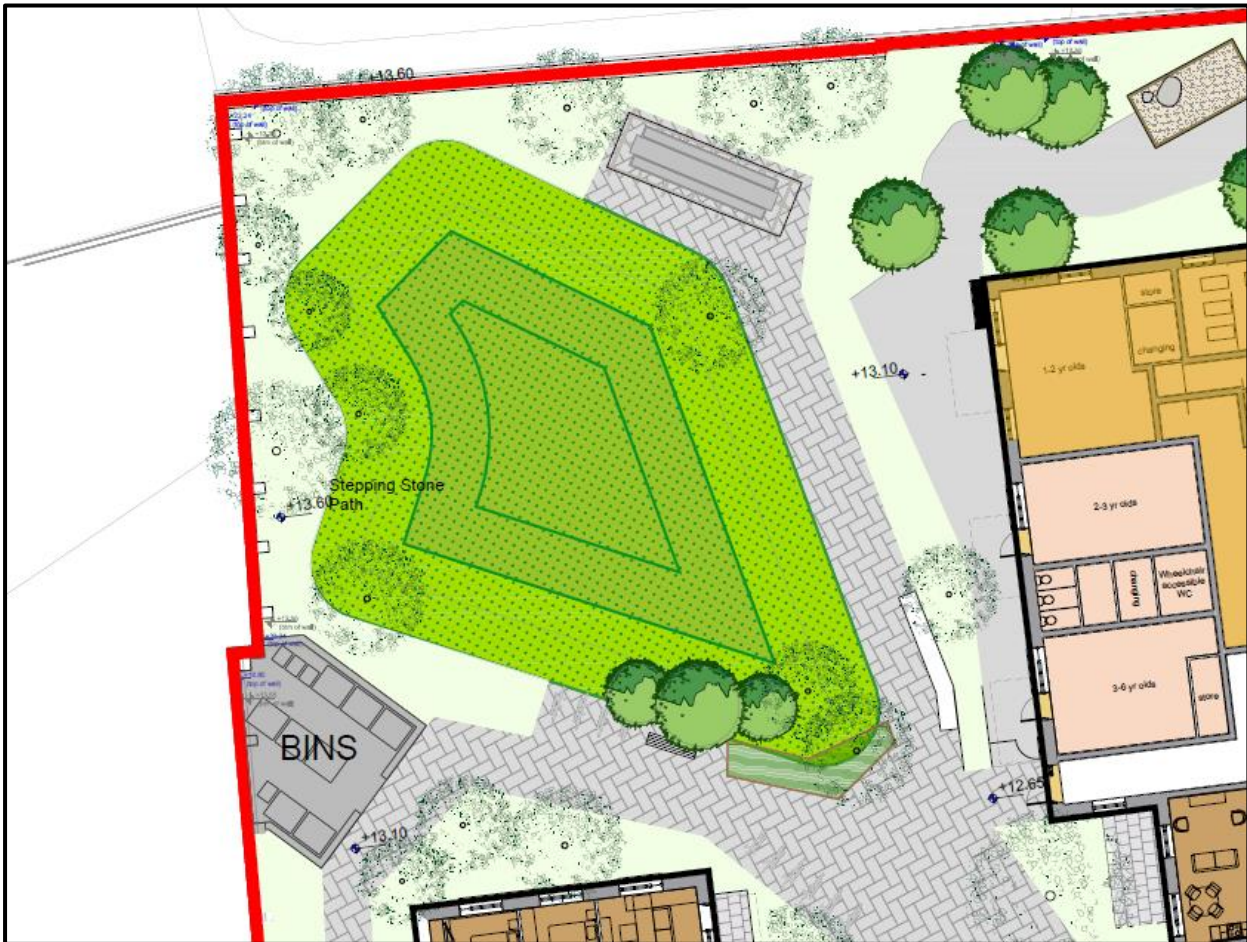
### Location: Adjacent to Play Area

The audit team note that the detention basin runs parallel to pedestrianised surface which could be a high footfall area for children in particular. As no protection is provided for vulnerable users, the audit team has concerned that a vulnerable road user could inadvertently enter the bioretention area which could result in potential drowning incidents.

The design team should provide adequate protection to the detention basin and any protruding pipework is provided to prevent vulnerable users from entering the pond area.

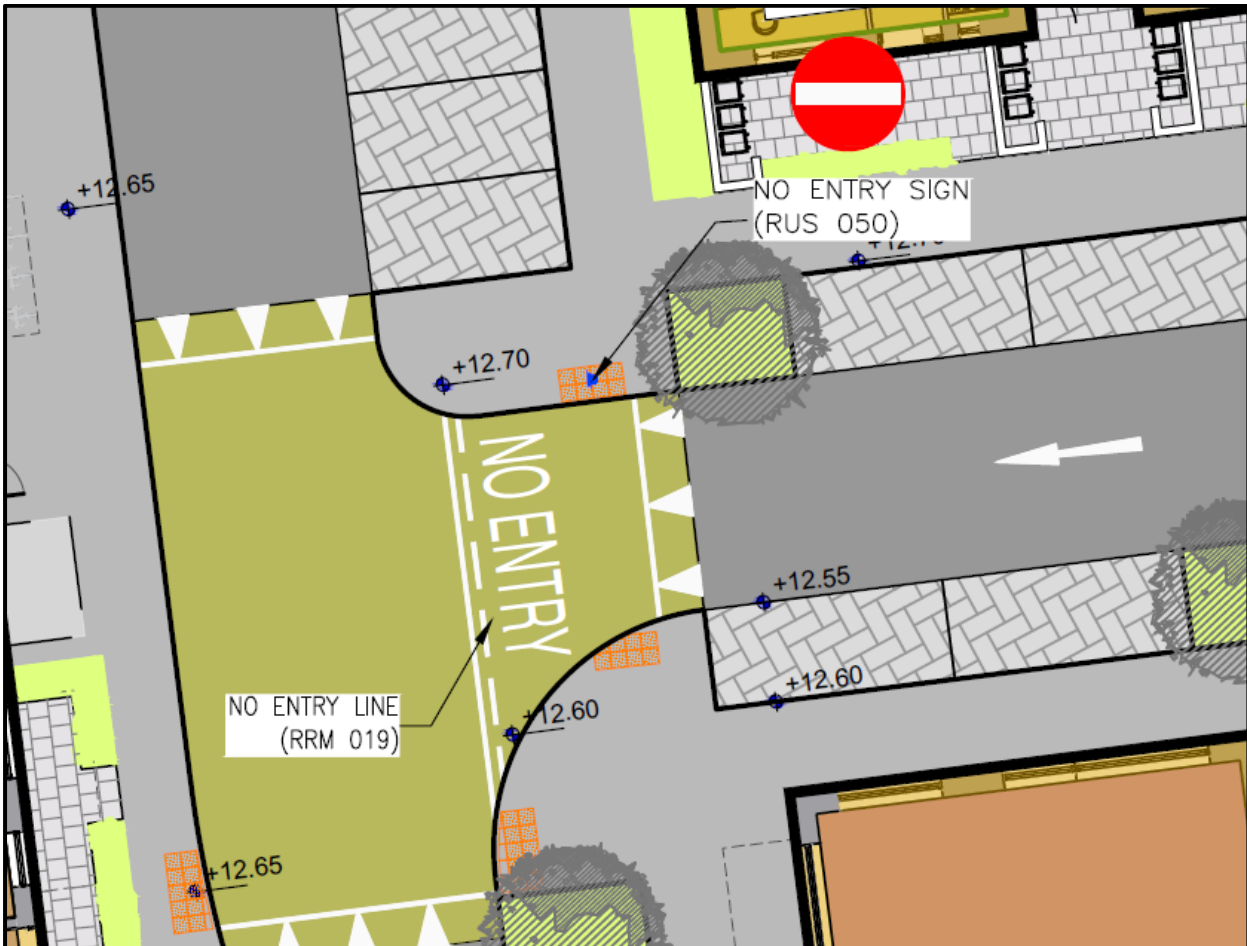
### Location: Identified Location

The audit team note that there are public lighting columns which appears to be positioned on the crossing point identified. The positioning of this column will restrict the movement of vulnerable users and will result in a safety hazard for visually impaired users.

The design team should ensure that this sign is relocated away from the crossing point to mitigate the safety risk.

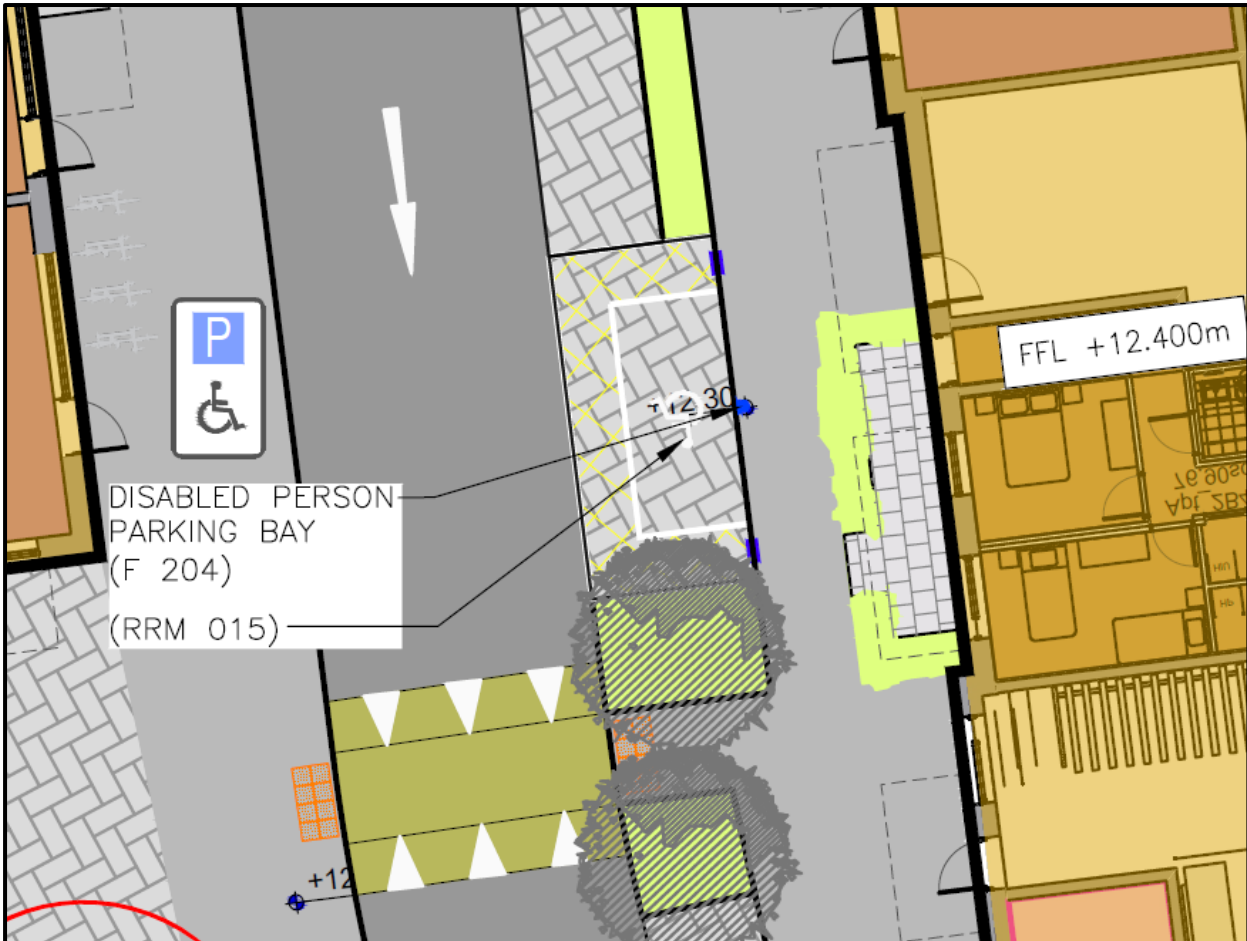
### Location: Identified Location

The audit team note that there is a risk that the proposed disabled parking sign may impact on the ability for users to open car doors once parked.

The design team should ensure that this sign is positioned such that it does not impeded users from exiting their vehicles and that it does not restrict vulnerable users' movement on footpaths.

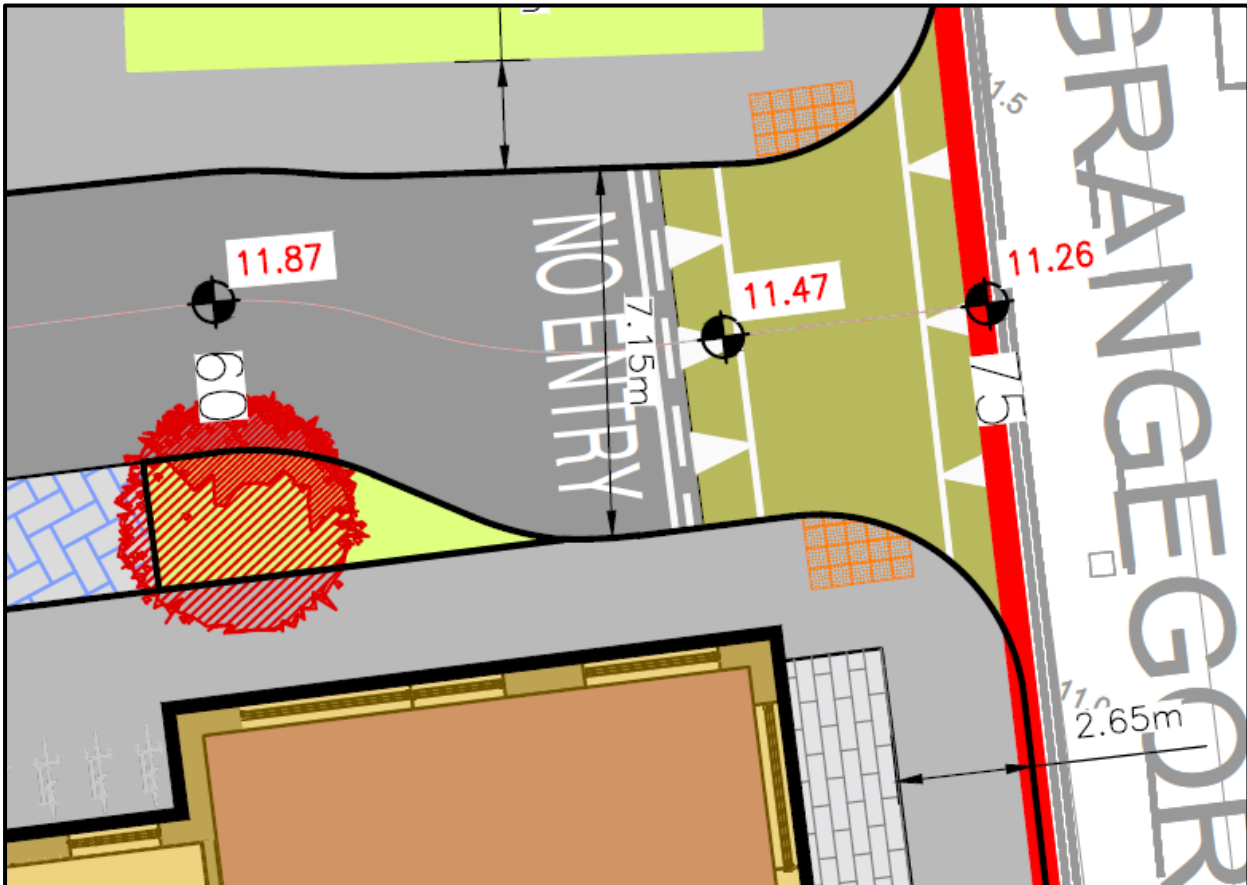
### Location: Identified Location

The audit team note that the proposed junction arrangement at Grangegorman Lower Road appears excessively wide for single vehicle entries and could encourage higher speeds of vehicles accessing the development. This creates a safety risk for vulnerable users at the crossing if vehicles enter the development at higher speeds.

The design team should ensure reduce the width of this access to mitigate the safety risk identified.
