**Stage 1 Quality Audit Report
Social Housing Bundle 4, Development
at Wellmount Road, Finglas**

Client:	Dublin City Council
Document No:	SHB4-WRF-RP-ORS-CS-P3-0001-Stage 1 Quality Audit Report

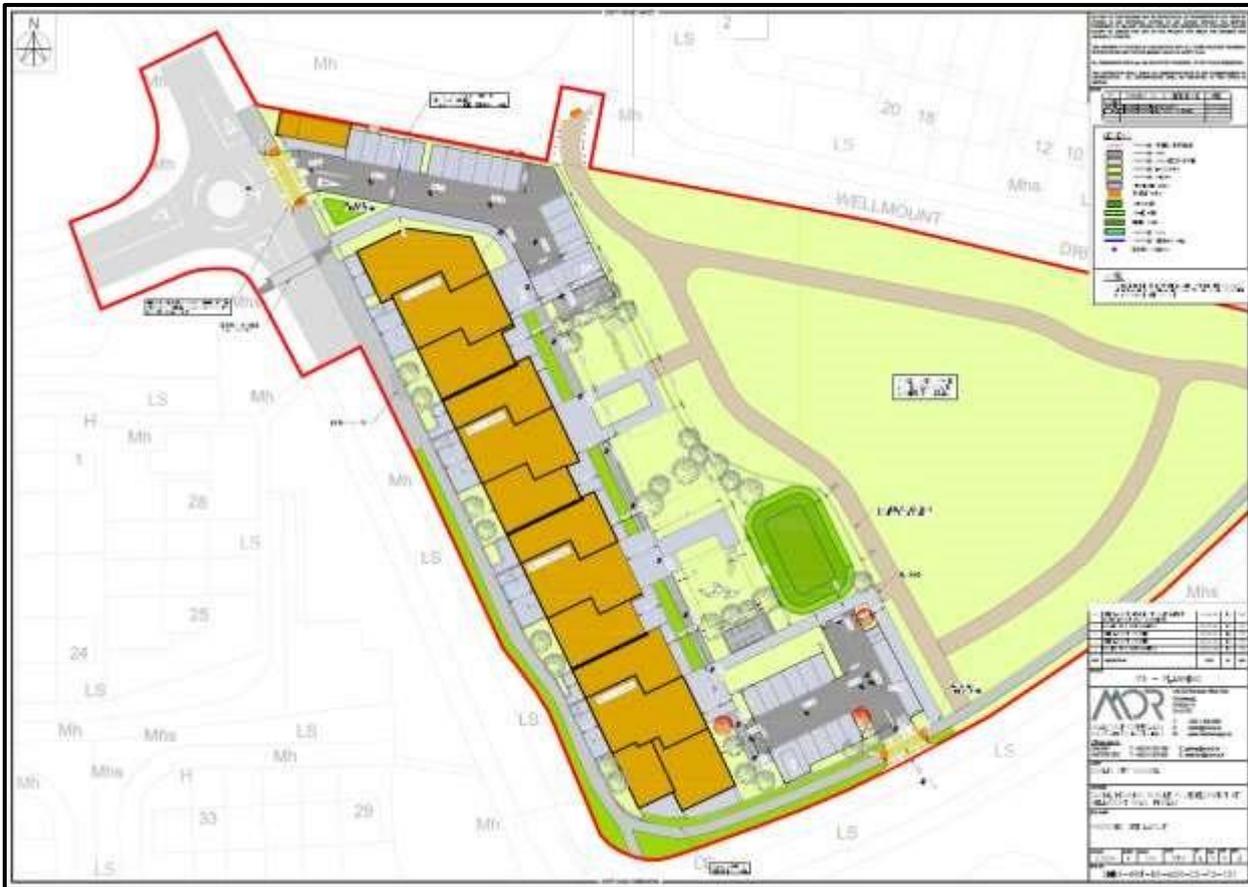
Figure 2.2: Site Layout (Source: Malone O'Regan Consulting Engineers)

Figure 2.2 shows the proposed site layout provided by Malone O'Regan Consulting Engineers.

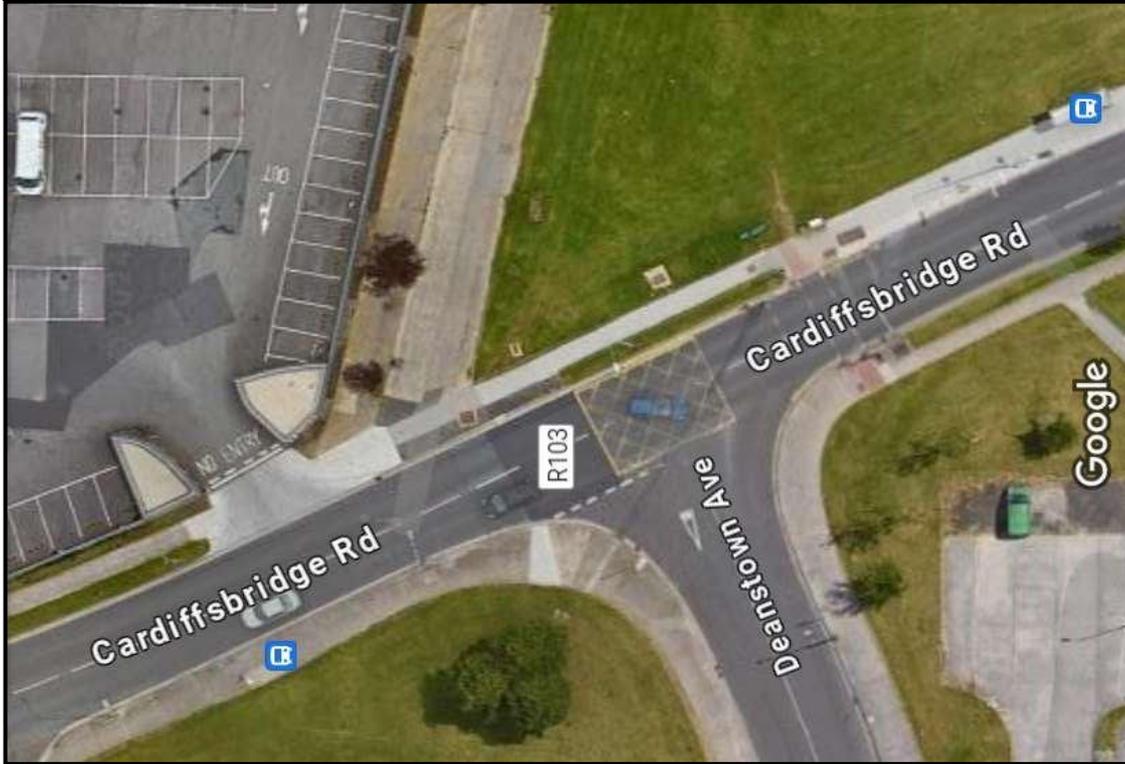
Figure 2.3: Pedestrian facilities along R103 (Cardiffsbridge Rd) (Source: Google Maps)

The R103 (Cardiffsbridge Rd) is a two-way regional road with single lane in each direction of the carriageway. R103 (Cardiffsbridge Rd) connects Mellows Road/Kildonan Road junction towards the north of the application site to the Tolka Valley Road/R103 junction to the south of the site. The overall width of the vehicular carriageway is approximately 11.2 metres with footpaths and streetlights on either side of the carriageway. The junction with Deanstown Ave/

R103 (Cardiffsbridge Rd) is equipped with a signalised pedestrian crossing, well connected pedestrian infrastructure, road markings and signage as shown in **Figure 2.3** and **Figure 2.4**.

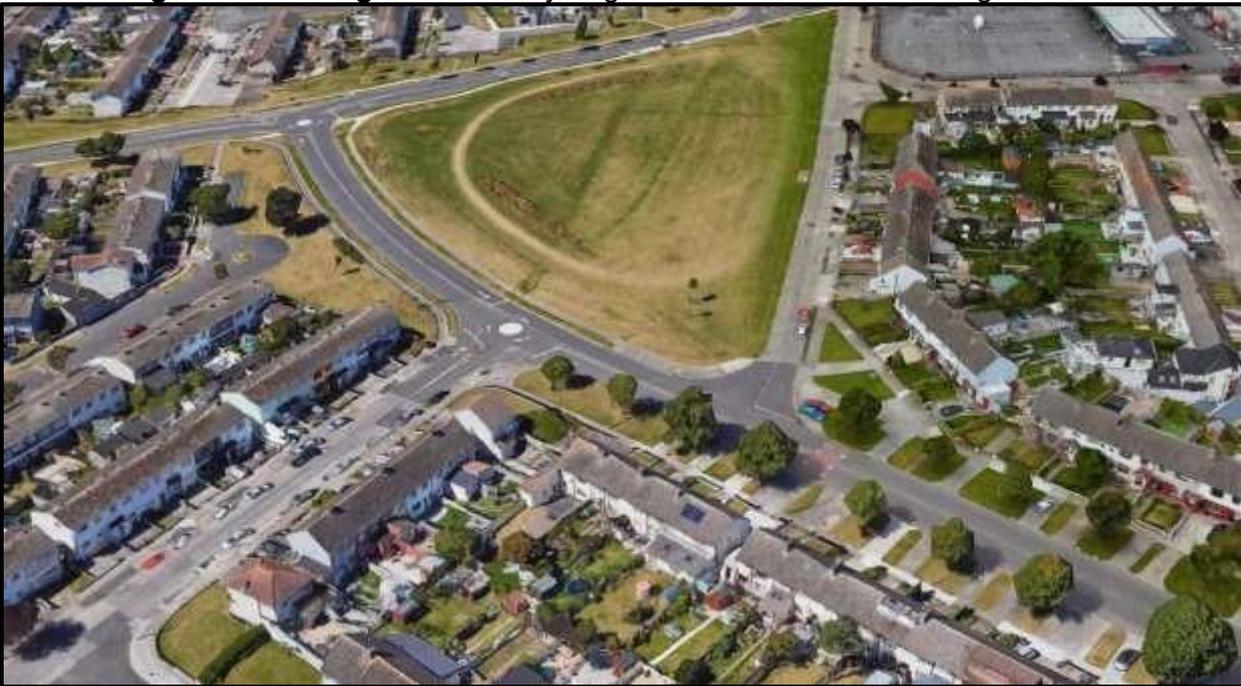
Figure 2.5: Overview of Wellmount Road (Source: Google Earth)

Wellmount Road is a two-way local road forming the southeast boundary of the application site. The road connects the R103/Wellmount Round roundabout towards the southern corner of the application site to the R135 (Finglas Road)/Wellmount road junction to the northeast of the site. Wellmount road runs parallel to the southern boundary of the site while passing through the proposed vehicular access junction of the site. Along the length of the carriageway the road features uncontrolled pedestrian crossings. The overall width of the vehicular carriageway is approximately 11.2 metres with footpaths and streetlights on either side of the carriageway as shown in **Figure 2.6** and **Figure 2.6**. No cycling facilities are observed along the road.

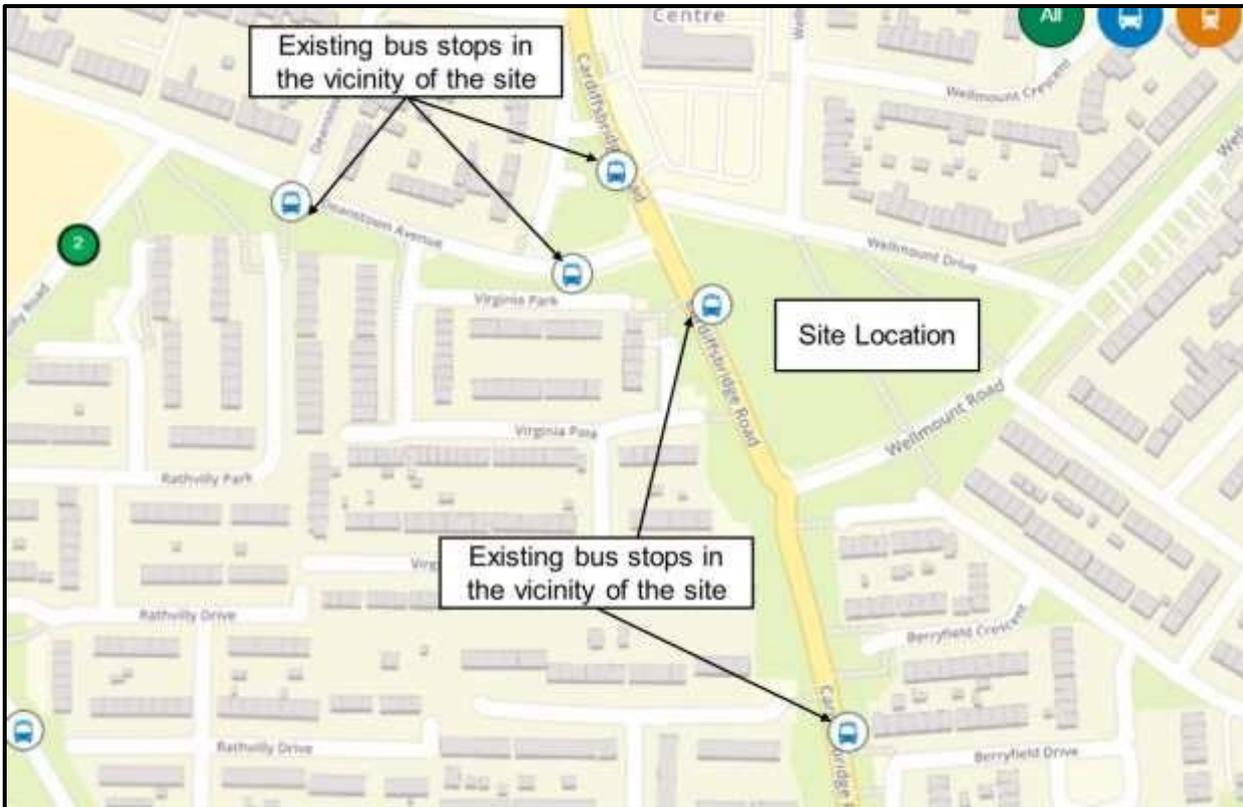
Figure 5.1: Bus stops in the vicinity of the development (Source: TFI)

There are 5 No. bus stops located in the vicinity of the site out of which 3 No. are located on Cardiffsbridge Rd and 2 No. are located on Deanstown avenue. All the bus stops are located ca. 100 to 200 metres from the application site. Pelletstown Train Station is located to the south of the site which is served by Dublin-Maynooth and Longford and M3 Parking. There are continuous footpaths leading the site to the bus stops located adjacent to the site and the train station. The footpaths are deemed to be in good condition and of appropriate width in the vicinity of the site entrance. The bus stop provided in the vicinity of the site on Cardiffsbridge Rd has the provision of a bus shelter with a bench. **Table 5.1** overleaf outlines the available bus services in the area.

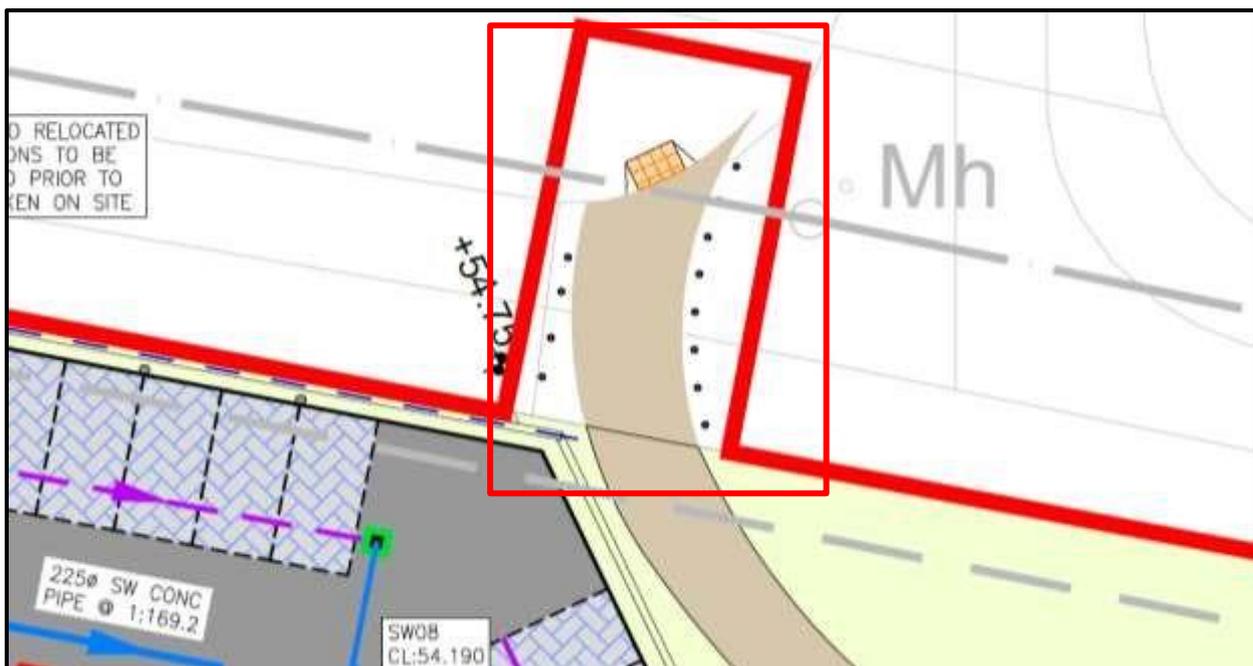
Problem No.1: Crossing Point Orientation/Location

Location: Wellmount Drive

The audit team note from the provided drawings that a pedestrian crossing is proposed at the identified location. The pedestrian path is not aligned at right angles to the main carriageway. Additionally, tactile paving is only provided at one end of the pedestrian path, with none at the proposed development's end, which could create conflicts for visually impaired users. The audit team is concerned that this misalignment could lead to trips and falls for vulnerable users.

Recommendation:

The design team should ensure crossing facilities are provided on both sides of the carriageway with tactile paving and dropped kerbs for vulnerable users and ensure that it is orientated at right angles to the main carriageway.

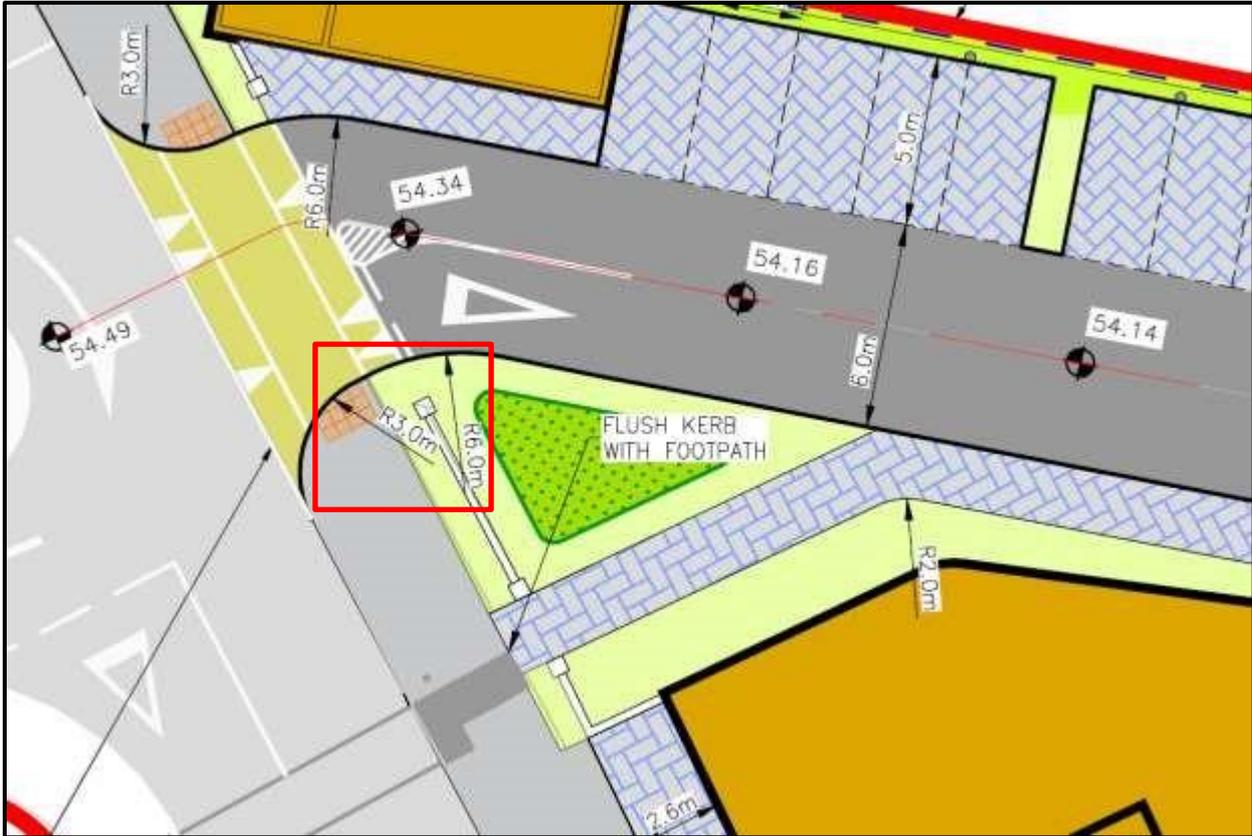
Problem No.2: Proposed Surfacing

Location: Adjacent to Northwest Access of the Site

The audit team notes from the drawings that clarity is lacking at the specified location regarding the proposed surfacing in the area identified. It appears that the surface is not a formal proposed pedestrian access. However, integrating it with the existing pedestrian infrastructure without appropriate detailing could create a significant safety hazard for vulnerable users.

Recommendation:

The design team should ensure that measures are implemented to prevent pedestrians from accessing this surface, or that appropriate tie-in measures are detailed in the proposed drawings.

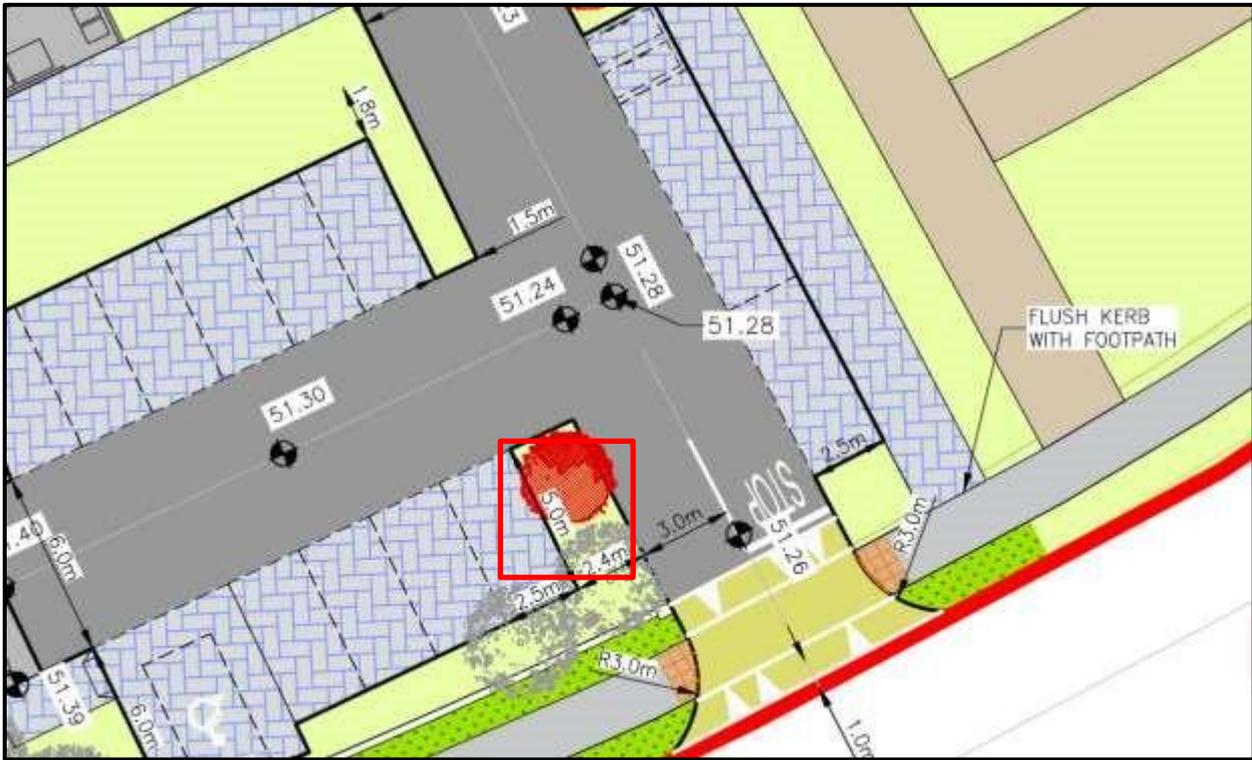
Problem No.3: Landscaping Restricting Visibility

Location: Access Road along Southeast Side of Development

The audit team note from the drawings that the proposed landscaping at the identified car park access point may obstruct drivers' sightlines to the left, potentially compromising visibility and safety for vehicles entering the car park.

Recommendation:

The design team should ensure that the proposed landscaping does not impair visibility of internal roads and junctions or affect forward visibility.

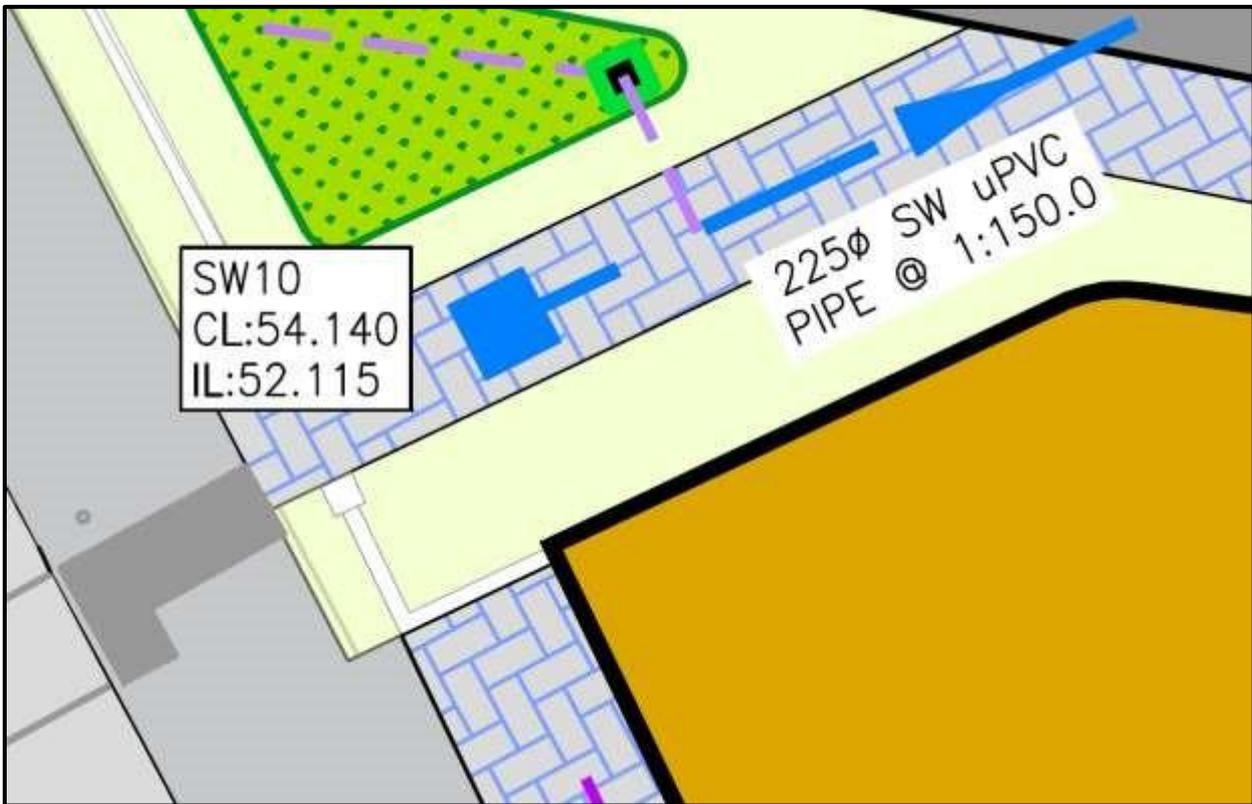
Problem No.4: Drainage Manhole Lids

Location: Pedestrianised area

The audit team note from the provided drawings that drainage manholes are proposed within the footpath are identified which is designated for pedestrian movement. The proposed placement of drainage manholes in footpaths raises concerns. If walkways are not kept clear of gratings, or channels, and are not level with the pavement surface or should the surface be slippery, it may pose challenges for wheelchair users or individuals with mobility aids, potentially resulting in trips and falls.

Recommendation:

The design team should ensure that manholes are strategically positioned to minimise obstruction to pedestrian movement and level with the pavement surface to eliminate tripping hazards. The design team should also ensure that the manhole lids are covered with anti-slip surfacing.

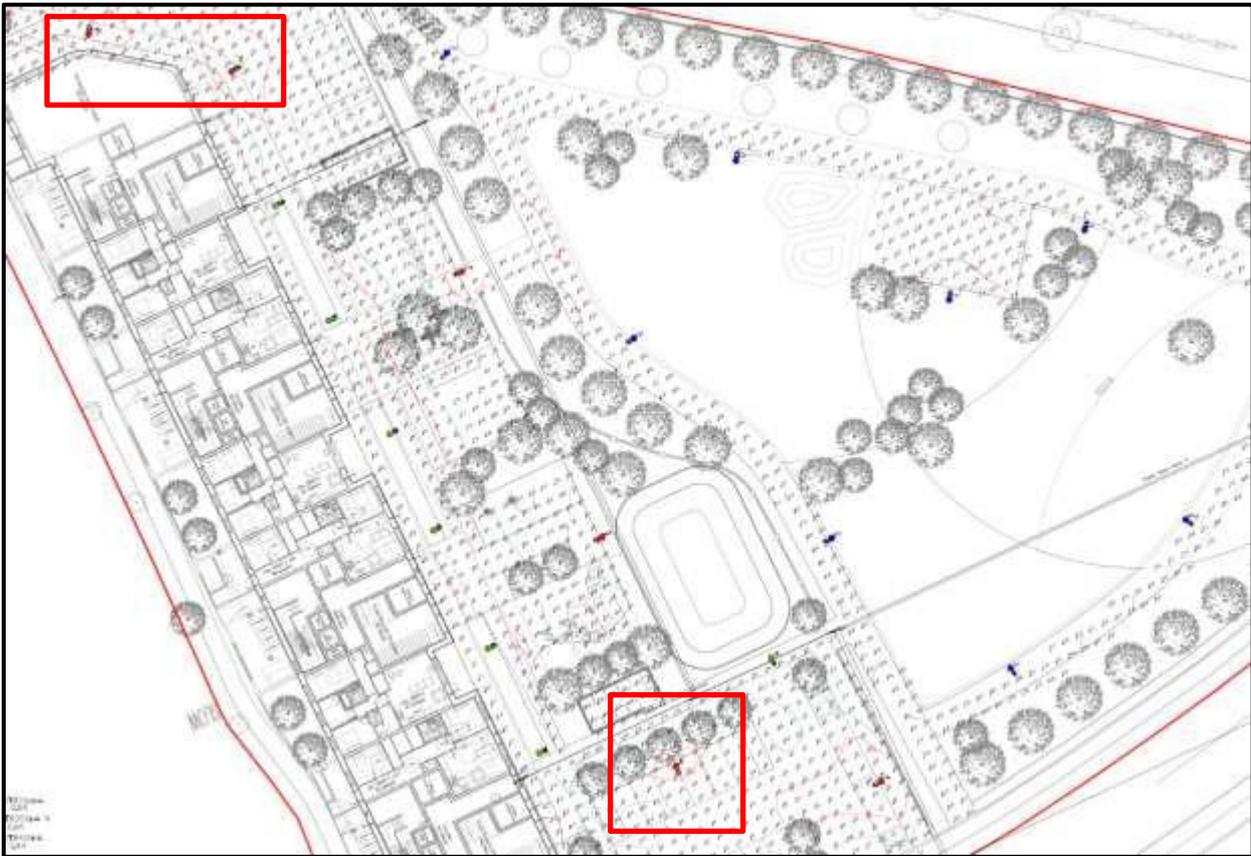
Problem No.5: Public Lighting Columns in Footpath & Parking Spaces

Location: Throughout Development

The audit team note from the provided drawings that some public lighting columns are positioned with the footpath in the northern carpark which could result in potential conflicts with vulnerable users and will restrict the passage of mobility impaired users. The audit team also note that there is also a public lighting column within a car parking space in the southern carpark which will result in vehicle conflicts with the column.

Recommendation:

The design team should ensure that public lighting columns are positioned outside of pedestrian walkways and to ensure that they are positioned outside of carpark and carriageway areas. The design team should also ensure that lighting columns do not restrict users from exiting parked vehicles.
