**Underwater Archaeological Impact Assessment (UAIA)
Proposed Rowing Pontoon
River Liffey
Islandbridge, Co. Dublin**

23D0020, 23R0117

Subject: UAIA, proposed Rowing Pontoon.

Location: Islandbridge, River Liffey, Dublin.

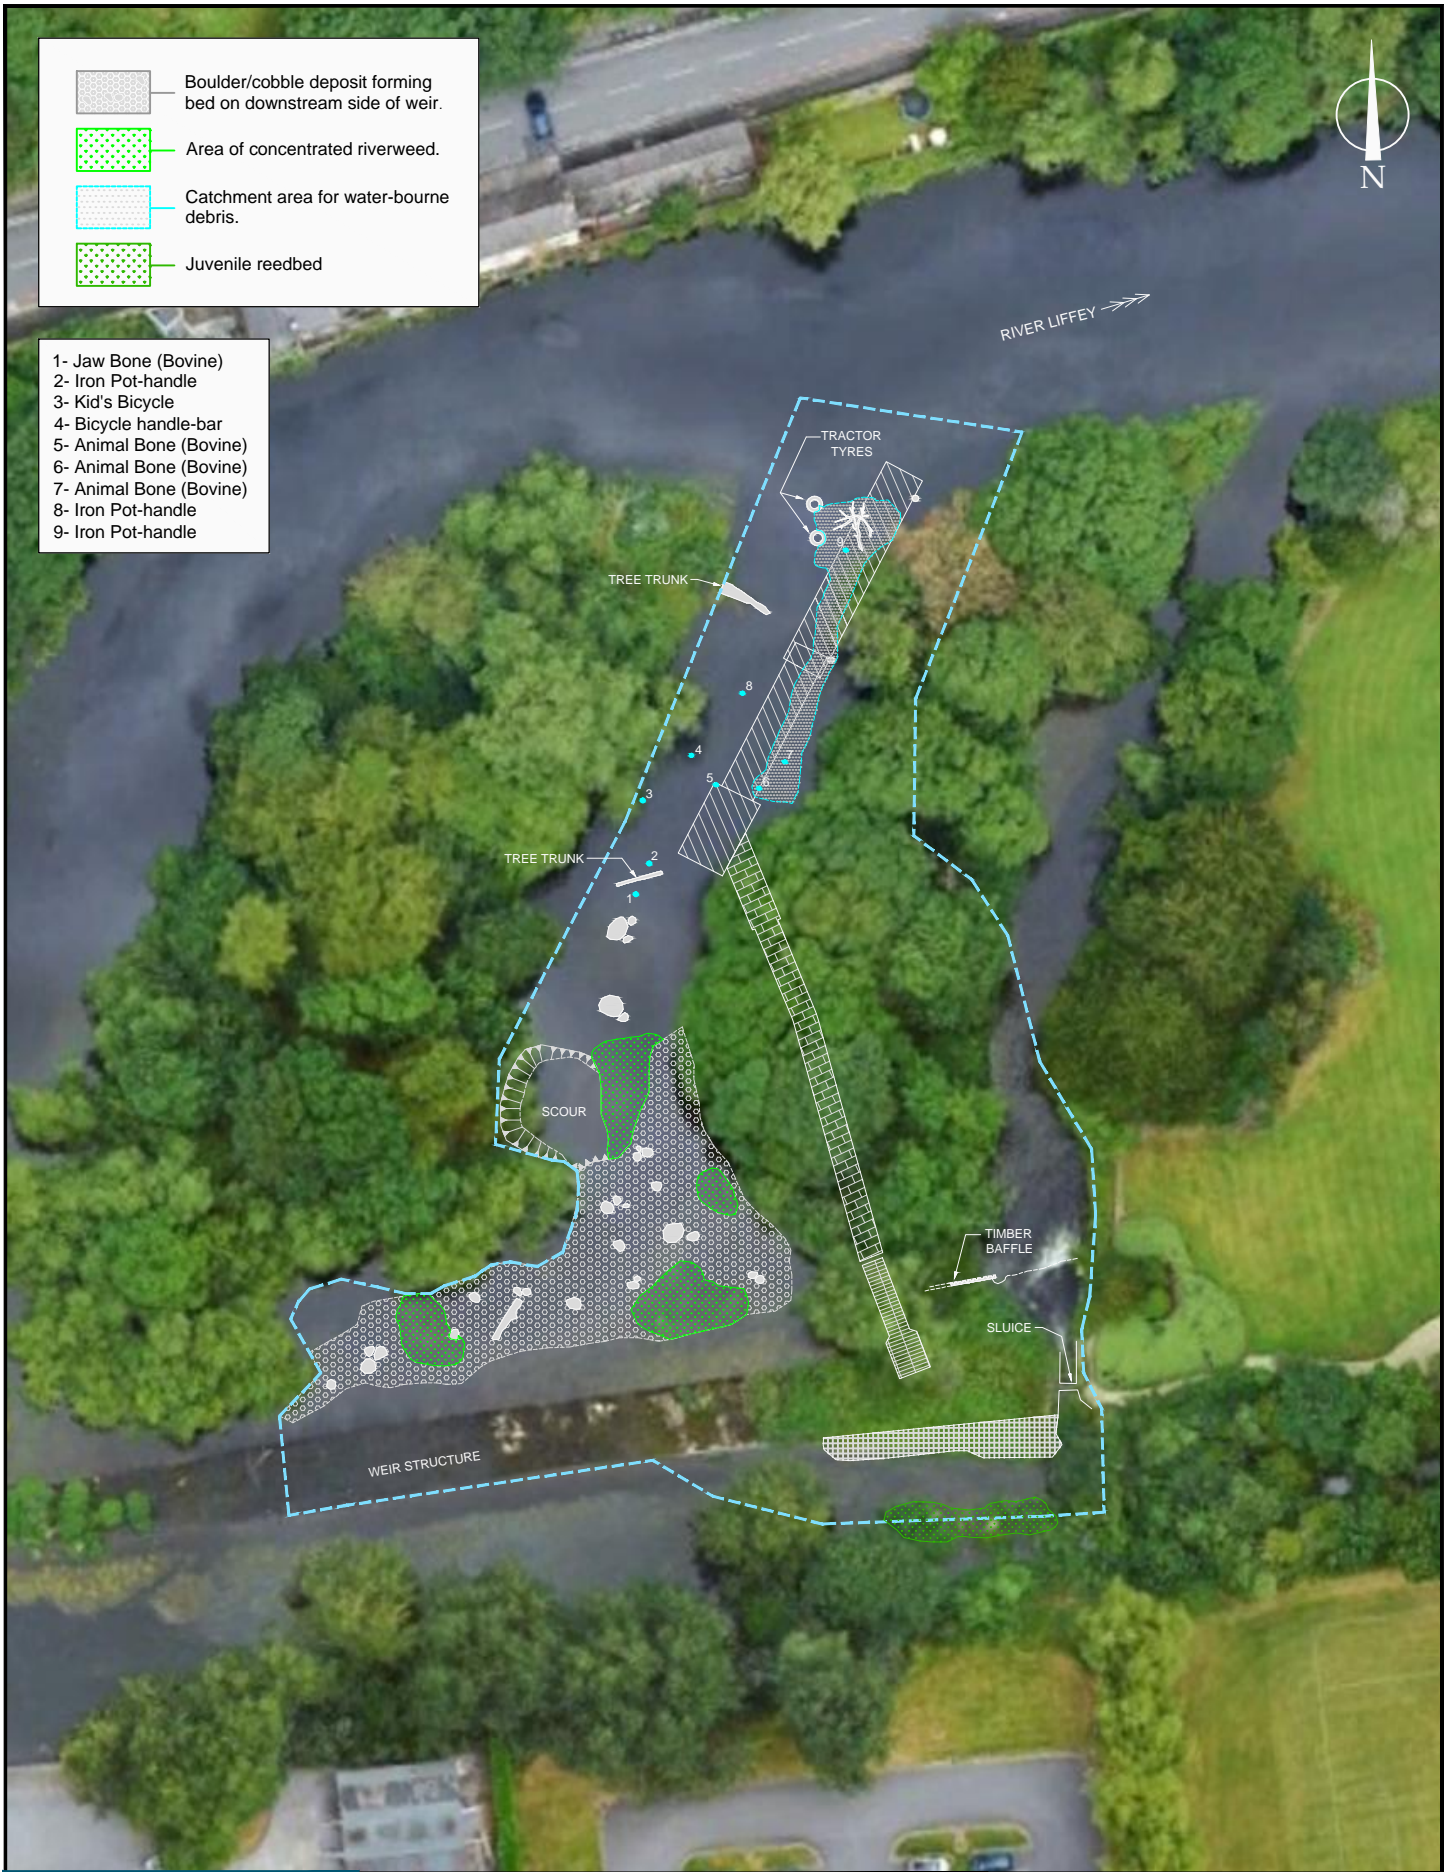
Drawing No.
Figure 4

- Boulder/cobble deposit forming bed on downstream side of weir.
- Area of concentrated riverweed.
- Catchment area for water-bourne debris.
- Juvenile reedbed

- 1- Jaw Bone (Bovine)
- 2- Iron Pot-handle
- 3- Kid's Bicycle
- 4- Bicycle handle-bar
- 5- Animal Bone (Bovine)
- 6- Animal Bone (Bovine)
- 7- Animal Bone (Bovine)
- 8- Iron Pot-handle
- 9- Iron Pot-handle

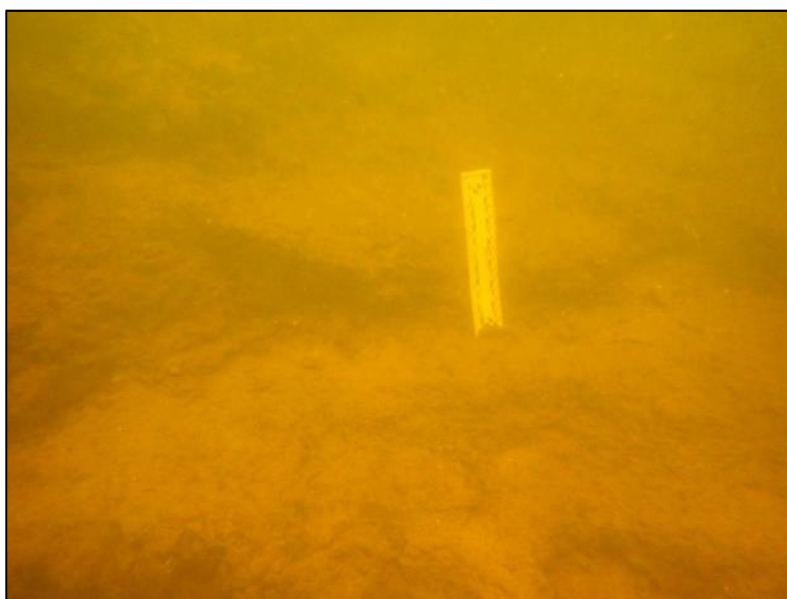
Siltation is active along the east side of the river channel, this deposition being caused by the weir upstream (Plate 7). A scour pool (1m deeper than the surrounding riverbed) has formed on the western side of the river channel; localised to the area around the base of the weir. This part of the riverbed retains higher frequency of large boulders (300mm x 300mm x 300mm on average) as well as aquatic vegetation (riverweed, etc.) that has anchored itself onto these boulders (Plate 8).

Plate 7: Silt build-up on eastern side of riverbed (150mm scale).

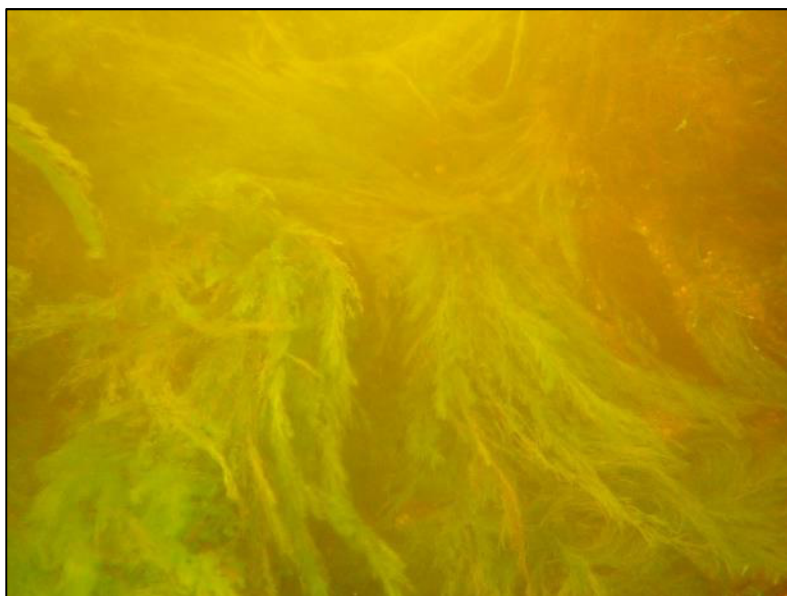
Plate 8: Riverweed coverage on boulders around the base of the weir.

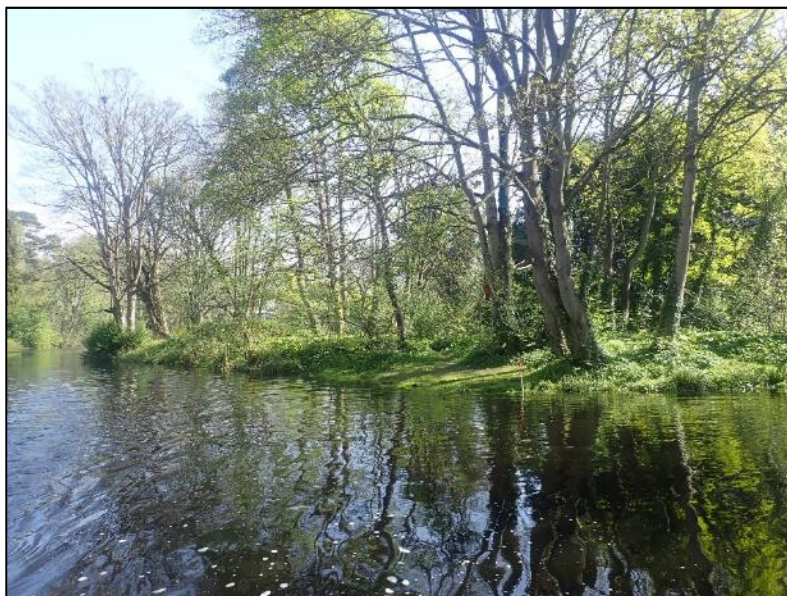
At the propped river impact location, the riverbank is comprised of topsoil and vegetation (above the high-water mark), sitting upon a clay bank (Plate 9). Considerable undercutting of the bank structure was observed (500mm height and 700mm in depth) before it meets with the gravelly sand riverbed previously described (Plate 10). This bankside undercutting appears to run the length of the proposed rowing pontoon, although visual confirmation was obstructed by a number of large, felled tree trunks that lay across the riverbed at the northwest side of the island (Plate 11).

Plate 9: Riverbank at location of proposed rowing pontoon.

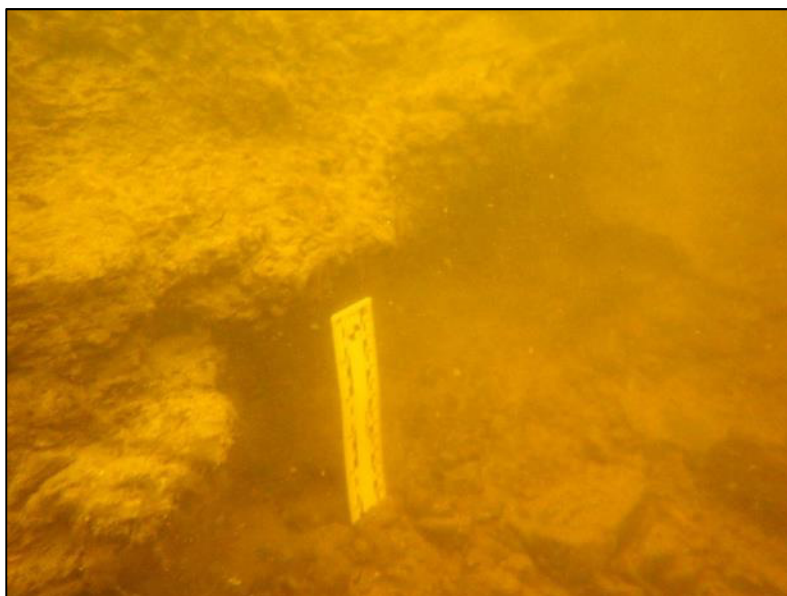
Plate 10: Beginning of undercutting beneath eastern riverbank (150mm scale).

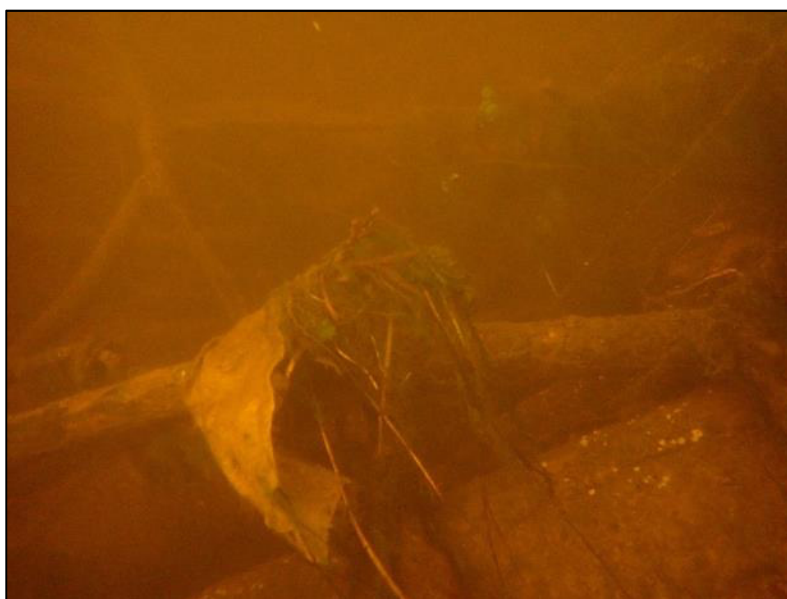
Plate 11: Felled tree trunk lying across riverbed.

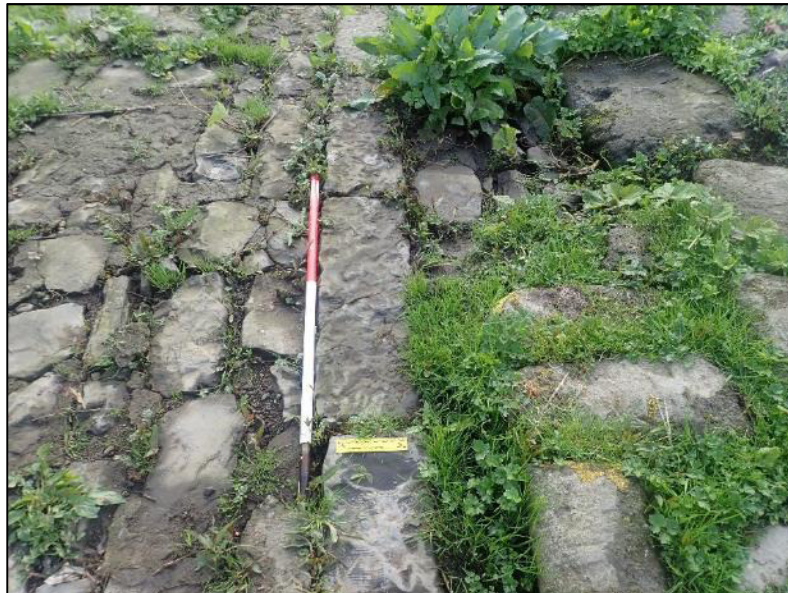
Plate 14: Weir (left) and weir sill (centre) with hessian sacks (right) (1m/ 150mm scales).

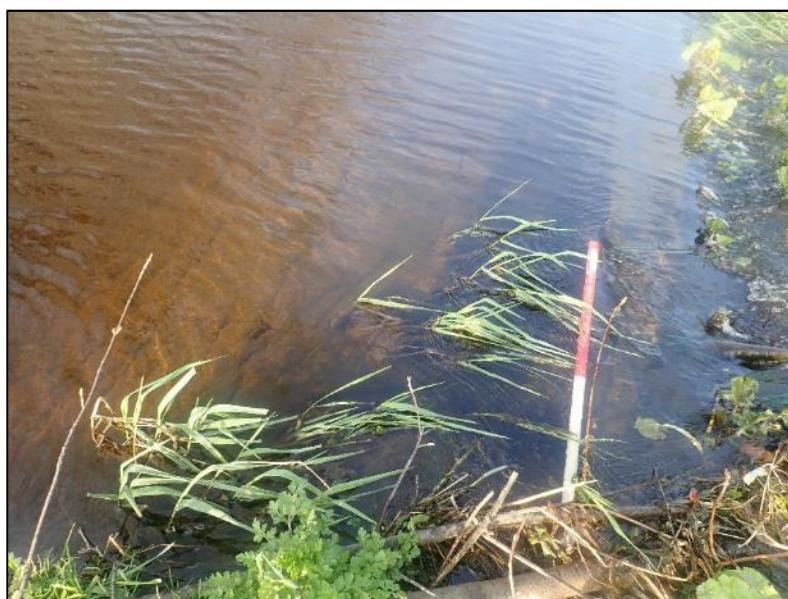
Plate 15: Ramp of weir (underwater) (1m scale).

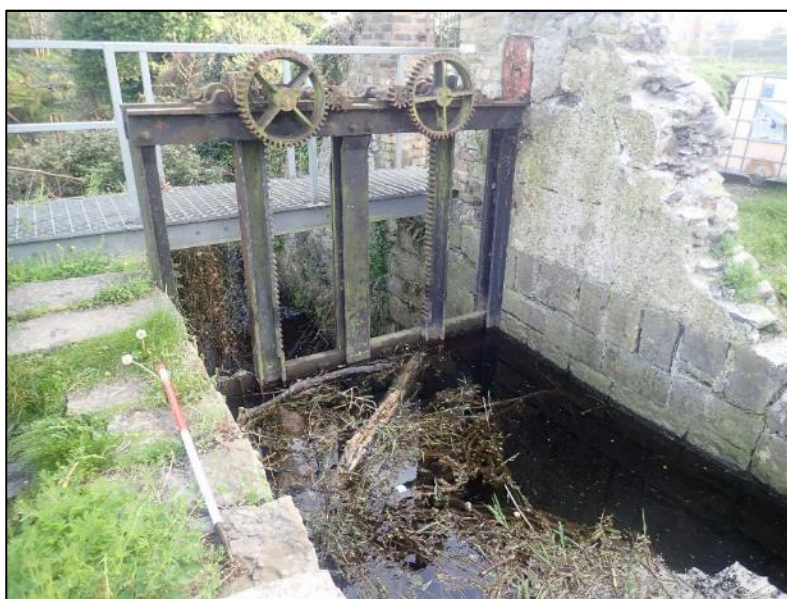
Plate 17: Upstream side of flow control sluice gate (1m scale).

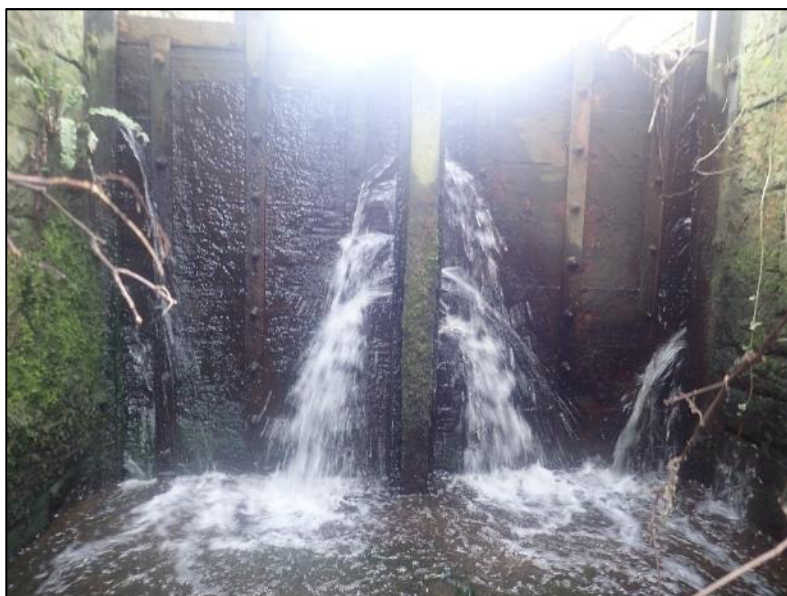
Plate 18: Downstream side of flow control sluice gate.

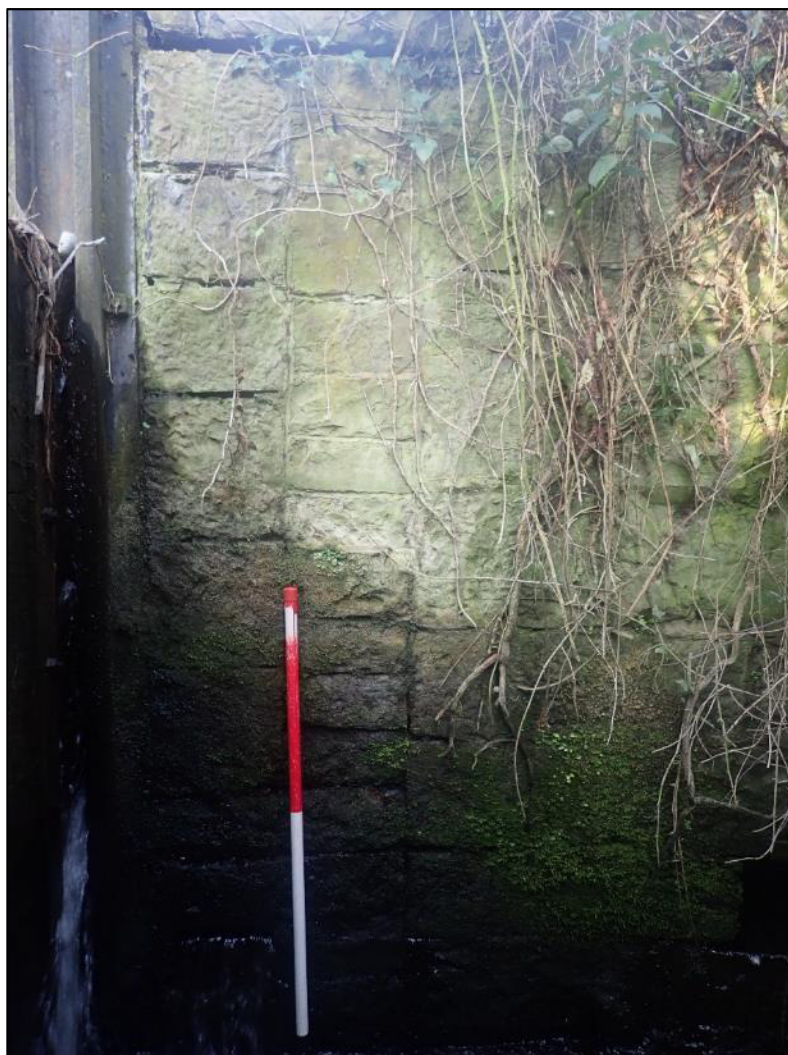
Plate 20: Masonry feature indicating the previous presence of an anchor point for the timber post of an earlier sluice gate (1m scale).

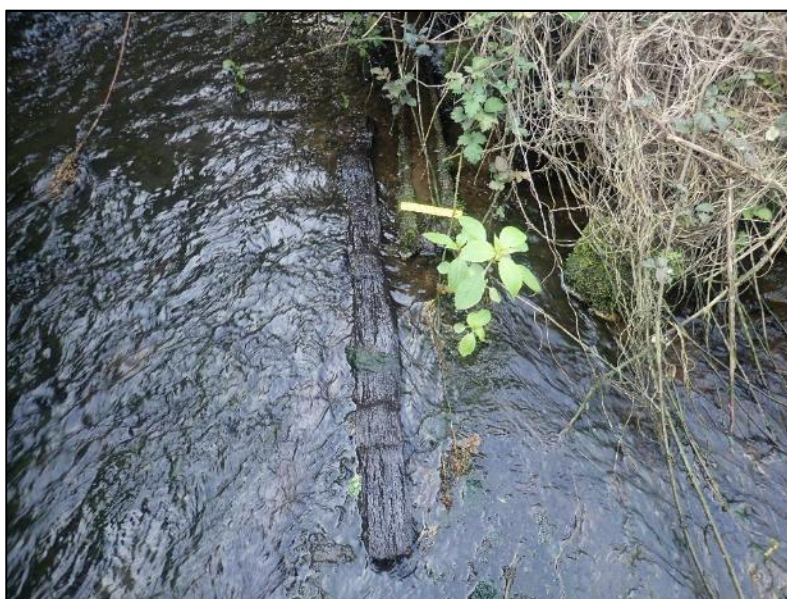
Plate 21: Oak timber and steel I-beam resting on concrete covered stone apron.

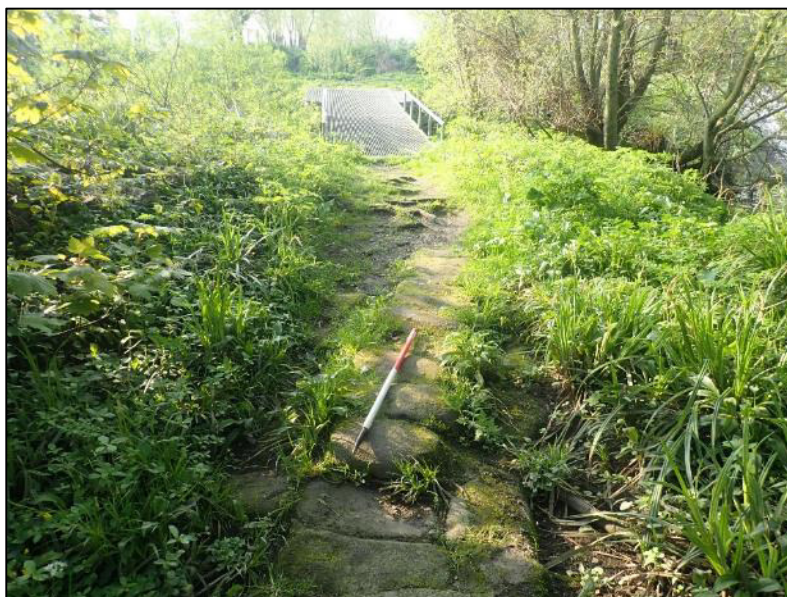
Plate 22: Existing footbridge proposed to be removed; baffle rests to the left of this bridge (1m scale).

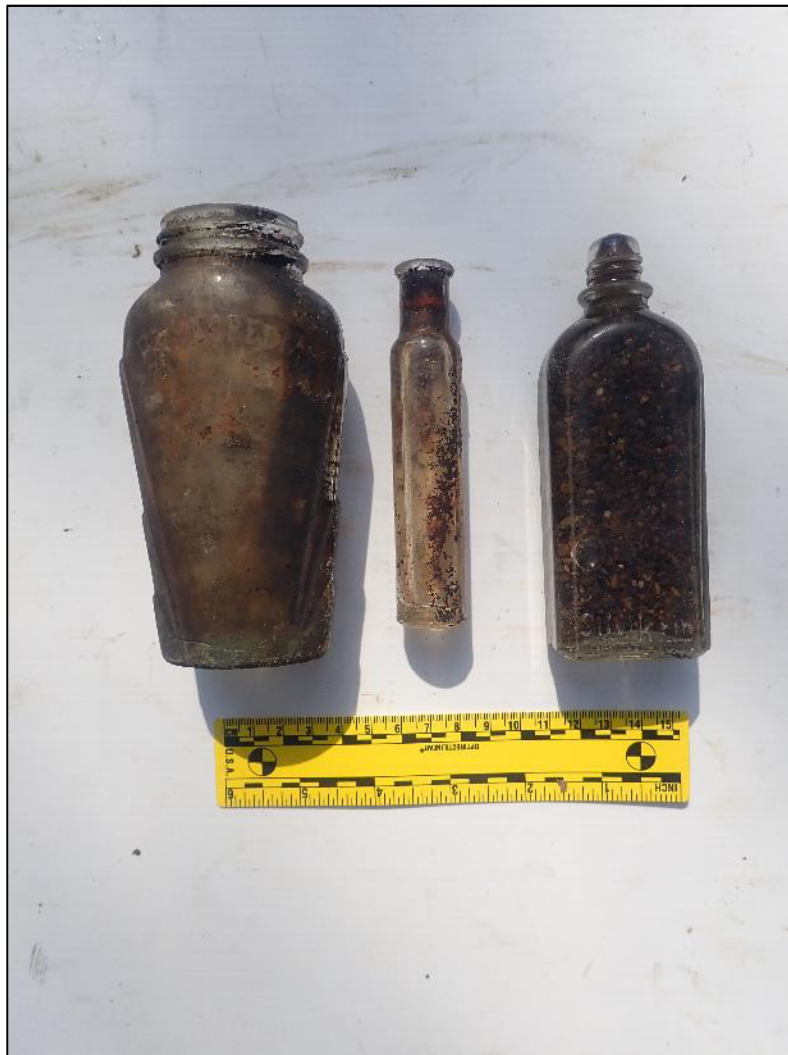
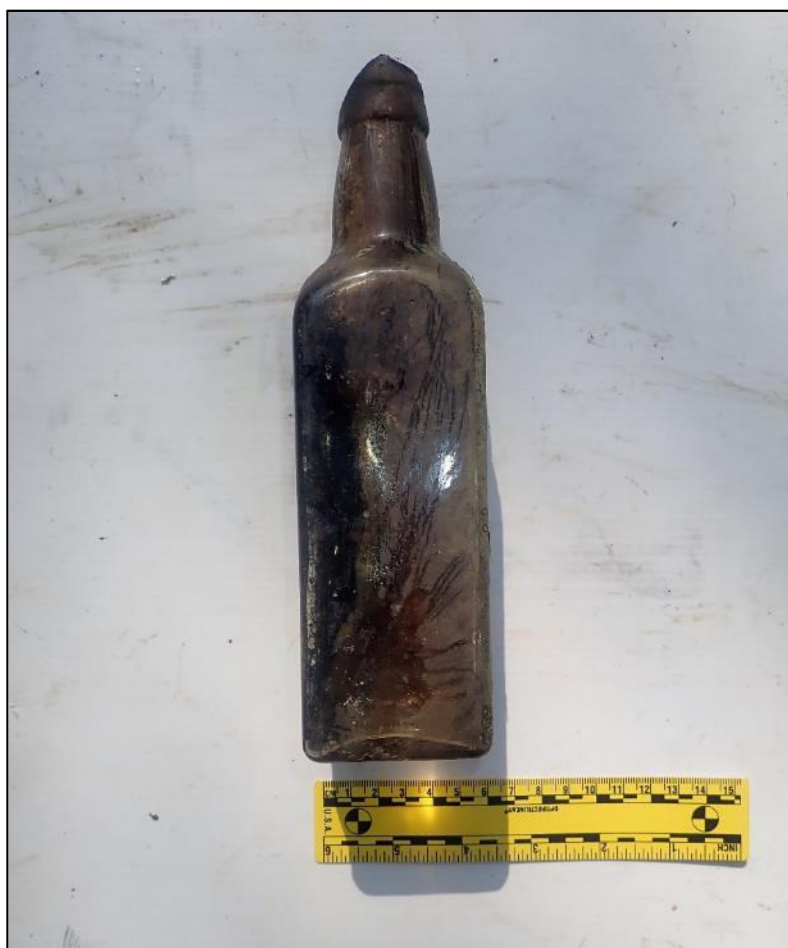
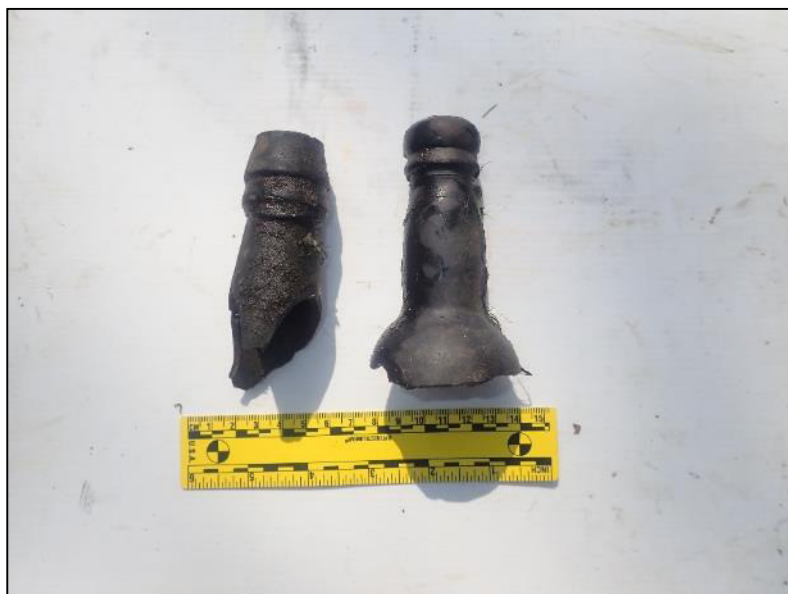
Four (4) complete glass bottles and two (2) bottle neck fragments were found in total. The one (1) rectangular of the four (4) complete bottles may date from the first-half of the twentieth century, with the other three (3), as well as the two (2) neck fragments, dating to the second-half of the twentieth century (Plates 25-27).

Plate 25: Three (3) complete glass bottles found throughout underwater survey area (150mm scale).

Plate 26: One (1) complete glass bottle found in underwater survey area (150mm scale).

Plate 27: Two (2) glass bottle necks found in underwater survey area (150mm scale).

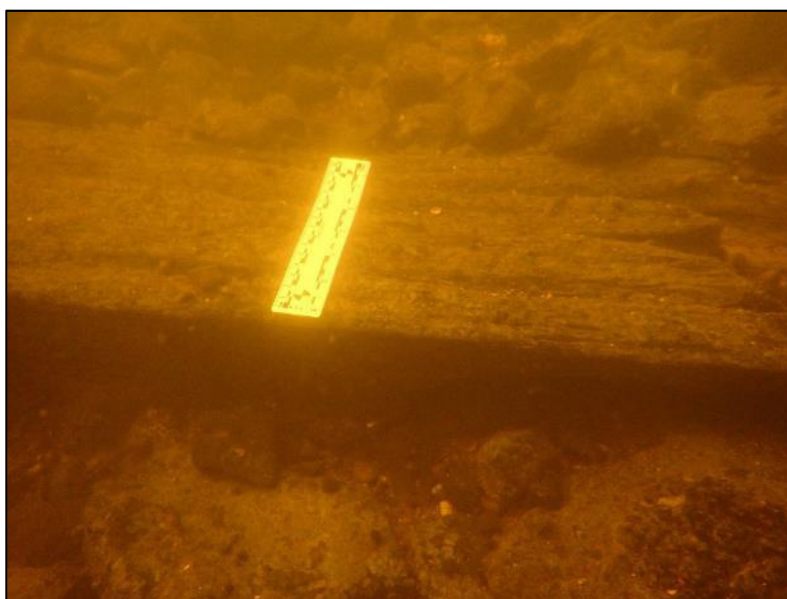
timber had a flat surface as if milled into a plank. However, its underside was rounded, giving it the profile of a half-split log. The flattening of this timber's upper surface may have been caused by river erosion rather than it having been milled. Nevertheless, it showed no signs of fastenings and did not appear to be a component of any present structure or feature (Plate 28).

Plate 28: Eroded tree trunk resembling half-split log (150mm scale).

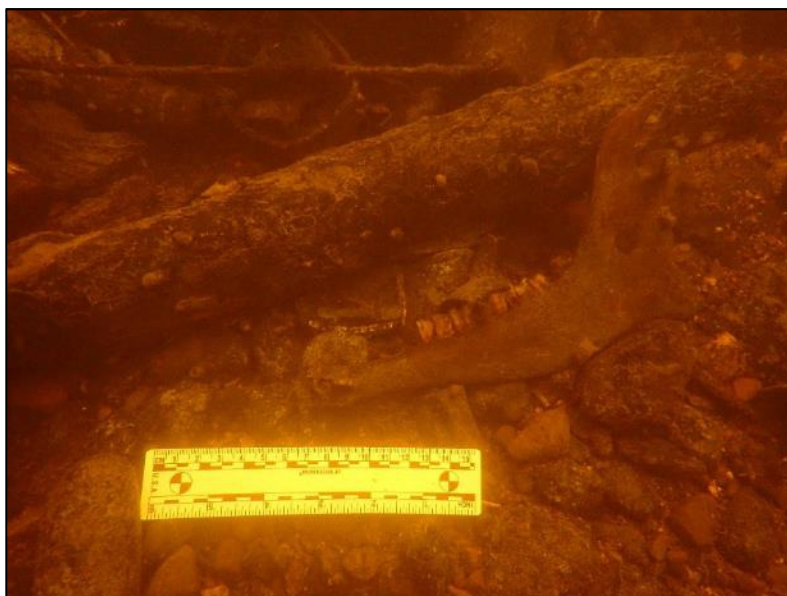
A number of bone pieces were identified throughout the survey area. A cow jawbone and a section of cow's teeth were found underneath where the gangway will connect the caissons (Plate 29). A range of other animal bones were also scattered throughout the survey area.

Plate 29: Cow jawbone (150mm scale).

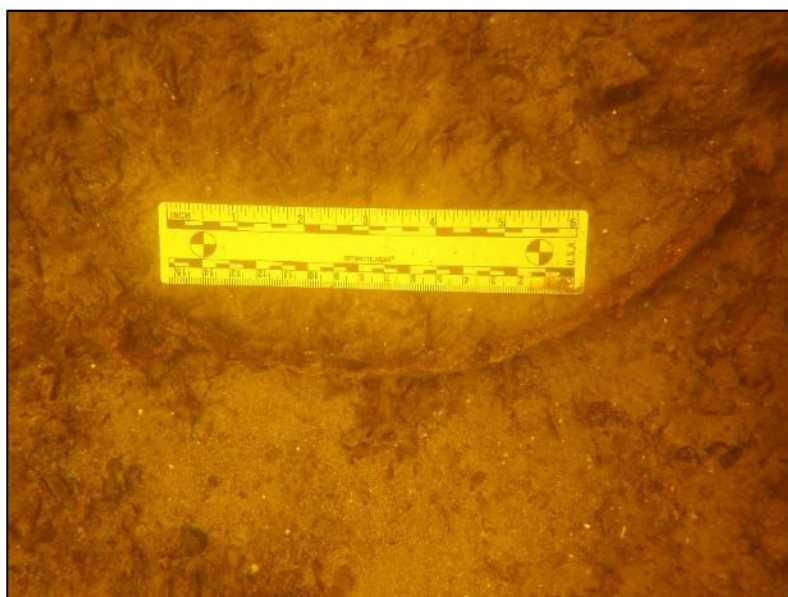
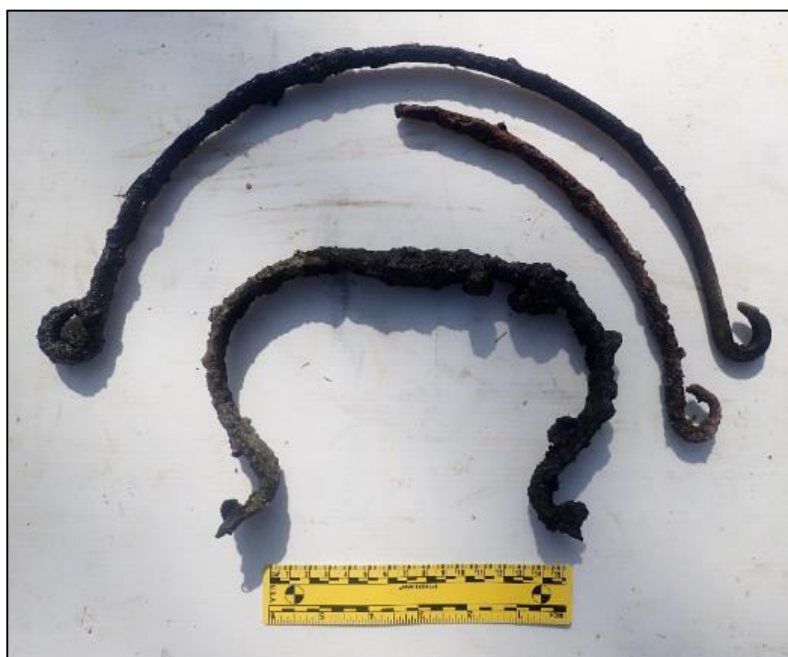
There were three (3) metal pot handles found strewn across the riverbed, located in close proximity to the proposed river impact area. One was found where the north-western corner of the caisson base will be situated. It had a base measurement of 370mm, indicating the diameter of the pot or bucket it was once connected to. A half fragment of an iron pot handle was encountered 2m south of the proposed caisson base of the rowing pontoon (Plate 30). It had an approximate base measurement of 300mm. Another iron pot handle was encountered 3m north-west of this caisson base. It exhibited a base measurement of 170mm (Plate 31). The style and material of these pot handles place their manufacture around the mid-twentieth century.

Plate 30: Fragment of iron pot-handle lying on riverbed (150mm scale).

Plate 31: Three (3) iron pot-handles found retrieved from riverbed (150mm scale).

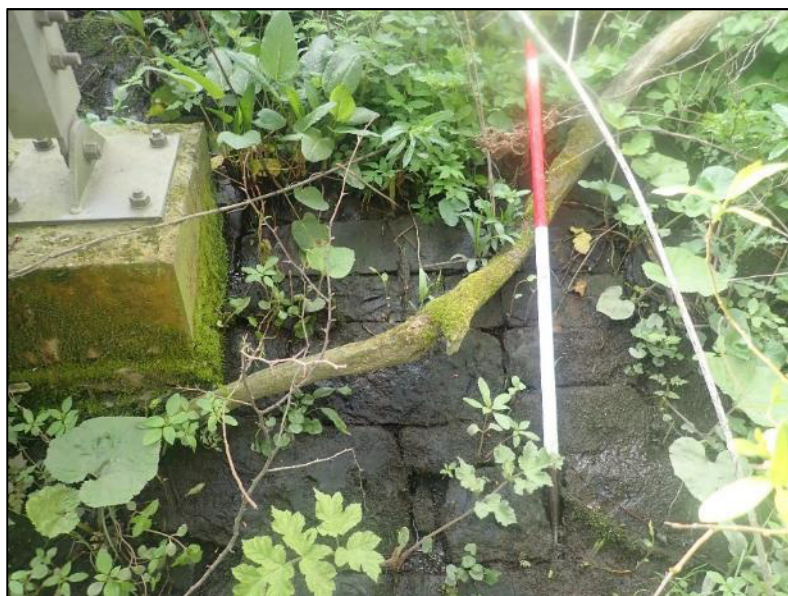
The existing footbridge, that is to be temporarily removed, is supported by concrete foundations built directly onto the weir's stonework (Plate 33). The construction of the replacement to this bridge has been designed to be supported off these concrete foundations and, therefore, poses no new impact to the weir's stonework.¹⁵

Plate 33: Concrete support of footbridge built onto weir stonework (1m scale).
