Library Square, Ringsend

Stage 1 Road Safety Audit

**Document Ref:** P23022-PMCE-XX-ZZ-RP-SA-RSA-3\_00\_01

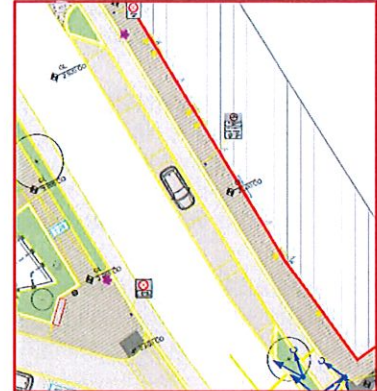
*Location: Parallel parking arrangements on Irishtown Road*

*Summary: The absence of an adequate buffer between the amended parallel parking spaces and the adjacent cycle lane may result in vehicle doors being opened into the path of a cyclist.*

It is proposed to reposition the existing parallel parking spaces along the eastern side of Irishtown Road and to position the cycle track to the rear of the parking spaces.

No buffer zone has been indicated between the parallel parking spaces and the adjacent cycle track, which could result in vehicle occupants opening their doors into the path of an oncoming cyclist.

An appropriate buffer zone should be provided between the cycle track and the parking spaces.

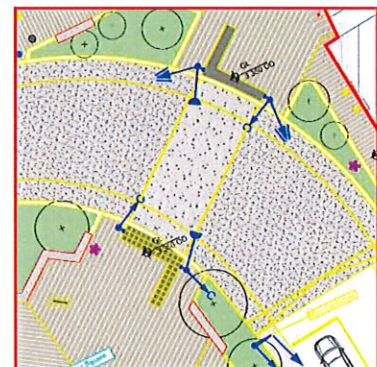
*Location: Proposed Toucan Crossing*

*Summary: Measures to advise visually-impaired pedestrians of the Shared Path on the approaches to/departures from the Toucan crossing have not been indicated.*

It is proposed to provide a new Toucan crossing on the corner between Bridge Street & Irishtown Road. This is likely to encourage cyclists to travel within the footpaths on either side of the crossing, in essence making the footpaths an area shared by both pedestrians & cyclists.

No measures have been indicated to advise visually-impaired pedestrians that they are entering an area shared with cyclists. This would lead to visually impaired pedestrians being insufficiently aware that they are entering a shared area where cyclists may also be present which could result in an increased risk of pedestrian-cyclist collisions.

Measures should be provided to advise visually impaired pedestrians when they are entering/leaving a Shared Path (e.g. Ladder & Tramline tactile paving at the interfaces between shared and segregated surfaces).

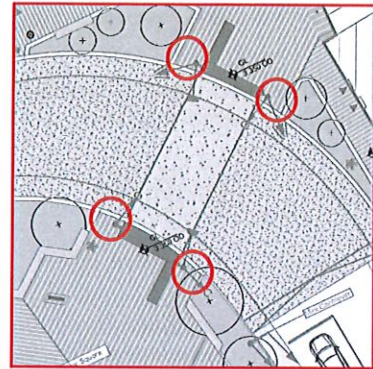
*Location: Proposed raised table between Bridge Street & Irishtown Road*

*Summary: Unclear if the raised table would be level/flush with the adjacent path.*

A raised-table is proposed on the corner between Bridge Street & Irishtown Road. It is unclear from the information provided if it is intended to provide a level difference between the path and the raised-table away from the proposed signalised pedestrian crossing.

Should there be insufficient level difference between the path and the raised-table, there is a risk that a visually impaired pedestrian may inadvertently enter the carriageway where there is an increased risk of being struck by a vehicle.

The proposed design should include measures to ensure that visually-impaired pedestrians do not inadvertently enter the carriageway at the proposed raised-table (e.g. providing an appropriate level difference between the footpath and the raised-table away from crossing locations).

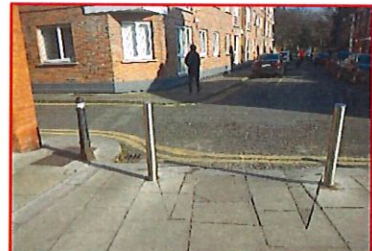
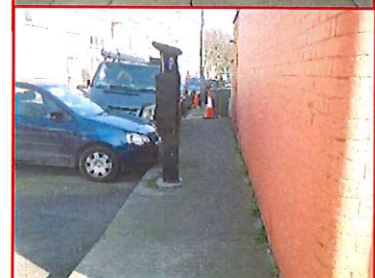
*Location: Saint Patrick's Villas*

*Summary: Likely pedestrian desire line not catered at scheme extents.*

It is proposed to provide a new Toucan crossing on the corner between Bridge Street & Irishtown Road. This is likely to increase the volumes of pedestrians crossing the road and wishing to travel along Saint Patrick's Villas towards Ringsend Park, however the existing footpath leading to the park is unlikely to be able to cater for the increased volumes of pedestrians.

This may result in pedestrians travelling within the side road carriageway leading to an increased likelihood of vehicle/pedestrian collisions.

New or amended pedestrian/cyclist desire lines created as result of the proposed new Toucan crossing should be assessed and, where necessary, appropriate measures provided to ensure that vulnerable road users can safely join the existing road network.

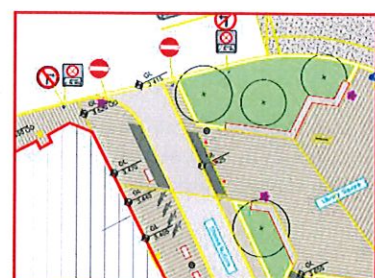
*Location: Fitzwilliam Street/Bridge Street junction.*

*Summary: Visibility for drivers exiting Fitzwilliam Street may be impeded by the proposed planting on Bridge Street.*

Trees/planting have been indicated on the southern side of Bridge Street, to the east of Fitzwilliam Street/Bridge Street junction. At this early stage in the design process it is not clear what planting is proposed at this location, and there is a risk that when mature planting in this area could restrict an exiting driver's visibility towards approaching vehicles, possibly resulting in unsafe exiting manoeuvres and side-on collisions.

The proposed planting/landscaping should not impede a driver’s visibility towards approaching traffic when exiting side roads within the scheme.

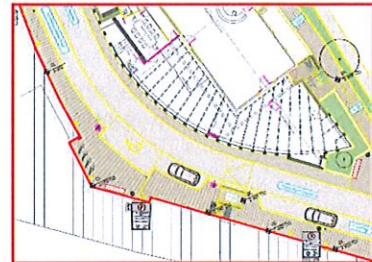
*Location: Fitzwilliam Street*

*Summary: No “Safe Zone” for visually-impaired pedestrians has been indicated within the proposed shared area along Fitzwilliam Street.*

At this early stage in the design process it is unclear if a level difference is proposed between the footpath and the carriageway on Fitzwilliam Street. A note on the drawing provided indicates that this area is to be a “Shared Space”, however no “Safe Zone” for visually-impaired pedestrians has been indicated. It is also unclear if there would be sufficient tonal contrast between the footpath areas and the shared carriageway area.

The absence of a “Safe Zone” for partially-sighted and visually-impaired pedestrians would increase the difficulties experienced by these road users in independently & safely navigating the proposed street layout, and could result in a visually impaired pedestrian inadvertently entering the carriageway unsafely.

A “Safe Zone” should be provided within shared areas/paths within the scheme with appropriate measures to ensure that it can be detected and traversed safely by the visually-impaired.

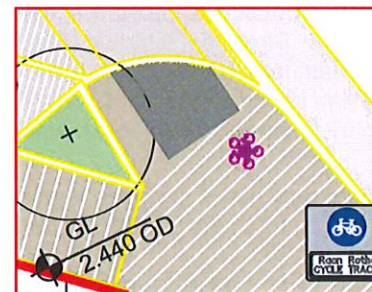
*Location: Fitzwilliam Street/Irishtown Road Junction*

*Summary: Position of lighting column may present a hazard to non-motorised road users (NMUs).*

A public lighting column is indicated centrally within the footpath on the southern side of the crossing of Fitzwilliam Street. This would present a hazard to inattentive or visually-impaired pedestrians travelling within the footpath.

Items of roadside furniture, including public lighting columns, should be positioned where they do not present an obstacle or a hazard to non-motorised road users within the footpaths.

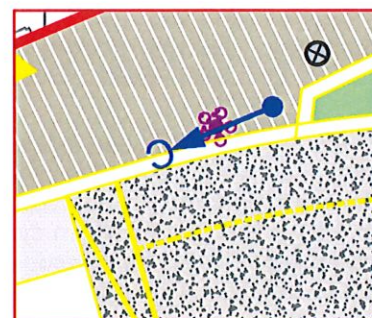
*Location: Bridge Street*

*Summary: Lighting column may impede visibility towards proposed signals.*

A lighting column is indicated positioned in front of the eastbound cyclist secondary traffic signal head at Bridge Street. This might impede visibility to the signal head.

Items of roadside furniture, including public lighting columns, should be positioned where they do not impede visibility towards the existing or proposed traffic signals.

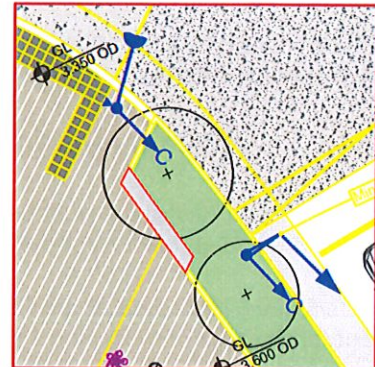
*Location: Cycle Lanes*

*Summary: Unclear if adequate vertical clearance would be available for cyclists within the cycle lane at all locations.*

Proposed trees have been indicated as extending over the cycle track/lane along Irishtown Road/Bridge Street at a number of locations. It is unclear at this early stage in the design process what the proposed tree species are, and if sufficient clearance/headroom would be available.

Insufficient clearance to the canopies could present a hazard to cyclists, or lead to sudden avoidance manoeuvres by cyclists resulting in possible loss-of-control incidents and personal injury.

Trees adjacent to, or overhanging, the cycle track should have a vertical clearance of 2.5m to the cycle track.

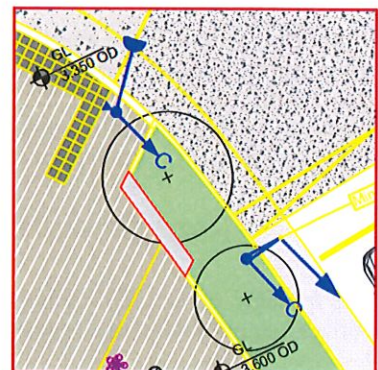
*Location: Proposed Cantilever Signal Supports at new Toucan Crossing*

*Summary: Unclear if the proposed cantilever signal supports at the new Toucan crossing will provide adequate clearance to cyclists within the cycle lane, and if measures are proposed to avoid them being struck by a vehicle that encroaches into the cycle lane.*

Cantilever signal supports posts have been indicated which overhang the proposed cycle lanes at a number of locations. It is unclear what the proposed clearance will be to the signals and their supports at these locations, and if insufficient they could present a hazard to cyclists, or lead to avoidance manoeuvres resulting in loss-of-control collisions.

In addition, no measures have been indicated to prevent vehicles from encroaching into the cycle lanes at these locations. Where a high-sided vehicle travels partially within the cycle lane there is a risk that they may strike the signals resulting in material damage.

The proposed cantilever signal supports should provide adequate vertical clearance to the cycle lanes, and measures provided to ensure that vehicles cannot strike the cantilever signals.

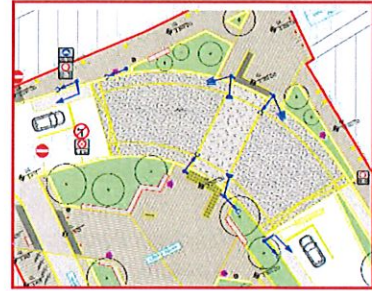
*Location: Irishtown Road/Bridge Street*

*Summary: Unclear if the swept path of two-way traffic can be accommodated within the amended road layout.*

Details of vehicle swept paths along Irishtown Road/Bridge Street have not been provided, and it is therefore unclear if two vehicles travelling in opposite directions can pass each other safely on the short radius horizontal bend between Irishtown Road & Bridge Street.

If there is insufficient space for opposing traffic to pass there is a risk of vehicles encroaching onto the cycle lanes and striking a cyclist, or side-swipe collisions between opposing vehicles.

A swept path analysis should be undertaken to confirm that the proposed road layout can accommodate the swept path of opposing vehicles safely at the short radius horizontal curve.

In addition, measures should be provided to ensure vehicles, in particular northbound vehicles, do not encroach onto the cycle lane through the bend.

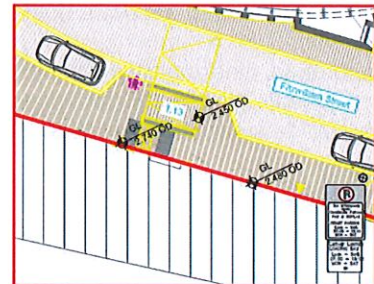
*Location: Fitzwilliam Street*

*Summary: Steep gradient within the footpath & carriageway.*

An 'external ramp' is proposed within the footpath on the western side of Fitzwilliam Street with a gradient of 1V:13H (c. 7.7%). The proposed ramp gradient may create difficulties for non-motorised road users. In particular a mobility-impaired wheelchair user, or someone pushing a pram, might fall forward out of a wheelchair when descending or the wheelchair or stroller may tip backwards when ascending.

In addition, at this early stage in the design process, it is unclear how the ramp will be implemented within the carriageway along Fitzwilliam Street. Should the gradient within the carriageway be similar to that within the footpath, and insufficient vertical curvature provided, there is a risk of vehicles "grounding" at the top of the ramp resulting in material damage.

The gradient on external ramps should not exceed 5% and an appropriate vertical alignment should be provided within the carriageway.

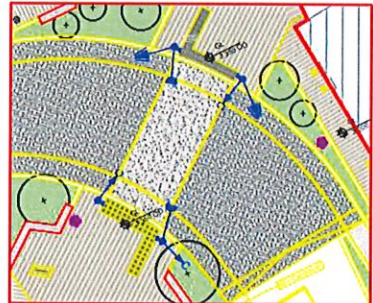
- 4.3 At this early stage of the design a number of issues relating to the tactile paving were identified that are likely to be addressed during the detailed design, however they are listed here to assist in the next design stage: -

- a. The stems on the tactile paving layouts at the new toucan crossing don't extend far enough to be intercepted by a visually impaired pedestrian travelling along the approaching footpaths.
- b. It is unclear from the information provided what the colour/texture of the footpath surface will be, and consequently whether there will be adequate tonal contrast between the various tactile paving layouts and the footpath.

- c. The depth of the tactile paving indicated at a number of in-line pedestrian crossings of St Patrick's Villas, along the eastern side of Irishtown Road, is not indicated as being of sufficient depth.

- d. Unclear if there will be level difference between the footpath and carriageway at Fitzwilliam Street. It is therefore unclear if dropped kerbs and tactile paving will be required at the proposed mobility impaired parking space and the footpaths on Fitzwilliam Street.

- e. No tactile paving has been indicated at the top/bottom of the steps at the library entrance.

- f. No dropped kerbs or tactile paving has been indicated within the footpath along the eastern side of Irishtown Road at the southern terminal of the scheme, and the existing opposing dropped kerb at this junction has no tactile paving.
