PUBLIC REALM IMPROVEMENT AND LIBRARY REFURBISHMENT AND EXTENSION, DUBLIN

Flood Risk Assessment

Flood Risk Assessment Report – For Planning

Document No:	PRDWLS-ROD-EWE-SW_AE-RP-EN-300001
Author:	Richard Wheatley (RW)
Checker:	Ciaran McGee (CMG)
Approver:	Eoin Ó Catháin (EOC)

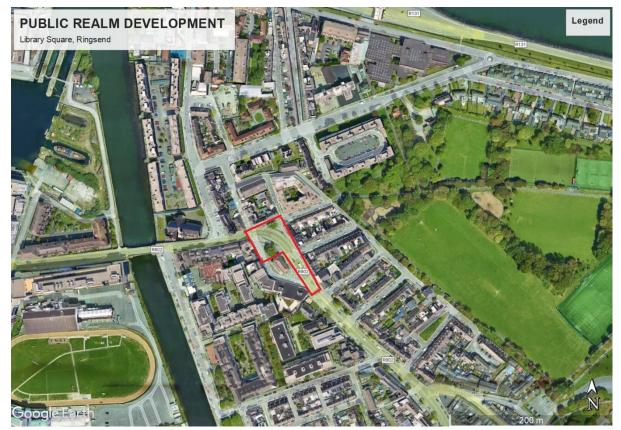
Figure 3.1 Site Boundary

The development area is focused at Library Square, Bridge Street, Irishtown Road and Fitzwilliam Street Ringsend, Dublin. The site area is currently an existing public space which includes Ringsend Library and local amenities adjacent to Fitzwilliam Street. The proposals are focused on enhancements to the public realm including the introduction of a raised table to control traffic flow speeds with controlled pedestrian crossing, cycle lane, shared surface plaza, defensive planting, communal seating and feature lighting. The site boundary is shown in Figure 2.1.

Bridge Street and Irishtown Road areas appear to be positively drained via a number of gullies located within the highway. The public space areas to the north of Bridge Street contains precast concrete channels to convey captured surface water to the surrounding gullies located at Parkview Place and Saint Patricks Villas. Captured surface water from the hardstanding areas surrounding Ringsend Library appears to be guided to the highways gullies at Bridge Street and Fitzwilliam Street and surface water captured at Fitzwilliam Street is drained to highway gullies.
