# **A Noise Study as part of the Dalymount Park Stadium redevelopment on behalf of DCC in accordance with a noise survey requirements specification.**

**Document Reference: 102025-ICN-01-RP-Y-0001-XX-XX-S2-01**

**Prepared by:**

**Diarmuid Keaney, ICAN Acoustics.**

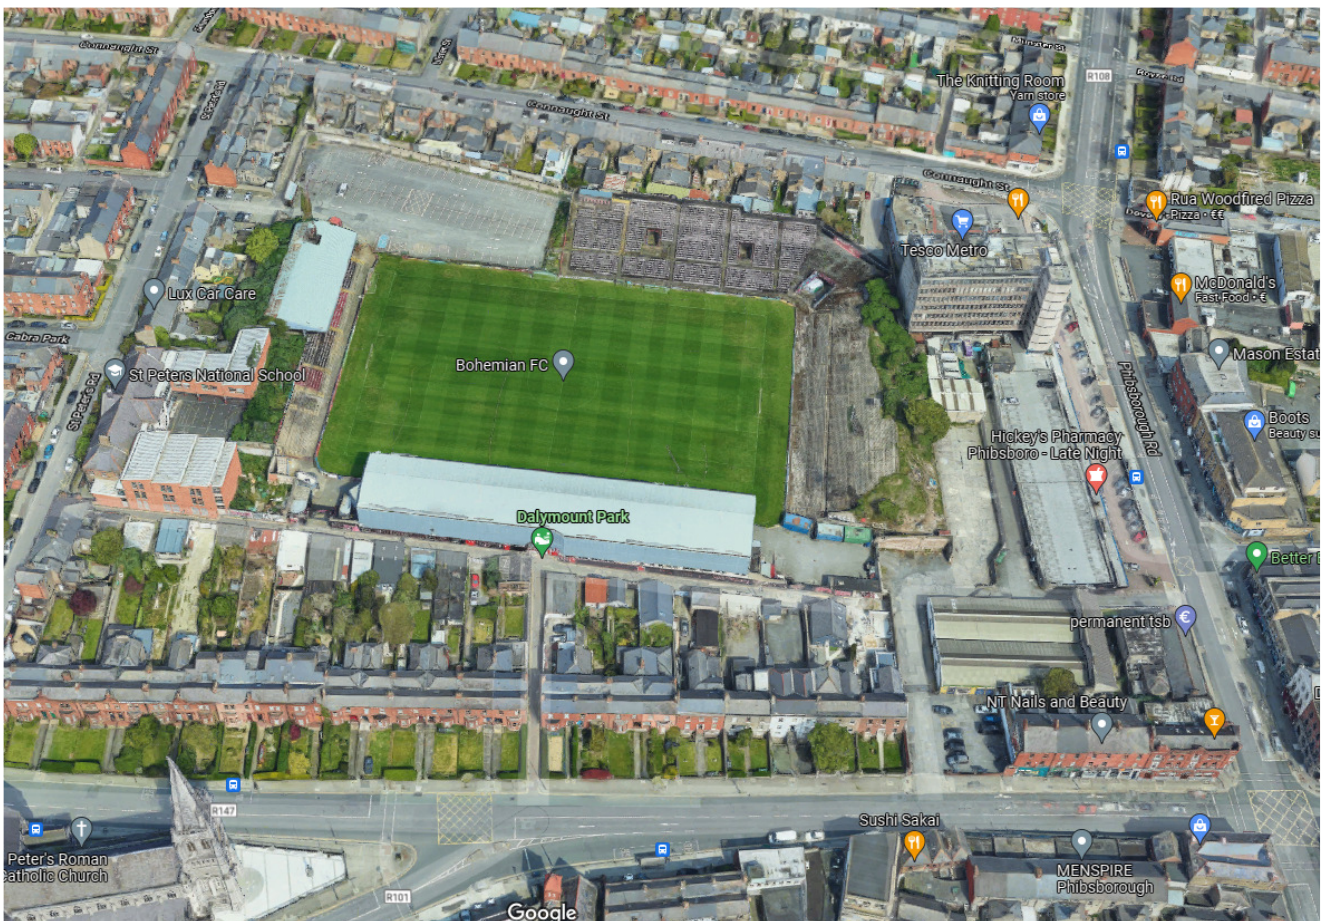
Figure 1: 3D Aerial View of Dalymount park (Source: Google maps, imagery 2021).

Dalymount Park is located in a typical urban environment, and the site is bounded on two sides by two busy roads. The heavily trafficked R147 runs from east to west on the southern side of Dalymount Park. On the eastern side of Dalymount Park, the Phibsborough Road (R108) runs from north to south and is also a heavily trafficked route. On the northern side of Dalymount Park, Connacht Street runs from east to west and is a busy route but not comparable and insignificant relative to the R108 and R147. On the western side of Dalymount Park is St Peters Road, which is a residential road and provides access to Dalymount Park's Car Park and St Peters National School.

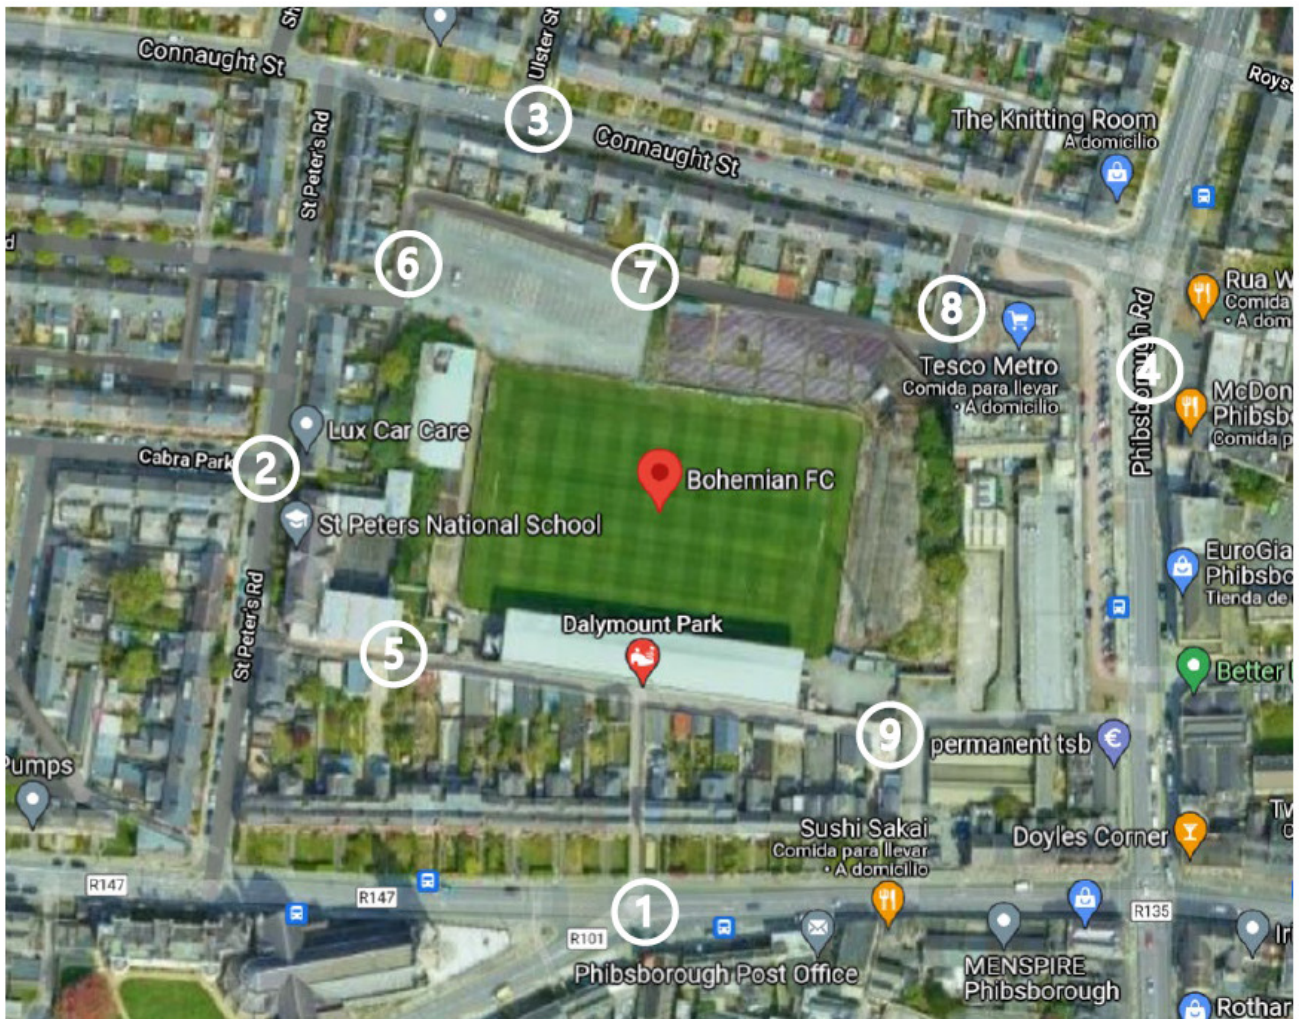
Figure 2: Noise monitoring locations shown on an aerial map of the site (Source: Google Earth).

Figure 2 shows the general area and locations used to gather baseline noise data for the site.

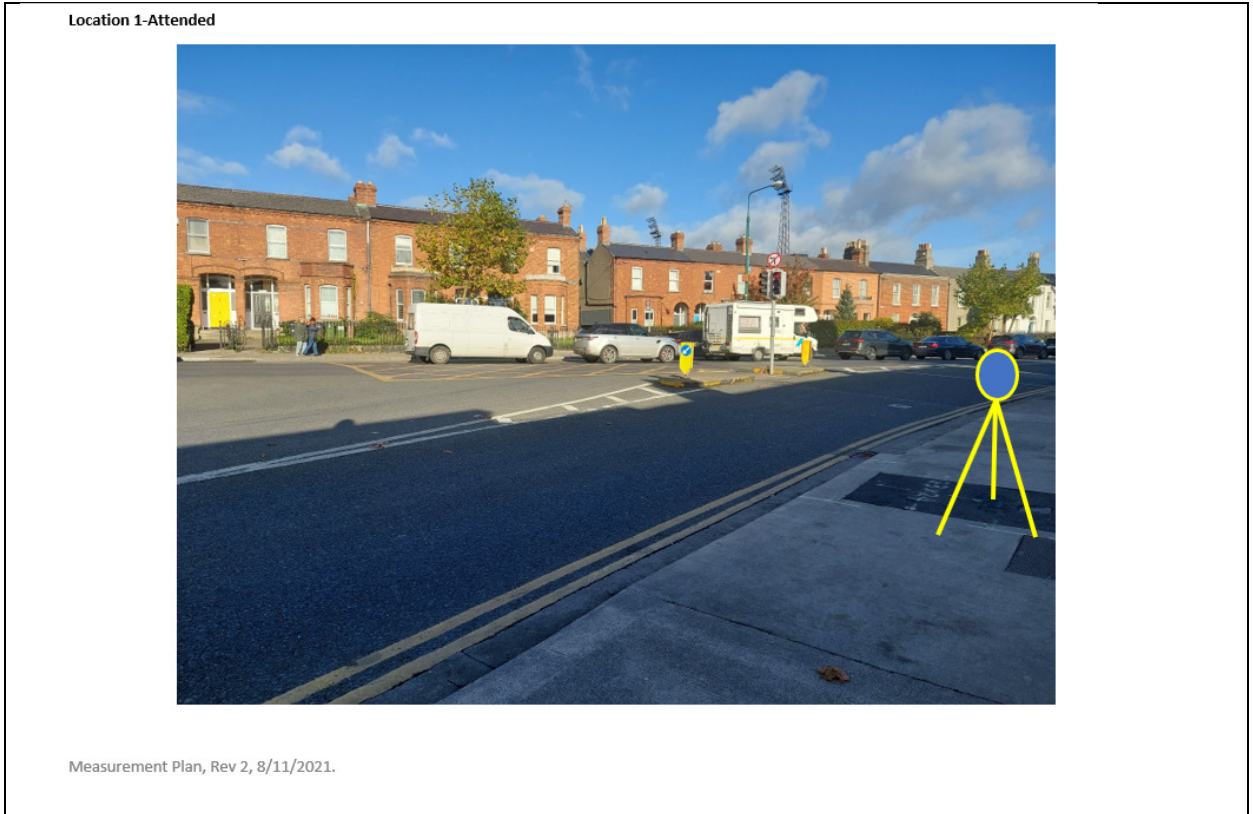
### 3.3 Location 1: Attended

Figure 4: Noise monitoring location used at Location1 (Source: Google Earth)

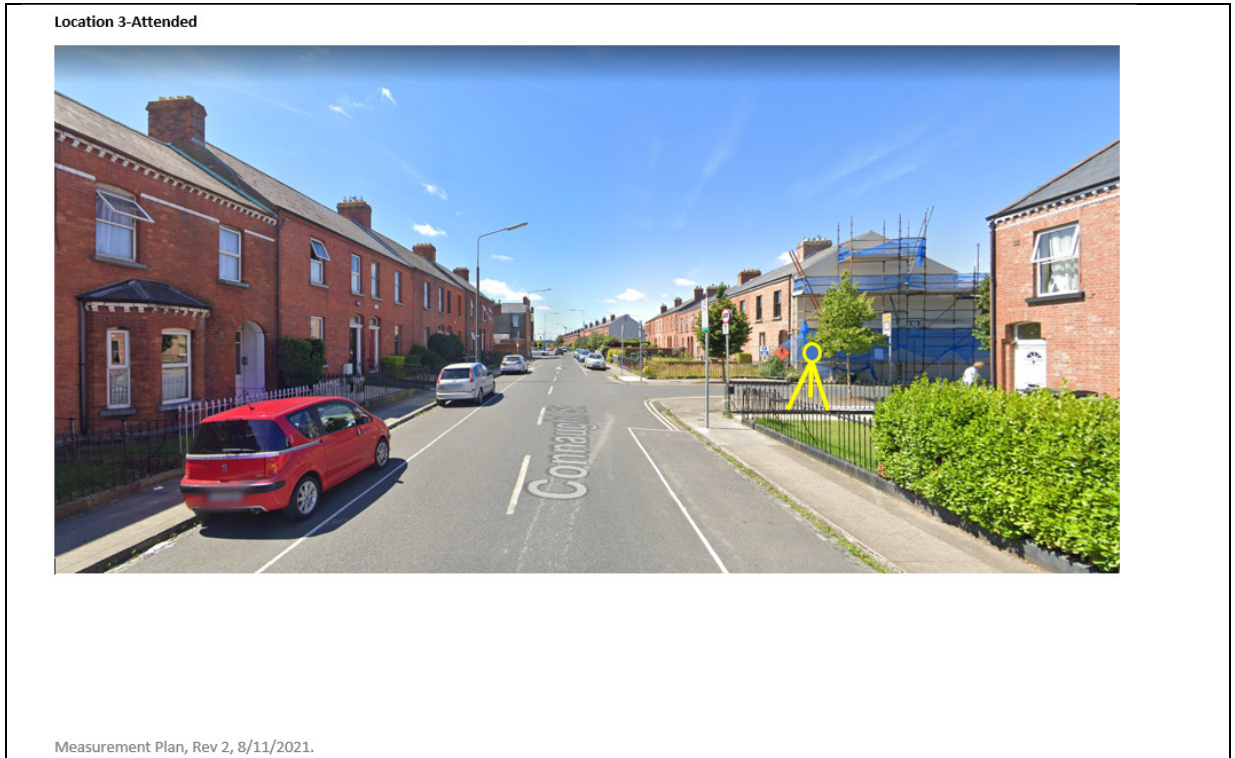
### 3.5 Location 3: Attended

Figure 6: Noise monitoring location used at Location3 (Source: Google Earth).

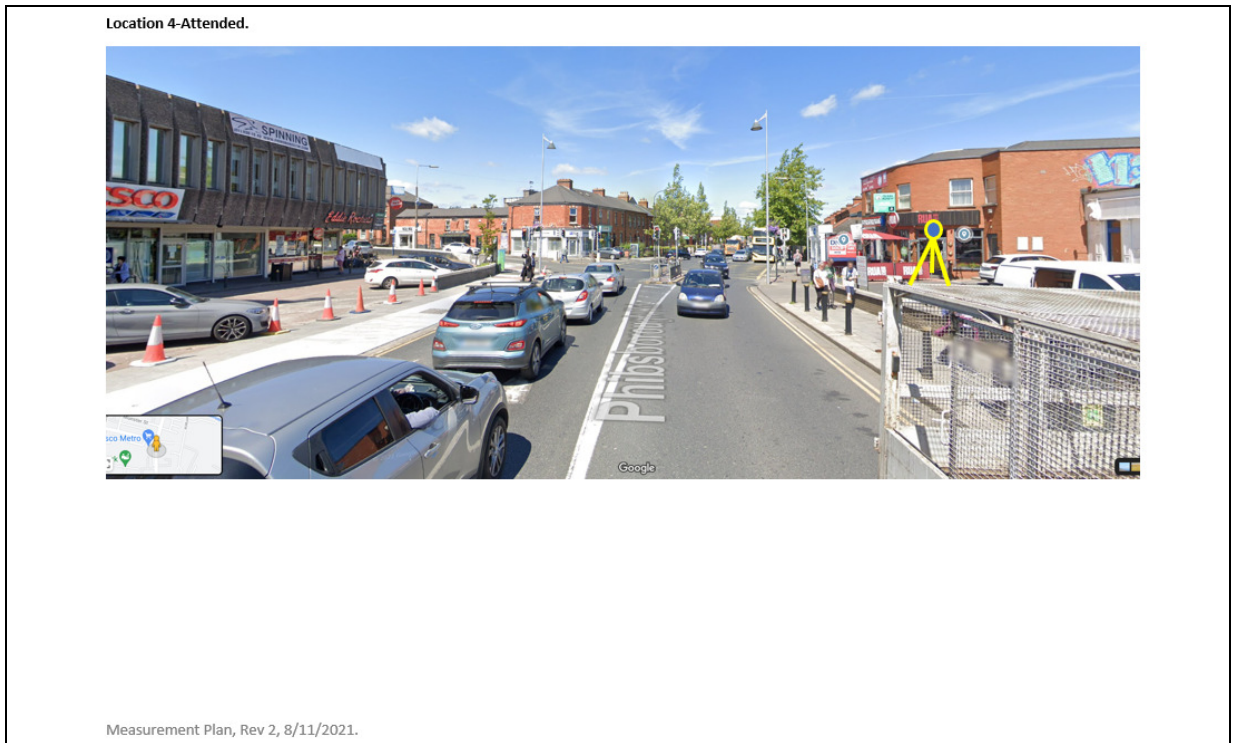
### 3.6 Location 4: Attended

Figure 7: Noise monitoring location used at Location 4 (Source: Google Earth)

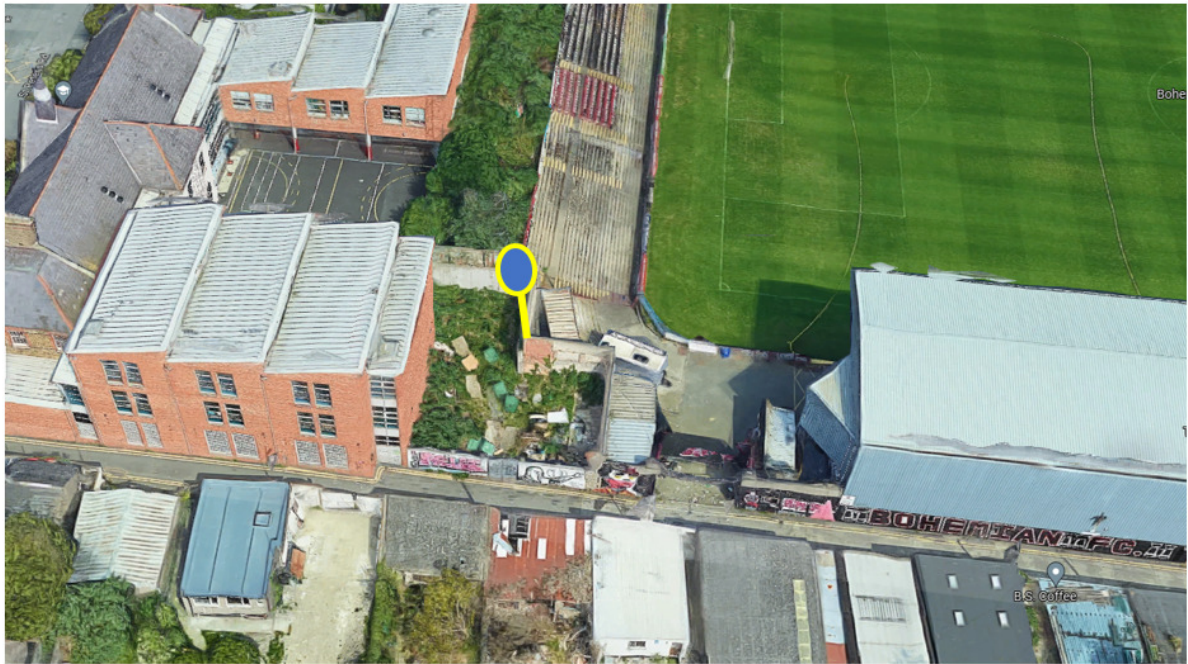
### 3.7 Location 5: Unattended

Location 5-Unattended on telescopic poles

Figure 8: Noise monitoring location used at Location 5 (Source: Google Earth).

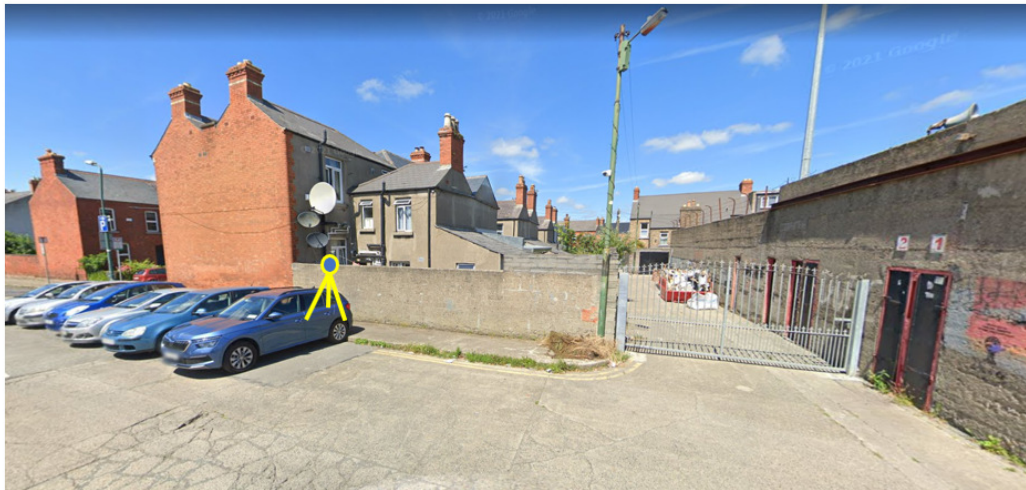
### 3.8 Location 6: Unattended

Location 6 -Attended

Figure 9: Noise monitoring location used at Location 6 (Source: Google Earth).

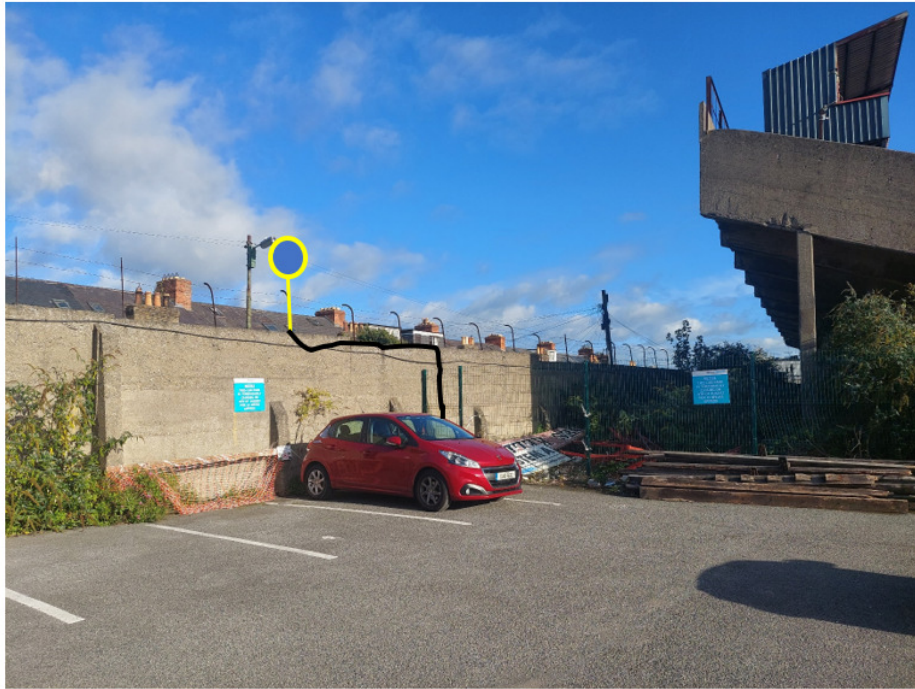
### 3.9 Location 7: Unattended

Location 7-Unattended on telescopic poles

Figure 10: Noise monitoring location used at Location 7 (Source: Google Earth).

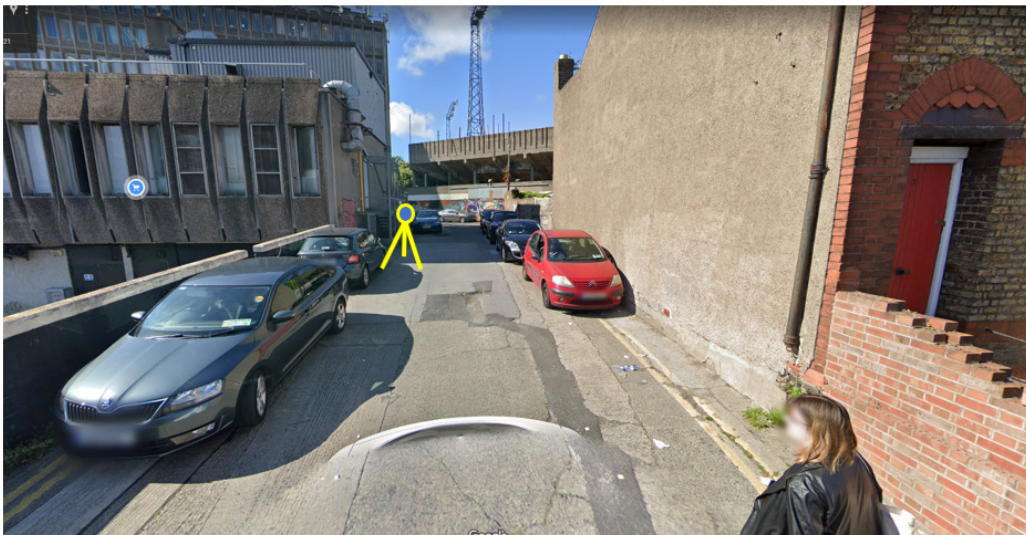
### 3.10 Location 8: Attended

Location 8-Attended

Figure 11: Noise monitoring location used at Location 8 (Source: Google Earth).

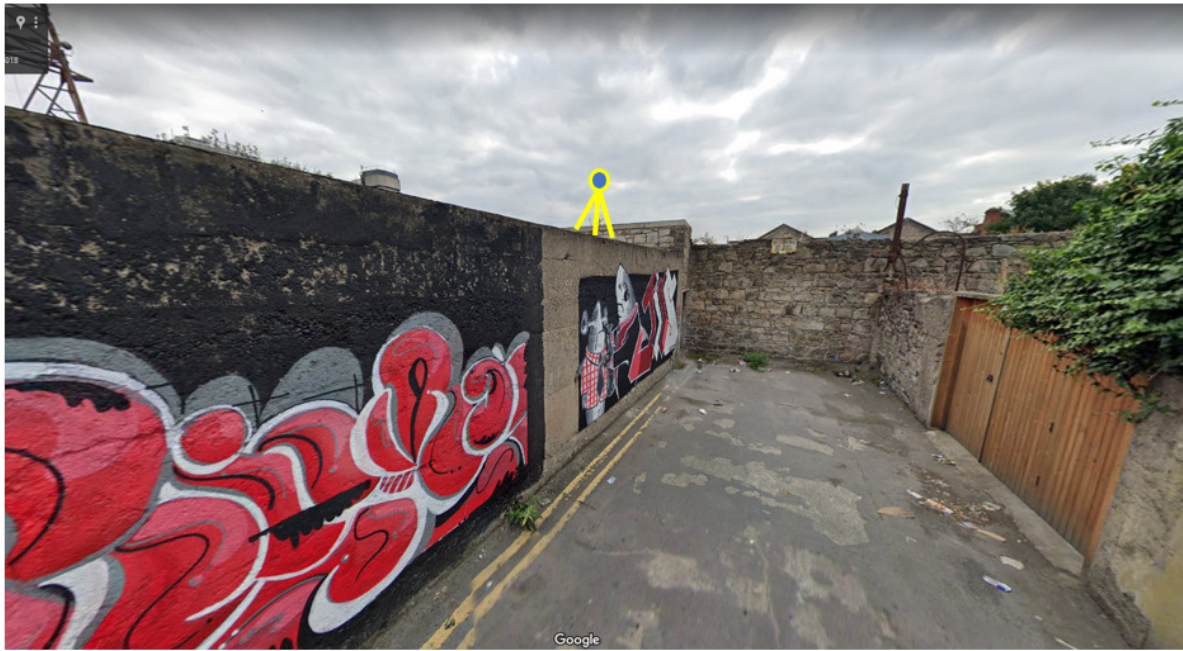
### 3.11 Location 9: Unattended

Location 9 -Unattended (on the flat roof).

Figure 12: Noise monitoring location used at Location 9 (Source: Google Earth).

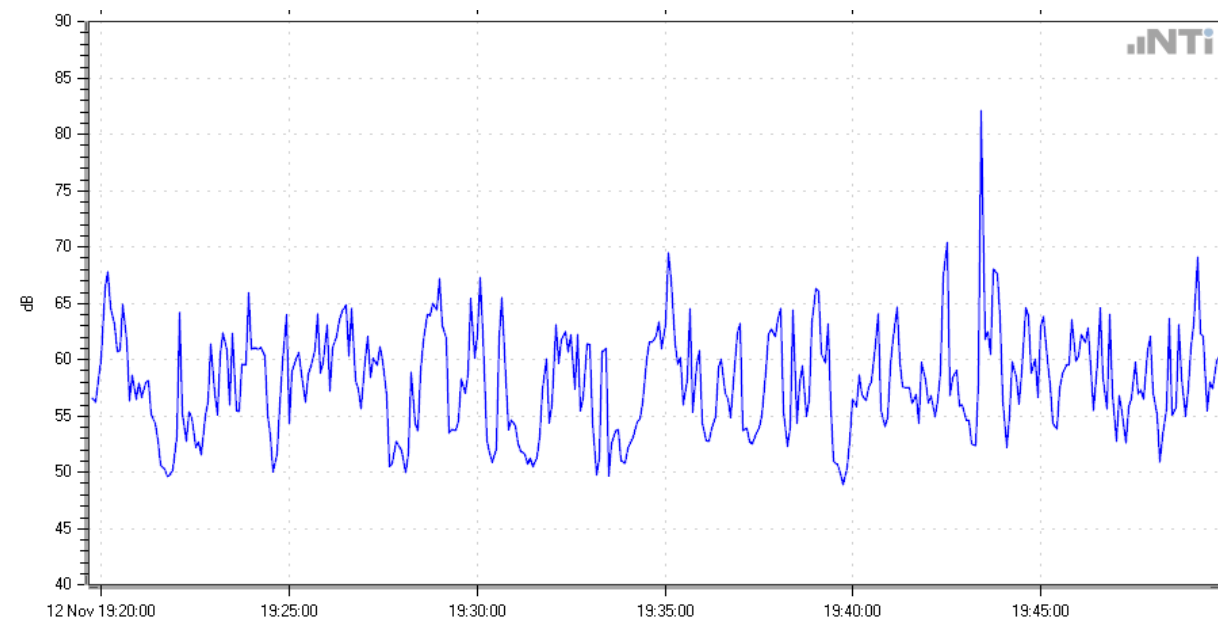
Description of the noise climate: the noise climate was dominated by traffic noise at this location. Other noise sources included pedestrians entering the Stadium. At this location, it was also possible to hear supporters inside the Stadium, who could be heard on occasion singing collectively in advance of the match. Noise from the vocal public address system used at Dalymount Park was also audible. Between speech announcements, there was background music playing through the stadium speakers, which could be heard, and in addition to this, patrons were occasionally singing along.

Type	Start	Duration	LAeq [dB]	LAFmax [dB]	LAFmin [dB]	L 10.0 % [dB]	L 90.0 % [dB]
Recorded	2021-11-12 19:19:44	00:30:00	61.8	91.9	47.2		
Project Result		00:30:00	61.8	91.9	47.2	64.0	51.6

Figure 14: Measurements at Location 2 included noise from increased traffic activity and patrons in advance of the game, which was scheduled to start at 19:45hrs.

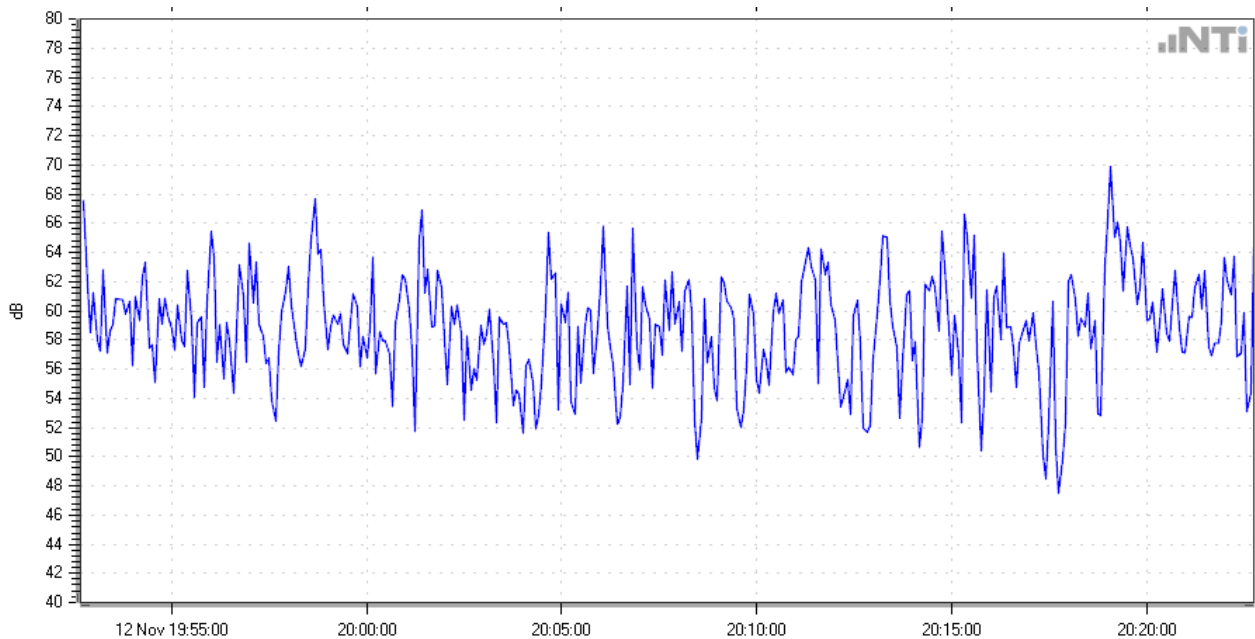
Description of the noise climate: the noise climate at this location consisted of noise from cars, motorbikes, and patrons cheering. While there were a number of sources present, traffic noise remains the dominant source of noise.

Type	Start	Duration	LAeq [dB]	LAFmax [dB]	LAFmin [dB]	L 10.0 % [dB]	L 90.0 % [dB]
Recorded	2021-11-12 19:52:44	00:30:00	60.2	74.4	46.1		
Project Result		00:30:00	60.2	74.4	46.1	63.5	52.7

Figure 15: Measurements at Location 3, which included a contribution from the game, which commenced at 19:45hrs.

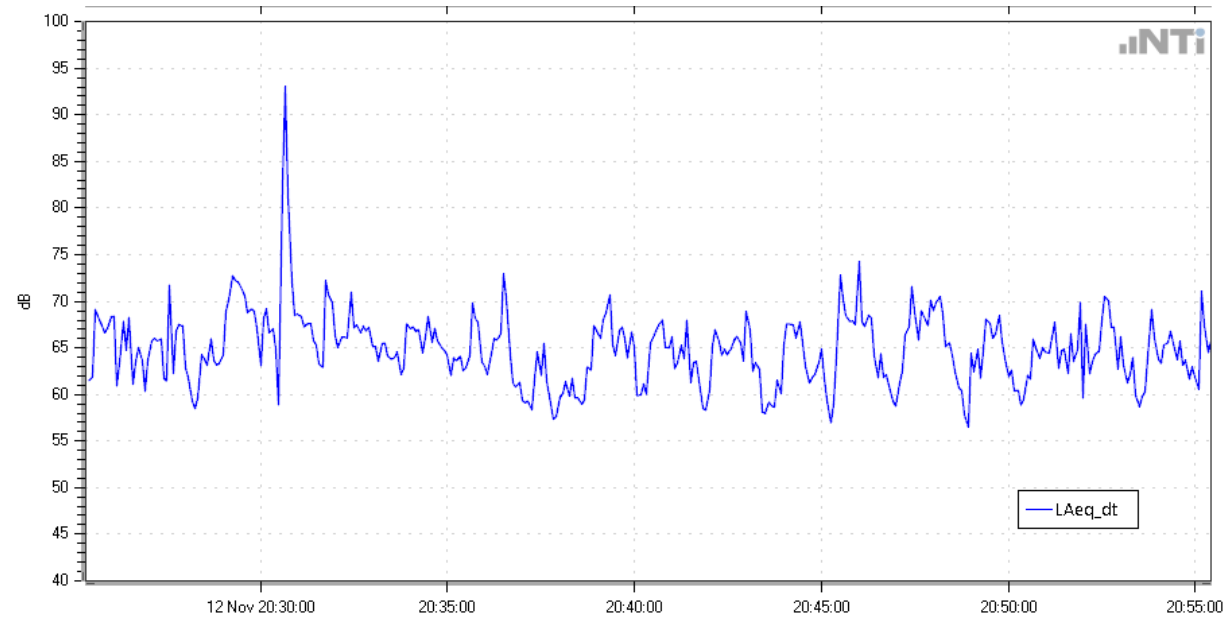
Description of the noise climate: The noise climate at this location was dominated by road traffic noise. This is a very heavily trafficked location, and at 20:30hrs, an emergency vehicle passed with its siren in use. Other sources of noise included auditory tones from the pedestrian crossing nearby. This location is close to a busy Junction with a significant quantity of traffic and activity. Occasionally there was some noise from pedestrians conversing nearby.

Figure 16: Measurements at Location 3, which included a contribution from the game which commenced at 19:45hrs.

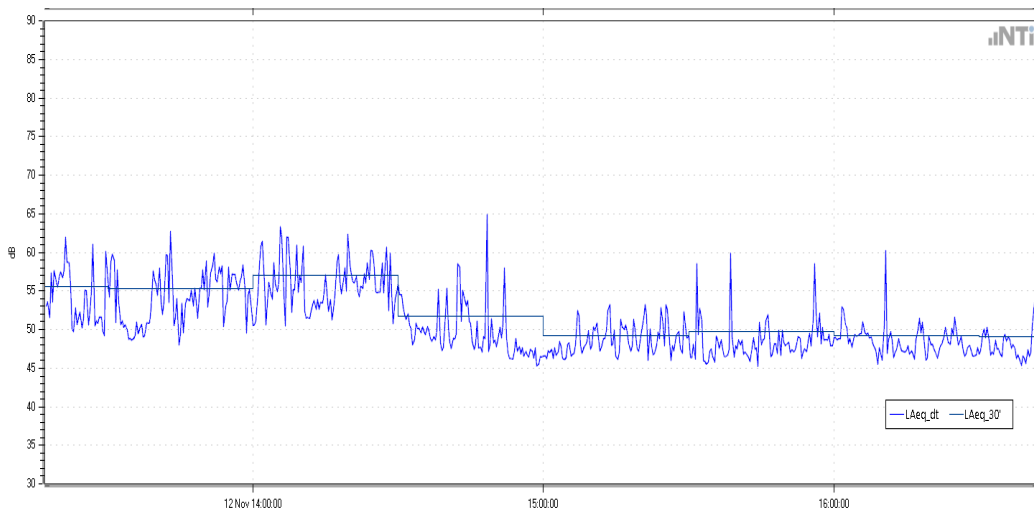
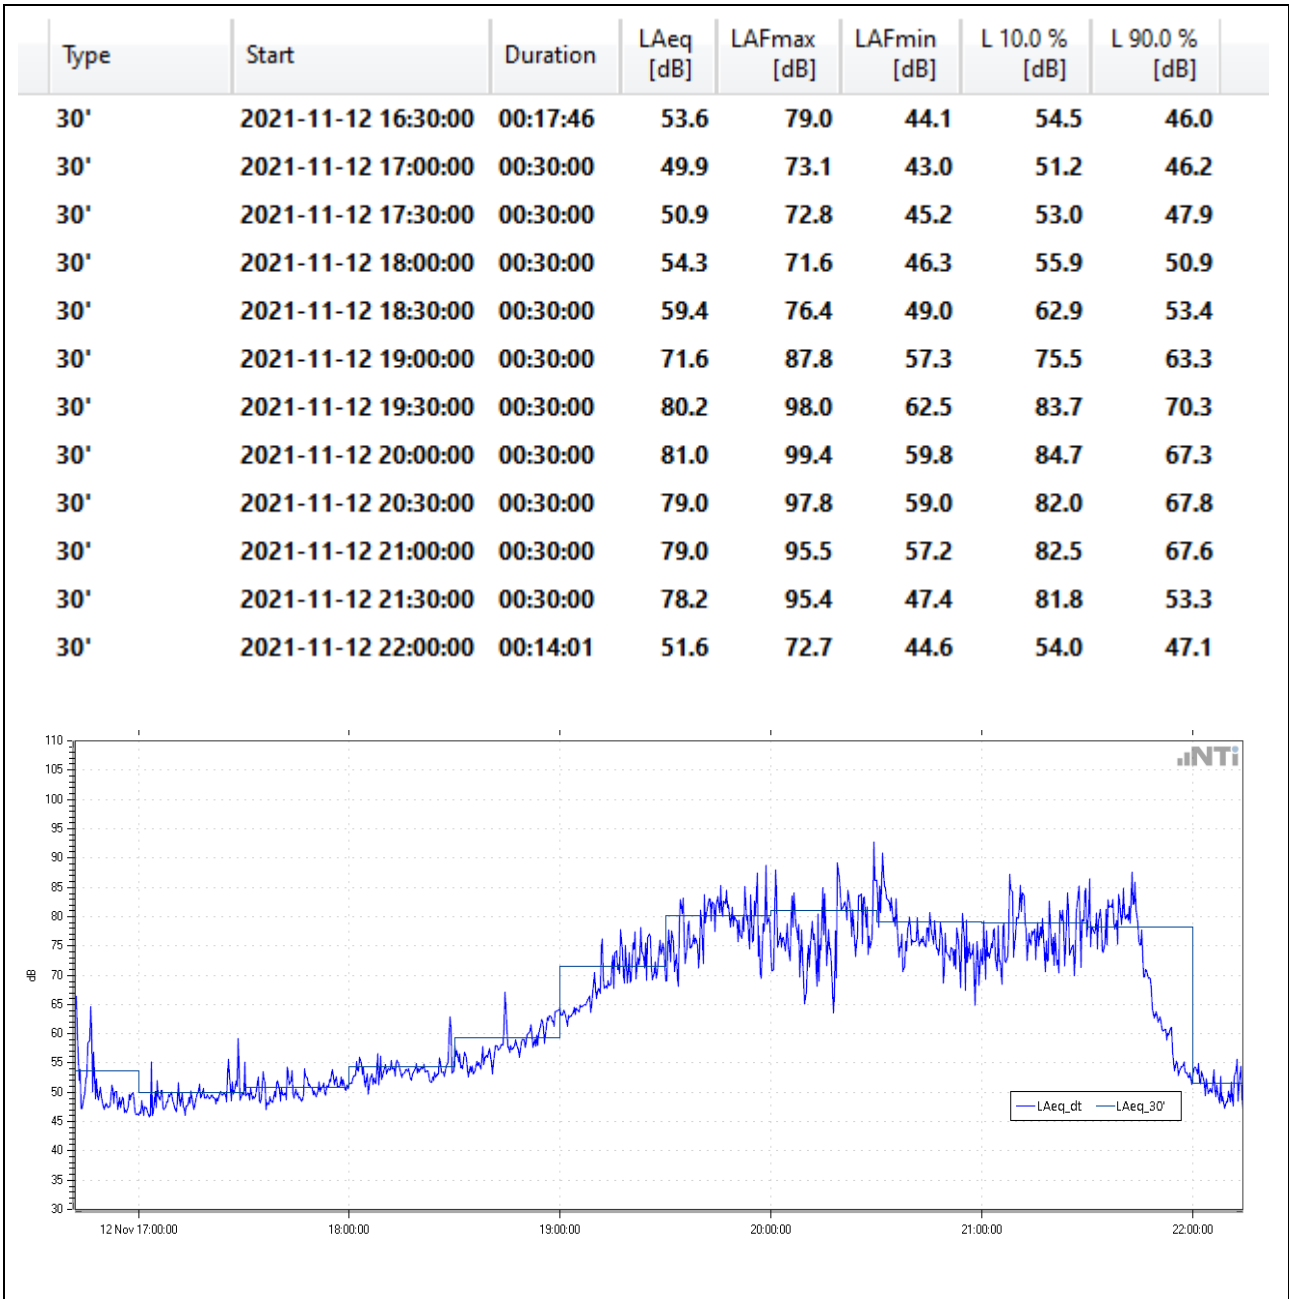
Description of the noise climate: during daytime hours, the school remains the nearest dominant noise source to this noise monitoring location. There was a notable noise contribution from the school playground during break times and after school. After 14:50hrs, there was no contribution evident from the school, and the background noise climate included noise from traffic and birdsong, with noise from one helicopter passing the area. Other sources of noise included distant sounds of emergency vehicles and children playing in the general area. It was noted from approximately 18:00hrs that noise started to build inside the Stadium. This location was within reasonable proximity to some of the catering and shop units that are present then the Stadium. Staff could be heard conversing and setting up in advance of the game. At 19:04hrs, music could be heard from the stadium speakers and conversation noise from patrons that were entering into the seating. There was a steady build-up of noise from 19:00hrs to 19:45hrs, score the match commenced at 19:45hrs. Noise levels remained elevated until 21:44hrs which included supporter noise which included chanting, audible clapping, cheering, whistling, booing and singing songs. From 21:44hrs, noise levels started to decrease when the match was over and as patrons began to leave the Stadium.

Type	Start	Duration	LAeq [dB]	LAFmax [dB]	L 10.0 % [dB]	L 90.0 % [dB]	L 95.0 % [dB]
30'	2021-11-12 13:00:00	00:12:52	55.6	72.6	58.3	48.7	48.2
30'	2021-11-12 13:30:00	00:30:00	55.3	71.1	58.6	48.6	48.1
30'	2021-11-12 14:00:00	00:30:00	57.0	76.0	59.9	49.9	49.1
30'	2021-11-12 14:30:00	00:30:00	51.7	77.0	52.9	46.3	45.8
30'	2021-11-12 15:00:00	00:30:00	49.2	69.6	51.7	46.2	45.8
30'	2021-11-12 15:30:00	00:30:00	49.7	73.8	50.4	45.7	45.3
30'	2021-11-12 16:00:00	00:30:00	49.2	77.0	50.2	46.1	45.6
30'	2021-11-12 16:30:00	00:11:45	49.1	67.8	50.1	45.6	45.0

Figure 17: Measurements at Location 5 showing measured noise levels over 30 minutes observation period along with graphed time history plots

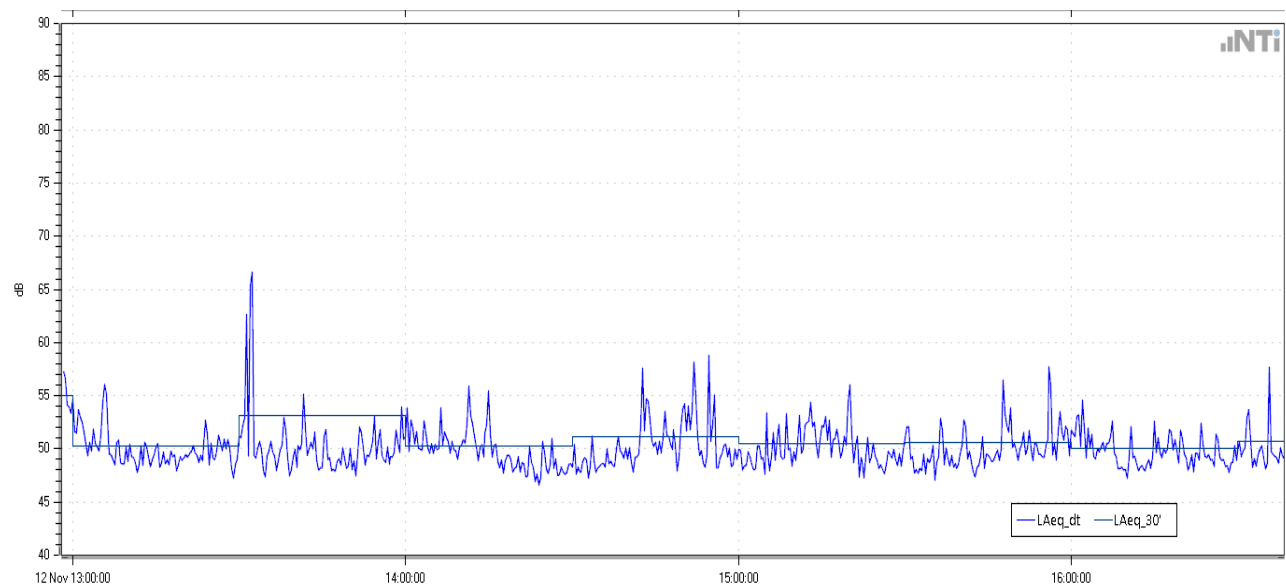
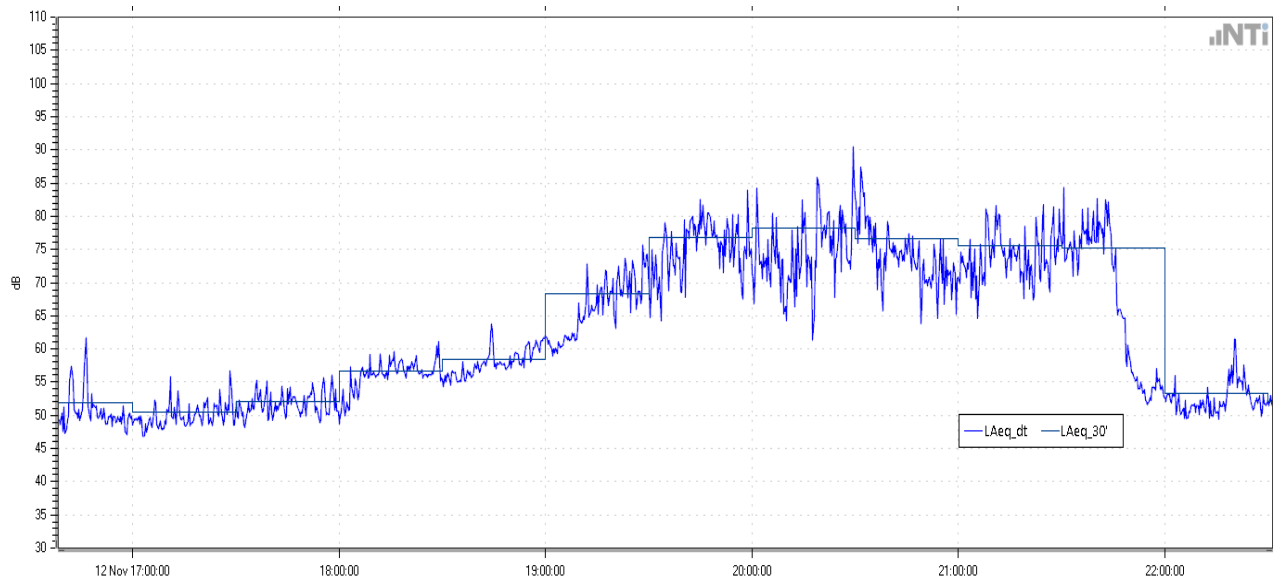
Type	Start	Duration	LAeq [dB]	LAFmax [dB]	L 10.0 % [dB]	L 90.0 % [dB]	L 95.0 % [dB]
30'	2021-11-12 12:30:00	00:01:50	55.0	64.8	57.6	52.3	51.7
30'	2021-11-12 13:00:00	00:30:00	50.3	67.4	52.0	47.9	47.5
30'	2021-11-12 13:30:00	00:30:00	53.2	75.1	52.2	47.7	47.4
30'	2021-11-12 14:00:00	00:30:00	50.2	66.6	52.2	47.2	46.8
30'	2021-11-12 14:30:00	00:30:00	51.2	71.2	53.2	47.6	47.3
30'	2021-11-12 15:00:00	00:30:00	50.5	66.6	52.4	47.7	47.4
30'	2021-11-12 15:30:00	00:30:00	50.6	73.8	52.4	47.5	47.1
30'	2021-11-12 16:00:00	00:30:00	50.0	67.5	51.7	47.6	47.3
30'	2021-11-12 16:30:00	00:08:09	50.8	72.2	52.1	47.7	47.4

Type	Start	Duration	LAeq [dB]	LAFmax [dB]	LAFmin [dB]	L 10.0 % [dB]	L 90.0 % [dB]
30'	2021-11-12 16:30:00	00:21:24	51.9	68.3	45.4	53.7	47.5
30'	2021-11-12 17:00:00	00:30:00	50.4	71.1	44.4	52.2	47.6
30'	2021-11-12 17:30:00	00:30:00	52.0	67.6	46.6	54.4	48.8
30'	2021-11-12 18:00:00	00:30:00	56.6	72.9	46.9	58.5	51.9
30'	2021-11-12 18:30:00	00:30:00	58.5	76.3	52.3	61.0	55.0
30'	2021-11-12 19:00:00	00:30:00	68.3	82.9	55.5	72.2	60.4
30'	2021-11-12 19:30:00	00:30:00	76.8	91.0	59.3	80.5	67.0
30'	2021-11-12 20:00:00	00:30:00	78.2	97.8	57.8	81.4	64.6
30'	2021-11-12 20:30:00	00:30:00	76.5	96.8	57.8	79.4	64.5
30'	2021-11-12 21:00:00	00:30:00	75.6	91.0	58.1	79.4	65.1
30'	2021-11-12 21:30:00	00:30:00	75.2	93.3	47.3	79.0	52.6
30'	2021-11-12 22:00:00	00:30:00	53.3	75.5	46.2	55.3	49.0
30'	2021-11-12 22:30:00	00:01:14	52.0	68.7	46.9	53.6	48.5

Figure 19: Measurements at Location 7

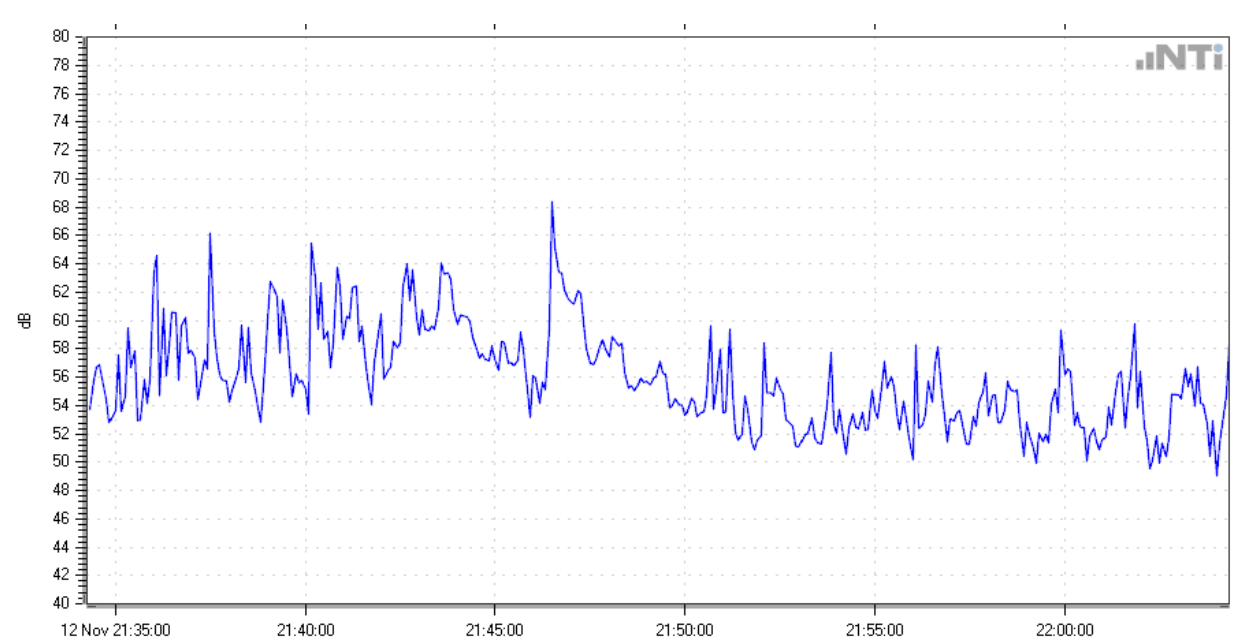
Description of the noise climate: the noise climate of this location included noise from the Stadium. Additionally, it was noted that there was some fan noise, possibly from a kitchen extract unit in use at Eddie Rockets nearby. At 21:40hrs, it was possible to hear the Spandau Ballet song 'Gold' played through the stadium sound system. Patron noise had fallen considerably at the latter part of this measurement. Other sources noted in the area was a car starting locally, which then departed, which may have been a patron of the Stadium using this public parking space.

Figure 20: Measurements at Location 8

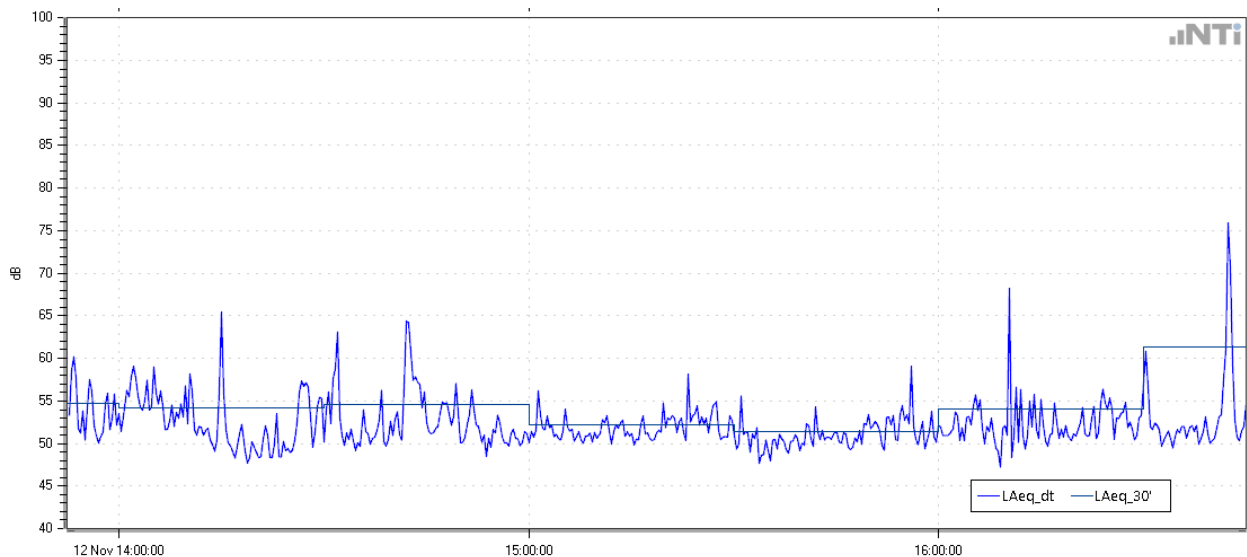
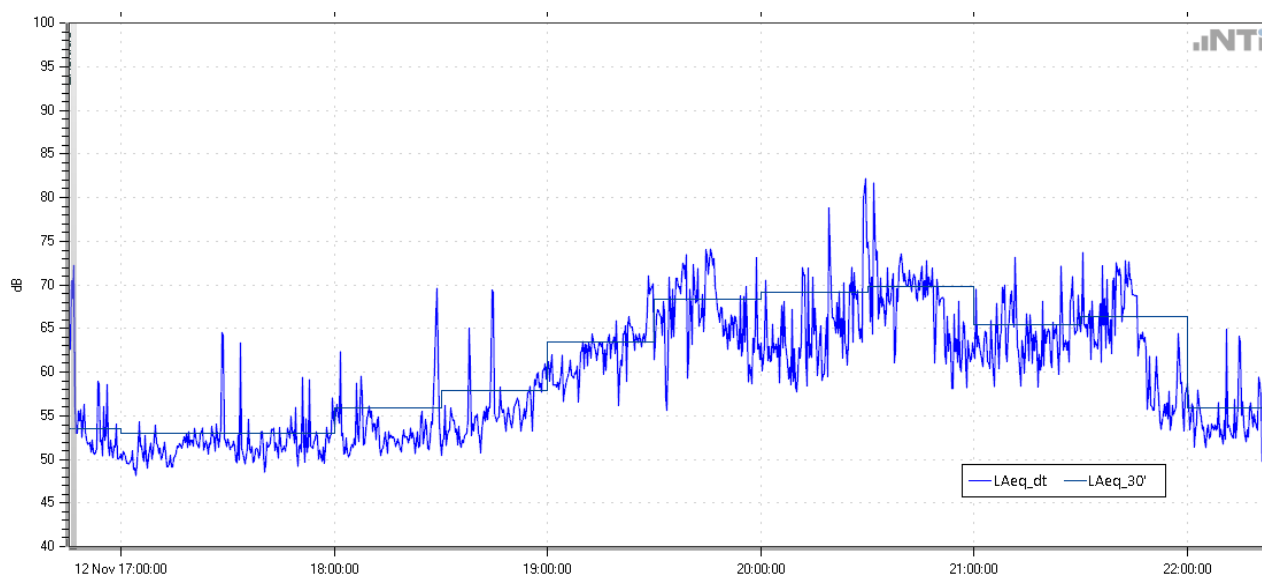
Description of the noise climate: the noise climate at this location mainly consisted of distant traffic throughout the daytime. Other noise sources included birdsong and occasional noise from residents conversing. Occasionally emergency vehicles could be heard in the distance as well as some light aircraft traffic. Some of the noise sources noted included the use of gates at the existing Dalymount Park stadium. Distant traffic noise remains the dominant source of noise up to 18:00hrs. From 1800 hours, there was a noticeable increase in levels as the Stadium was being prepared for the game at 19:45hrs. Noise levels started to build in the Stadium from 19:00hrs and reached a maximum at 19:45hrs which continued until the music was ceased at 21:45hrs.

Type	Start	Duration	L <sub>Aeq</sub> [dB]	L <sub>AFmax</sub> [dB]	L 10.0 % [dB]	L 90.0 % [dB]	L 95.0 % [dB]
30'	2021-11-12 13:30:00	00:07:38	54.7	78.8	57.3	49.6	49.3
30'	2021-11-12 14:00:00	00:30:00	54.2	74.9	56.8	48.4	47.8
30'	2021-11-12 14:30:00	00:30:00	54.6	77.9	56.1	49.2	48.8
30'	2021-11-12 15:00:00	00:30:00	52.1	72.2	53.7	49.5	49.1
30'	2021-11-12 15:30:00	00:30:00	51.5	71.7	53.0	48.6	48.1
30'	2021-11-12 16:00:00	00:30:00	54.1	86.8	54.1	49.3	48.8
30'	2021-11-12 16:30:00	00:14:54	61.3	94.6	55.2	49.6	49.2

Type	Start	Duration	LAeq [dB]	LAFmax [dB]	LAFmin [dB]	L 10.0 % [dB]	L 90.0 % [dB]
30'	2021-11-12 16:30:00	00:12:40	53.5	69.2	46.9	56.1	49.7
30'	2021-11-12 17:00:00	00:30:00	53.0	74.9	46.2	53.7	49.0
30'	2021-11-12 17:30:00	00:30:00	52.9	77.8	46.8	53.9	49.1
30'	2021-11-12 18:00:00	00:30:00	55.9	78.5	46.9	55.7	50.1
30'	2021-11-12 18:30:00	00:30:00	57.9	78.4	48.7	59.5	51.7
30'	2021-11-12 19:00:00	00:30:00	63.4	78.9	51.0	66.0	57.7
30'	2021-11-12 19:30:00	00:30:00	68.3	82.7	52.2	72.3	58.9
30'	2021-11-12 20:00:00	00:30:00	69.2	91.7	51.5	71.5	57.3
30'	2021-11-12 20:30:00	00:30:00	69.7	89.8	51.6	73.4	57.7
30'	2021-11-12 21:00:00	00:30:00	65.4	82.2	50.8	68.7	57.5
30'	2021-11-12 21:30:00	00:30:00	66.4	83.8	48.9	70.5	53.9
30'	2021-11-12 22:00:00	00:23:38	56.0	75.3	46.5	57.4	50.7

Figure 21: Measurements at Location 9

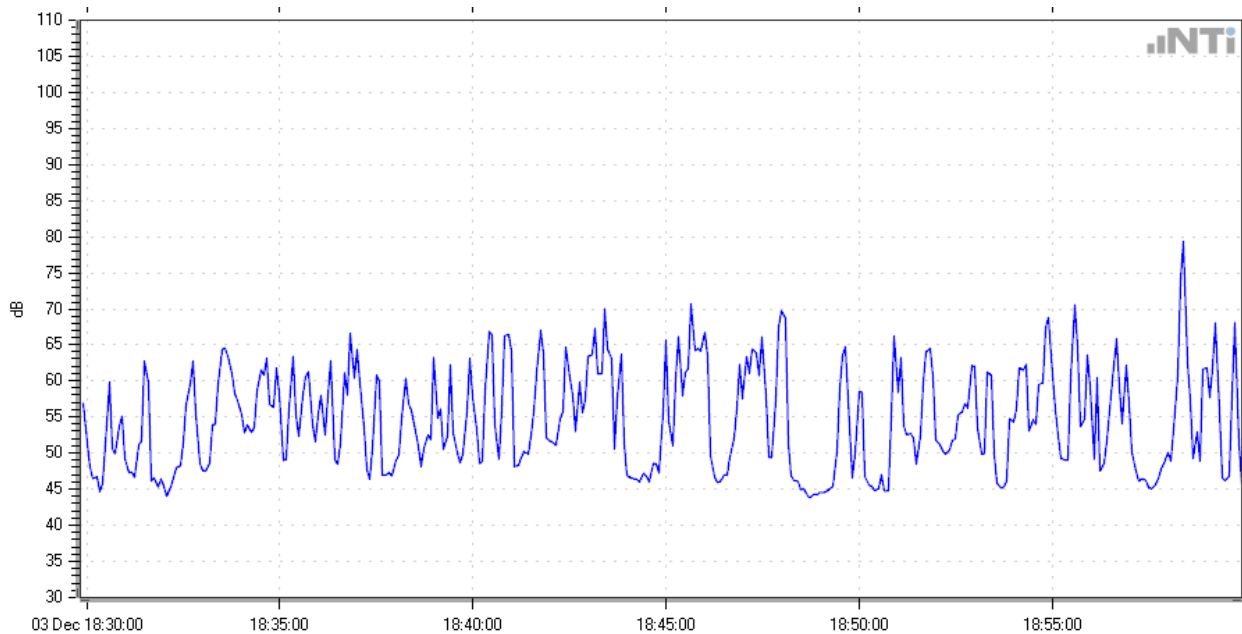
Description of the noise climate: At this location on Saint Peters Rd, the noise climate was dominated by road traffic noise. This measurement location is relatively close to the road, and individual vehicle passing events were clearly evident. Other sources noted including an aircraft event at 18:52hrs which was notable.

Figure 28: Measurements at Location 2 Daytime.

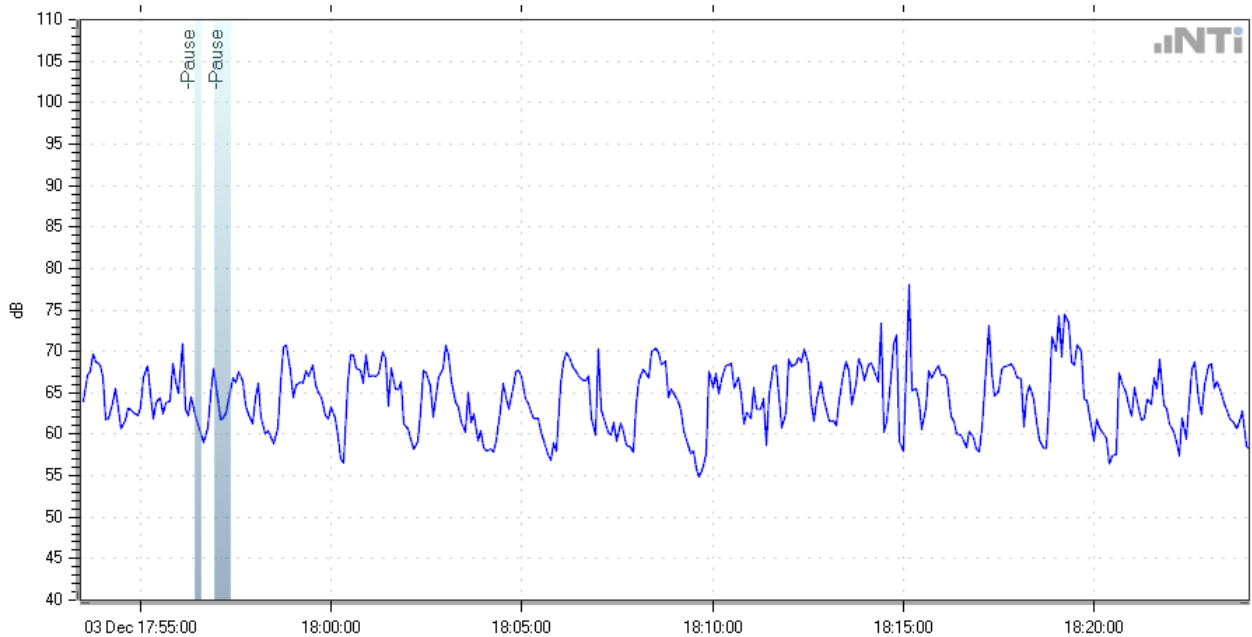
Description of the noise climate: The noise climate at this location is dominated by the heavily trafficked Phibsborough Road (R108) which remains the dominant source of noise right throughout his measurement period. Other sources noted included noise from the pedestrian crossing nearby.

Figure 38: Measurements at Location 4 Daytime.

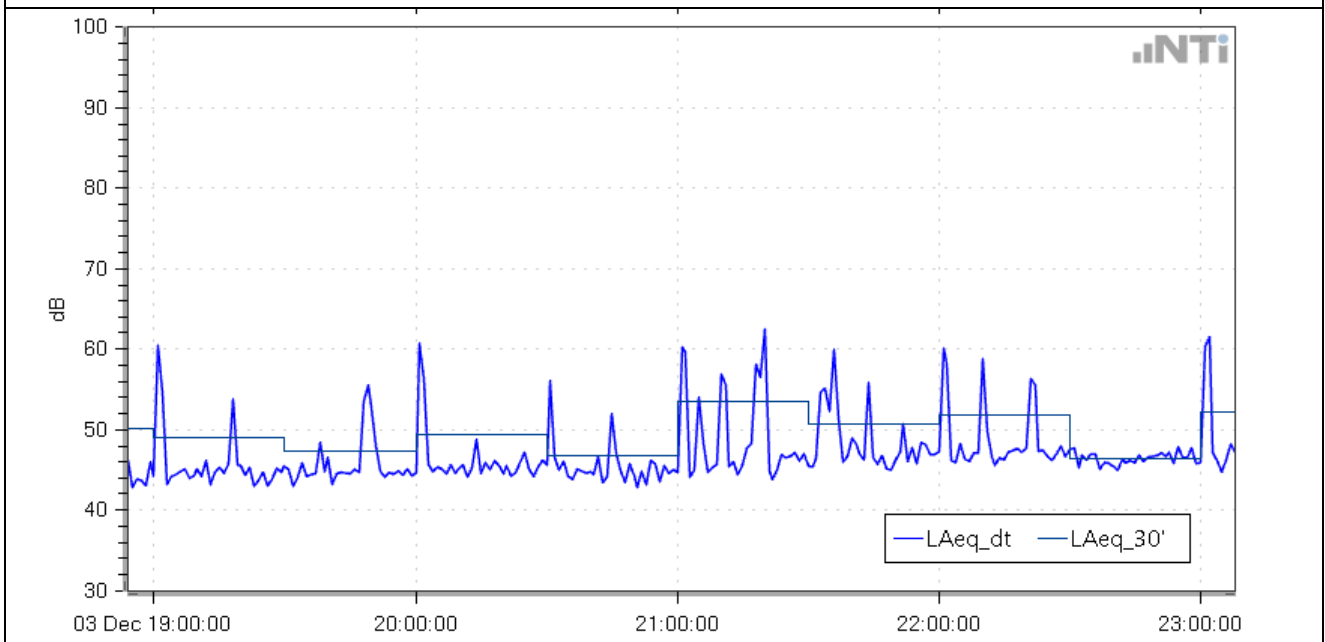
Description of the noise climate: in the absence of any noise from the nearby school, road traffic noise remains the dominant source of noise at this location. Occasional air traffic was also noted in the measurements, but it was infrequent.

Type	Start	Duration	LAeq [dB]	LAFmax [dB]	LAFmin [dB]	L 10.0 % [dB]	L 90.0 % [dB]
30'	2021-12-03 19:00:00	00:30:00	49.1	75.5	41.1	46.7	42.7
30'	2021-12-03 19:30:00	00:30:00	47.4	64.4	40.6	47.2	42.9
30'	2021-12-03 20:00:00	00:30:00	49.4	75.7	41.5	47.0	43.3
30'	2021-12-03 20:30:00	00:30:00	46.8	66.5	40.1	47.5	42.6
30'	2021-12-03 21:00:00	00:30:00	53.6	75.1	40.6	51.0	42.9
30'	2021-12-03 21:30:00	00:30:00	50.7	72.2	42.5	50.7	44.8
30'	2021-12-03 22:00:00	00:30:00	51.8	76.0	42.8	49.9	45.2
30'	2021-12-03 22:30:00	00:30:00	46.5	58.6	41.8	48.2	44.2

Figure 43: Measurements at Location 5 during the evening period.
