# **A Noise Study as part of the Dalymount Park Stadium redevelopment on behalf of DCC in accordance with a noise survey requirements specification.**

**Document Reference: 102025-ICN-01-RP-Y-0001-XX-XX-S2-01**

**Prepared by:**

**Diarmuid Keaney, ICAN Acoustics.**

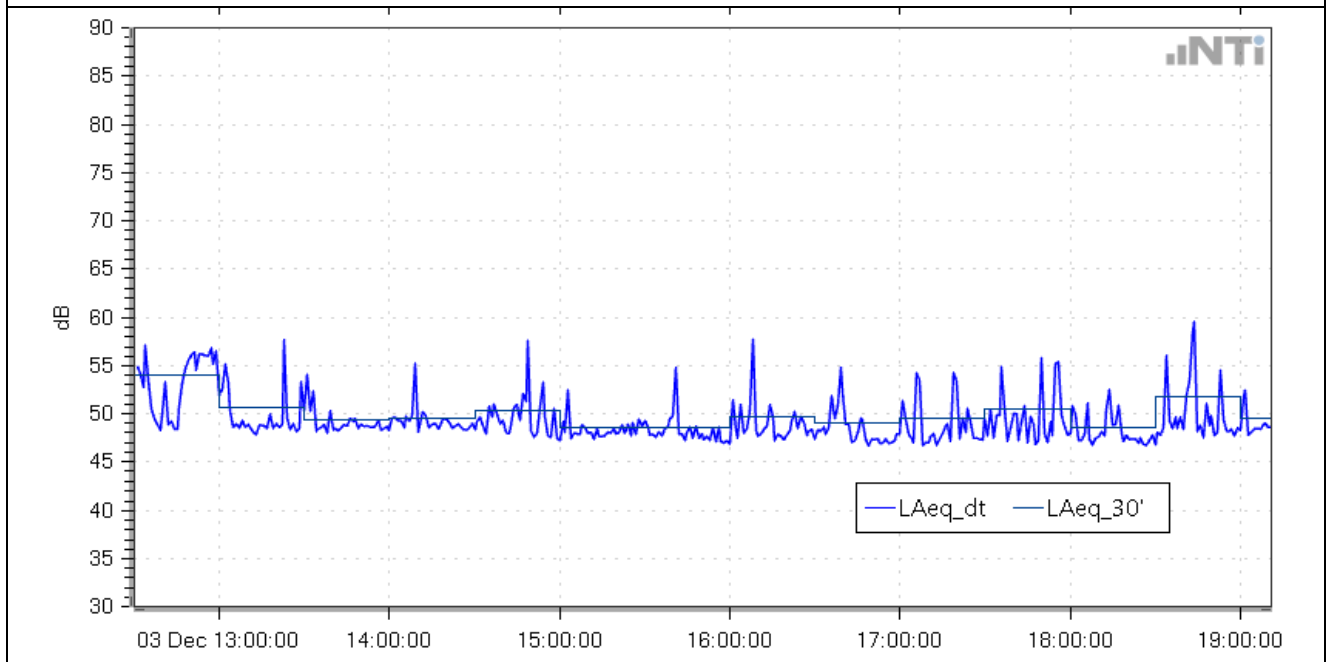
Description of the noise climate: This noise monitoring location was well set back from any local road traffic noise sources. The noise climate at this location remained dominated by distant traffic noise, which could clearly be heard. Other noise sources noted at this location included noise from emergency vehicles that occurred on occasion. This location is relatively close to the car park at Dalymount Park, and there was some light car park traffic.

Type	Start	Duration	LAeq [dB]	LAFmax [dB]	LAFmin [dB]	L 10.0 % [dB]	L 90.0 % [dB]
30'	2021-12-03 12:30:00	00:29:42	54.0	66.3	47.0	56.9	48.5
30'	2021-12-03 13:00:00	00:30:00	50.6	74.2	46.3	51.1	47.8
30'	2021-12-03 13:30:00	00:30:00	49.3	68.3	46.3	49.6	47.7
30'	2021-12-03 14:00:00	00:30:00	49.5	67.4	46.1	50.1	47.9
30'	2021-12-03 14:30:00	00:30:00	50.4	69.3	45.4	51.5	47.3
30'	2021-12-03 15:00:00	00:30:00	48.5	66.3	45.6	49.3	47.0
30'	2021-12-03 15:30:00	00:30:00	48.5	64.7	44.6	49.1	46.7
30'	2021-12-03 16:00:00	00:30:00	49.7	65.8	45.1	50.8	46.9
30'	2021-12-03 16:30:00	00:30:00	49.0	64.6	44.9	50.2	46.6

Figure 49: Measurements at Location 7 during a Day period.

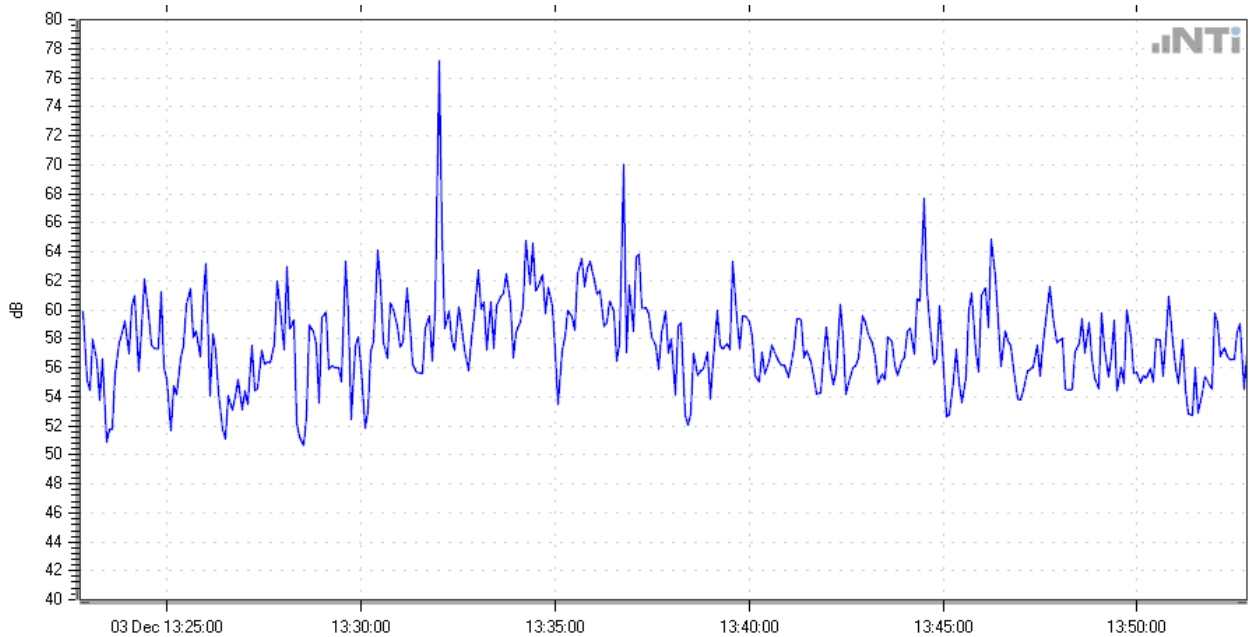
Graph showing LAeq,dt

Type	Start	Duration	LAeq [dB]	LAFmax [dB]	LAFmin [dB]	L 10.0 % [dB]	L 90.0 % [dB]
<b>Recorded</b>	<b>2021-12-03 13:22:46</b>	<b>00:30:00</b>	<b>59.4</b>	<b>82.6</b>	<b>49.7</b>		
<b>Project Result</b>		<b>00:30:00</b>	<b>59.4</b>	<b>82.6</b>	<b>49.7</b>	<b>61.4</b>	<b>53.6</b>

Figure 53: Measurements at Location 8 during a Daytime period.

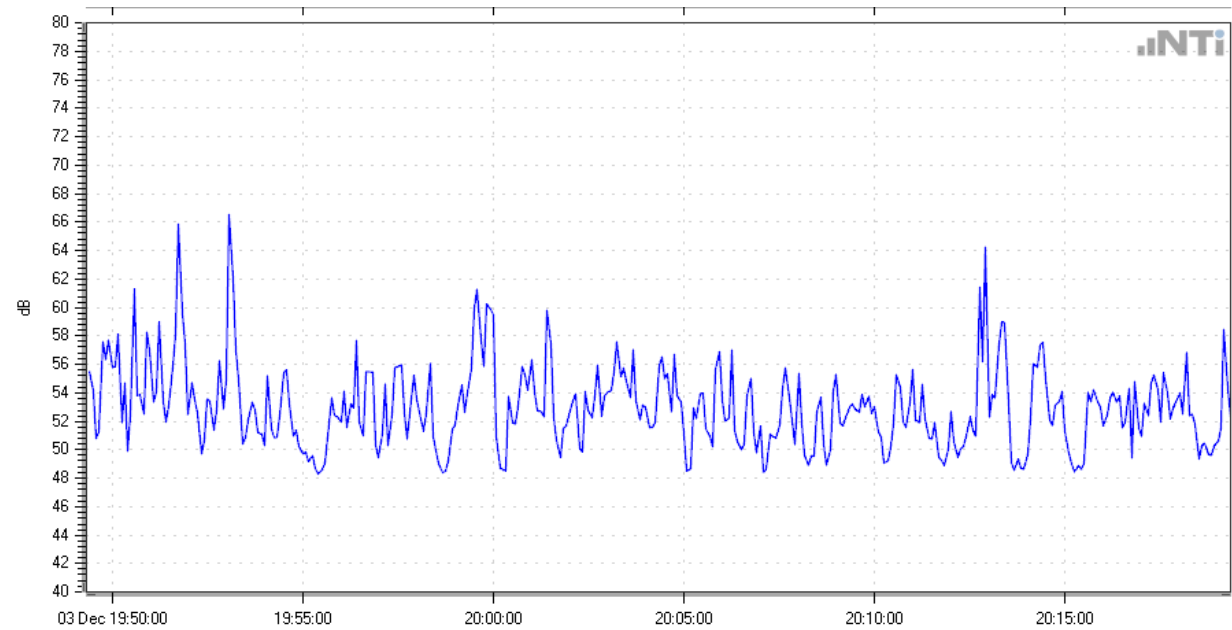
Description of the noise climate: the noise climate at this location was dominated by noise from road traffic noise on Connacht Street. There was a steady-state noise ever-present understood to be from kitchen extract fans in use at the nearby Eddie Rockets restaurant. Church bells were heard sounding at 20:00hrs. There was some light use of the bottle bins nearby which was noted at 20:03hrs.

Figure 54: Measurements at Location 8 during an Evening period.

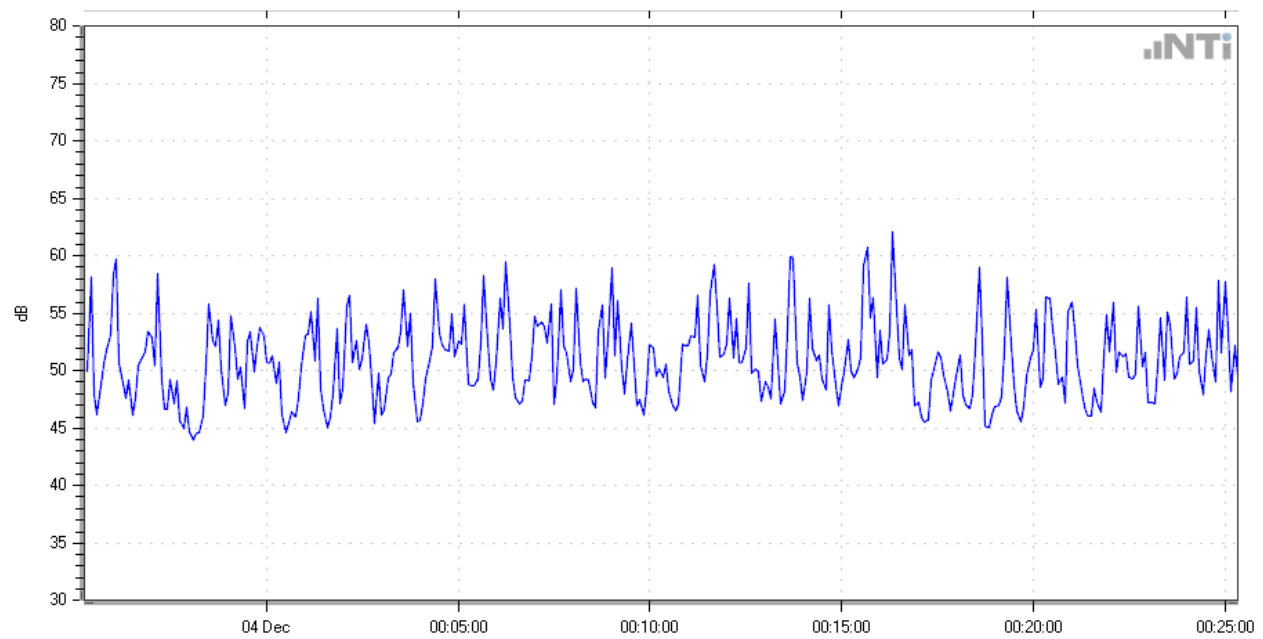
Description of the noise climate: the noise climate at this location was dominated by noise from road traffic noise on Connacht Street. There was a steady-state noise ever-present understood to be from kitchen extract fans in use at the nearby Eddie Rockets restaurant. Other sources included noise from pedestrians and youths conversing in the area. There was no noted use of the bottle bins at this time.

Figure 55: Measurements at Location 8 during a Night period.
