Griffith Avenue – Phase 1 Protected Cycle Lanes

Stage 3 Road Safety Audit

October 2020

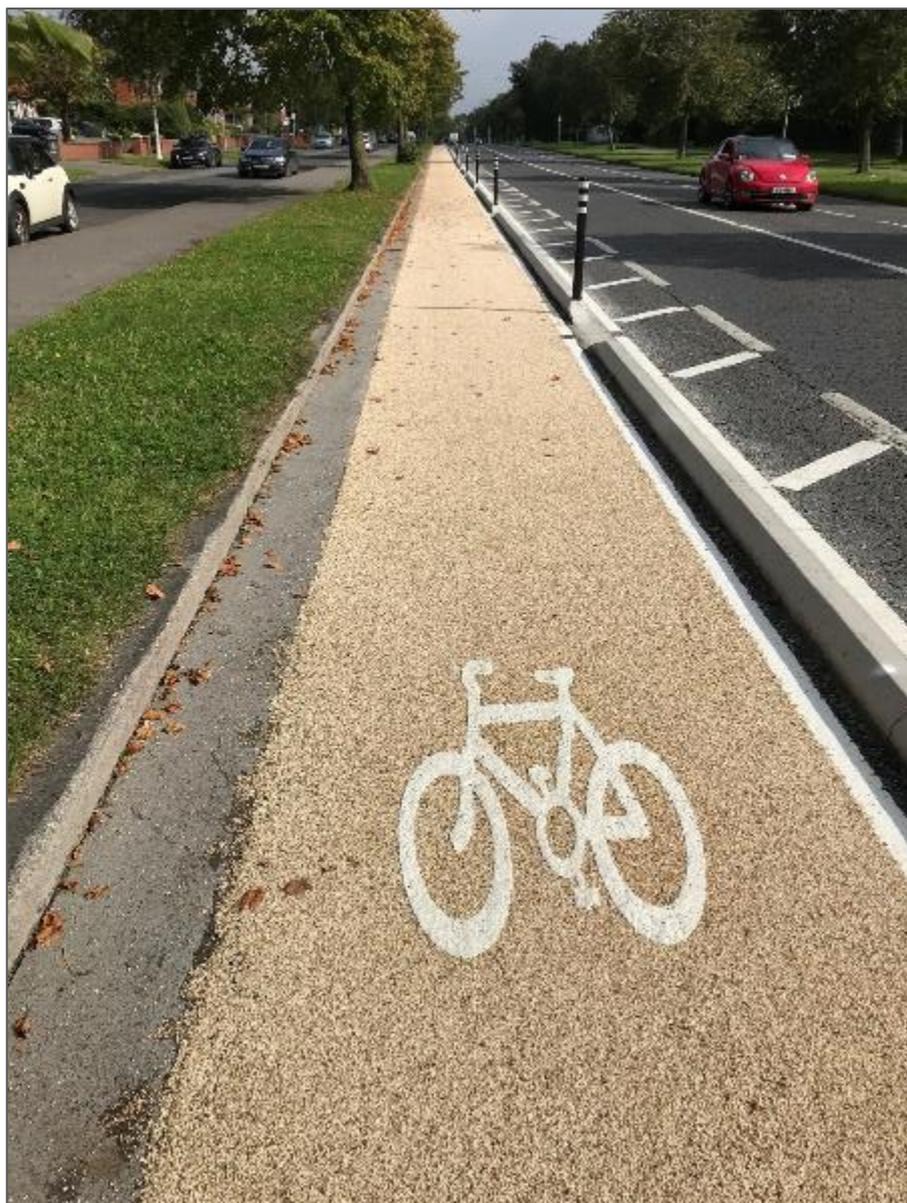
Figure 1.1 – Section of the Constructed Scheme

The scheme consists of the provision of a new protected cycle lane on the northside of Griffith Avenue. The cycle lane was facilitated with the removal of one of two eastbound traffic lanes. A protected cycle lane is one which is segregated from traffic with the provision of a concrete kerb. The height of the concrete kerb is 125mm. Bollards are provided at regular intervals to provide demarcation of the new kerb, with a keep right bollard placed at the start of each cycle link. These bollards have been provided on the top of the protection kerbs. Gaps in the kerbs are provided to allow drainage and where utility covers are present. Figure 1.1 demonstrates a section of the constructed scheme.

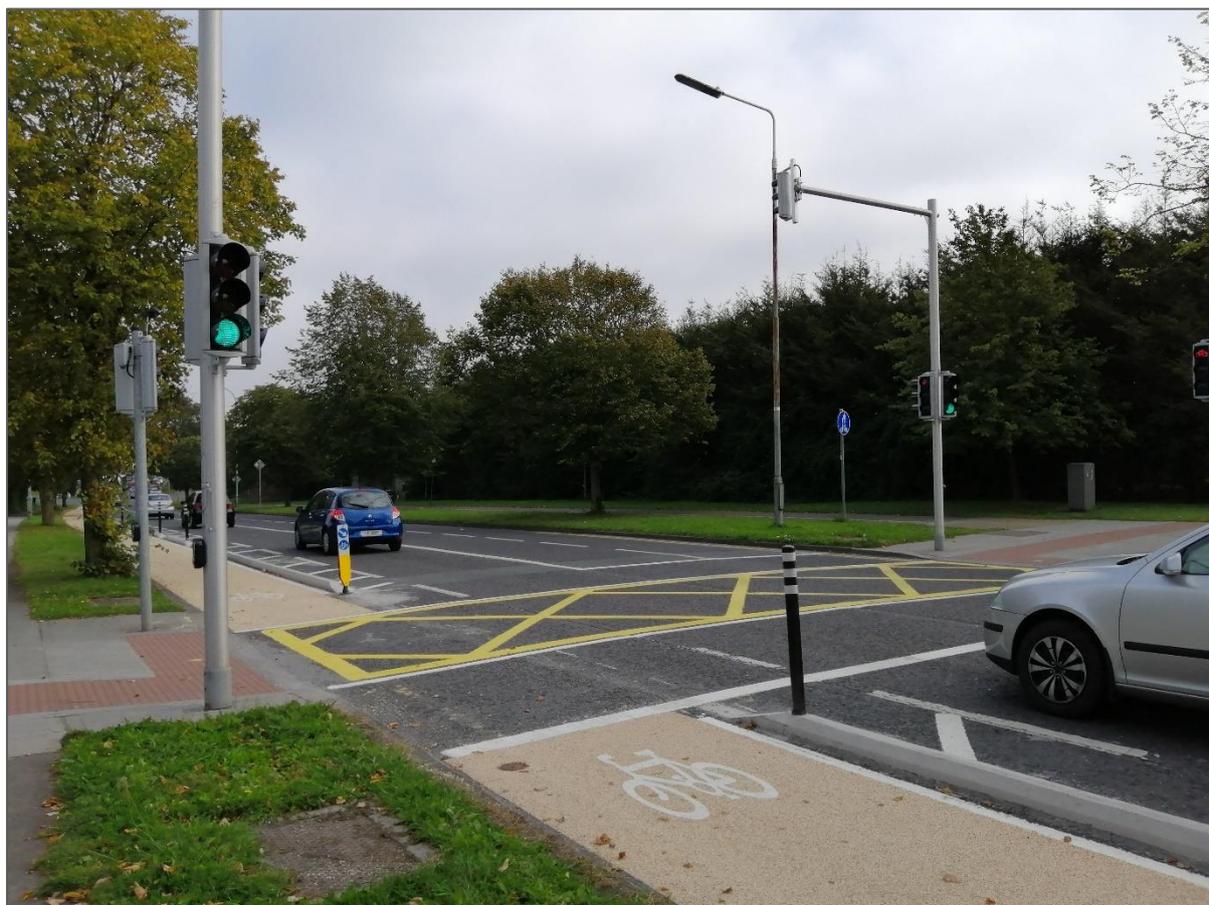
Figure 2.2 – Existing Pedestrian Crossing on Griffith Avenue adjacent to the National School

- A pedestrian footpath is provided north of the Griffith Avenue located behind a grass verge. A shared pedestrian / cycle lane is provided on the southern side of the road carriageway behind a grass verge. Pedestrians and cyclists are segregated by the use of a white line.
- A controlled pedestrian crossing is provided on Griffith Avenue adjacent to the Educate Together National School, as shown in Figure 2.2. There was a large number of pick-ups during the site visit, with parents collecting their children from school. Motorists seemed in general to park their cars on the residential road, which runs north of the main Griffith Avenue road carriageway.

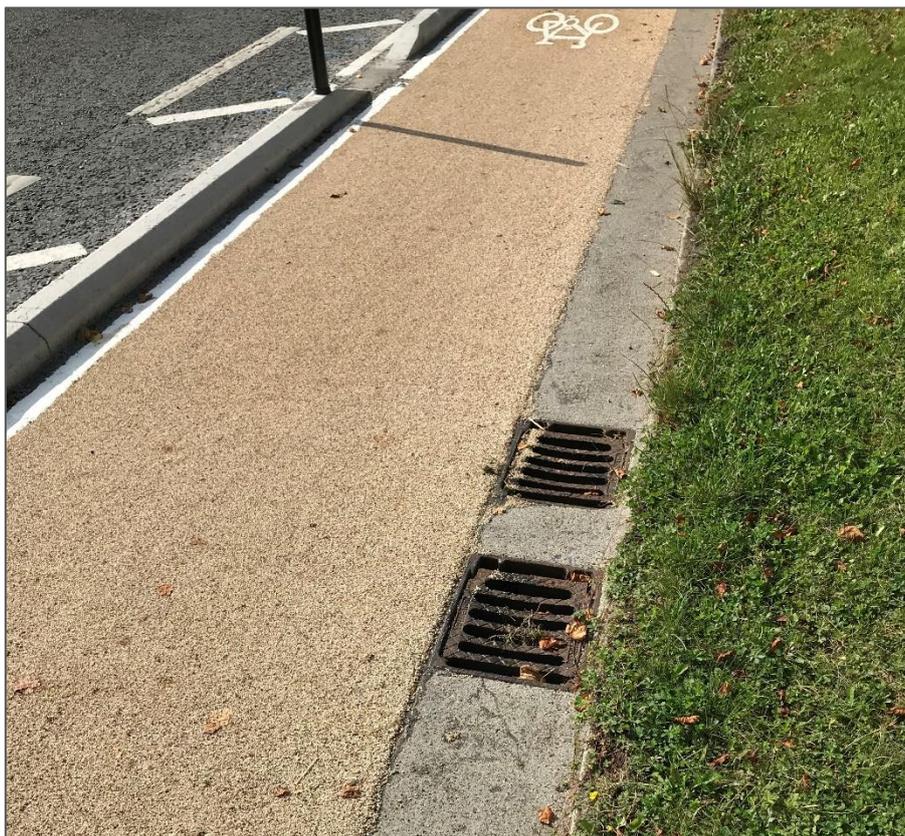
Figure 2.3 – Existing Drainage Channel and Gullies

- The newly constructed protected cycle lane is provided on the northern side of the road carriageway only, for eastbound cyclists. The cycle lane, from kerb to protected kerb is approximately 2.0m wide. A white line is provided on the inside of the kerb to increase the visibility of the kerb to cyclists, and potentially to pedestrians who may cross the road away from dedicated crossing points. A wide hatch is provided on the outside of the kerb, to highlight the kerb to motorists and to maintain a wide gap between the kerb and vehicles.
- A drainage channel is maintained on the inside of the cycle lane, with existing gullies maintained, as shown in Figure 2.3. The cycle lane is highlighted further with a beige anti-skid surfacing provided.

- The protected segregation kerbs feature gaps in the kerblines to facilitate drainage.

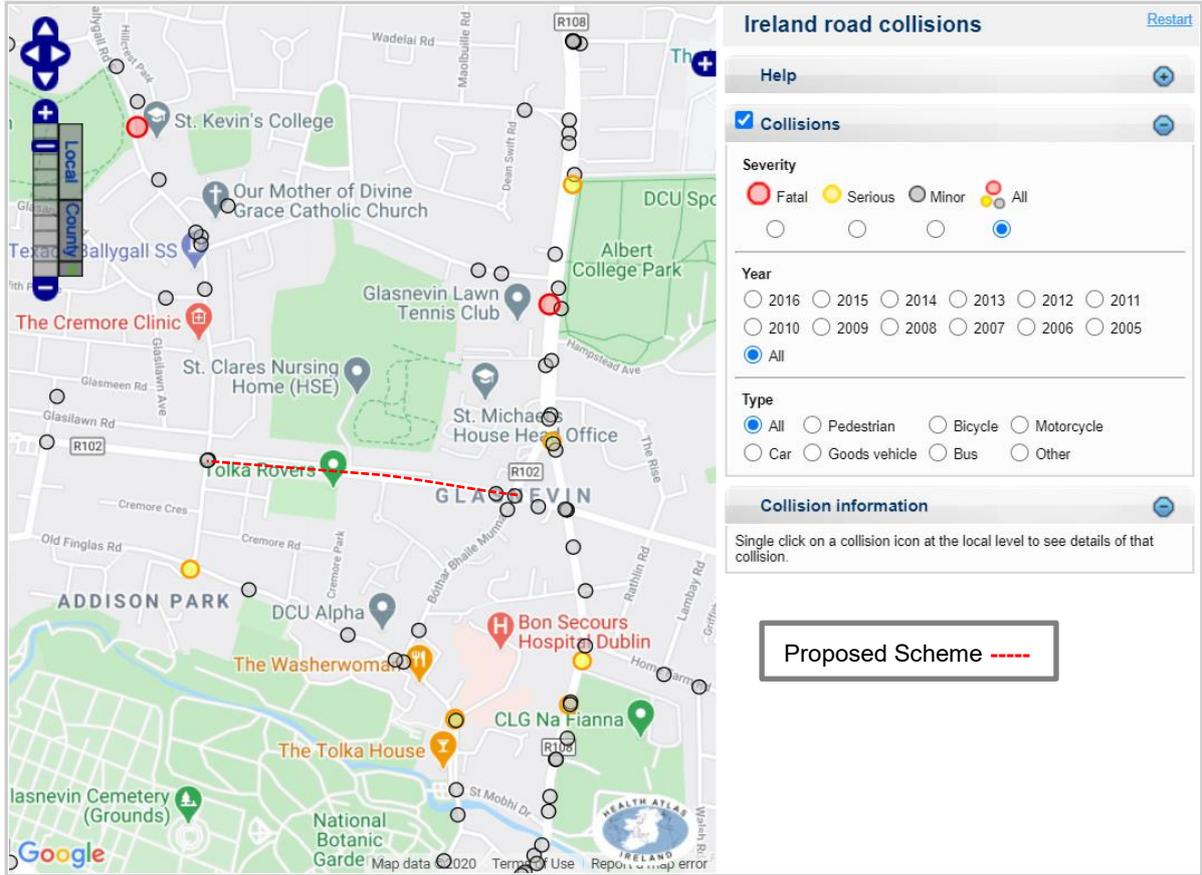
Figure 2.4 – RSA Collisions Records (2005-2016) in vicinity of the proposed scheme (www.RSA.ie)

- The RSA database of road collisions was examined to establish if there are any existing safety issues within the site that were not evident from the site visit.
- The database provides collision records for the period 2005 to 2016, with Figure 2.4 below outlining the recorded collisions over the 12 year period.
- 3 collisions occurred on the Griffith Avenue along the proposed scheme, of which all were minor and occurred at the junctions at either ends of the scheme. One collision involved a motorcycle with the other two involving cars.

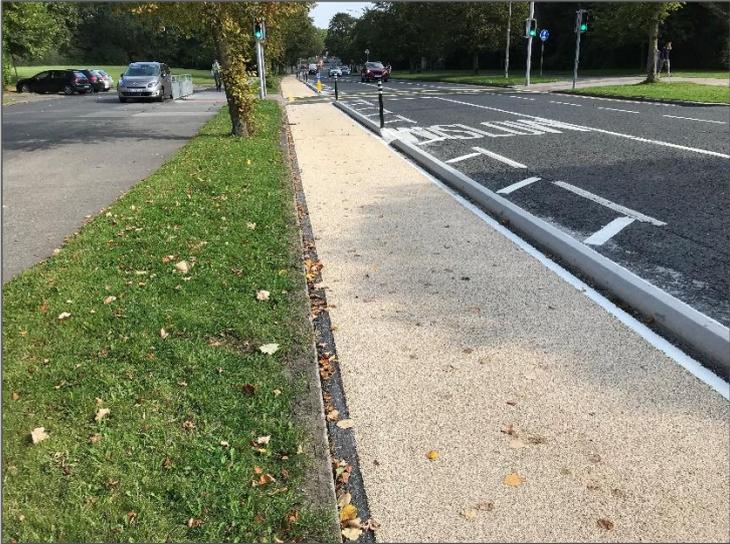
<p><i>Location:</i></p>	<p>Approach to the pedestrian crossing</p>	
<p><i>Drawing:</i></p>	<p>NA</p>	
<p><i>Summary:</i></p>	<p>Visibility of the pedestrian crossing to cyclists</p>	
<p>Description:</p> <p>The approach to the signalised pedestrian crossing along Griffith Avenue is slightly downhill. This could result in cyclists travelling at excessive speeds along the cycle lane with some cyclists failing to observe pedestrians, particularly school children, using the pedestrian crossing. Cyclists failing to observe pedestrians using the crossing could result in a pedestrian-cyclist collision with the potential for severe injuries to occur.</p>		<p>Figure 4.1 – Approach to Existing Signal Controlled Junction</p>
<p>Recommendation:</p> <p>Additional measures should be provided along the cycle track to increase the conspicuousness of the existing pedestrian crossing. At a minimum, a cycle signal head should be provided at a lower level.</p>

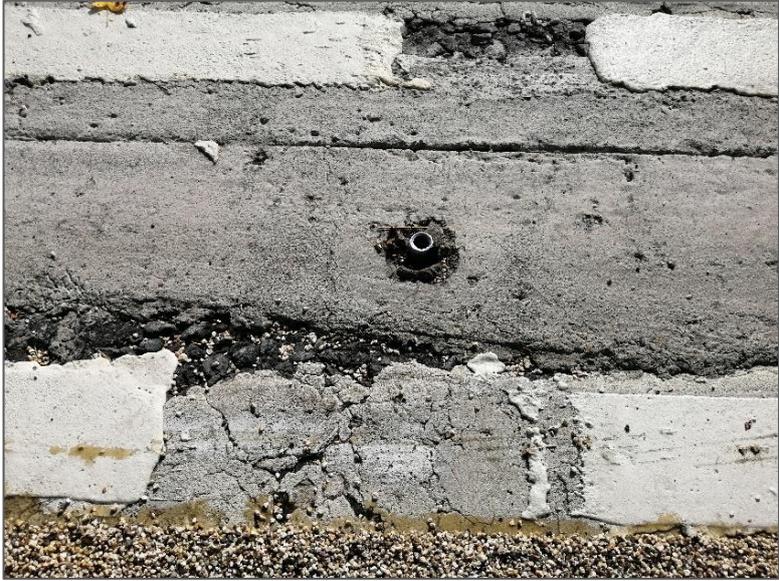
Figure 4.2 – Old Screw Lodged in Road Carriageway

<i>Location:</i>	At gaps in the concrete protection kerb	
<i>Drawing:</i>	NA	
<i>Summary:</i>	Potential Trip Hazard	
Description:		<p>The bollards are currently provided on the top of the protection kerbs. The audit team were informed that initially these bollards were to be provided in between the kerbs but were moved to the top of the protection kerbs. It was noted during the site visit that some of the screws that were used to install these bollards were sticking up from the carriageway. These screws present a trip hazard to pedestrians as they may trip and fall into the vehicle carriageway or cycle lane.</p>
Recommendation:		<p>All old bollard screws should be removed.</p>

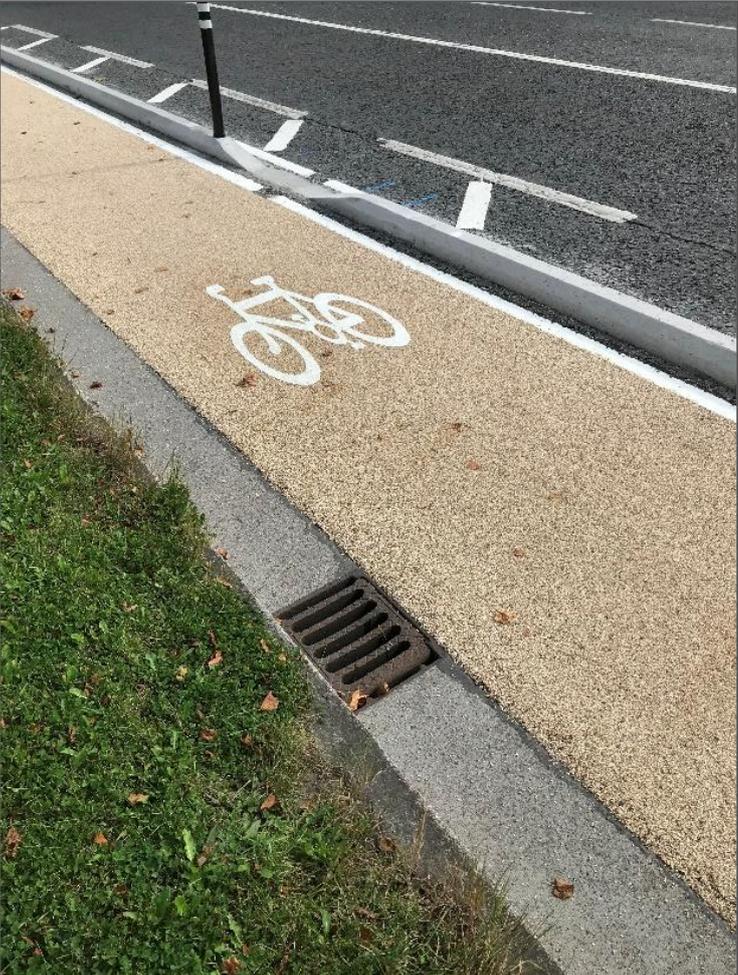
Figure 4.3 – Gap in kerb located downhill of gully

<i>Location:</i>	Throughout the scheme	
<i>Drawing:</i>	NA	
<i>Summary:</i>	Risk of ponding	
Description:		<p>The raised protection kerbs will block existing run off water flows. Gaps have been provided in the concrete kerbs to facilitate water run-off. However, if additional ponding was to build up on the road carriageway there is a risk that motorists will swerve to avoid it resulting in a collision with an oncoming vehicle.</p>
Recommendation:		<p>The scheme should be monitored for ponding. If ponding is to occur at any location, a cut should be made in the protection kerbs to ensure that no additional ponding occurs on the road carriageway or cycle lane.</p>

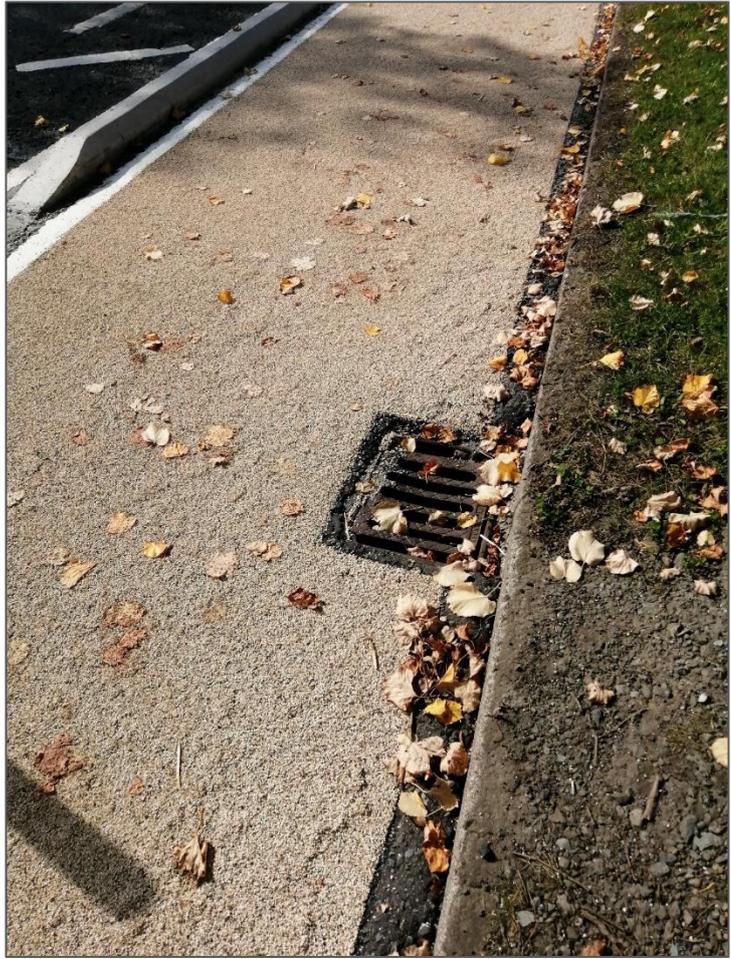
Figure 4.4 – Example of Leaves Along the Cycle Lane

4.5.2 Problem	
<i>Location:</i>	Throughout the scheme
<i>Drawing:</i>	NA
<i>Summary:</i>	Maintenance of the cycle lanes

Due to trees being provided along both sides of the carriageway adjacent to the cycle lane, there is a risk that should regular maintenance not be undertaken that this would lead to a build-up of debris in the cycle lane. This would result in the cycle lane becoming slick with leaves and may lead to cyclists losing grip and falling off their bike.

An appropriate maintenance strategy should be developed to keep the cycle lane clear of tree foliage and debris.

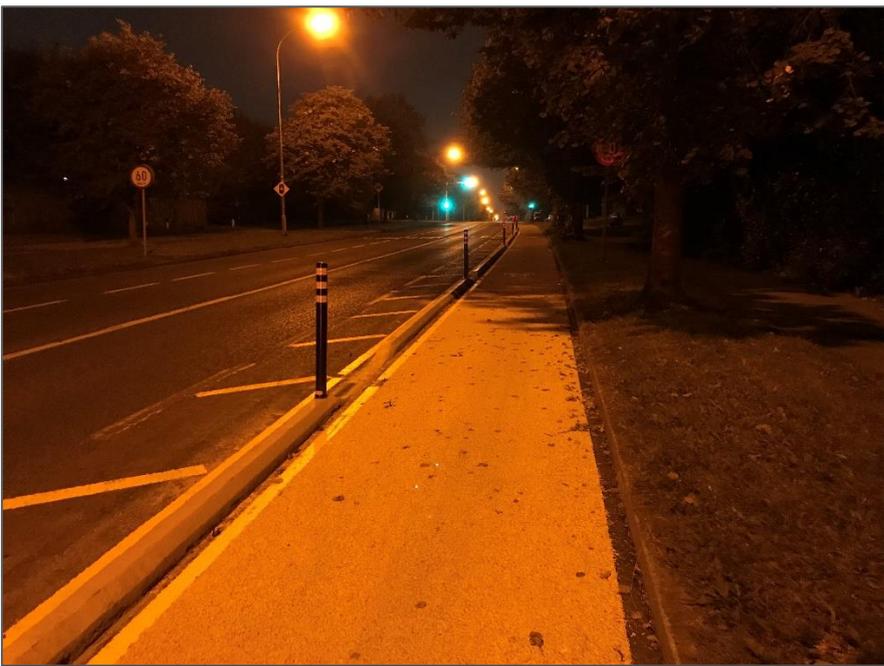
Location:	Throughout the scheme	
Drawing:	NA	
Summary:	Maintenance of existing trees	
<p>Description:</p> <p>Due to trees being provided along both sides of the carriageway adjacent to the cycle lane, there is a risk that should regular maintenance not be undertaken that the existing lighting levels will be reduced. This may result in poor visibility between cyclists and motorists and could result in a collision at conflict points.</p>		<p>Figure 4.5 – Night-time lighting levels</p>
<p>Recommendation:</p> <p>An appropriate maintenance strategy should be developed to keep the trees from obstructing the streetlights.</p>
