Griffith Avenue – Phase 2 Segregated Cycle Lanes

Stage 3 Road Safety Audit

December 2020

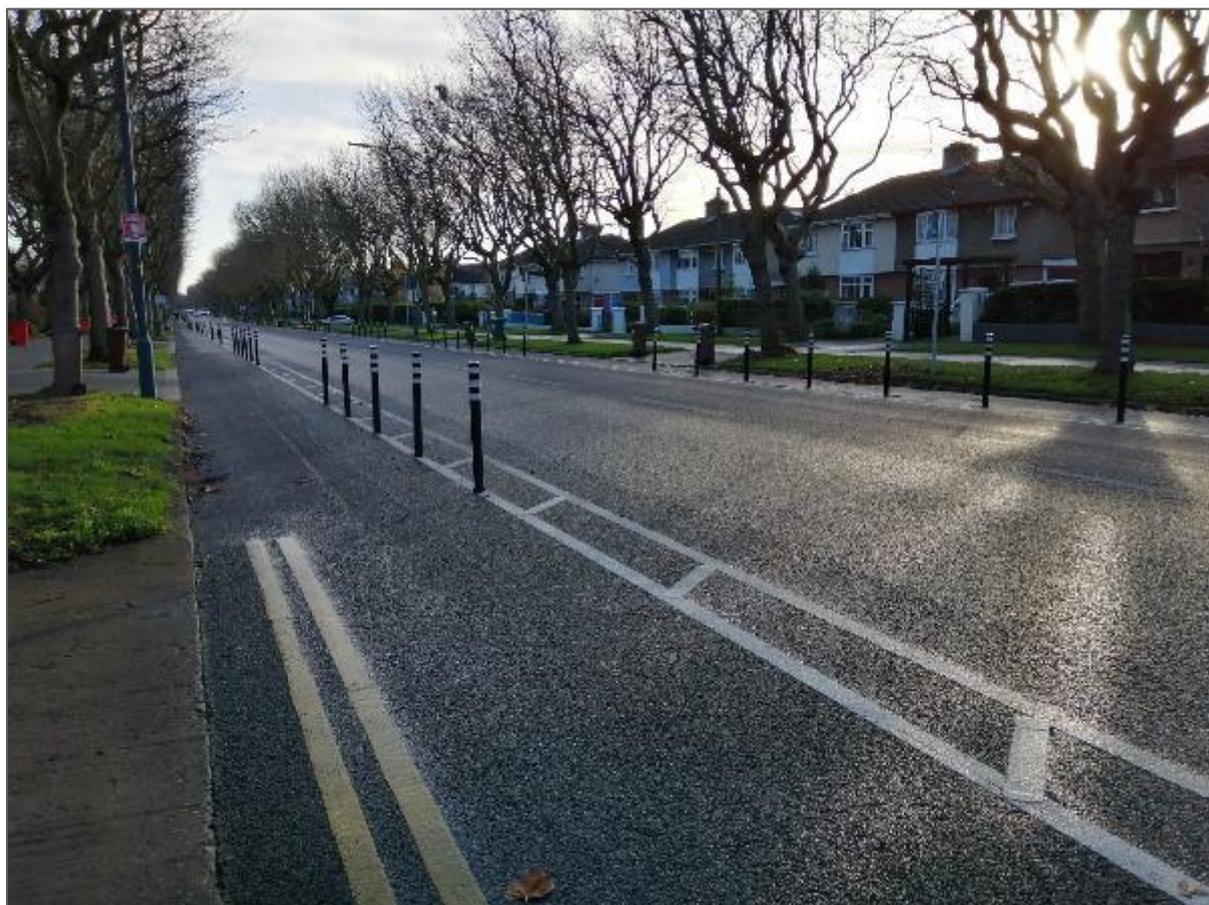
Figure 1.1 – Section of the Constructed Scheme

The segregated cycle lanes are separated from traffic with the provision of a 0.55m hatch and bollards, with a keep right bollard placed at the start of each cycle link. The existing kerb lines have been maintained. The existing priority junctions through the scheme have been maintained with no changes to their alignments or road markings. The approach lanes at the two signal-controlled junctions, at the eastern and western extents of the scheme, have been narrowed, thus reducing the junction's capacity.

Figure 1.1 demonstrates a section of the constructed scheme.

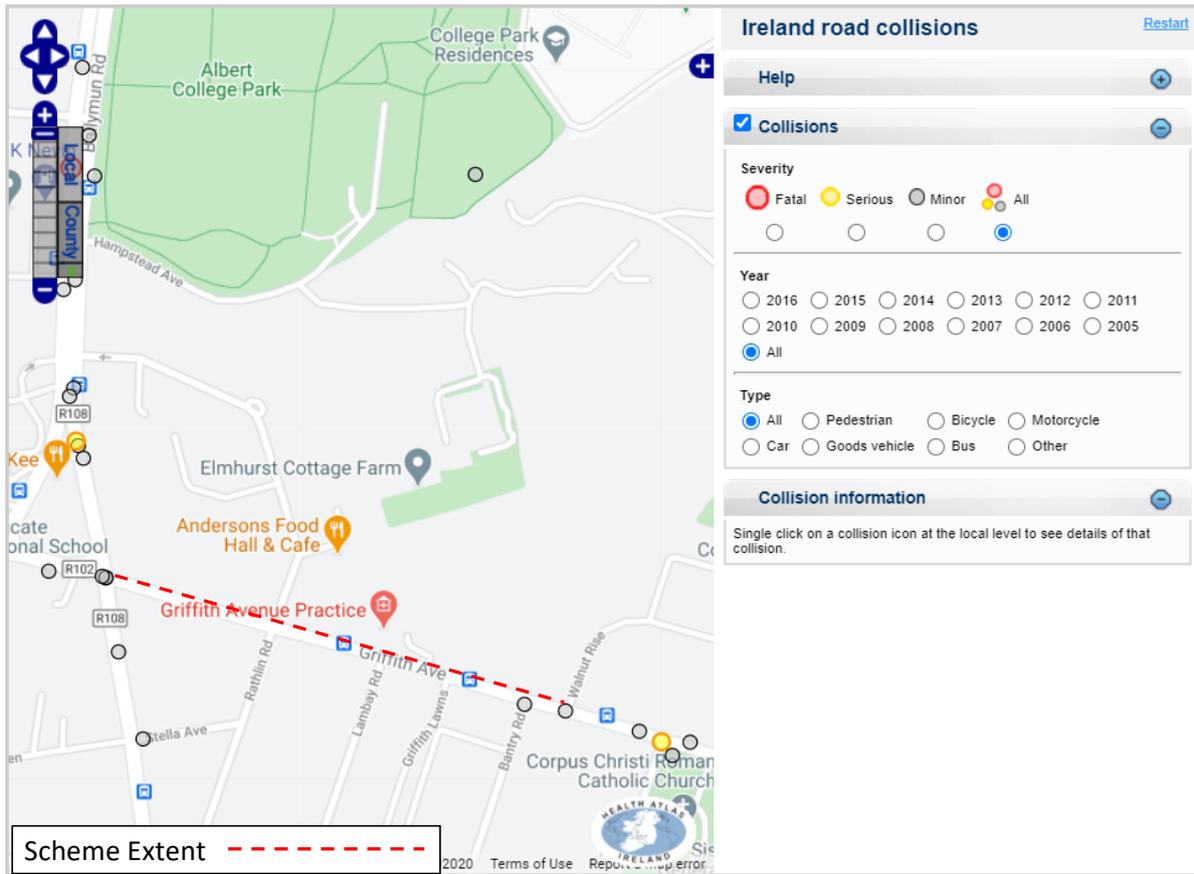
Figure 2.2 – RSA Collisions Records (2005-2016) in vicinity of the proposed scheme (www.RSA.ie)

- The RSA database of road collisions was examined to establish if there are any existing safety issues within the site that were not evident from the site visit.
- The database provides collision records for the period 2005 to 2016, with Figure 2.2 below outlining the recorded collisions over the 12 year period.
- 4 collisions occurred on the Griffith Avenue along the proposed scheme, of which all were minor in severity. 3 of the collisions occurred at the junctions at either ends of the scheme. Two collisions were single vehicle collisions with the other two involving pedestrians. One pedestrian collision occurred at the Mobhi Road junction and the other at the Walnut Rise junction.

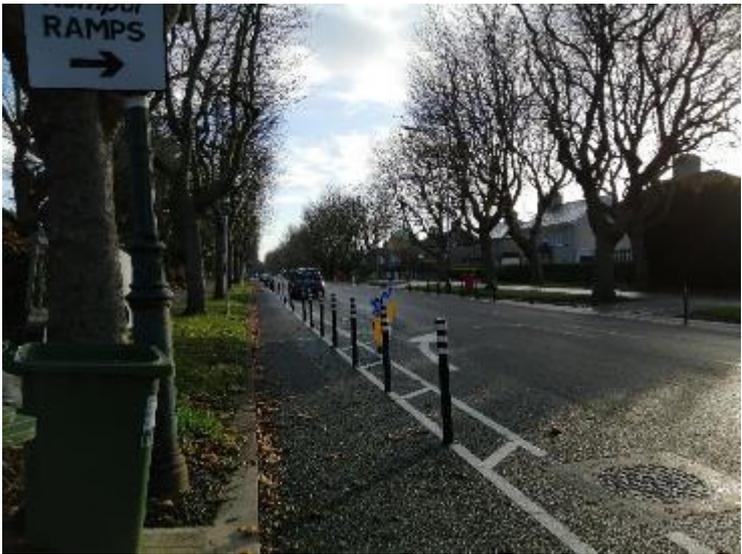
Figure 4.1 – Parking Bay on the North Side of Griffith Avenue

Location:	Approach to Build-Out for Parking	
Drawing:	NA	
Summary:	Sudden turn at Parking	
Description:		<p>At the eastern extent of the scheme, the road narrows and is shifted to the south on the approach to the new vehicle parking spaces. The change in the horizontal alignment is indicated with the change in the centreline, a deflection arrow, and four keep right flexi-signs.</p> <p>The deflection arrow is provided very close to parking build-out and may not give motorists sufficient warning to turn before the vehicle parking spaces which could result in a collision with a parked vehicle.</p>
Recommendation:		<p>An additional deflection arrow should be provided, at a suitable distance, on approach to the parking bays. Consideration should be given to lengthening the hatched area.</p>

4.2.1	Yes	Yes		An addition arrow will be installed. The hatching will be modified.	
4.2.2	Yes	Yes		We will contact Dublin Bus and enquire if their drivers have issues with this bus stop. We will modify bollards as required.

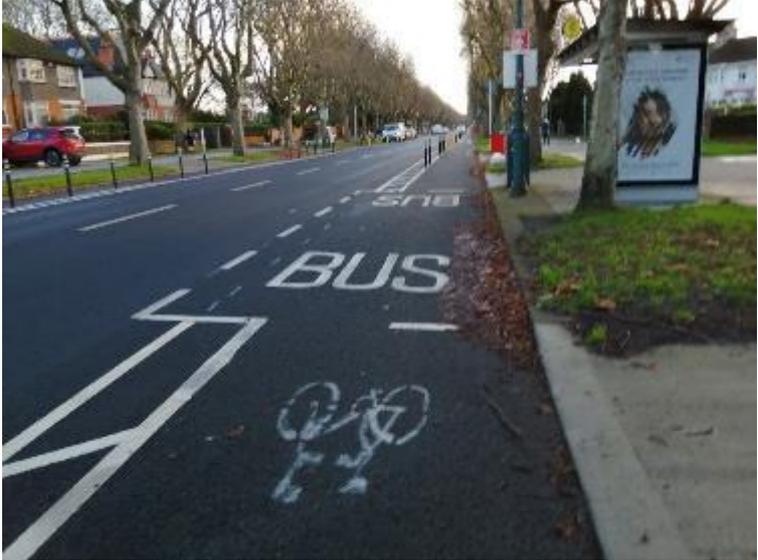
Figure 4.2 – Existing Bus Stop

<i>Location:</i>	Bus Stops	
<i>Drawing:</i>	NA	
<i>Summary:</i>	Buses pulling in tight to the Bus Stop	
Description:		<p>There are 2 Bus Stops within the scheme. It was noted during the site visit, that one of the buses did not pull in tight to the existing kerb line. It is unclear whether bollards used as part of the cycle scheme are preventing buses from pulling in tight to the kerbside.</p> <p>Buses should be able to manoeuvre into a bus stop right up to the kerbside. Gaps of 100mm or more can present access difficulties for some users such as the elderly; people with push chairs or wheelchairs and people with sight impairment or with walking difficulties, with could result in a trip and injury.</p>
Recommendation:		<p>It should be ensured that the bollards used as part of the cycle scheme do not prevent buses manoeuvring into a bus stop right up to the kerbside.</p>

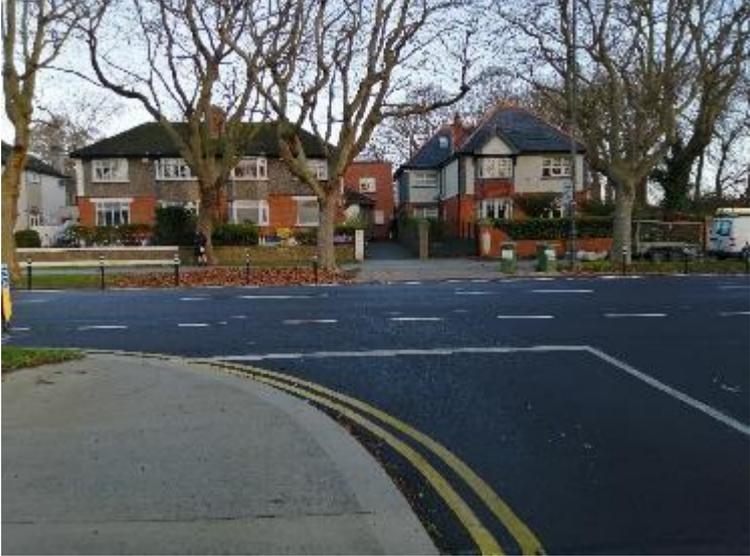
Location:	Priority junctions throughout scheme	
Drawing:	NA	
Summary:	'STOP' road markings or signage not provided	
<p>Description:</p> <p>The existing priority junctions have not been upgraded as part of this scheme. However, the introduction of a cycle lane across these junctions means that the attention of a driver should not solely be focused on approaching vehicles and the acceptance of gaps but that they should now also be focused on cyclists in the cycle lane. The vulnerable road users should be higher in the movement hierarchy.</p>		<p>Figure 4.3 – Lambay Road Priority Junction</p>
<p>Recommendation:</p> <p>'STOP' road markings and signage should be provided at all the residential estates junctions.</p>

4.3.1	Yes	Yes		We will arrange for Stop lines and signs to be installed	
4.3.2	Yes	Yes		We will arrange for the Clearway signs to be removed	
4.4.1	Yes	Yes		We will widen the buffer to a minimum of 0.750m and extend the hatching to driveways where present.

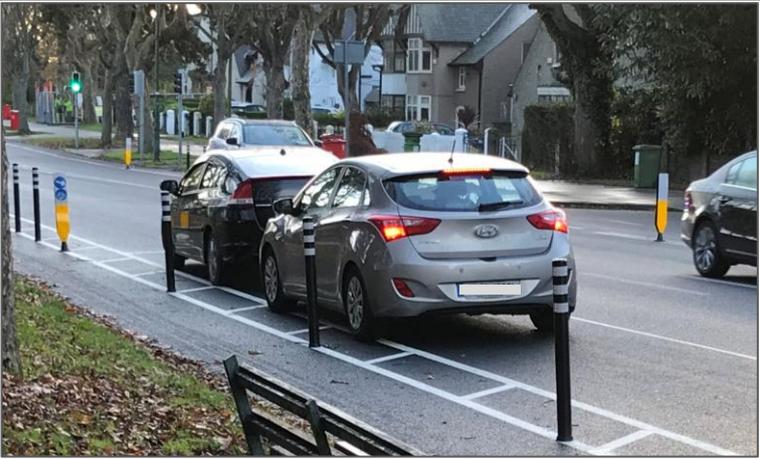
<p><i>Location:</i></p>	<p>Parking</p>	
<p><i>Drawing:</i></p>	<p>NA</p>	
<p><i>Summary:</i></p>	<p>Narrow Car Parking and Buffer and Widths</p>	
<p>Description:</p>		<p>Figure 4.5 – Car Parked in Hatching</p>
<p>The car parking provided is approximately 2.0m wide with a buffer provided between the parking and the cycle lane of approximately 0.55m.</p> <p>There is a risk that with a narrow car parking space and buffer that a motorist may open their door suddenly, without checking, which swings out into the cycle lane resulting in a collision with a passing cyclist.</p>		
<p>Recommendation:</p> <p>A minimum of 2.1m wide car parking and 0.75m buffer should be provided, either by narrowing the road carriageway or cycle lane width at these locations.</p> <p>The widened hatching should be extended to driveways at both ends of the parking.</p>

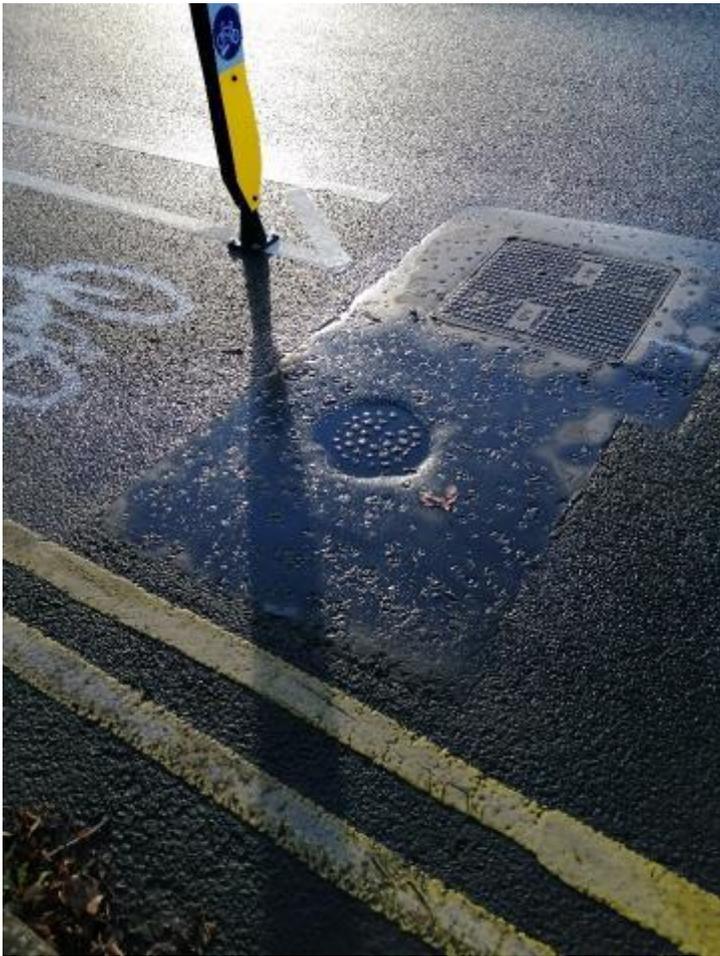
Location:	Eastern end of Scheme	
Drawing:	NA	
Summary:	Risk of ponding	
<p>Description:</p> <p>Ponding was noted in one of the chambers at the western end of the scheme on the northern side. If ponding was to build up in the cycle lane and freeze there is a risk that cyclists could skid on it, falling off their bike onto the vehicle carriageway, resulting in a collision.</p> <p>Recommendation:</p> <p>The chamber lid should be raised to ensure that ponding does not occur at this location.</p>		<p>Figure 4.6 – Ponding the Chamber Cover</p>

4.5.1	Yes	No		It should not be necessary to raise this chamber. We intend on surfacing the entire cycle lane with a buff anti-skid and this should take care of any ponding issue.

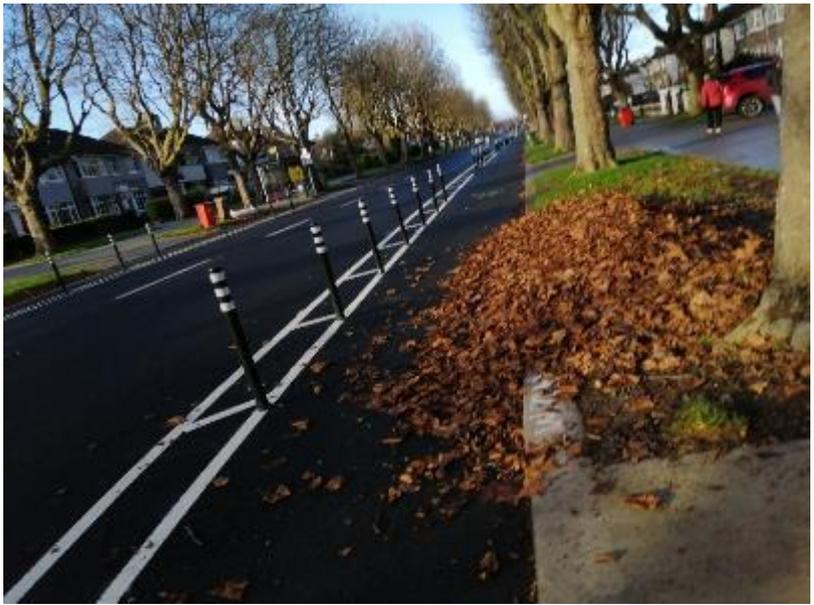
<i>Location:</i>	Throughout the scheme	
<i>Drawing:</i>	NA	
<i>Summary:</i>	Maintenance of the cycle lanes	
Description:		<p>Figure 4.7 – Example of Leaves Along the Cycle Lane</p>
<p>Due to trees being provided along both sides of the carriageway adjacent to the cycle lanes, there is a risk that should regular maintenance not be undertaken that this would lead to a build-up of debris in the cycle lanes. This would result in the cycle lane becoming slick with leaves and may lead to cyclists losing grip and falling off their bike.</p>		
Recommendation:		
<p>An appropriate maintenance strategy should be developed to keep the cycle lane clear of tree foliage and debris.</p>

4.5.2	Yes	Yes		The Cleansing Department is aware of this issue and are purchasing additional compact mini-sweepers to maintain protected cycle lanes.

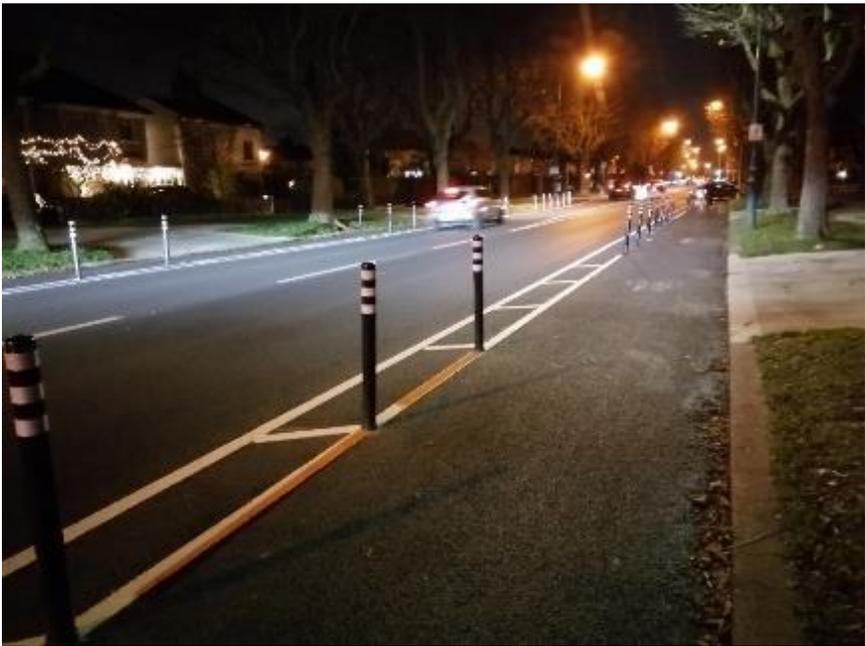
Location:	Throughout the scheme	
Drawing:	NA	
Summary:	Maintenance of existing trees	
<p>Description:</p> <p>Due to trees being provided along both sides of the carriageway adjacent to the cycle lane, there is a risk that should regular maintenance not be undertaken that the existing lighting levels will be reduced. This may result in poor visibility between cyclists and motorists and could result in a collision at conflict points.</p> <p>Recommendation:</p> <p>An appropriate maintenance strategy should be developed to keep the trees from obstructing the streetlights.</p>		<p>Figure 4.8 – Night-time lighting levels</p>

4.6.1	Yes	Yes		The Parks Department has been made aware of this concern.	
-------	-----	-----	--	---	--
