Residential Development at
Shangan Road, Co. Dublin

Combined Stage 1 & 2
Road Safety Audit

Document Ref: P21-090-PSW1-RP-001

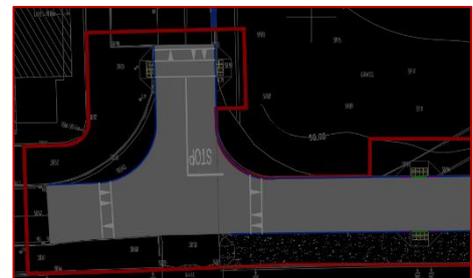
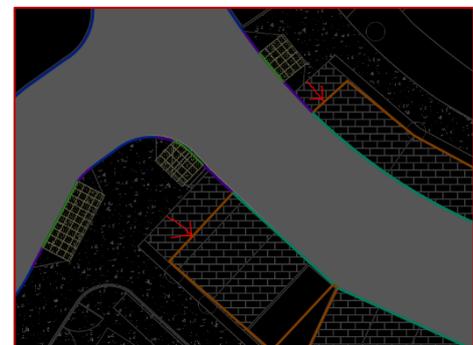
- Location 1:** A new access road will tie into Shangan Road near the rear access to Trinity Comprehensive School. The new access road will extend in an east-west direction, and require a revision to the priority of the existing road at this location. A raised table will be provided with an uncontrolled pedestrian crossing on the minor arm of the new T-Junction. The junction shall include a Stop sign and associated road markings.
- Location 2:** A new uncontrolled pedestrian crossing will be provided at the Public Open Space in the north-eastern corner of the development. The uncontrolled pedestrian crossing will provide access for pedestrians, including visually and mobility impaired pedestrians, wishing to access the amenities within the Public Open Space.
