**KAVANAGH
MANSFIELD
& PARTNERS
CONSULTING
STRUCTURAL
AND CIVIL
ENGINEERS**

**NDFA SOCIAL HOUSING
BUNDLES 04 AND 05
STRUCTURAL SURVEY REPORT ON
BUILDINGS TO BE DEMOLISHED**

STANLEY STREET

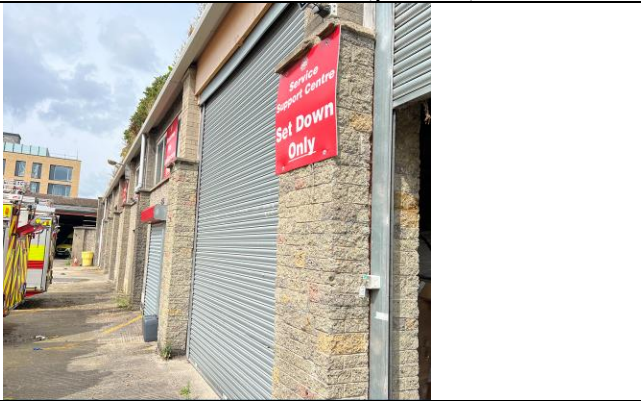
External View (photo 10)

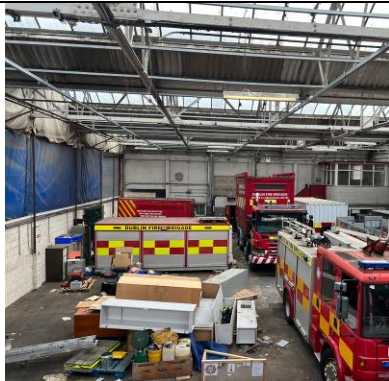
Internal View (Photo 23)

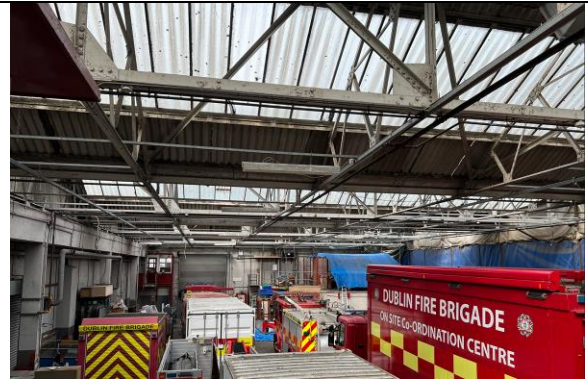
Internal view -rear side (photo 24)

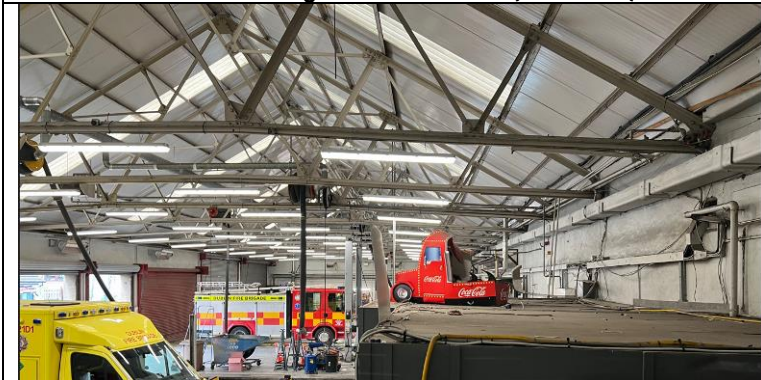
Roof view (photo 43)

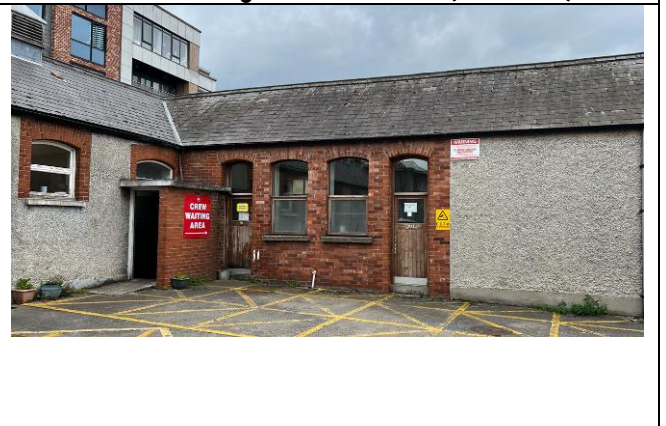
Roof view external side (photo 50)

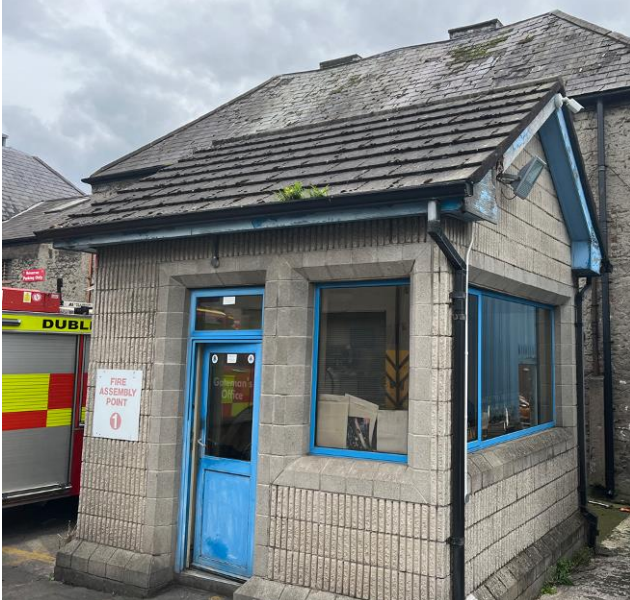
External view (Photo 58)
