SOCIAL HOUSING BUNDLE 4 DEVELOPMENT AT THE STANLEY STREET DEPOT, DUBLIN 7

Boundary Wall Survey SHB4-SSD-RP-MOR-CS-P3-004

DUBLIN CITY COUNCIL
September 2024

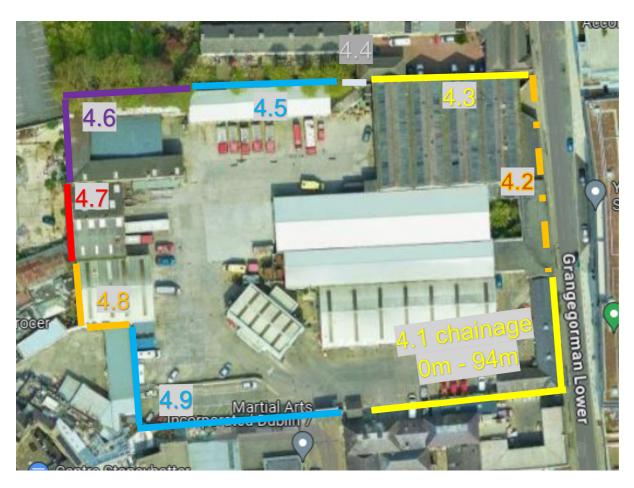
Figure 3.1 Plan Location of wall sections 4.1 to 4.9

Defects were noted on the old brickwork wall. Vertical cracking was visible running the full height of the wall. Remedial works were undertaken in the past in the form of stitching across the cracked brick sections of wall with steel channels and bolting into secure brickwork either side of the cracks.

This wall section currently acts as a perimeter wall to the vehicle wash building. Wall design to be checked to ensure the wall can function as a free-standing 5m high wall once the building has been removed.
