ASBESTOS DEMOLITION SURVEY REPORT

DCC Stanley Street Depot

Grangegorman

Project Number
39237

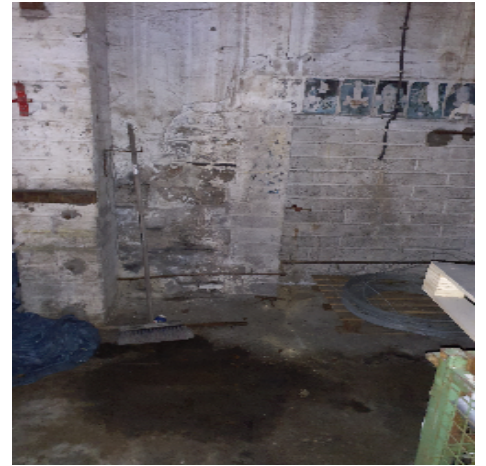
Location Details : 76698 No Asbestos Found

<p>Building/Area : First Aid Building Ground floor</p> <p>Room/Section : Store rooms</p> <p>Location : Walls, floor and ceiling</p> <p>Description : Insulation debris</p> <p>Sample No. : DBB20231101002</p> <p>Confirmation : Sampled</p> <p>Access : Full Access</p> <p>Normal Use :</p> <p>Recommendations :</p> <p>Notes :</p>	
---	--

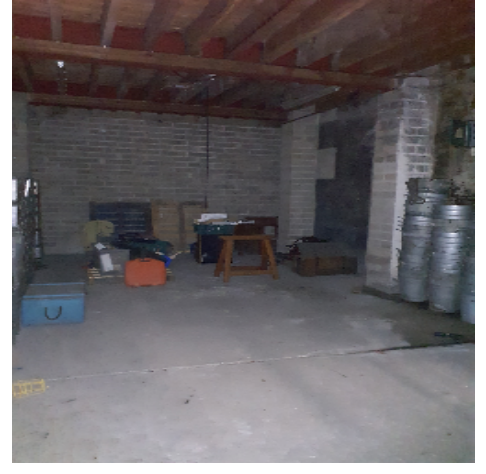
Location Details : 76699 No Asbestos Found

<p>Building/Area : First Aid Building Ground floor</p> <p>Room/Section : Civil Defence Store</p> <p>Location : Walls, floor and ceiling</p> <p>Description : Block, concrete, timber</p> <p>Sample No. :</p> <p>Confirmation :</p> <p>Access : Full Access</p> <p>Normal Use :</p> <p>Recommendations :</p> <p>Notes :</p>	
--	--

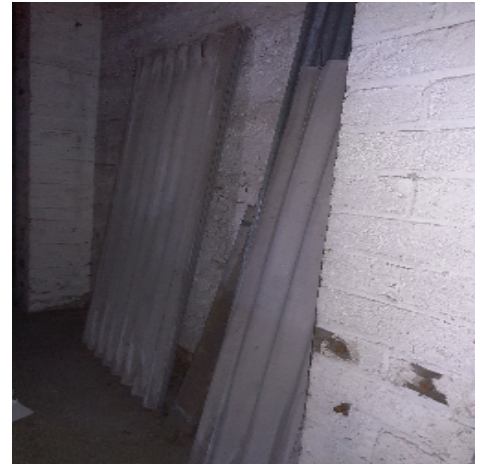
Location Details : 76701 No Asbestos Found

Building/Area : First Aid Building Ground floor
 Room/Section : Civil Defence Store
 Location : Loose at wall
 Description : Cement
 Sample No. : DBB20231101004
 Confirmation : Sampled
 Access : Full Access
 Normal Use :
 Recommendations :
 Notes :

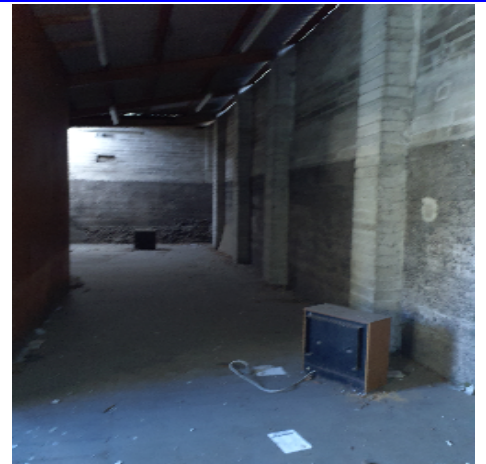
Location Details : 76703 No Asbestos Found

Building/Area : First Aid Building First floor
 Room/Section : Civil Defence Store
 Location : Walls, floor
 Description : Block, concrete, timber
 Sample No. :
 Confirmation :
 Access : Full Access
 Normal Use :
 Recommendations :
 Notes :

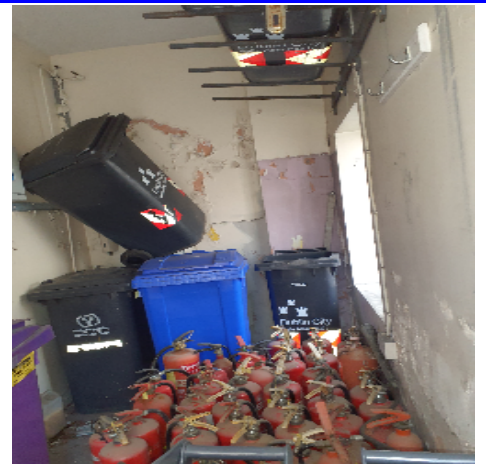
Location Details : 76705 No Asbestos Found

Building/Area : First Aid Building Ground floor
 Room/Section : First Aid room
 Location : Walls, floor, ceiling
 Description : Block, concrete, plaster
 Sample No. :
 Confirmation :
 Access : Full Access
 Normal Use :
 Recommendations :
 Notes :

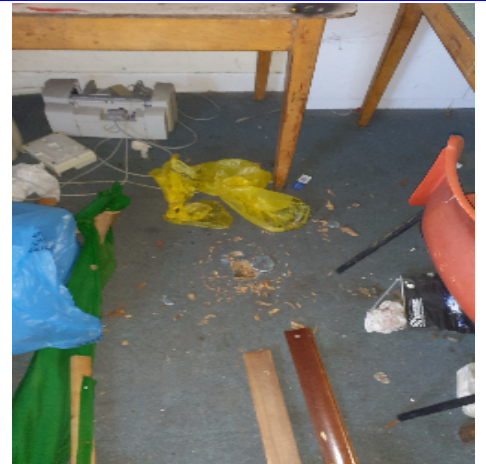
Location Details : 76719 No Asbestos Found

Notes : Plaster and timber panels

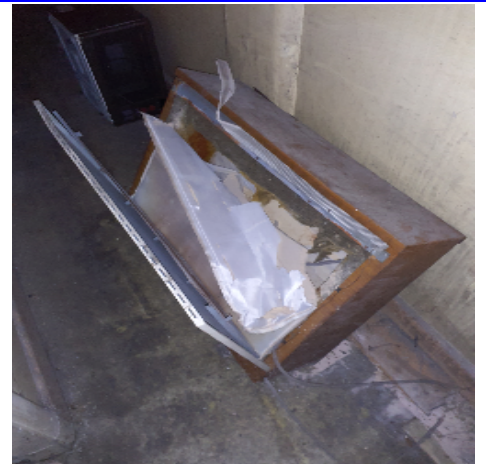
Location Details : 76721 No Asbestos Found

Building/Area : Derelict store Building Ground floor

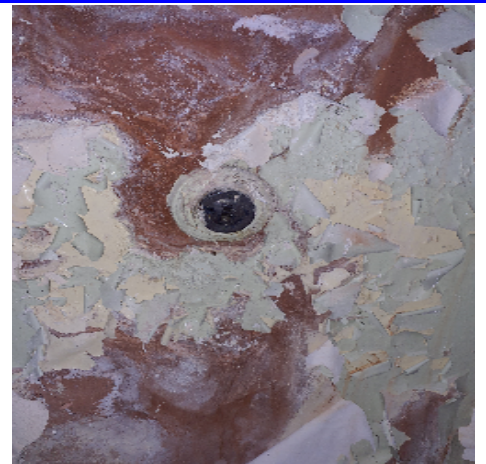
Location Details : 76724 No Asbestos Found

Building/Area : Derelict store Building Ground floor

Location : Loose flange

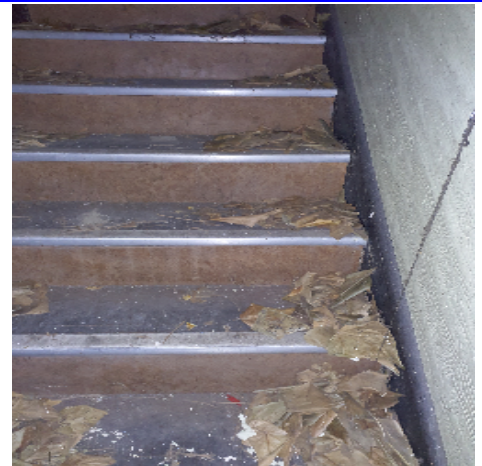
Location Details : 76725 No Asbestos Found

Building/Area : Derelict store Building Ground floor
 Room/Section : Stairs
 Location : White nosing
 Description : Bakelite
 Sample No. :
 Confirmation : Sampled
 Access : Full Access
 Normal Use :
 Recommendations :
 Notes :

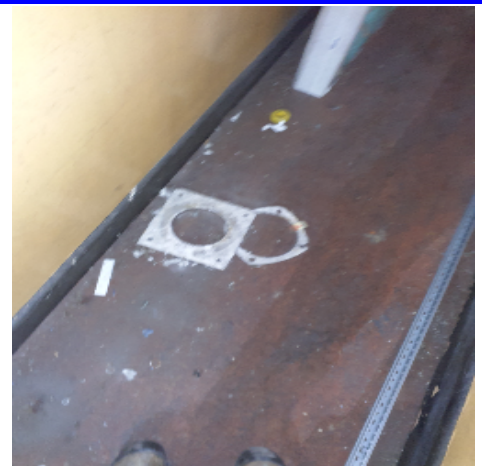
Location Details : 76726 No Asbestos Found

Building/Area : Derelict store Building First floor
 Room/Section : End store
 Location : Loose flange
 Description : Gasket
 Sample No. : DBB20231101015
 Confirmation : Sampled
 Access : Full Access
 Normal Use :
 Recommendations :
 Notes :

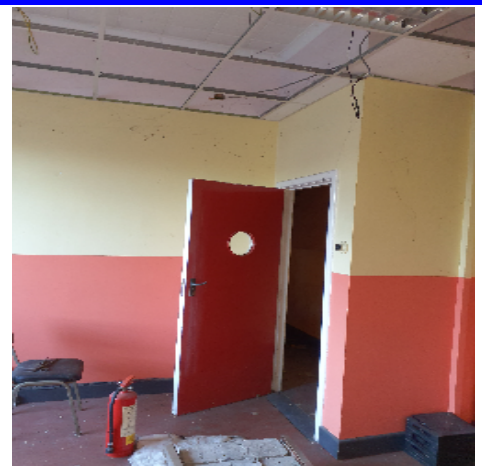
Location Details : 76727 No Asbestos Found

Building/Area : Derelict store Building First floor
 Room/Section : All rooms
 Location : Walls, floor, ceiling
 Description : Block, timber, plaster
 Sample No. :
 Confirmation :
 Access : Full Access
 Normal Use :
 Recommendations :
 Notes : Plaster and timber panels

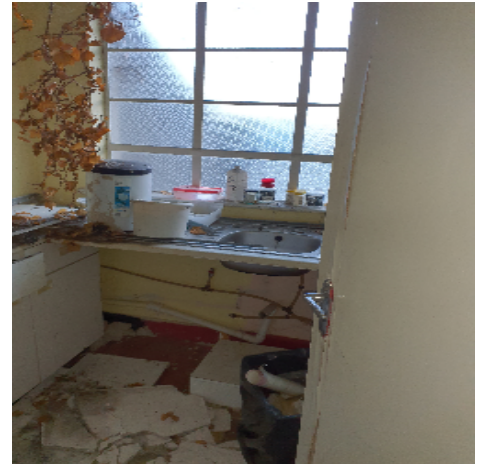
Location Details : 76728 No Asbestos Found

Building/Area : Derelict store Building First floor
 Room/Section : End room
 Location : Sink
 Description : Bitumen pad
 Sample No. : DBB20231101016
 Confirmation : Sampled
 Access : Full Access
 Normal Use :
 Recommendations :
 Notes :

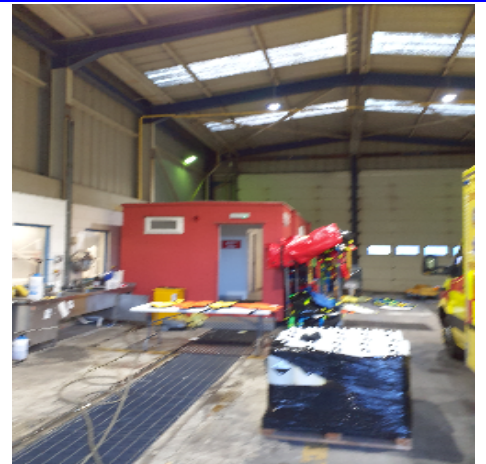
Location Details : 76731 No Asbestos Found

Building/Area :
 Room/Section : Ambulance wash
 Location : Walls, floor and ceiling
 Description : Block, concrete, metal
 Sample No. :
 Confirmation :
 Access : Full Access
 Normal Use :
 Recommendations :
 Notes :

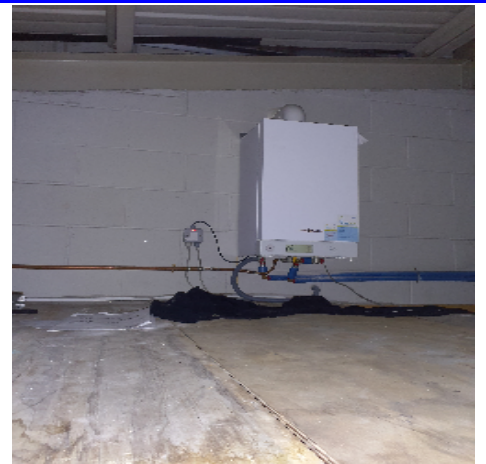
Location Details : 76732 No Asbestos Found

Building/Area :
 Room/Section : Ambulance wash attic
 Location : Walls, floor and ceiling
 Description : Block, concrete, metal
 Sample No. :
 Confirmation :
 Access : Full Access
 Normal Use :
 Recommendations :
 Notes :

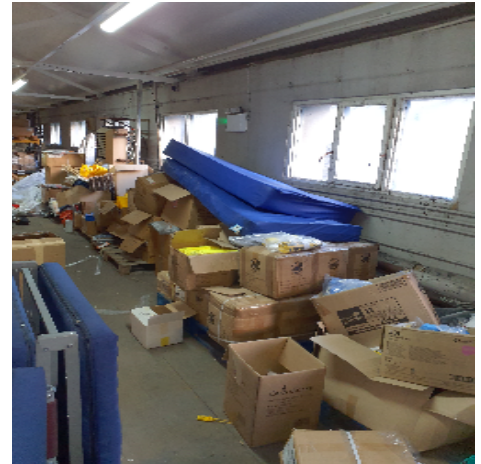
Location Details : 76742 No Asbestos Found

Building/Area : Fleet maintenance Ground floor
 Room/Section : Main store mezzanine
 Location : Walls, floor and ceiling
 Description : Block, concrete
 Sample No. :
 Confirmation :
 Access : Full Access
 Normal Use :
 Recommendations :
 Notes :

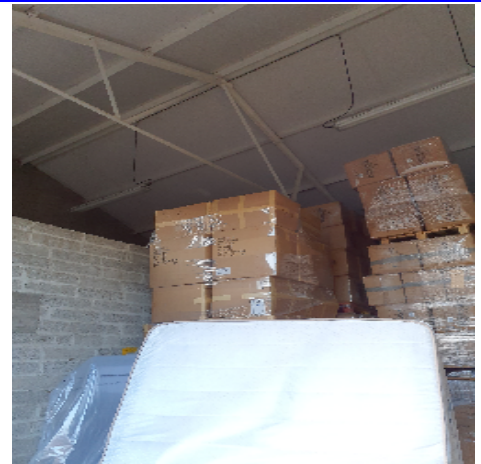
Location Details : 76744 No Asbestos Found

Building/Area : Stores Ground floor
 Room/Section : Store 1
 Location : Walls, floor and ceiling
 Description : Block, concrete, metal
 Sample No. :
 Confirmation :
 Access : Full Access
 Normal Use :
 Recommendations :
 Notes :

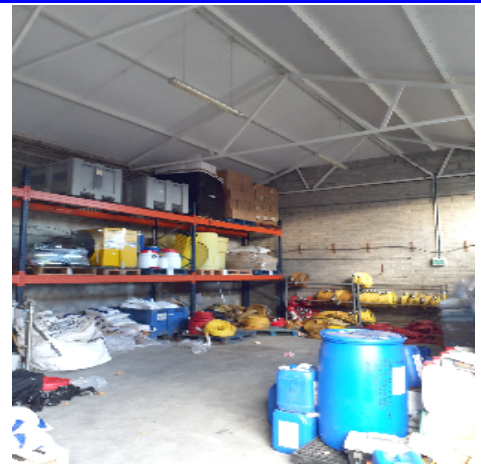
Location Details : 76745 No Asbestos Found

Building/Area : Stores Ground floor
 Room/Section : Store 2
 Location : Walls, floor and ceiling
 Description : Block, concrete, metal
 Sample No. :
 Confirmation :
 Access : Full Access
 Normal Use :
 Recommendations :
 Notes :

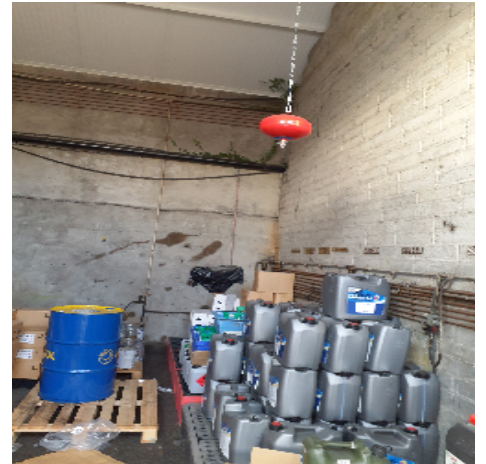
Location Details : 76746 No Asbestos Found

Building/Area : Stores Ground floor
 Room/Section : Store 3
 Location : Walls, floor and ceiling
 Description : Block, concrete, metal
 Sample No. :
 Confirmation :
 Access : Full Access
 Normal Use :
 Recommendations :
 Notes :

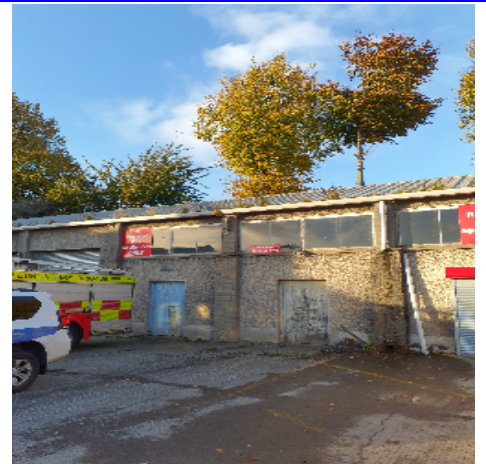
Location Details : 76747 No Asbestos Found

Building/Area : Stores Ground floor
 Room/Section : Roof, soffits,
 Location : External areas
 Description : Block, concrete, metal
 Sample No. :
 Confirmation :
 Access : Full Access
 Normal Use :
 Recommendations :
 Notes :

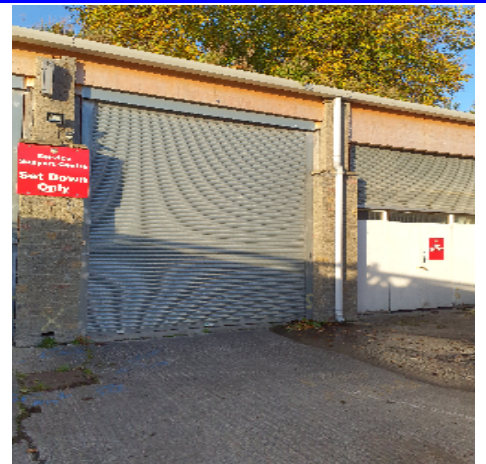
Location Details : 76748 No Asbestos Found

Building/Area : Stores Ground floor
 Room/Section : Store 3
 Location : Walls, floor and ceiling
 Description : Block, concrete, metal
 Sample No. :
 Confirmation :
 Access : Full Access
 Normal Use :
 Recommendations :
 Notes :

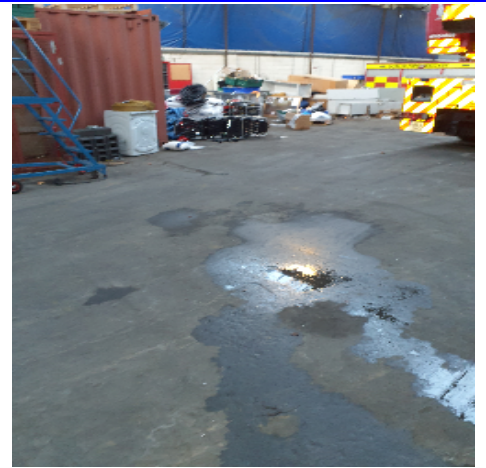
Location Details : 76766 No Asbestos Found

Building/Area : Vehicle store Ground floor
 Room/Section : Main store
 Location : Walls, floor
 Description : Block, concrete
 Sample No. :
 Confirmation :
 Access : Full Access
 Normal Use :
 Recommendations :
 Notes :

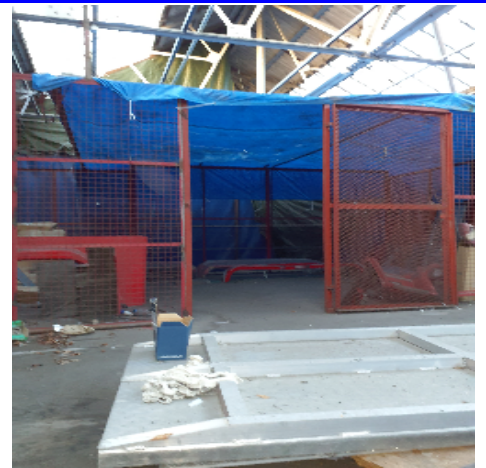
Location Details : 76768 No Asbestos Found

Building/Area : Vehicle store Ground floor
 Room/Section : Main store mezzanine
 Location : Walls, floor
 Description : Block, concrete
 Sample No. :
 Confirmation :
 Access : Full Access
 Normal Use :
 Recommendations :
 Notes :

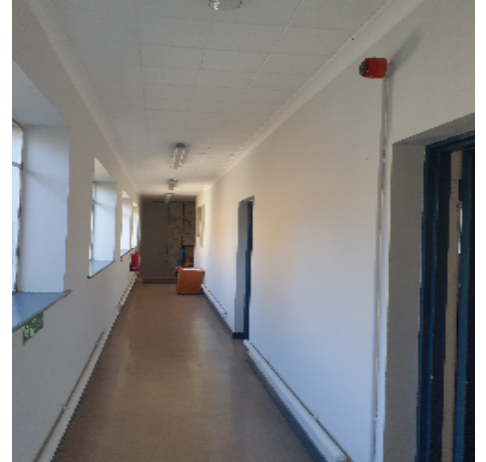
Location Details : 76771 No Asbestos Found

Building/Area : Canteen and office block First floor
 Room/Section : Corridor
 Location : Walls, floor and ceiling
 Description : Block, plaster, timber
 Sample No. :
 Confirmation :
 Access : Full Access
 Normal Use :
 Recommendations :
 Notes : Aero board ceiling panels

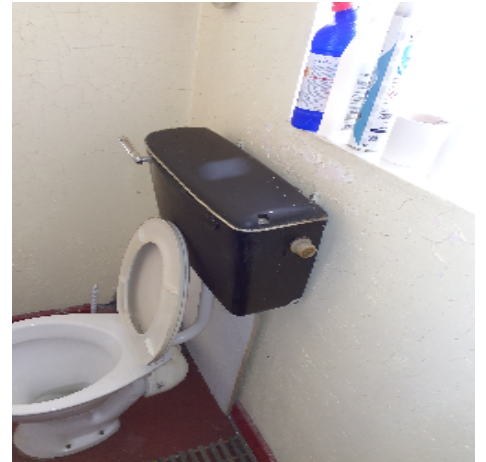
Location Details : 76772 No Asbestos Found

Building/Area : Canteen and office block First floor
 Room/Section : Toilet
 Location : Cistern
 Description : Bakelite
 Sample No. : DBB20231103001
 Confirmation : Sampled
 Access : Full Access
 Normal Use :
 Recommendations :
 Notes : Aero board ceiling panels

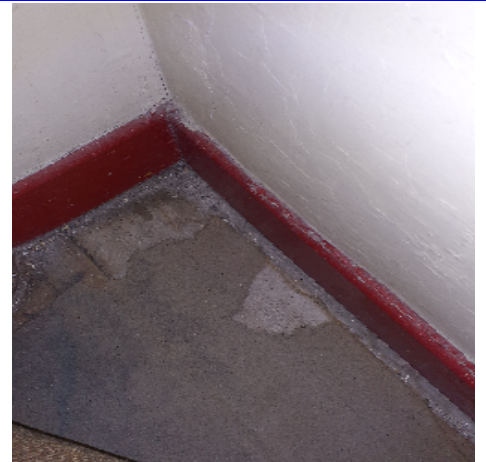
Location Details : 76773 No Asbestos Found

Building/Area : Canteen and office block First floor
 Room/Section : All rooms
 Location : Floor below lino
 Description : Paper
 Sample No. : DBB20231103002
 Confirmation : Sampled
 Access : Full Access
 Normal Use :
 Recommendations :
 Notes : Aero board ceiling panels

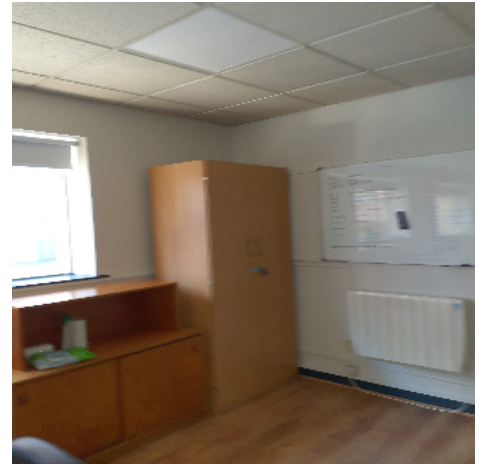
Location Details : 76774 No Asbestos Found

Building/Area : Canteen and office block First floor
 Room/Section : Offices and toilets
 Location : Walls, floor and ceiling
 Description : Block, plaster, timber
 Sample No. :
 Confirmation :
 Access : Full Access
 Normal Use :
 Recommendations :
 Notes :

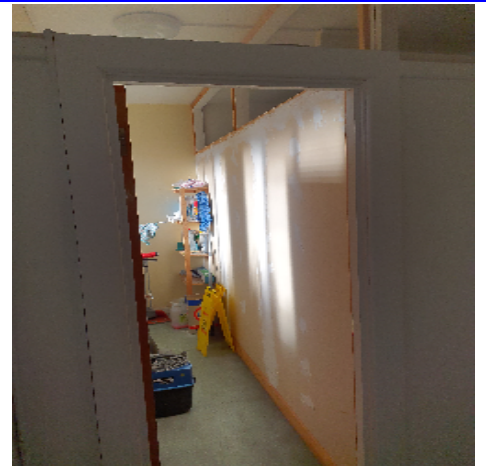
Location Details : 76775 No Asbestos Found

Building/Area : Canteen and office block First floor
 Room/Section : Ladies locker room and toilets
 Location : Walls, floor and ceiling
 Description : Block, plaster, timber
 Sample No. :
 Confirmation :
 Access : Full Access
 Normal Use :
 Recommendations :
 Notes :

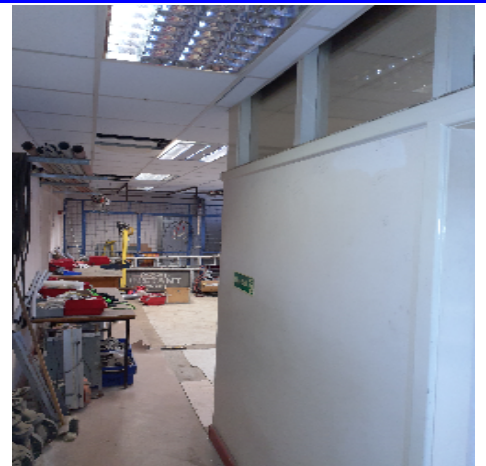
Location Details : 76777 No Asbestos Found

Building/Area : Canteen and office block First floor
 Room/Section : Work shop and canteen
 Location : Walls, floor and ceiling
 Description : Block, plaster, timber
 Sample No. :
 Confirmation :
 Access : Full Access
 Normal Use :
 Recommendations :
 Notes :

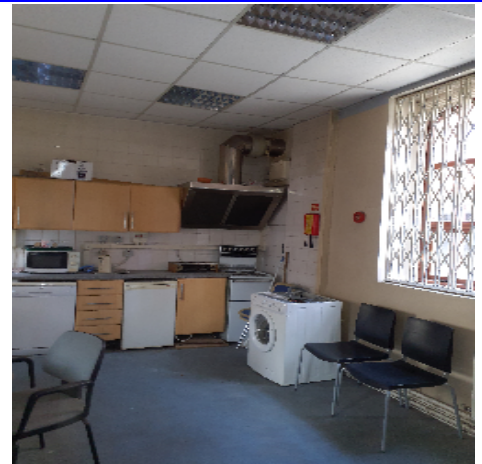
Location Details : 76796 No Asbestos Found

Notes : Mmmf ceiling panels

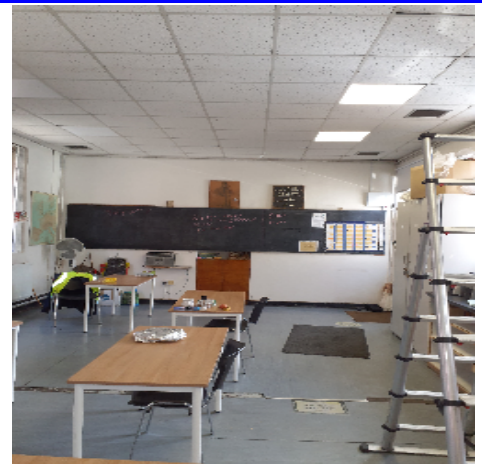
Notes : mmmf ceiling panels

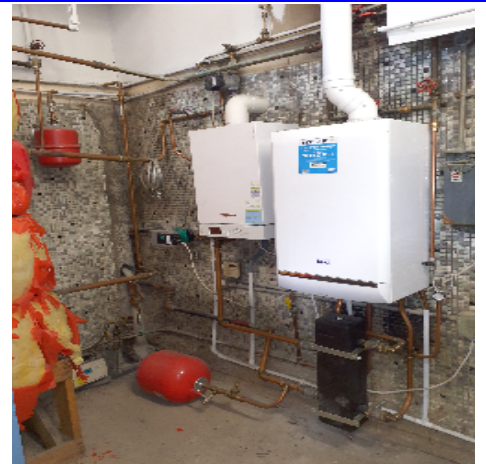
Notes : modern boiler, copper tank

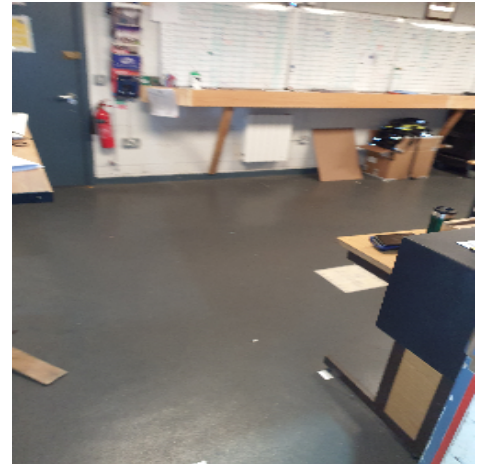
Location Details : 76809 No Asbestos Found

Building/Area : Ground floor
 Room/Section : Stores office
 Location : Floor below lino
 Description : Bitumen
 Sample No. : DBB20231103007
 Confirmation : Sampled
 Access : Full Access
 Normal Use :
 Recommendations :
 Notes : Screed contaminated

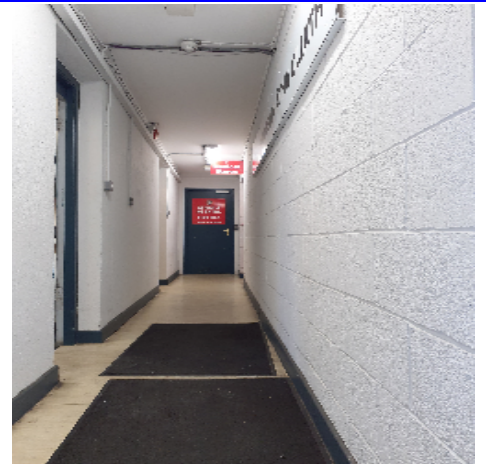
Location Details : 76810 No Asbestos Found

Building/Area : Ground floor
 Room/Section : Stores corridor
 Location : Walls, floor and ceiling
 Description : Block, plaster, concrete
 Sample No. :
 Confirmation :
 Access : Full Access
 Normal Use :
 Recommendations :
 Notes :

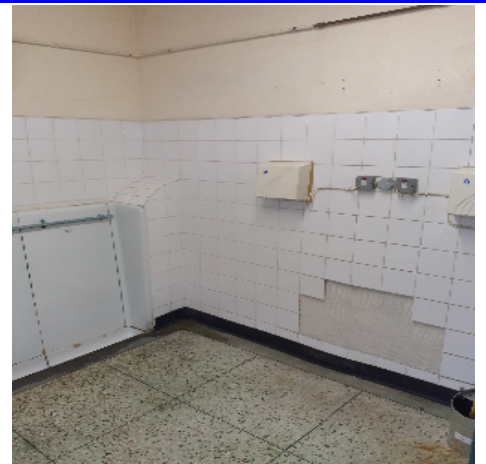
Location Details : 76811 No Asbestos Found

Building/Area : Stores building Ground floor
 Room/Section : Gents and ladies
 Location : Walls, floor and ceiling
 Description : Block, plaster, terrazzo
 Sample No. :
 Confirmation :
 Access : Full Access
 Normal Use :
 Recommendations :
 Notes :

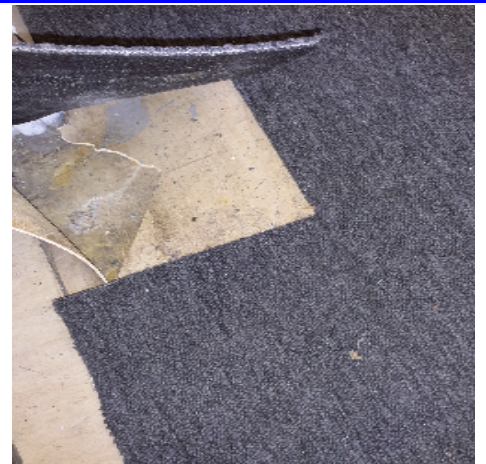
Notes : Screed contaminated
