ASBESTOS DEMOLITION SURVEY REPORT

Collins Avenue Depot

Project Number
39361

Client	Malone O Regan Consulting Engineers	
Project Title	39361 NDFA Project Collins Avenue Depot	
Document Title	Asbestos Demolition Report	
Report No.	39361

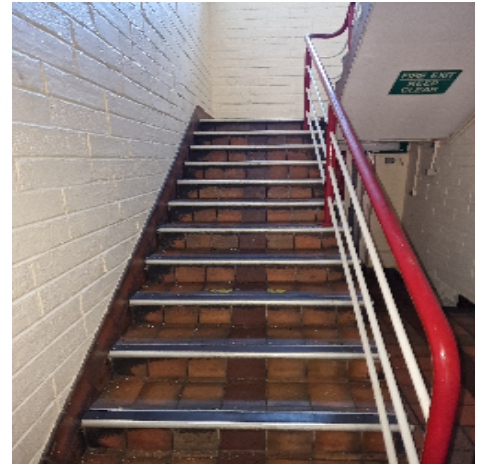
Location Details : 81111 No Asbestos Found

Building/Area :
 Room/Section : Stairs
 Location : stairs nosing
 Description : plastic resin
 Sample No. : ASB20231211005
 Confirmation : Sample Taken
 Access : Full Access
 Normal Use :
 Recommendations :
 Notes :

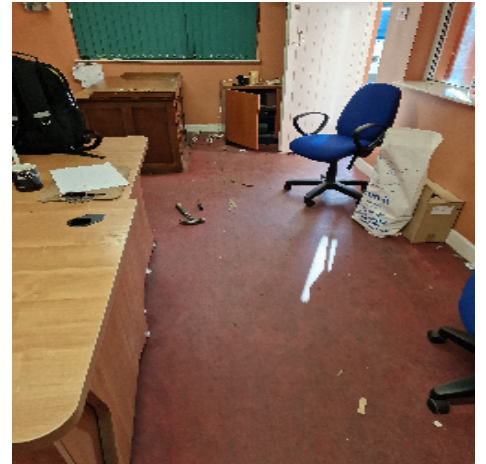
Location Details : 81120 No Asbestos Found

Building/Area :
 Room/Section : Store Office
 Location : Floor
 Description : vft and bitumen
 Sample No. : ASB20231211006
 Confirmation : Sample Taken
 Access : Full Access
 Normal Use :
 Recommendations :
 Notes :

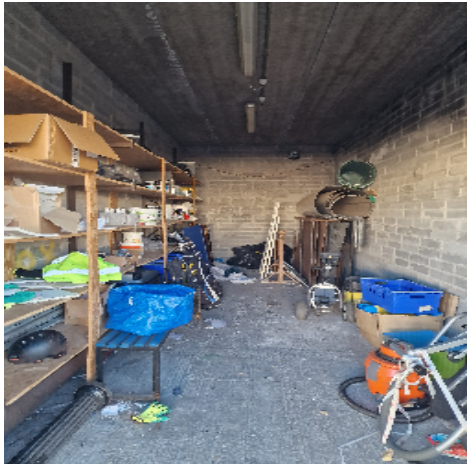
Location Details : 81123 No Asbestos Found

Building/Area :
 Room/Section : Store
 Location : Walls floor and ceiling
 Description : concrete
 Sample No. :
 Confirmation : No Asbestos Detected
 Access : Full Access
 Normal Use :
 Recommendations :
 Notes :

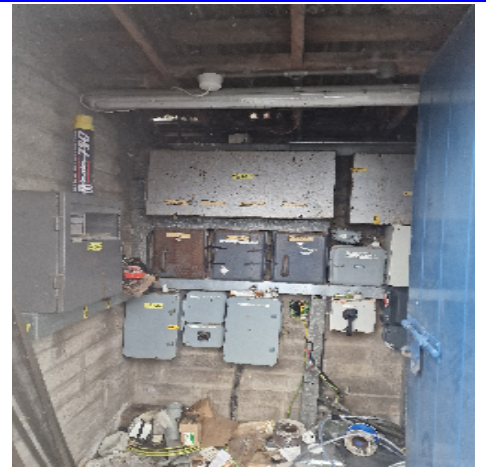
Location Details : 81131 No Asbestos Found

Building/Area : ESB room
 Room/Section : Esb room
 Location : walls floor ceiling
 Description : Concrete blocks
 Sample No. :
 Confirmation : No Asbestos Detected
 Access : Full Access
 Normal Use :
 Recommendations :
 Notes :
