**Architectural Heritage Impact Assessment
For Proposed
Universal Access Project at
The Mansion House, Dawson Street, Dublin 2**

November 2023

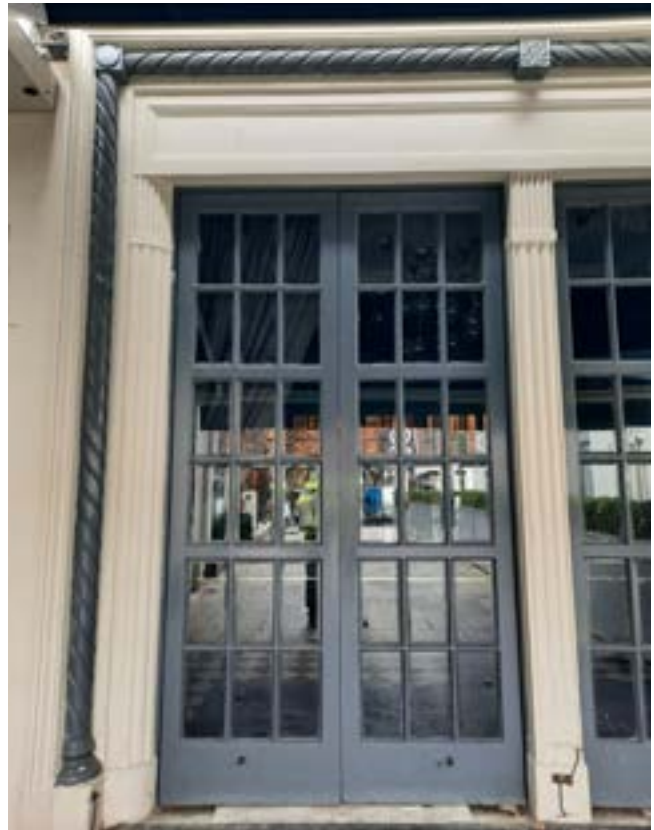
Fig. 4.3 Original timber doors inset into original opening. Decorative details surrounding doorsets.

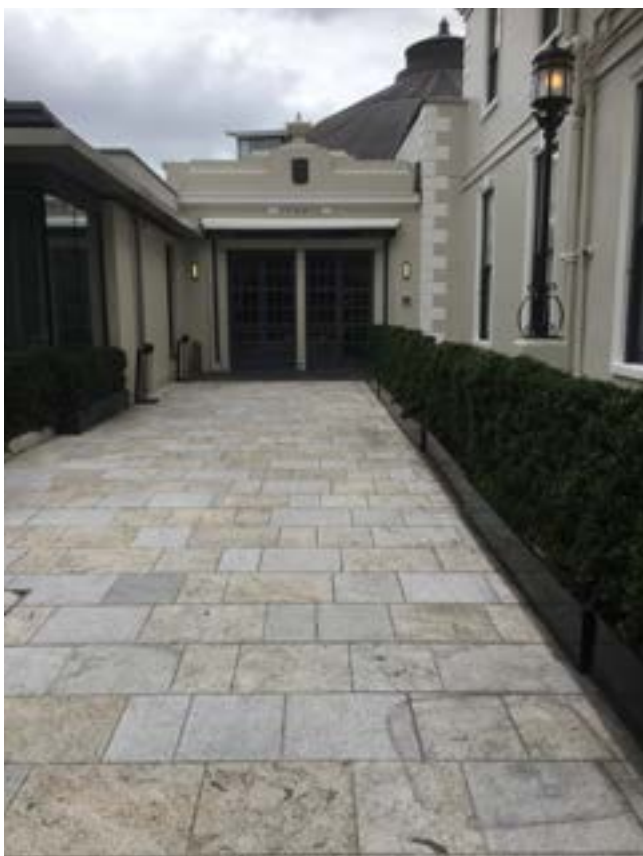
Fig. 4.5 Modern stone paving to upper level of approach route to Round Room.

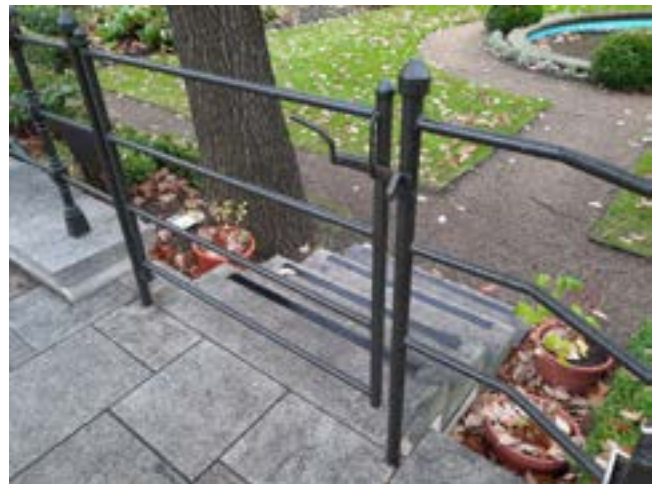
Fig. 4.6 Modern gate and railing between the Lord Mayor's Garden and approach route to the Round Room. All modern paving throughout.

20th century posts (possibly historic replicas from the 1940's) which are supplemented by modern interpretations. For safety reasons, horizontal runs of stainless steel rope have been installed in the gaps between the horizontal bars. The two gates to the garden are also modern inserts. The pedestrian gate between the Mansion House forecourt and the Entrance Approach Route is also modern. However this gate is a replica of a historic profile.

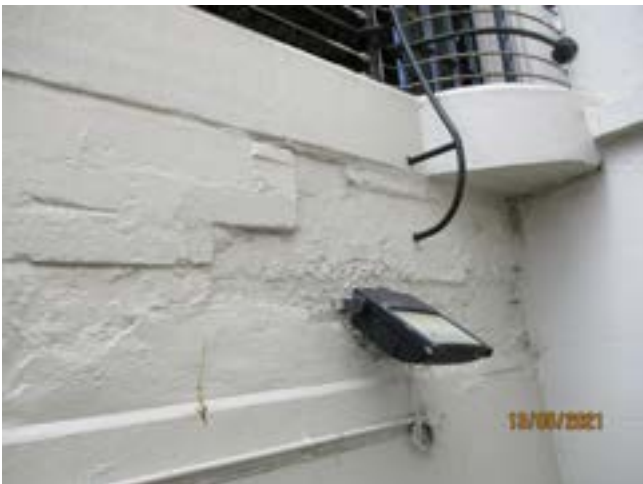
Mansion House is part modern and part historic. The lower section of the wall is of stone and dates to 1710. The wall was constructed at an angle as it acts as a retaining wall to the embankment behind. The lower part of the wall has been rendered and painted. No structural defects were observed and this section of the wall appears reasonably sound. The upper section is of painted concrete and differs to the masonry below. It is unclear at present if the plinth that supports the railing is of concrete or stone. The plinth was constructed at this level in 1928. How-

ever, the earlier stone plinth may have been reused albeit at the higher level. The presentation overall is poor. However, there are no structural defects recorded.

Fig. 4.9 Upper section of wall to light well is of concrete. Lower section is of stone.

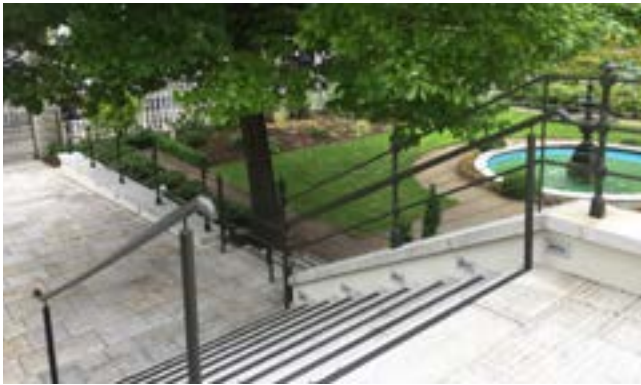
Fig. 4.12 Modern flight of steps along Approach Route to Round Room. All modern paving throughout.

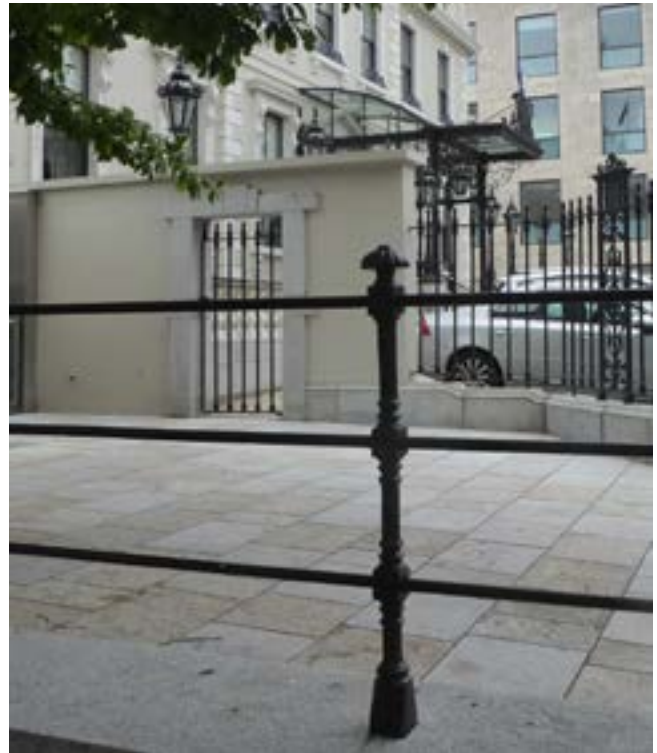
Fig. 4.15 Existing Cast Iron post at southern edge of Garden. These posts will be removed and will be re-laid at the new lower level.

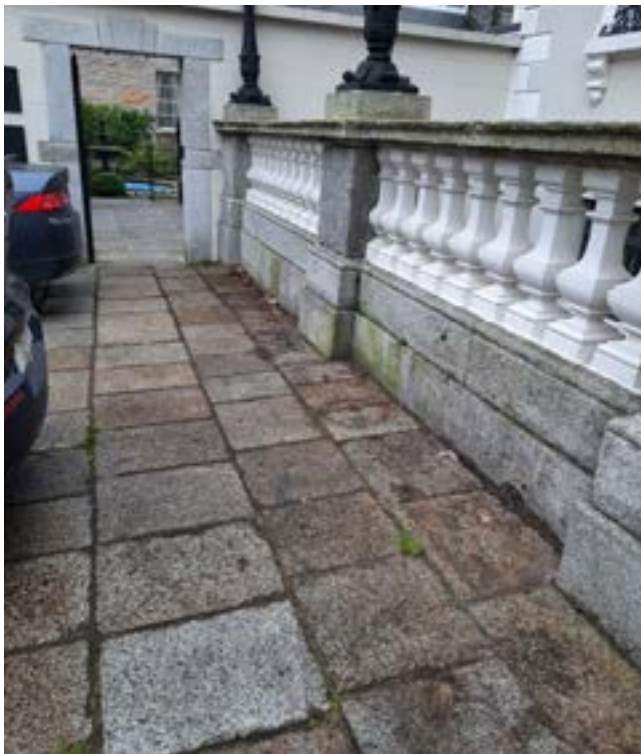
Fig. 4.14 Modern granite paving to forecourt at front of Mansion House. This paving is to be modified as part of the works.

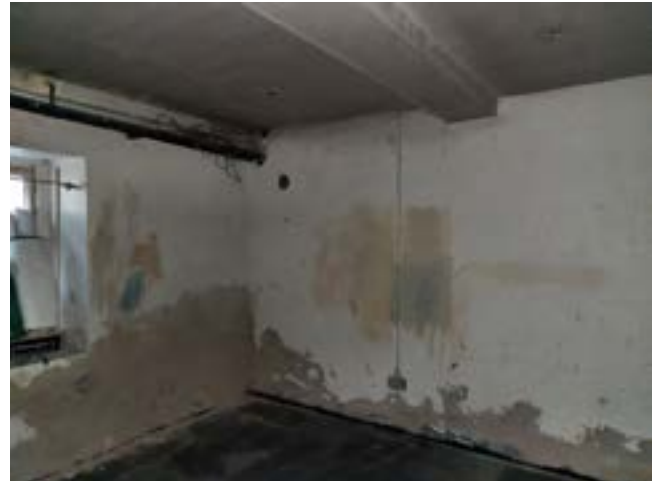
The masonry walls and floors to be removed are typical of walls construed in the early 18th century. Evidence of brick has been noted above and below the basement floor level. The brick walls currently sit on the directly on earth beneath. Generally all the walls are in sound condition. Schemes of re-plastering may have taken place since their construction. However much of the walls appear to retain their original plaster. Modern paints have been used to decorated the basement spaces.

Fig. 4.35 Eastern internal wall of basement where an internal door opening is to be made to adjacent room

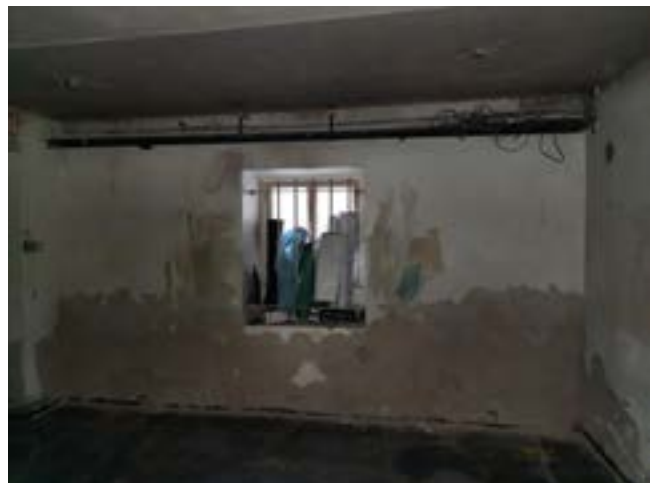
Fig. 4.36 Northern external wall of basement where the new door insertion is to take place

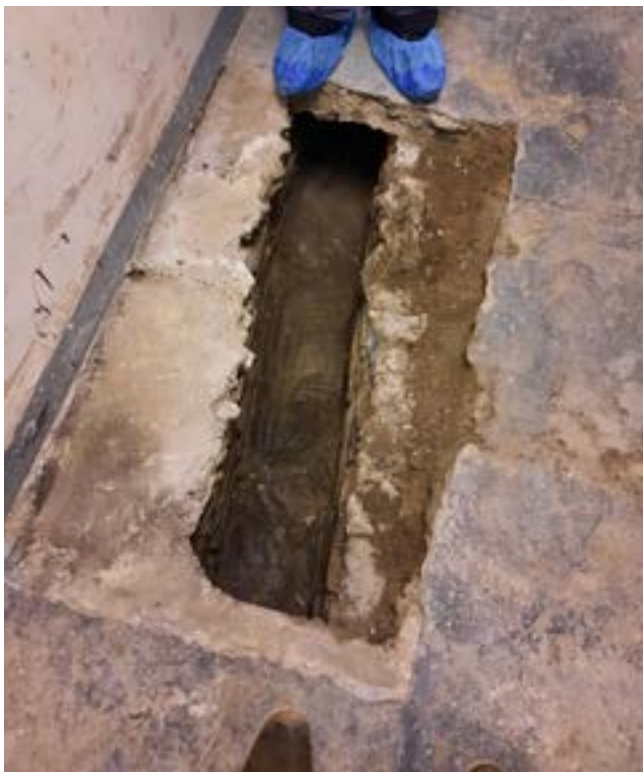
Original flagstones are present in locations where the lift shaft is proposed. The flagstones were generally found to be in reasonable condition. A number flagstones had cracked at some locations. As part of the design works, some site investigation works were required to establish the nature of the walls beneath floor level. The works were carried out following granting of archaeological licence and were supervised on site by an Archaeologist and Conservation Architect.

Fig. 4.39 Stone flags lifted in the basement floor at the location of the proposed lift pit

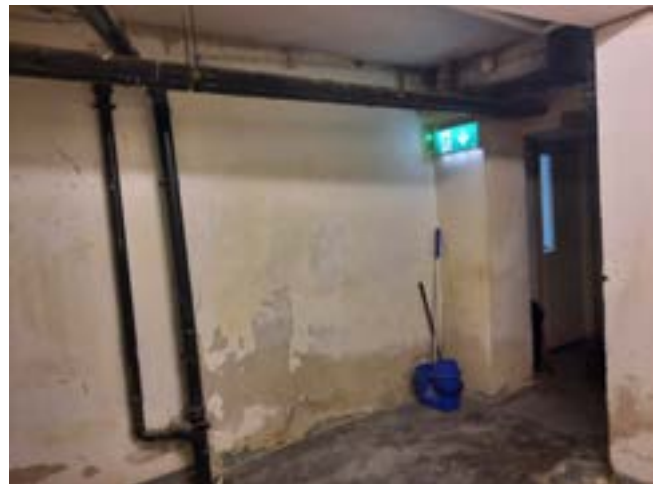
Fig. 4.40 Southern internal wall of basement where an opening is to be made for the lift insertion

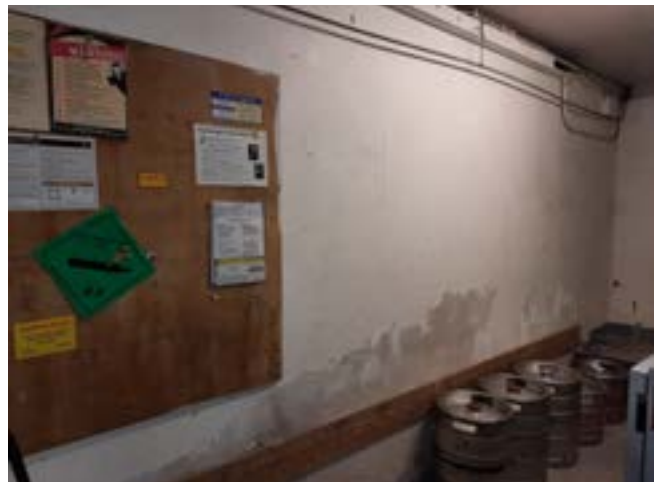
Fig. 4.41 Northern internal wall of basement where an opening is to be made for the lift insertion

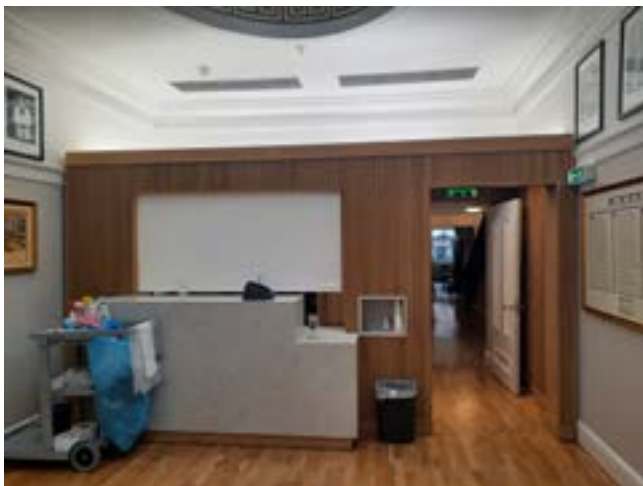
Fig. 4.42 Existing modern bar installed in the Rear Hall of the Mansion House

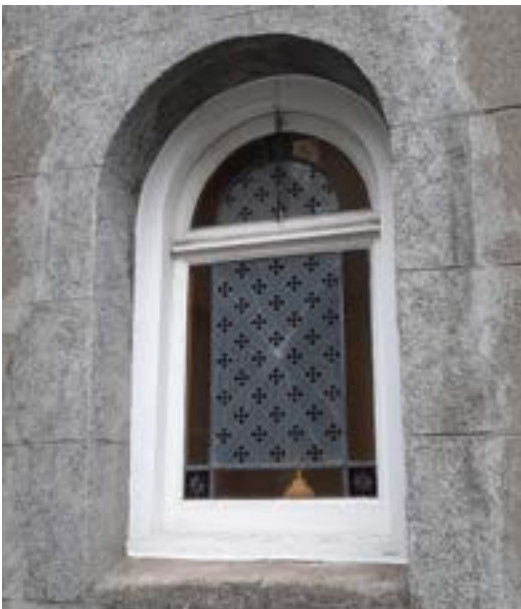
Fig. 4.40 Existing window to be removed.

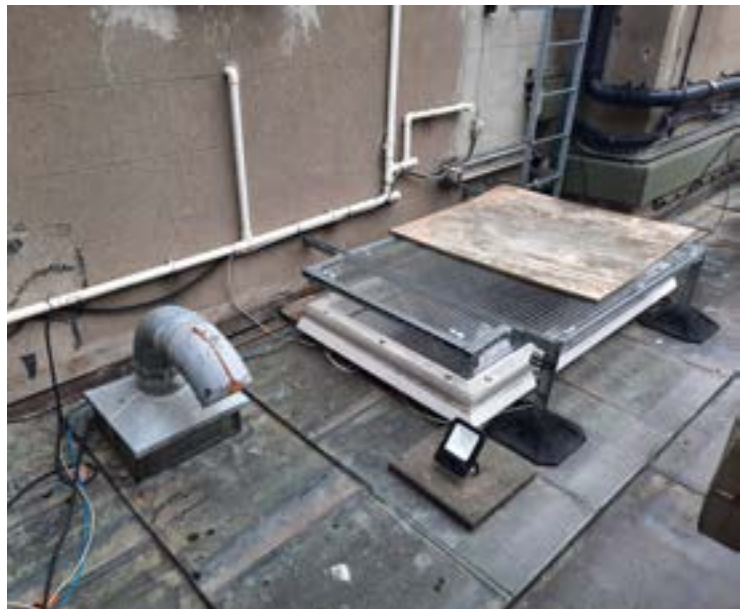
Fig. 4.50 Existing (unused) rooflight to toilets to be removed
